Transportation
Safety Board
of Canada

Marine Transportation Safety Investigation Report M20P0092

DRAGGING ANCHOR AND SUBSEQUENT COLLISION

Bulk carriers *Golden Cecilie* and *Green K-Max 1*
Plumper Sound, Southern Gulf Islands, British Columbia
30 March 2020

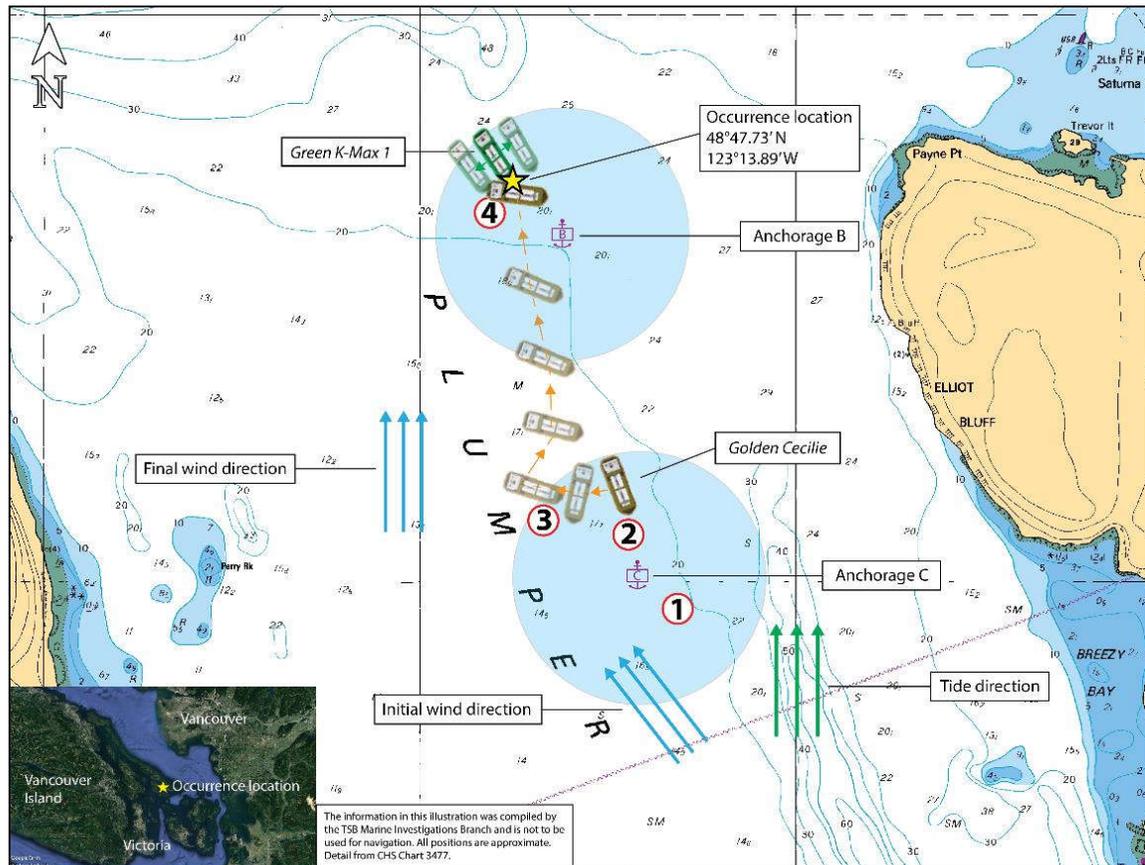
Figure 3. Area of the occurrence (Main image source: Canadian Hydrographic Service, with TSB annotations; inset image source: Google Earth, with TSB annotations)

- 1 Initial anchored position of the *Golden Cecilie* on 28 February
- 2 New anchored position of the *Golden Cecilie* on 19 March after changing anchors
- 3 Anchor dragging alarm activates on the *Golden Cecilie*
- 4 The *Golden Cecilie* collides with the *Green K-Max 1*

At 0326, as the *Golden Cecilie*'s anchor team were still having difficulties releasing the port anchor, the master ordered the starboard anchor to be paid out more. At about 0327, the starboard anchor was paid out 2 additional shackles to a total of 7 shackles in the water. Shortly afterwards, the anchor team managed to release the port anchor from its stowed position and deployed about 12 shackles. At 0328, the engineers started the main engine. The master ordered both anchors to be heaved up and used the main engine in an attempt to move away from the *Green K-Max 1*. The *Golden Cecilie* continued drifting toward the *Green K-Max 1* at a speed of about 1.4 knots. At 0330, the *Golden Cecilie*'s port mid-section collided with the starboard bow area of the *Green K-Max 1*.

At 0331, with the *Golden Cecilie*'s engine running slow ahead, the master attempted to move away from the *Green K-Max 1*, but was unsuccessful. The gusty wind caused the *Golden Cecilie*'s abaft port mid-section to collide with the starboard bow of the *Green K-Max 1* a second time, causing damage to both vessels. At some point during this sequence of events, the *Golden Cecilie*'s port anchor became entangled with the *Green K-Max 1*'s port anchor chain.
