Denman Island Local Trust Committee Regular Meeting Agenda

Date: October 21, 2014
Time: 10:30 am
Location: Denman Seniors Hall
1111 Northwest Rd, Denman Island, BC

Appendix A
**Photographs – Visual Site Reconnaissance, 2600 Swan Road, Denman
Island, BC, August 9, 2013**

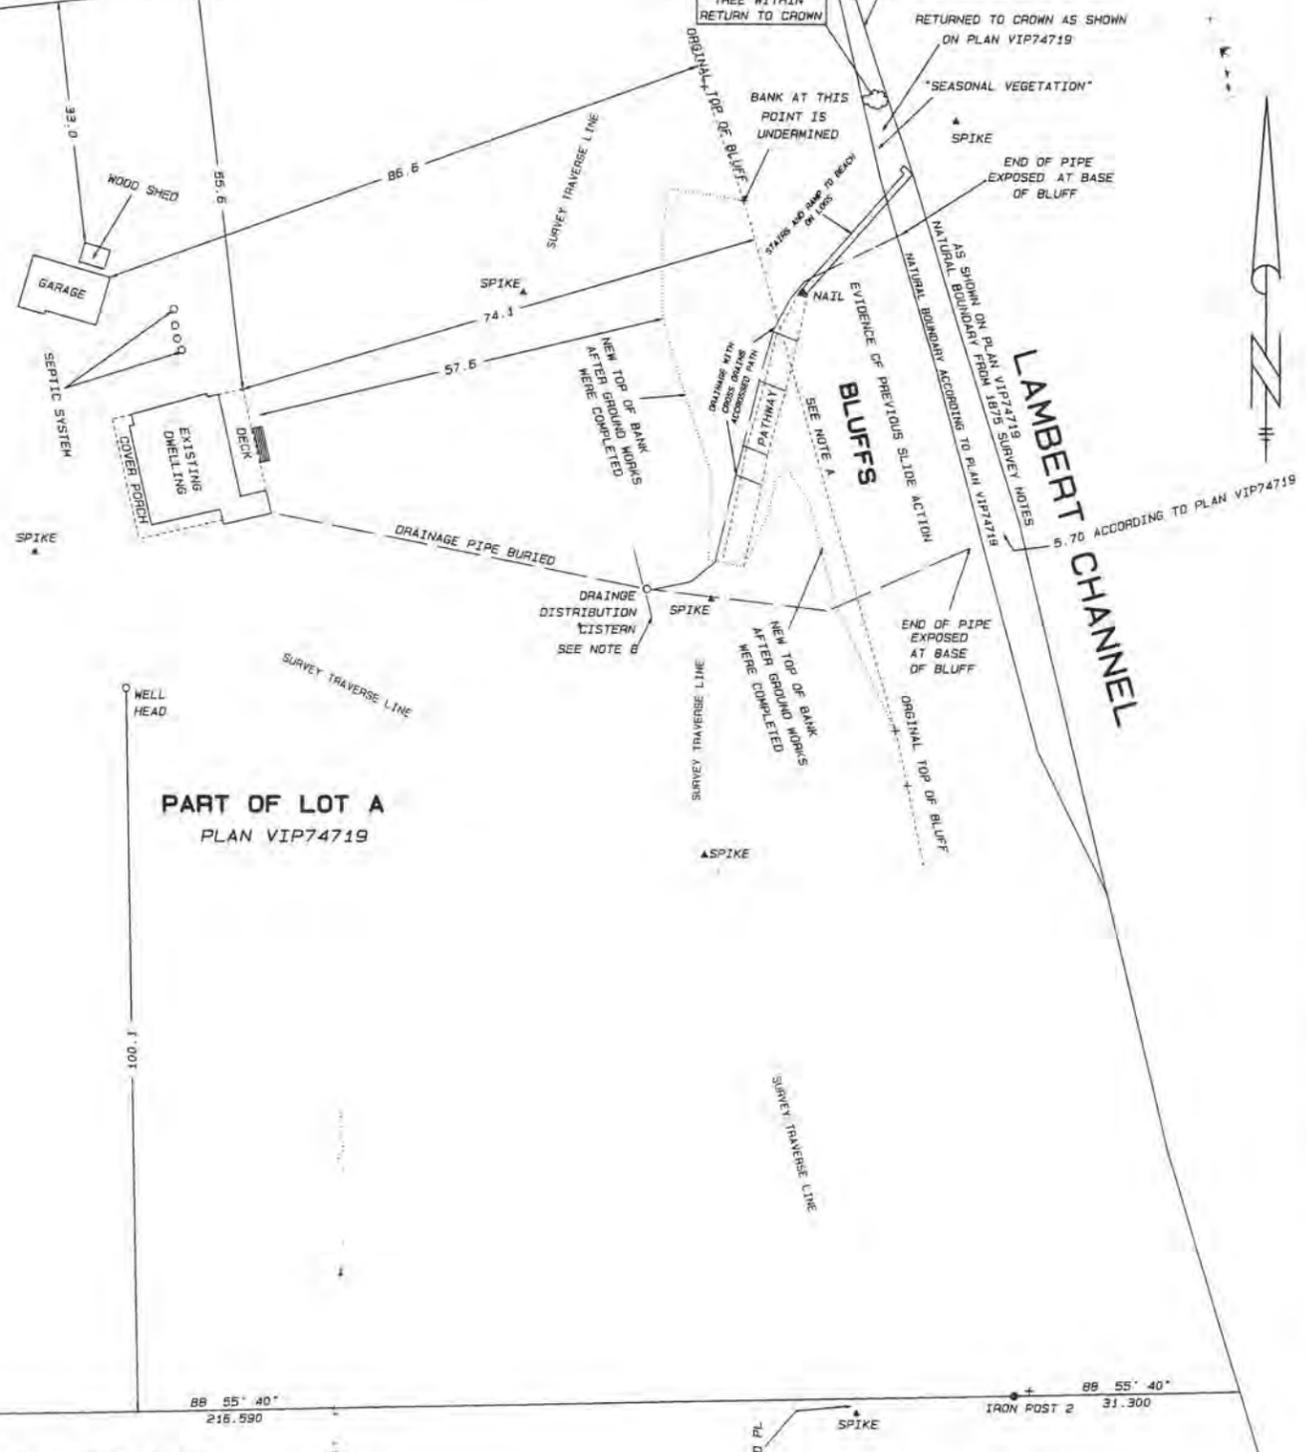
BLUFFS

NOTE A:
LOCATION OF ORIGINAL TOP OF BANK AT THIS LOCATION IS
INTERPOLATED FROM SHOTS TAKE ON ORIGINAL
TOP OF BANK TO THE NORTHWEST AND SOUTHEAST OF SLIDE AND GROUND DESTRUBED AREA

NOTE B:
OWNER INDICATED THAT THERE ARE .15 PERFORATED
DRAINAGE PIPES BURIED TO THE NORTHWEST AND SOUTHEAST OF
DRAINAGE CISTERN USED TO COLLECT GROUND WATER AND SEND
IT TO CISTERN AND AWAY FROM THE ENBANKMENT

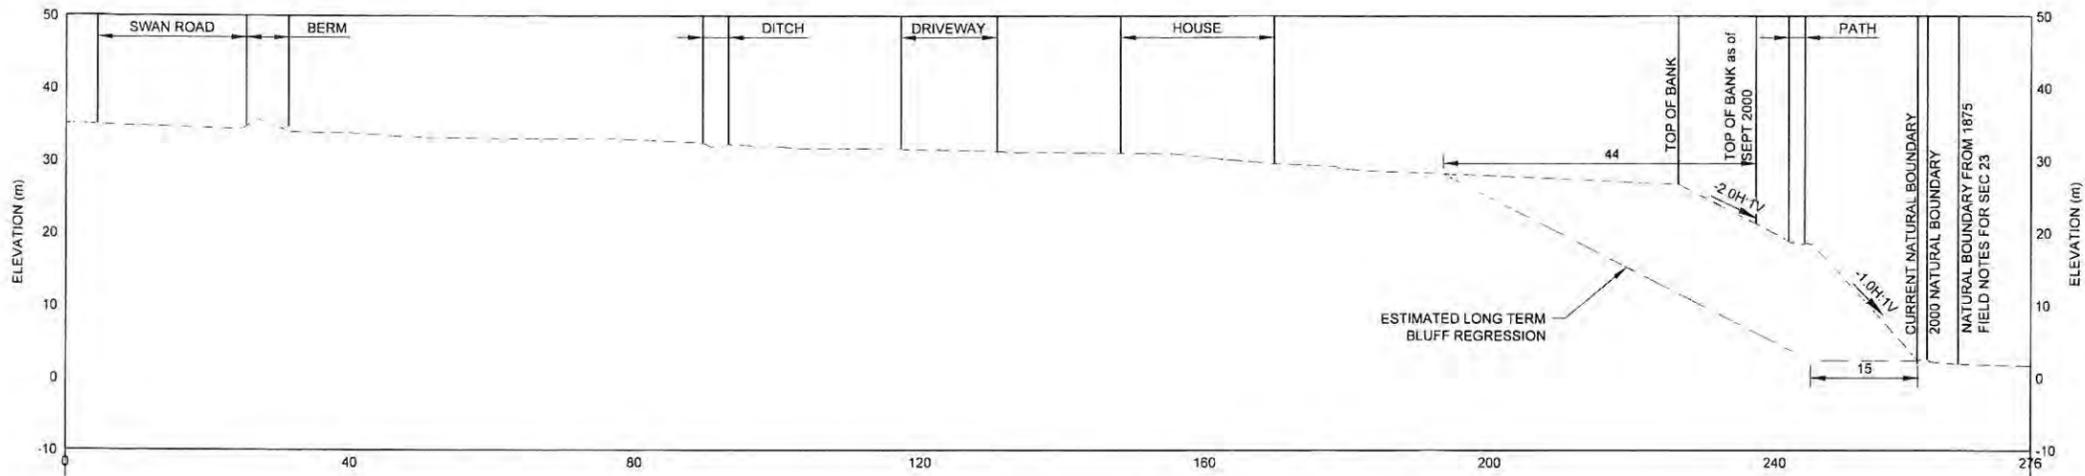
SCALE A **A** TYPICAL CROSS-SECTION
2

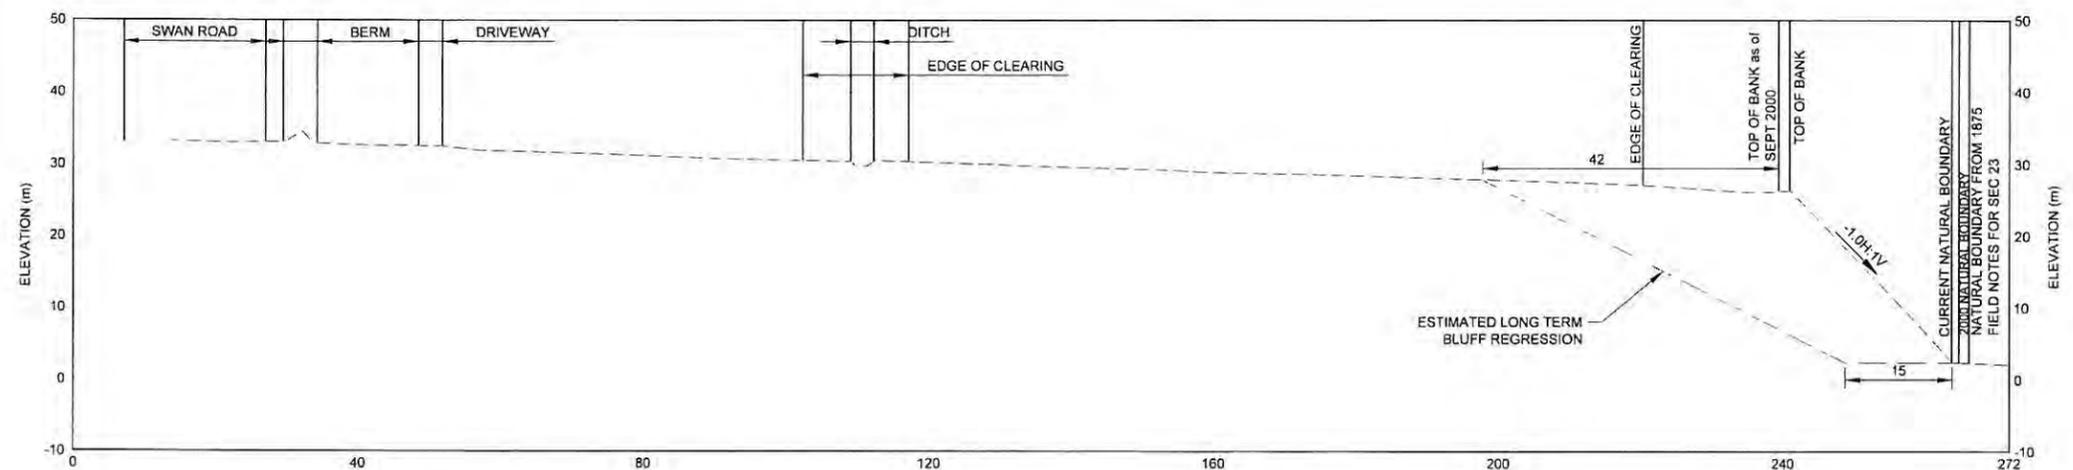
SCALE A **B** TYPICAL CROSS-SECTION
2

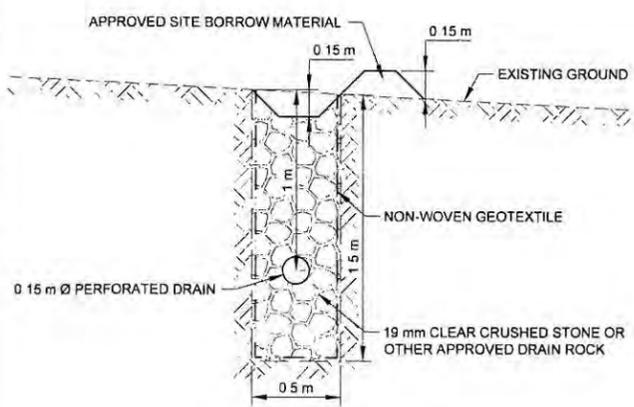
SCALE B **C** PROPOSED INTERCEPTOR TRENCH CROSS-SECTION
2

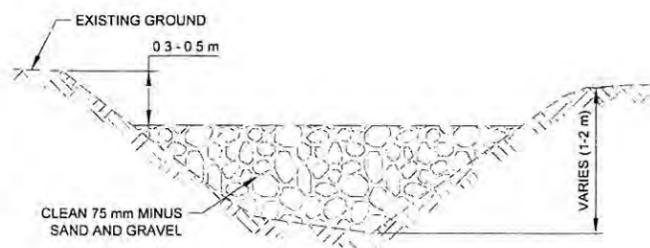
SCALE B **D** PROPOSED CHECK DAM TYPICAL CROSS-SECTION
2

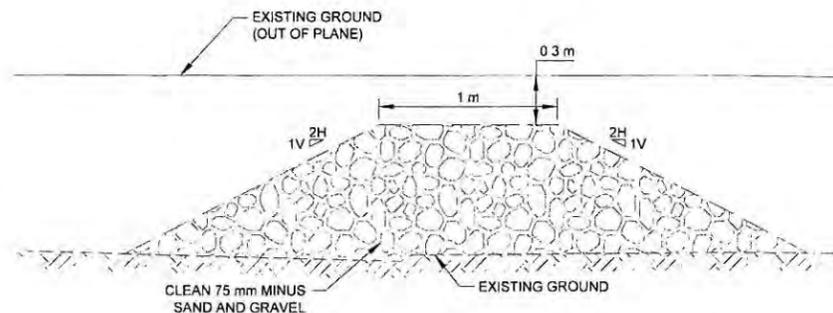
SCALE B **E** PROPOSED CHECK DAM TYPICAL CROSS-SECTION
2

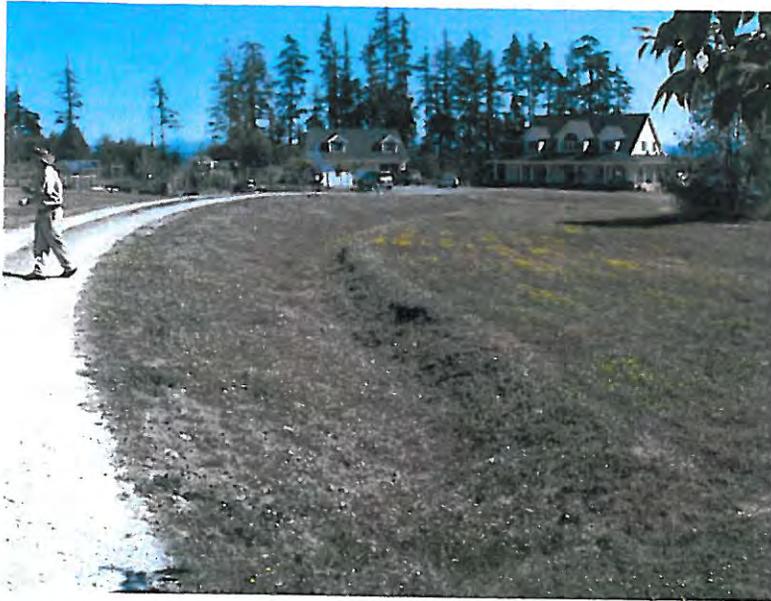
Plate A-1: Looking northeast along gravel surfaced driveway and drainage swale towards Stoneman residence and garage.

- Note:
- Gently sloping ground surface along driveway and swale towards residence.
 - Low, sparse grass cover and lack of tree cover.

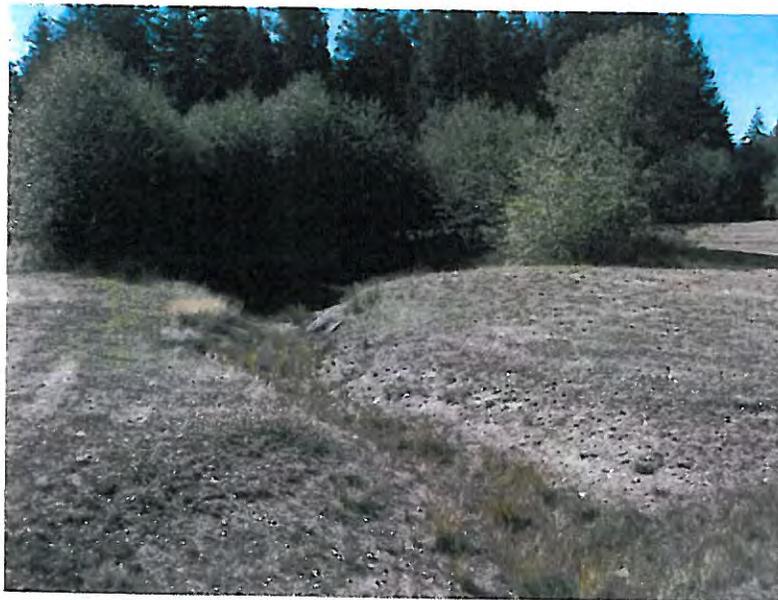
Plate A-2: Looking south along ditch into pond from swale along driveway.

- Note:
- Small trees around pond but sparse grass cover and exposed soil at surface on and above ditch side slopes.

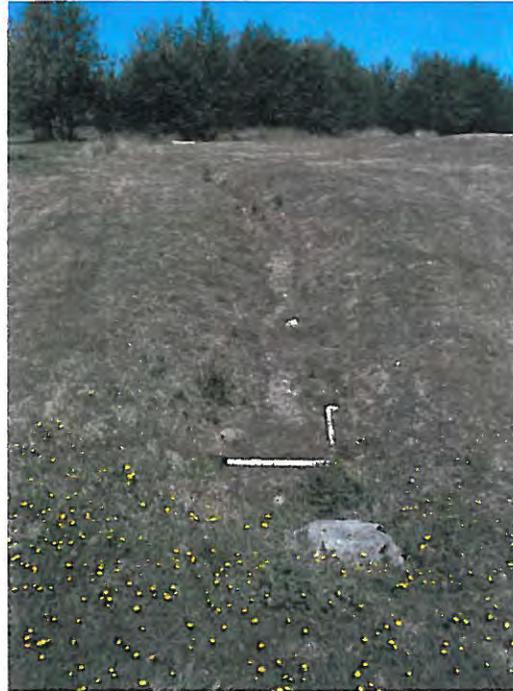
Plate A-3: Looking northwest from driveway along shallow swale or ditch above inlet of culvert under driveway.

- Note:
- Exposed piping or utility conduit crossing swale.
 - Moderate tree cover in northwest corner of property but sparse grass cover and exposed soil at surface along and adjacent to swale.

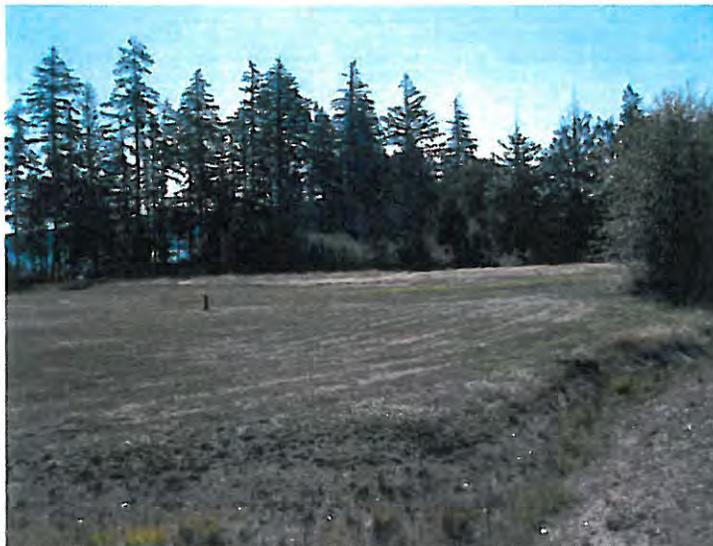
Plate A-4: Looking southeast across ditch into pond towards treed area adjacent to bluff slopes.

- Note:
- Gently sloping ground surface, with sparse dry grass or hay cover in foreground, dipping towards bluff.
 - Well casing extending above ground surface in grass area.

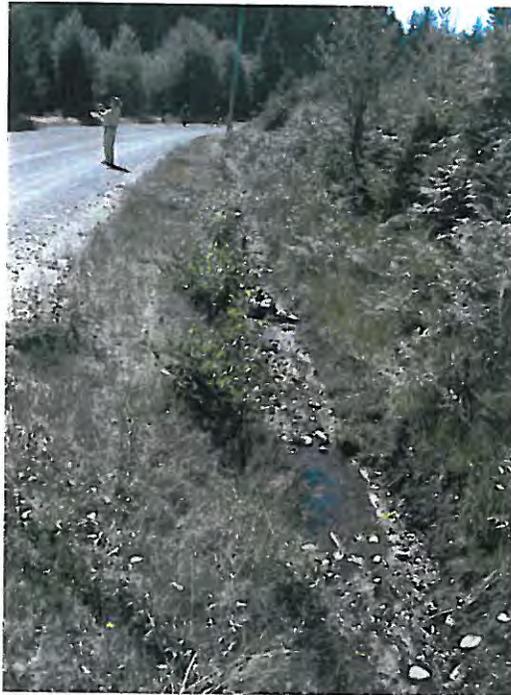
Plate A-5: Looking south along drainage ditch on west (upslope) perimeter of gravel surfaced Swan Road.

- Note:
- Ponded water and damp soil indicating seepage present locally along ditch, even during dry weather conditions.
 - Gentle (approximately 5 percent) slope of ditch and drain to south along 2600 Swan Road frontage.

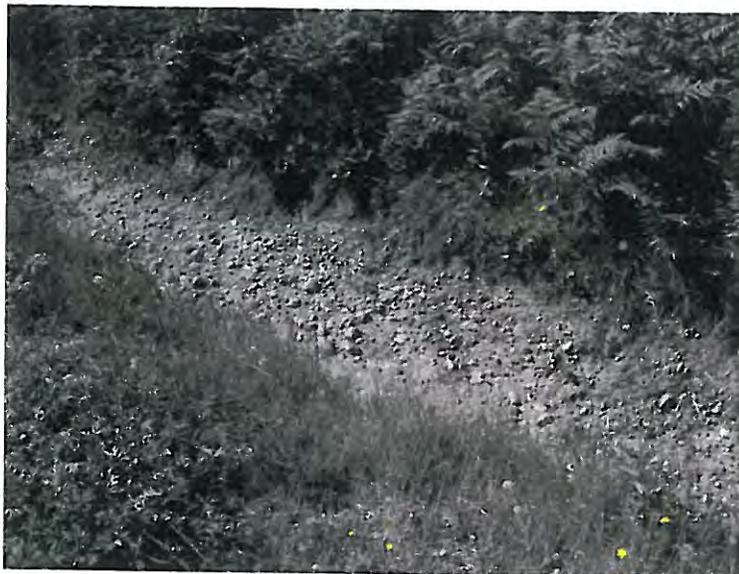
Plate A-6: Close-up of coarse sand and gravel or gravelly sand exposed along drainage ditch on west (upslope) perimeter of Swan Road.

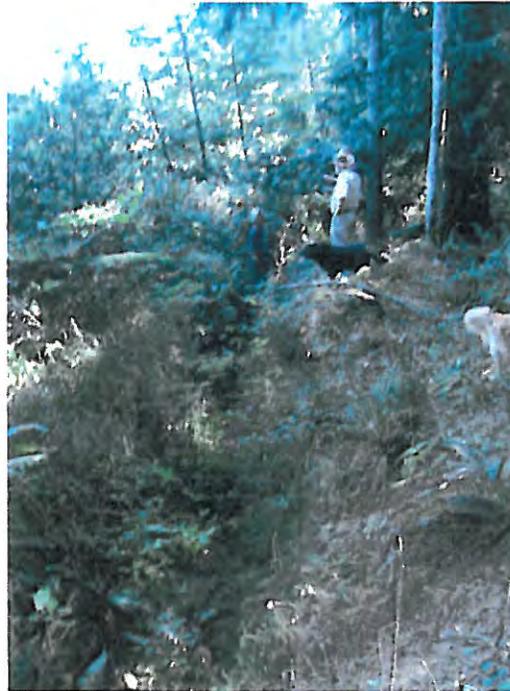
Plate A-7: Looking east at previously developed drainage ditch extending towards bluff near south property line of 2600 Swan Road.

Note: - Well established vegetation along and within 1.5 to 2 m deep ditch, plus adjacent tree cover.

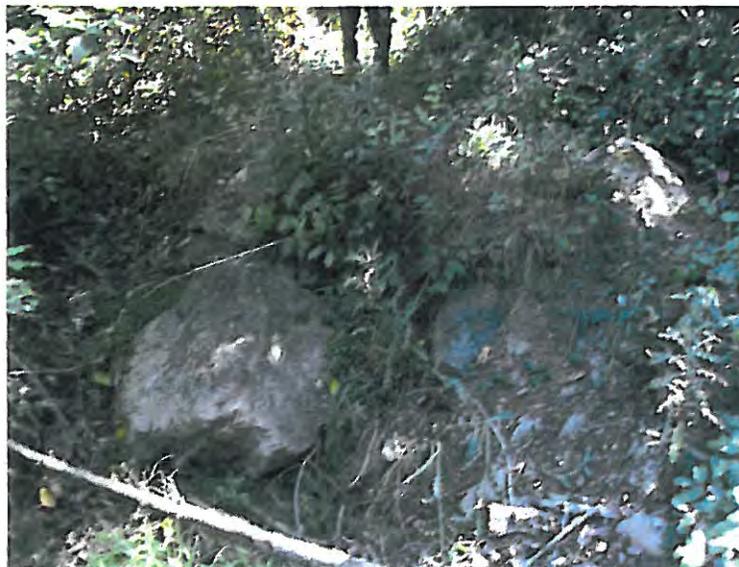
Plate A-8: Fill plug, including boulder sizes, at east end of existing, previously developed ditch near south property line.

Note: - Lack of evidence of concentrated overland flow beyond plugged ditch or connection to newly excavated channel on adjacent property to south.

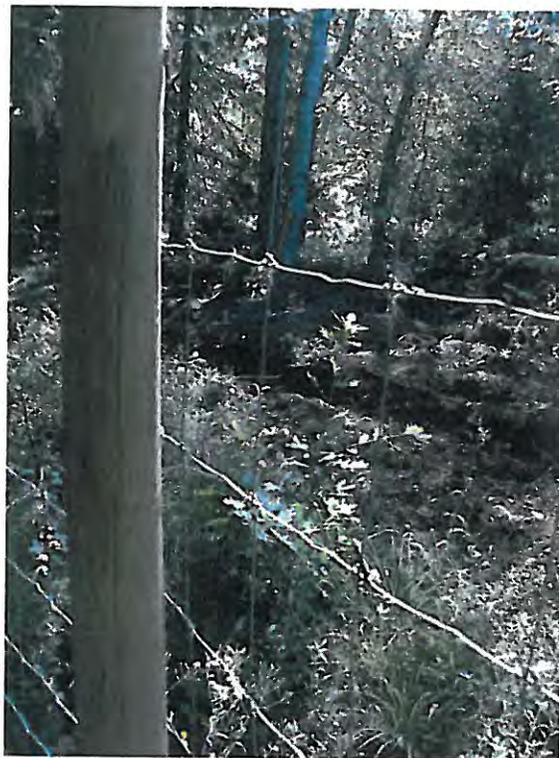
Plate A-9: Looking southeasterly at recently excavated channel or drainage ditch extending towards crest of bluff within adjacent property, and close to south property line.

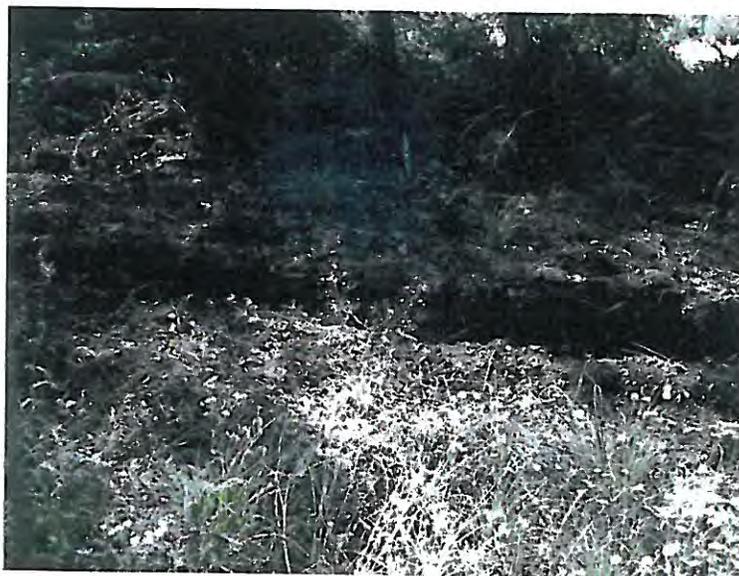
Plate A-10: Close-up of recently excavated channel or drainage ditch on adjacent property, close to south property line.

Note: - Loose, disturbed fine grained soils or fill within and adjacent to excavated channel.

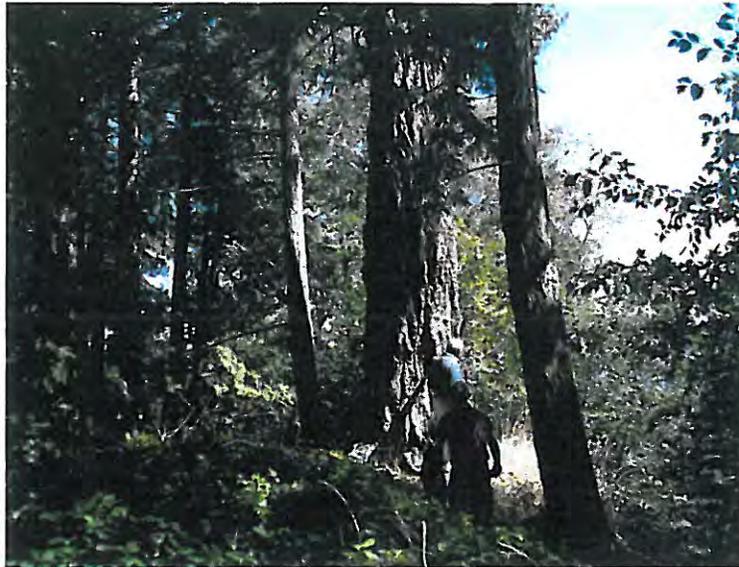
Plate A-11: Looking north along crest of bluff within southeast corner of property.

- Note:
- Extensive, generally vertical, mature coniferous tree cover extending up to crest of bluff.
 - Well established, extensive understory and ground cover within treed area.

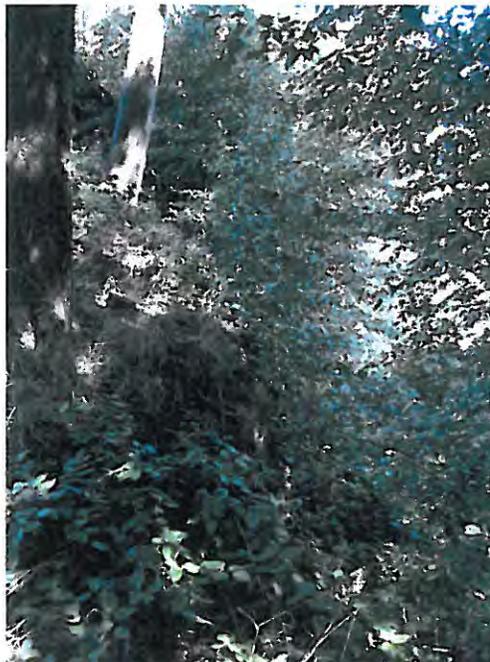
Plate A-12: Close-up of steep, near vertical or overhanging upper scarp of bluff in southeast corner of property.

- Note:
- Vertical to slightly tilted mature trees immediately adjacent to crest of bluff.
 - Extensive, well established deciduous (alder) tree cover and understory vegetation on bluff slopes below upper scarp.

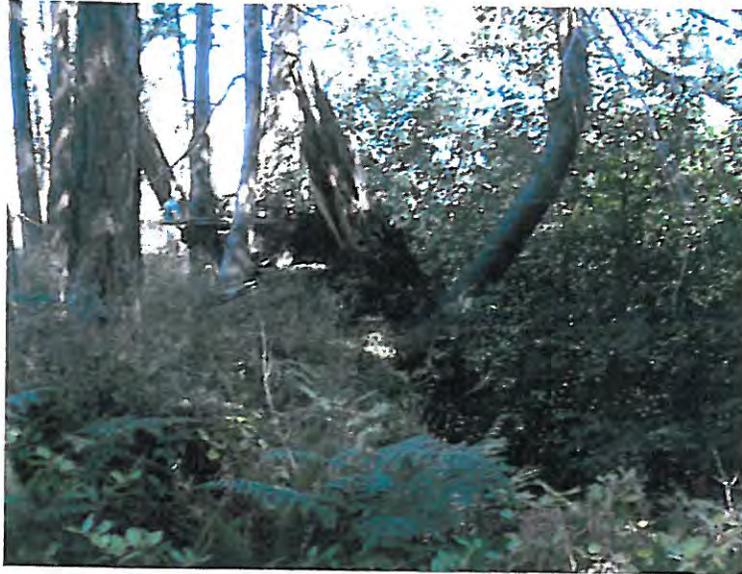
Plate A-13: Looking northerly along crest of bluff in southeast corner of property.

- Note:
- "Pistol butt" curvature or tilting of some trees at crest of bluff, but adjacent intact, well established trees and ground cover, as well as old tree toppled onto upper slope of bluff.
 - Well established deciduous tree cover on slopes below but rising above crest of bluff scarp.

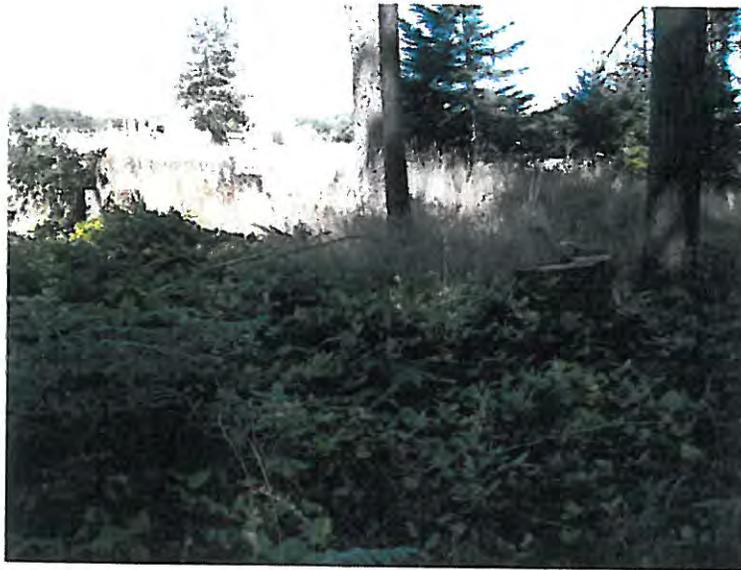
Plate A-14: Looking north towards central portion of property, with residence in background.

- Note:
- Stumps in foreground, and widely spaced remaining tree cover, plus local smaller coniferous trees.
 - Change from green, dense ground cover in treed area to dry, sparse grass or hay cover in cleared area.

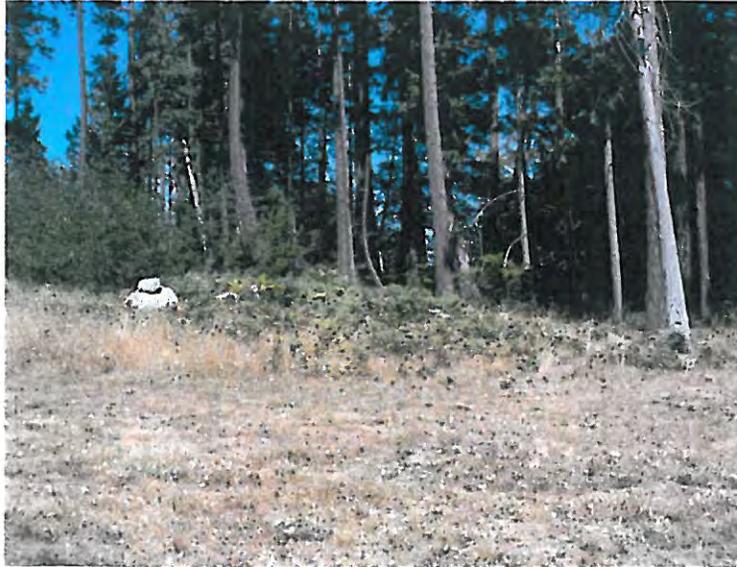
Plate A-15: Looking north towards treed area near bluff in northeast corner of property.

Note: - Change from dry, sparse grass or hay cover in cleared area to green, dense ground cover in tree covered area.

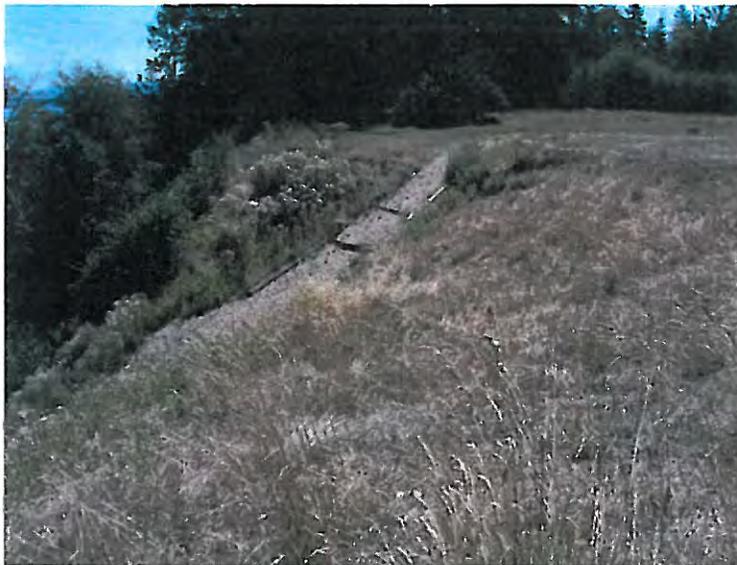
Plate A-16: Looking south across regraded upper slopes of bluff in central portion of property and path constructed on bluff slope.

Note: - Dry, sparse grass or hay ground cover in regraded area, with small, local understorey or deciduous tree growth in foreground, and extensive tree cover above bluff in background.

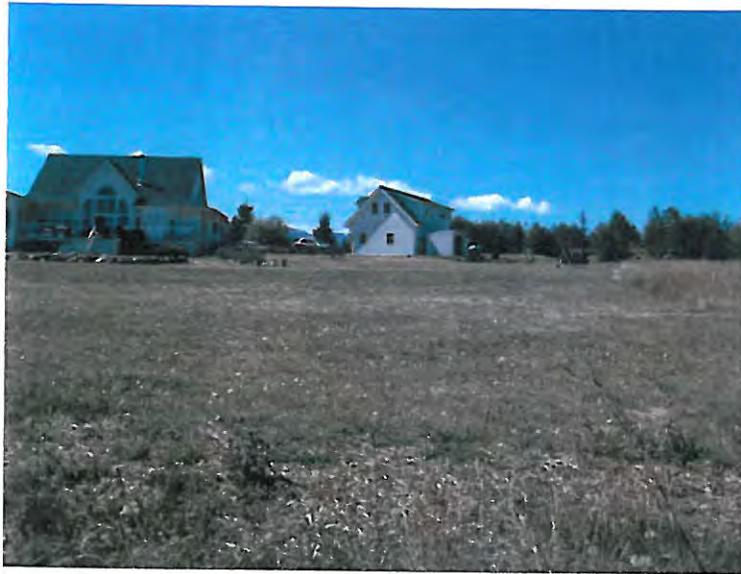
Plate A-17: Looking east from about crest of regraded bluff slope towards residence and garage.

- Note:
- Dry and short grass or hay cover between crest of slope to and beyond residence.
 - Ground surface dipping from residence towards crest of regraded slope.

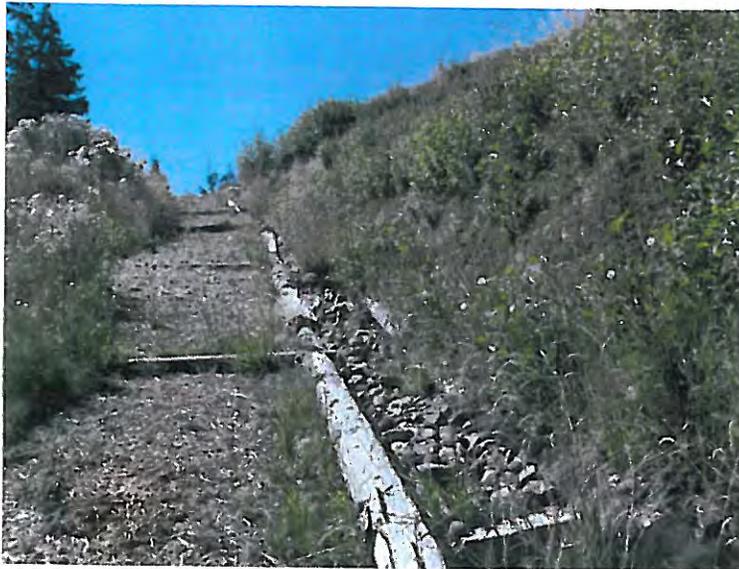
Plate A-18: Looking southerly up path constructed on excavated and regraded bluff slopes.

- Note:
- Sparse grass and low underbrush cover on steep cut bank above coarse, cobble filled collector drain along upslope edge of path.

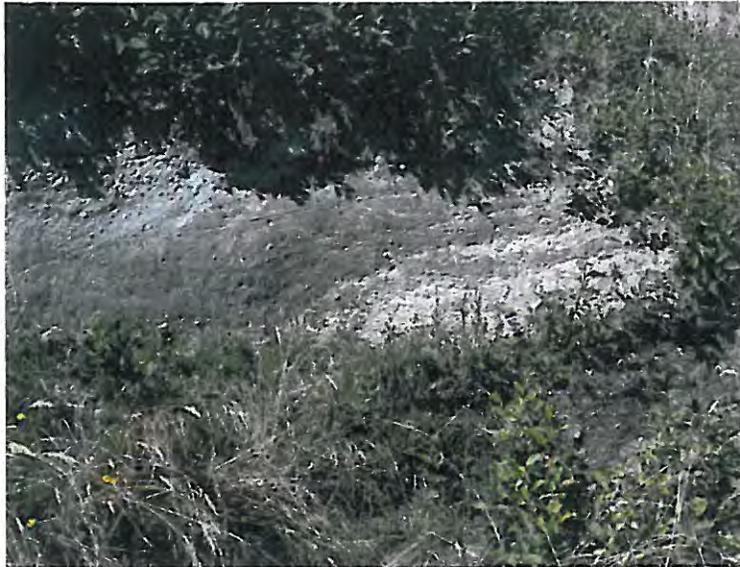
Plate A-19: Near vertical soil exposure above path on regraded bluff slope.

Note: - Generally fine grained silty sand to sandy silt, with trace to some small gravel sizes, with thin, near horizontal layering.

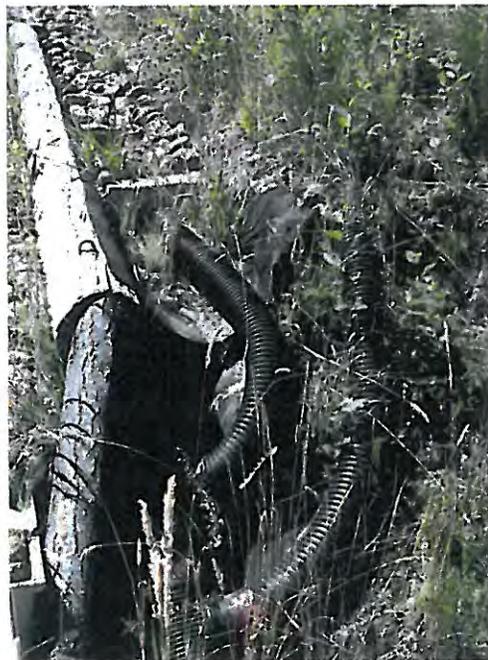
Plate A-20: Exposed, corrugated plastic piping and connections between three drain or subdrain systems at the transition from the path to the stairs on the regraded slope.

Note: - Red tape seal or cover at connections between various piping.

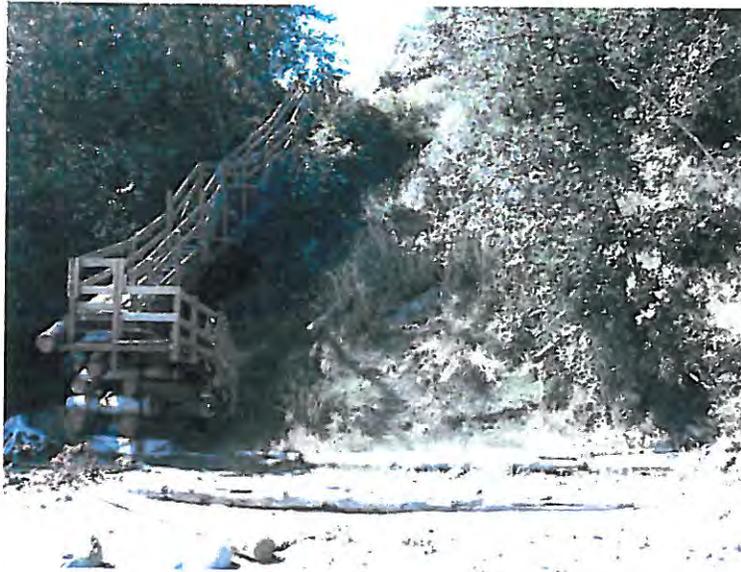
Plate A-21: Looking east at stacked log supported elevated stairs on lower portion of the bluff slopes.

- Note:
- Well established grass and minor small tree cover on previously cleared or slide area north of the stairs.
 - Extensive deciduous tree and understorey cover to the south of stairs and north of cleared/slide area.
 - Storm log debris and beach sediments extending to and inland of base of stairs.

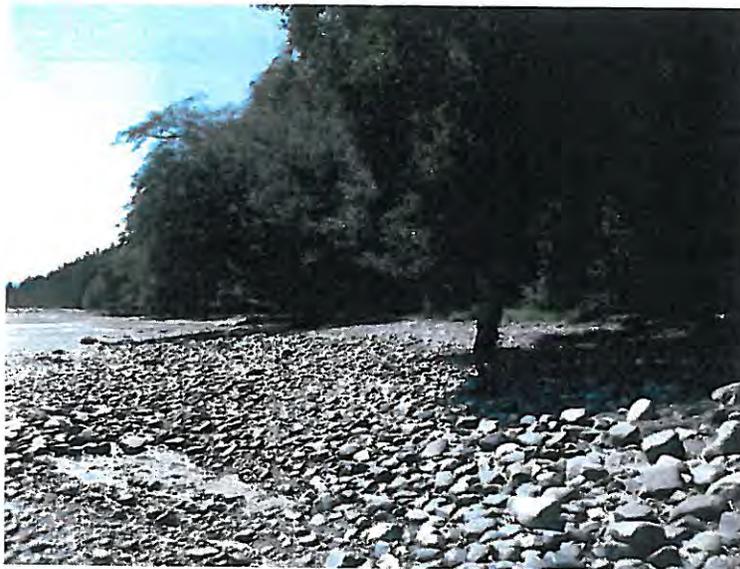
Plate A-22: Looking south along shoreline and toe of bluff slopes.

- Note:
- Extensive, well established tree cover on slopes, extending to toe of slope.
 - Coarse, rounded gravel, cobbles and boulders exposed at surface along intertidal zone and extending up to toe of slope.

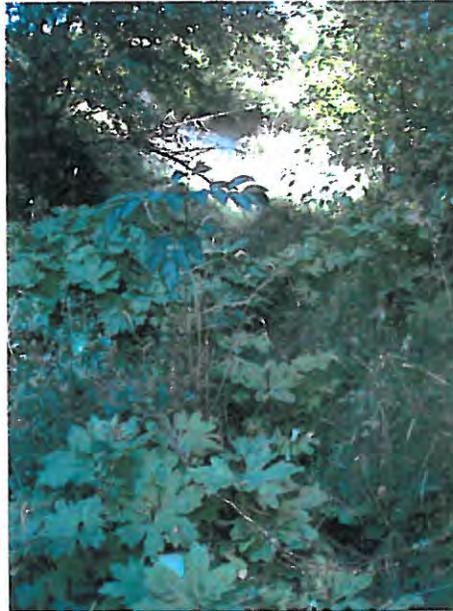
Plate A-23: Looking west up previous erosion or slope failure along bluff to the south of regraded slopes and constructed path and stairs.

- Note:
- Steep to near vertical and locally overhanging scarp, with exposed fine silty and sandy soils in background.
 - Well established ground cover vegetation on lower portion of slide failure and runout area.

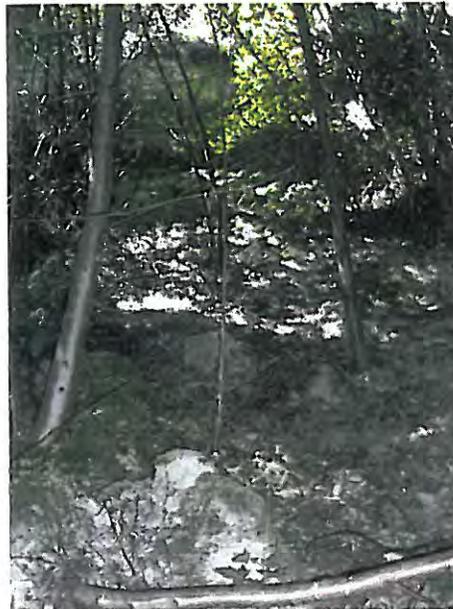
Plate A-24: Looking west up previous erosion or slope failure near south property line, with exposed, near vertical scarp in background and slide debris on lower slopes in foreground.

- Note:
- Small deciduous tree growth, tilted or with "pistol butt" curvature, within slide debris zone.

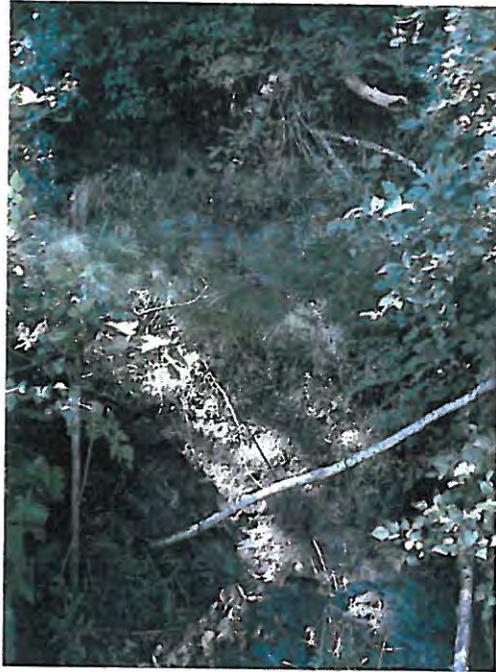
Plate A-25: Steep to near vertical soil exposure near toe of slope north of stairs.

- Note:
- Fine grained silty and sandy soils, with near horizontal layering.
 - Possible small erosion cavity or seepage "pipe" near the top of the soil exposure.

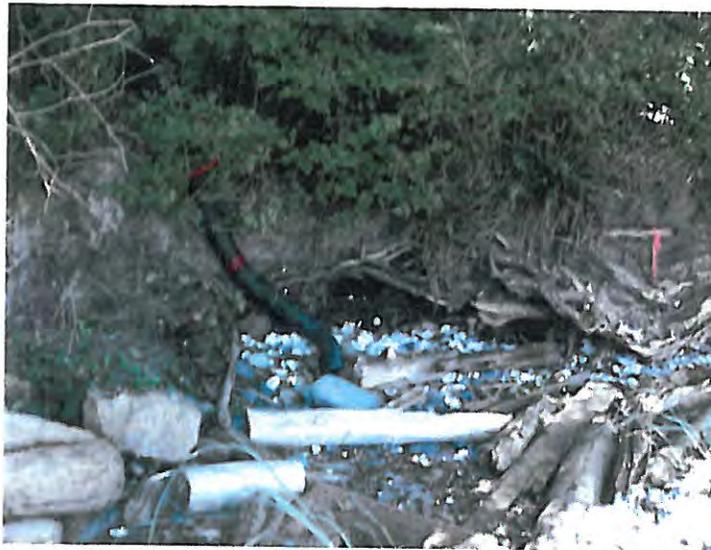
Plate A-26: Looking at discharge outlet of corrugated plastic drain pipe at toe of bluff slopes south of stairs.

- Note:
- Drain piping on or locally at shallow depth below ground surface of bluff slopes, with red tape cover or seal at pipe joints.
 - Near vertical, locally undermined toe of bluff slopes, with storm log debris and cobbles or boulders extending up to pipe outlet.

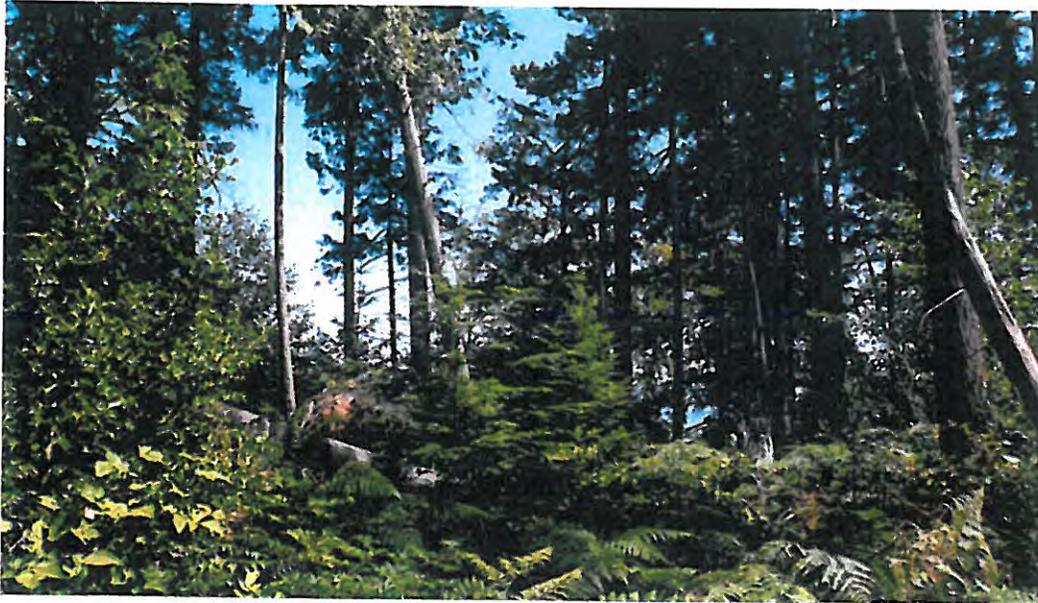
Plate B-1: Vegetation remaining in un-disturbed areas west of top of bank.

Note: - Douglas fir trees in a closed canopy, with understorey of mixed evergreen (salal, sword fern, young coniferous trees) and deciduous (salmonberry, bracken fern, etc.), with few grasses.

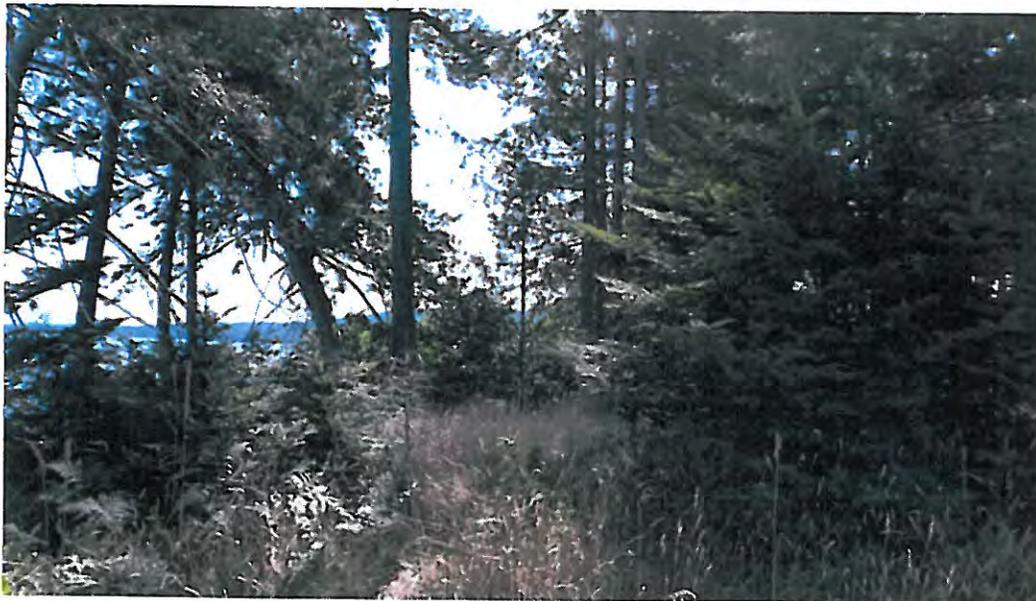
Plate B-2: Vegetation remaining in semi-disturbed areas west of top of bank.

Note: - Douglas fir trees in a semi-closed canopy, with understorey of mixed evergreen (salal, sword fern, young coniferous trees) and deciduous (salmonberry, bracken fern, etc.), with grasses intermixed in localized disturbed areas.

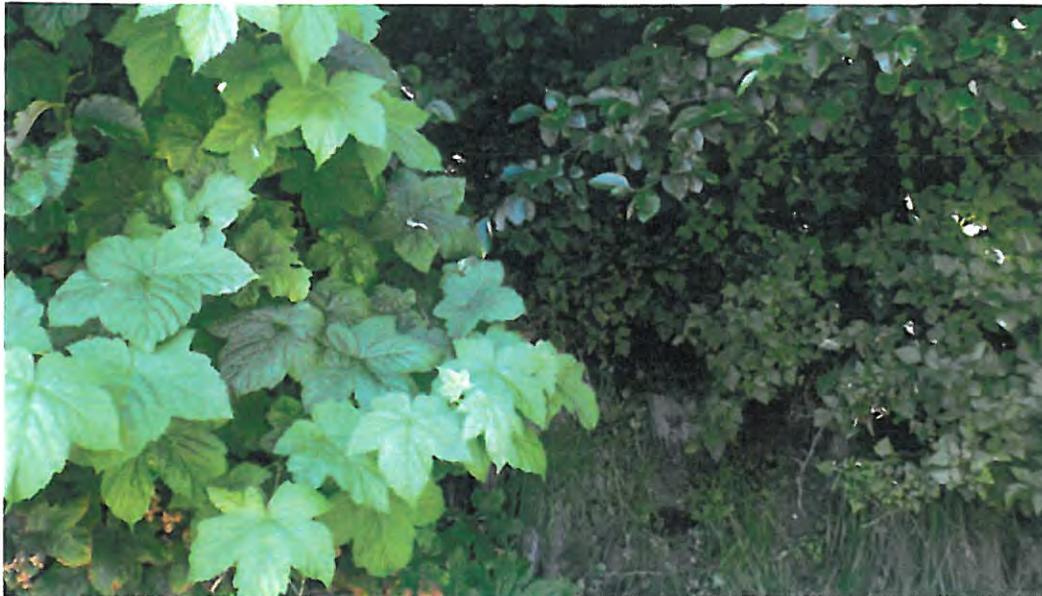
Plate B-3: Vegetation remaining in uncleared areas on waterfront slope areas east of top of bank.

Note: - Dominant tree cover of red alder, isolated cedar, with understory of salmonberry, some thimbleberry and limited rushes.

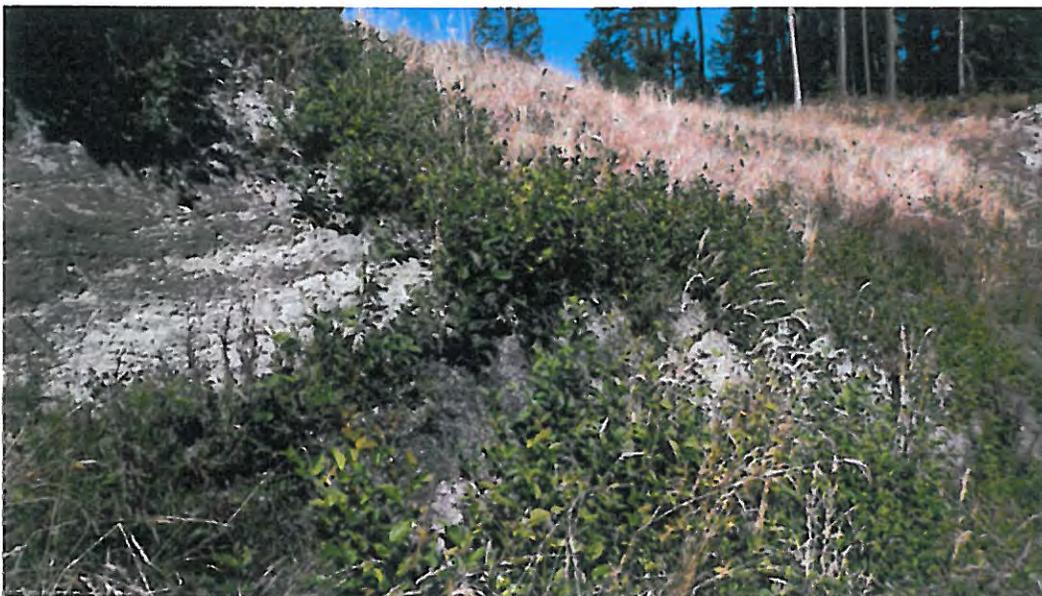
Plate B-4: Vegetation typical of areas of recently disturbed slopes where herbaceous seeding has taken place.

Note: - Seeded grass and legume cover has germinated in all but vertical faces, and young red alder are volunteering in various densities across the disturbed areas.

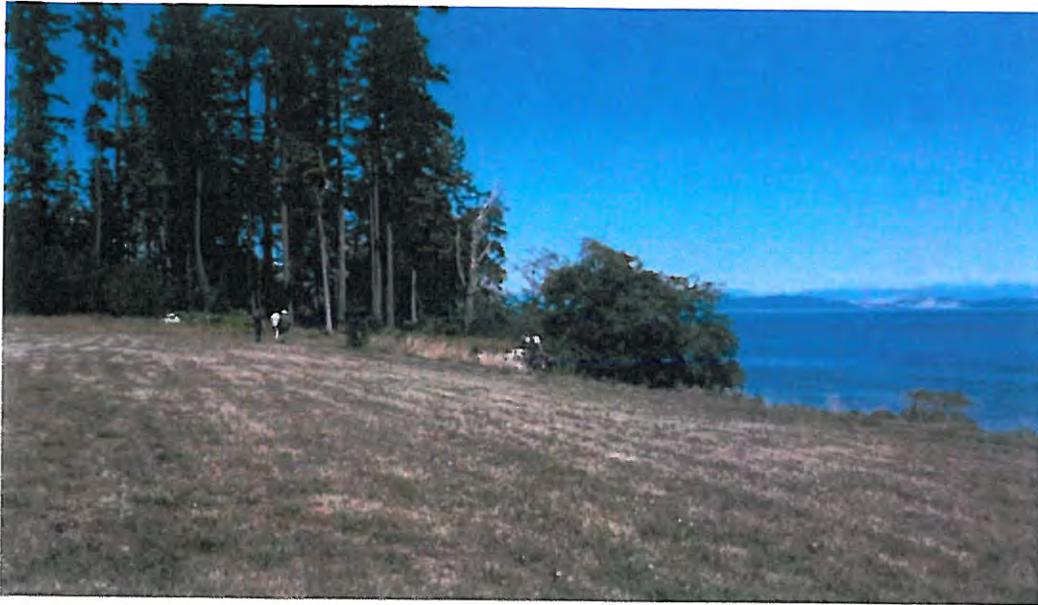
Plate B-5: Vegetation in proposed replanting area west of the existing top of bank.
