## **SATURNA ISLAND RIPARIAN AREA REGULATION STREAM IDENTIFICATION**

**Robert Kojima  
Islands Trust  
Suite 200 - 1627 Fort Street  
Victoria, BC, V8R 1H8**

**Trystan Willmott, B. Sc., A.Sc.T.  
MADRONE ENVIRONMENTAL SERVICES LTD.  
1081 Canada Avenue, Duncan, BC, V9L 1V2**

**March 31, 2010**

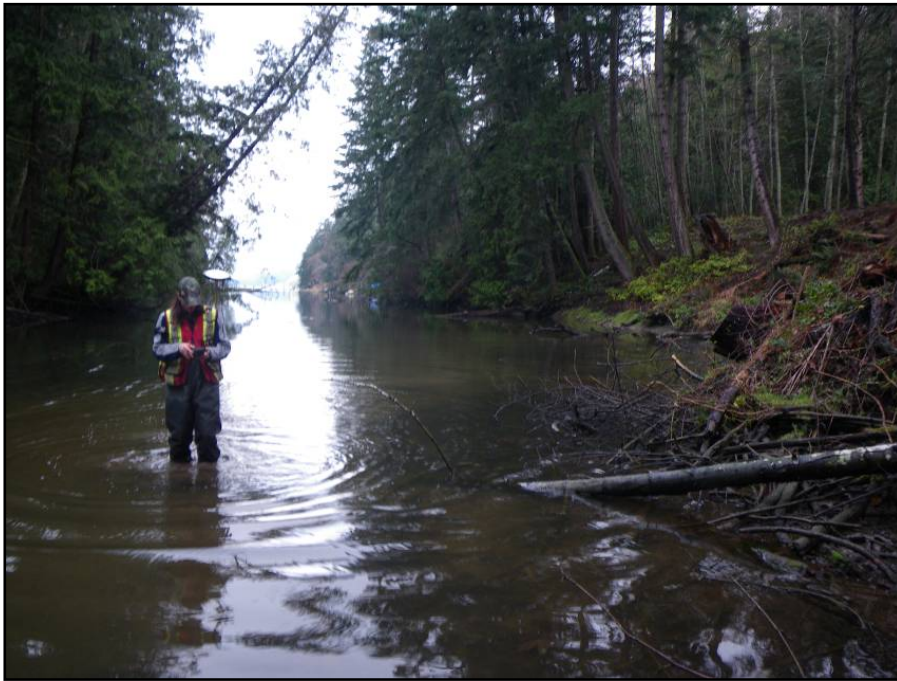
Looking northwest into Lyall Harbour through the estuarine habitat of Lyall Creek. Note mature riparian forested fringe.

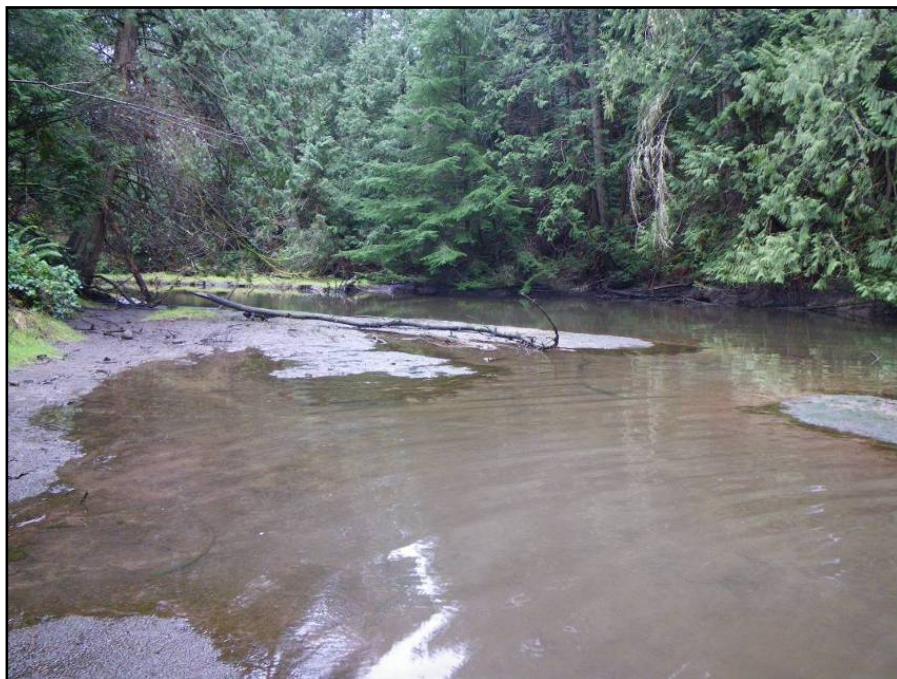
Looking southeast (upstream) along the lower reaches of Lyall Creek. Note important biological functions provided by the mature forested fringe (bank stability, shading, litter input and insect drop).

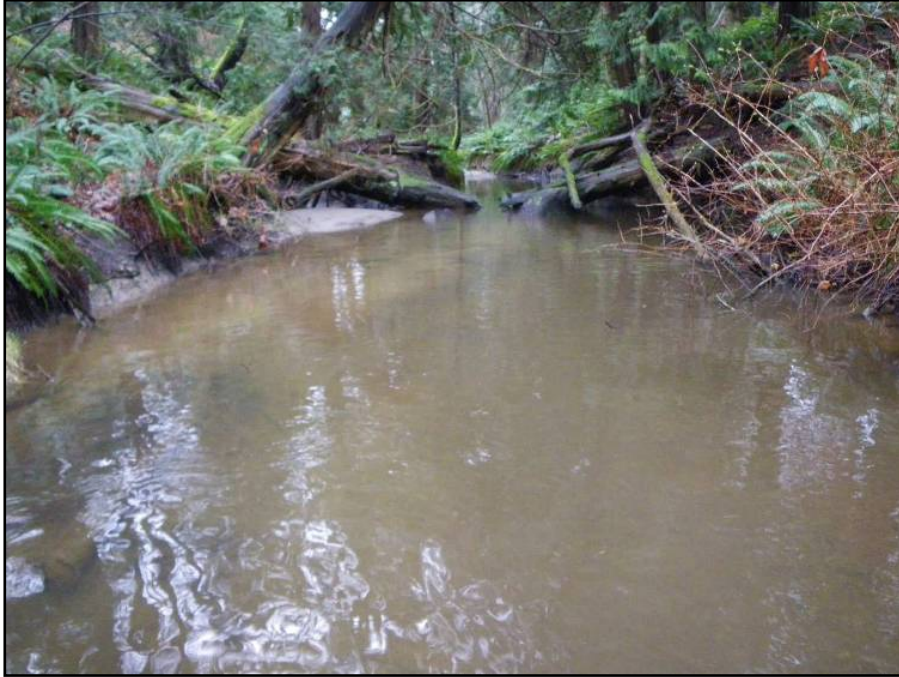
Looking upstream (south east) along the lower reaches of Lyall Creek. Note fish habitat diversity in the form of deep pools complexed with LWD, forming excellent security/rearing habitat for fish.

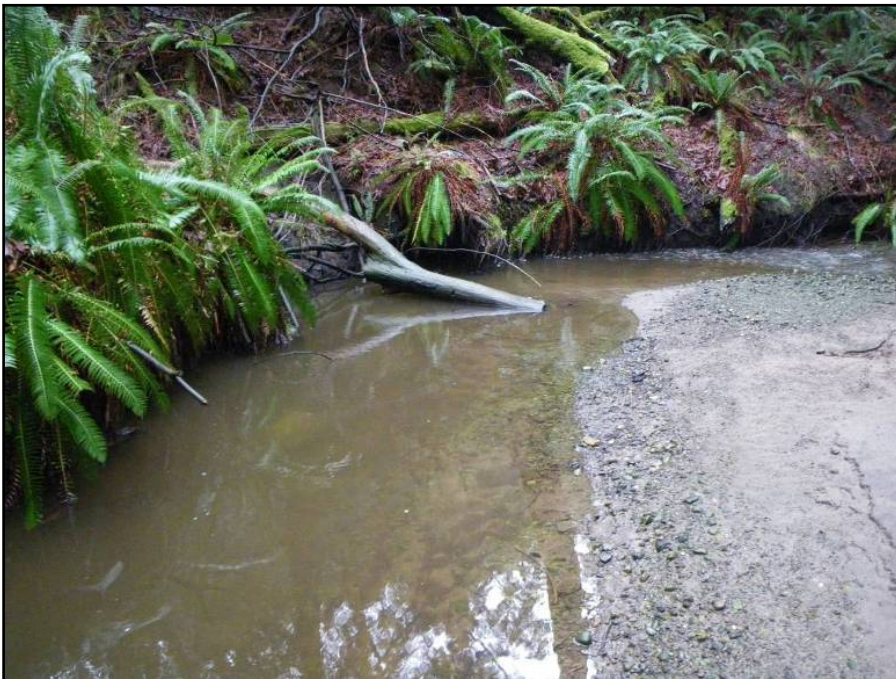
Typical riffle-pool sequence in the lower reaches of Lyall Creek. Note cover/security habitat for fish in the form of the deep pool and adjacent undercut banks.

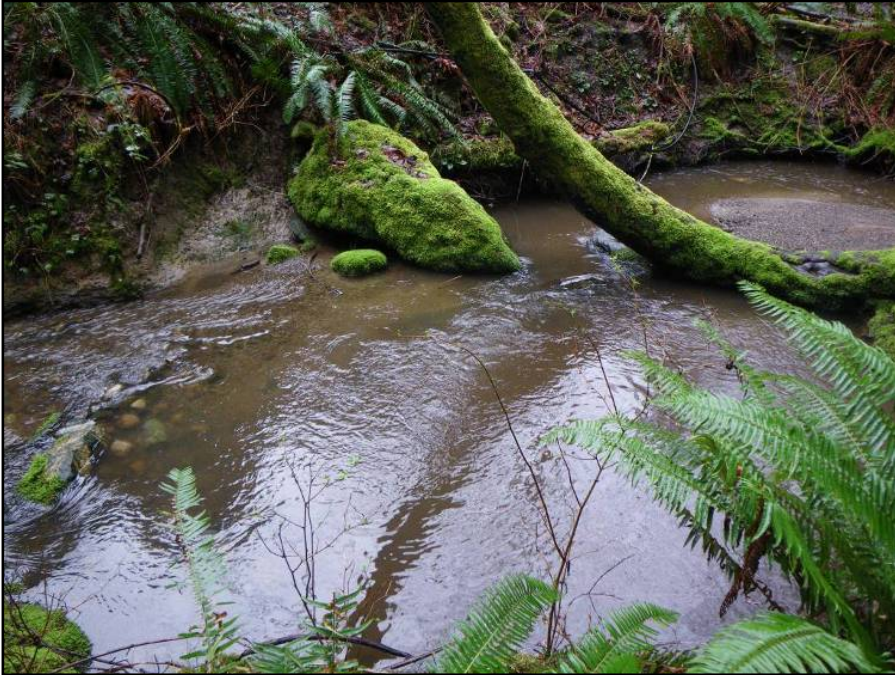
Deep pool and associated riffle crest located on the lower reaches of Lyall Creek. Deep pool and LWD provide excellent fish habitat diversity.

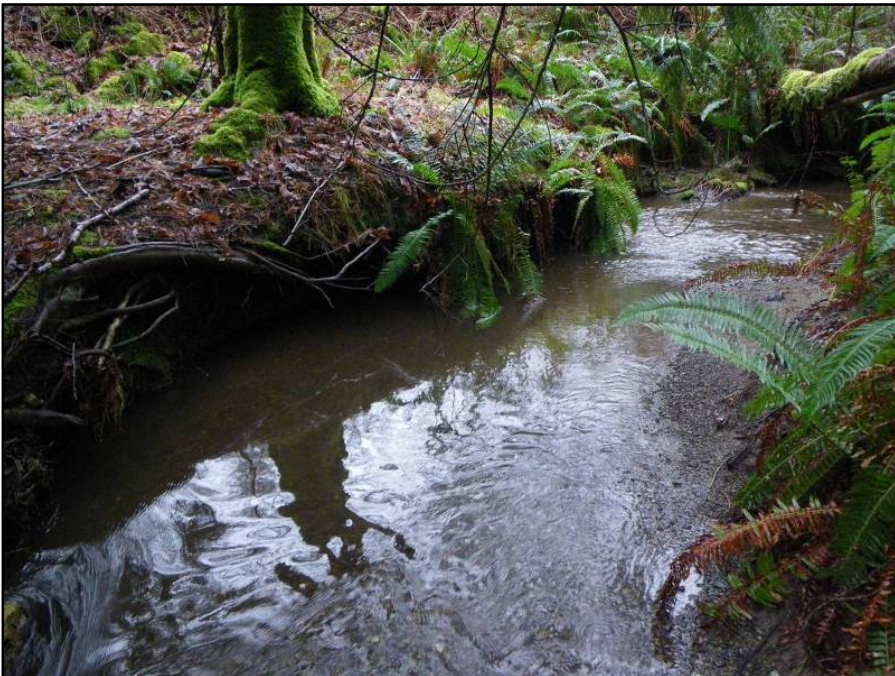
Typical channel characteristics of the lower reaches of Lyall Creek. Note deep pool and undercut bank, which provide excellent security habitat for fish.

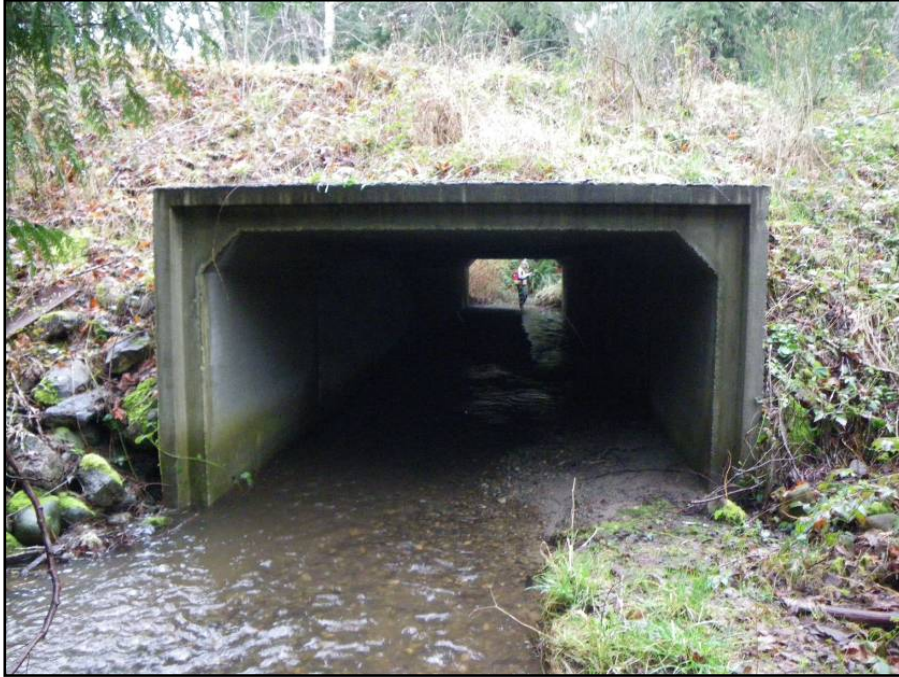
The creek flows underneath the first road crossing via a substantial box culvert approximately 3 m high and 5 m wide. This feature does not represent a barrier to the movement of fish, including adults and juveniles. Above the culvert, the creek continues to display good quality fish habitat attributes, with a cobble/gravel substrate, riffles alternating with deeper pools, an intact forested riparian zone and an adequate cover of LWD. The creek was mapped up to the boundary of the National Park Reserve.

Looking downstream (northwest) through the open-bottomed box culvert structure located on the first road crossing above tidewater.

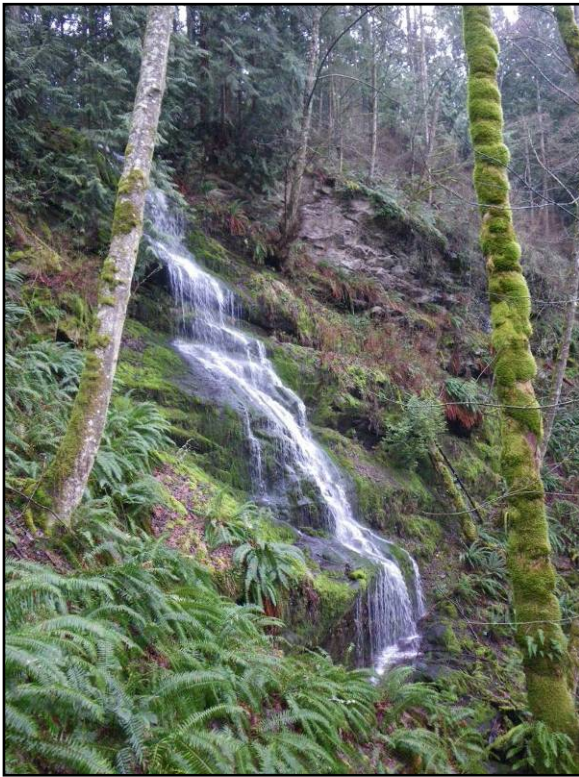
Where it enters Lyall Creek, fish could enter the tributary from the mainstem for a distance of approximately 70 m upstream of the confluence. The near vertical waterfall (25 m high) located on the tributary prevents any further migration of fish from Lyall Creek upstream. Above the waterfall, the creek is represented by a steep (20%) step-pool channel type, with a substrate dominated by large cobble and boulders. Beyond the boundary between the National Park Reserve and private property (where the stream was mapped), the topography becomes more subdued and the drainage flows as a well defined riffle-pool system with a gradient of 3.5%. Riparian vegetation is relatively sparse in comparison with the area bounded by the National Park. As a result of the lack of riparian vegetation, the banks of the creek are unstable, with exposed roots and sloughing of material in places. The creek crosses under Narvaez Road, which runs parallel to the National Park boundary via a closed metal culvert. The inflow of this culvert is damaged and water flows underneath the inflow.

Waterfall over bedrock representing a definitive barrier to the upstream movement of fish located approximately 70 m above the confluence with the mainstem Lyall Creek (located in the National Park Reserve).

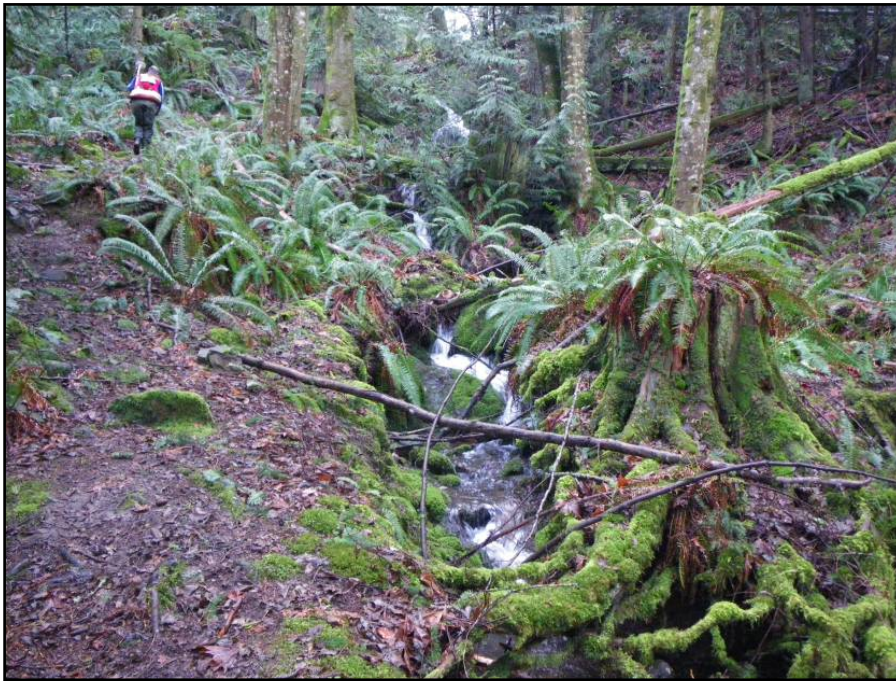
Looking south (upstream) along the Lyall Creek tributary drainage immediately upstream of the waterfall (located in the National Park Reserve). Note steep gradient of the drainage (20%) in this area.

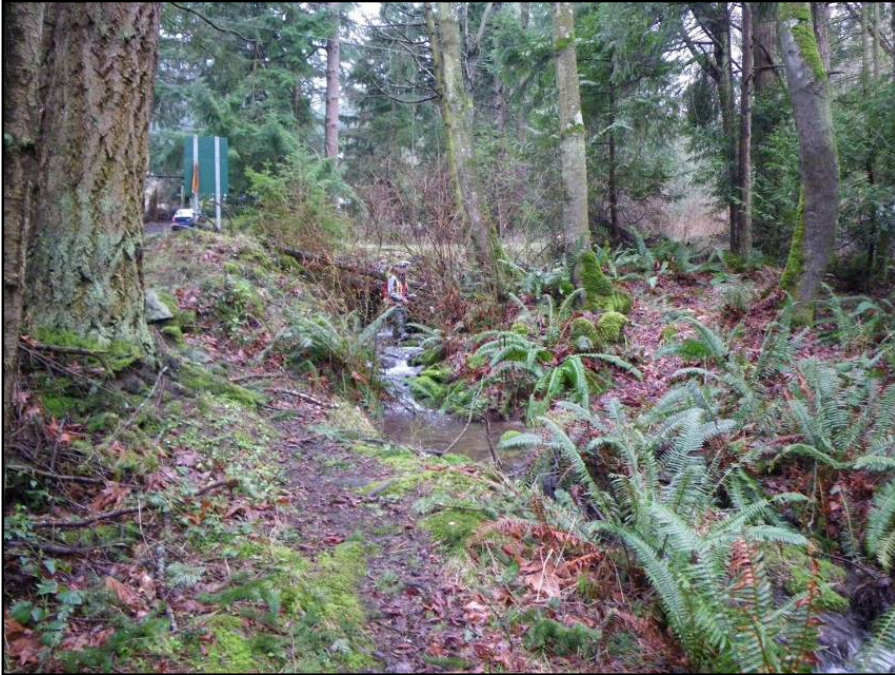
Looking southwest (upstream) along the Lyall Creek tributary drainage immediately downstream of the Narvaez Road crossing close to the point where the stream crosses the National Park Reserve boundary.

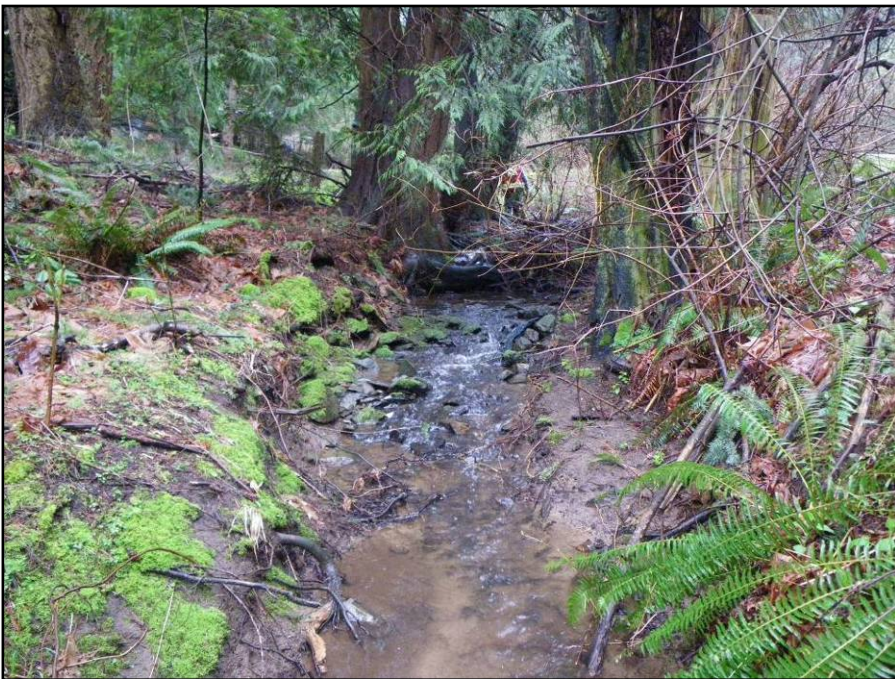
Looking upstream (southwest) along the Lyall Creek tributary drainage immediately upstream of the Narvaez Road crossing.

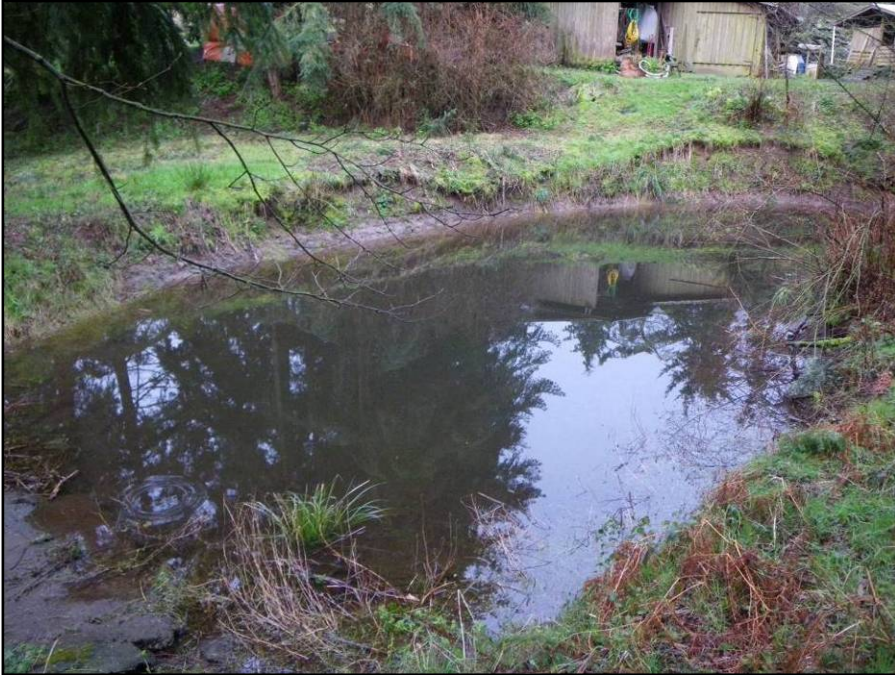
A dug pond exists upstream of the Narvaez Road crossing, which is approximately 8 m wide and 12 m long. The pond is drained by a concrete flume, although during the time of the assessment, the flume was dry. Water flowing underneath the flume, however, represented the main outflow of the pond and the continuation of the creek.

Looking over the dug pond located on the Lyall Creek tributary drainage.

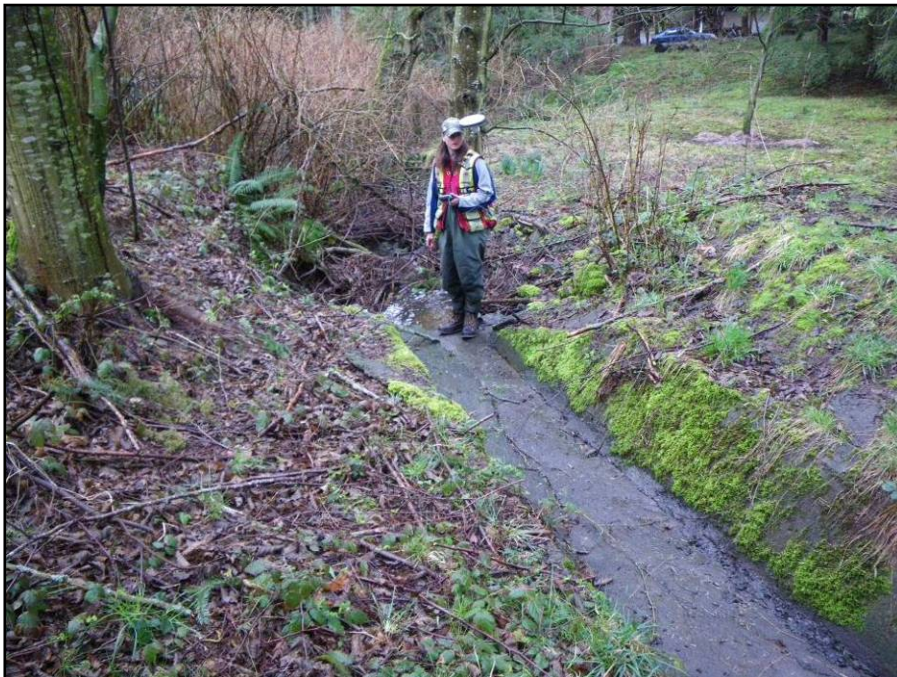
Looking down the concrete pond overflow. During the assessment, water was flowing underneath the flume.

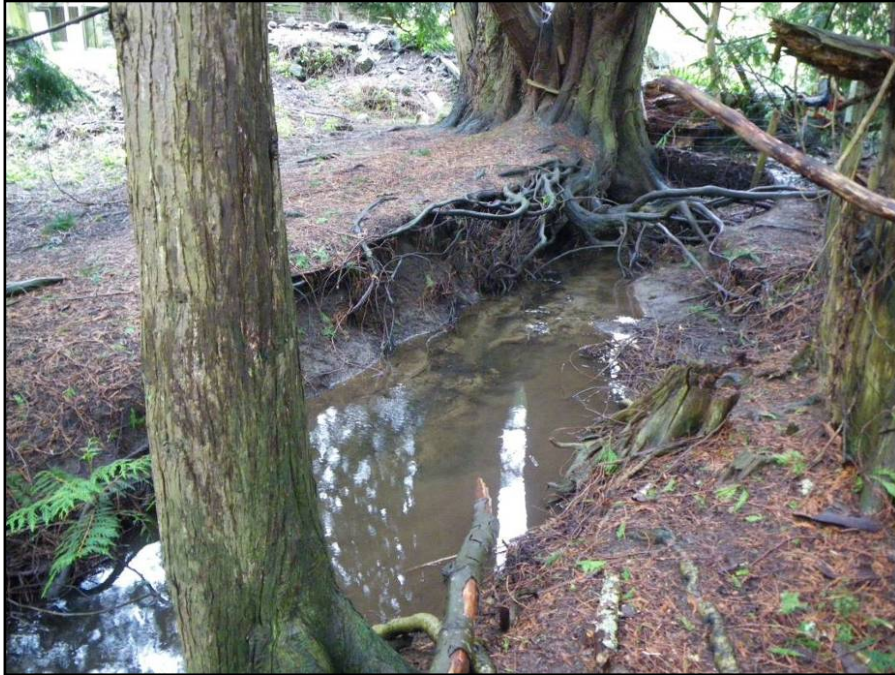
Typical example of unstable banks found in the upper reaches of the Lyall Creek tributary drainage. Note sparse nature of riparian vegetation, which has led to a decrease in the function of bank stability.

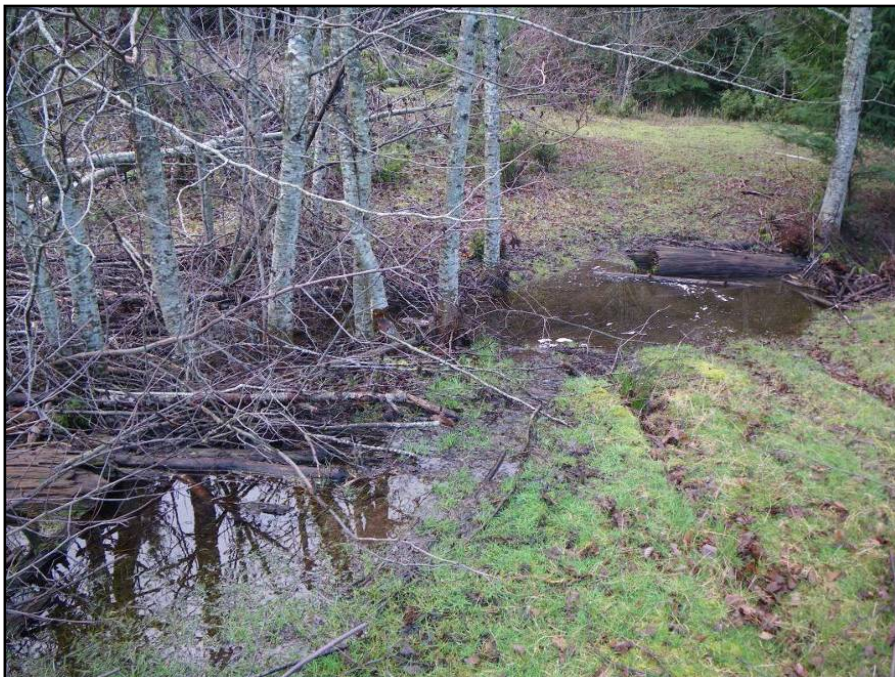
Looking downstream over the outflow from the lake situated at the head of the Lyall Creek tributary drainage.

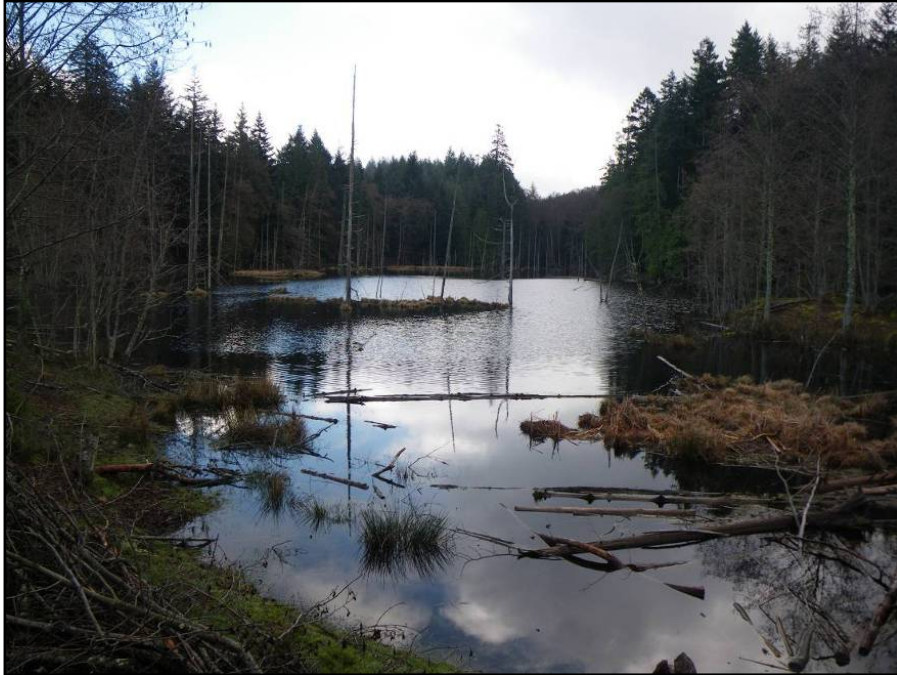
Looking east over the lake located at the head of the Lyall Creek tributary drainage. Note mature riparian forested fringe, serving important biological functions in the form of bank stability, shade, litter input and insect drop. Given the perennial habitat and habitat features, there is the potential for resident fish to occur in this water body.

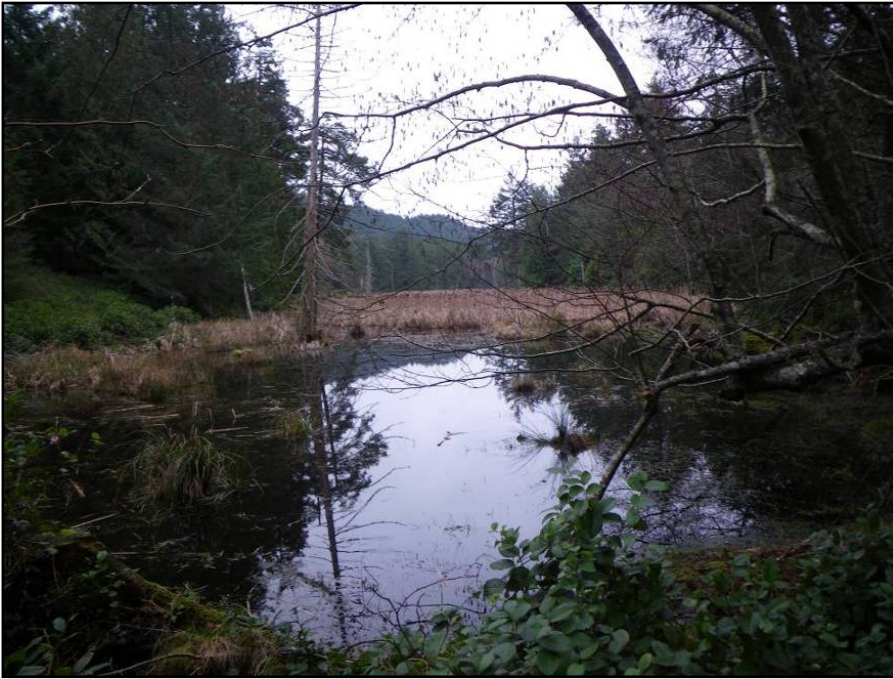
Looking west over the largest wetland located in the northwestern portion of the watershed located to the north of Lyall Harbour. Note mature riparian fringe and wildlife habitat complexity (e.g. wildlife tree in the foreground). Also note dominance of cattail and the abundance of potential amphibian egg mass attachment media in the form of woody debris and emergent vegetation.

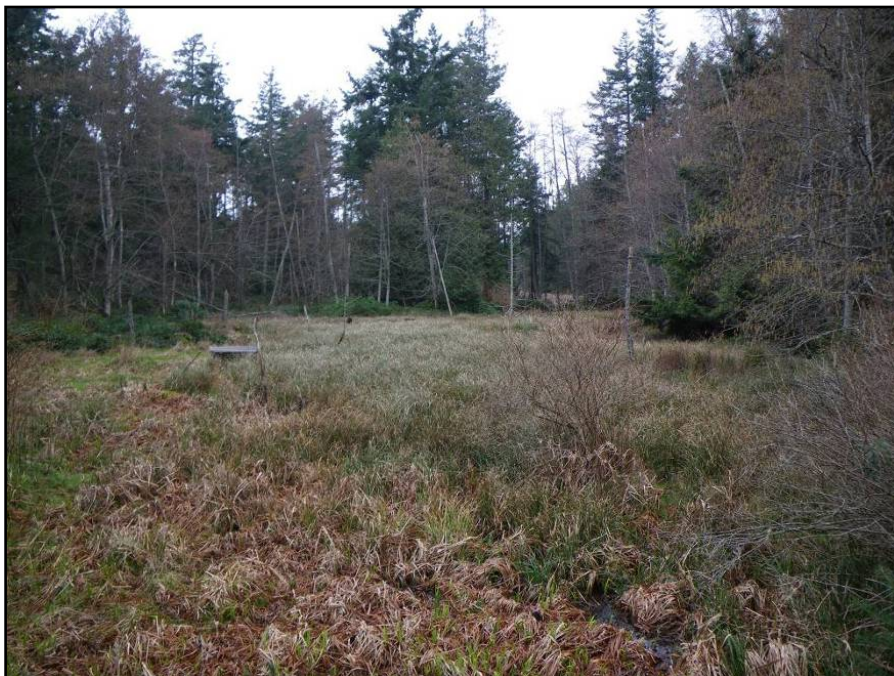
Looking northwest over the slough sedge dominated wetland located immediately to the south east of the largest wetland in the complex (pictured above).

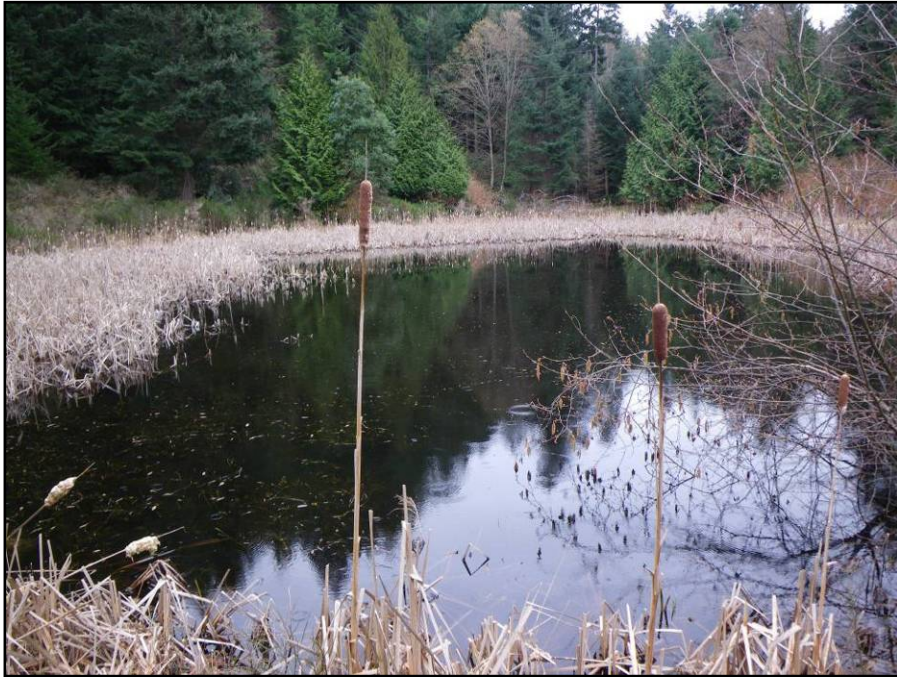
Looking east over the open water wetland located at the far eastern end of the wetland complex. Note mature riparian forested fringe and cattail-dominated vegetation type. Emergent vegetation will provide abundant egg mass attachment media for amphibians.
