**GABRIOLA ISLAND RIPARIAN AREA  
REGULATION STREAM IDENTIFICATION  
UPDATED REVISED VERSION FEBRUARY 24, 2012**

**Chloe Fox  
Island Planner (Gabriola Island Local Trust Committee)  
700 North Road, Gabriola Island, BC, V0R 1X3**

**Trystan Willmott, B.Sc. A.Sc.T.  
Justin Lange, B.Sc., B.I.T., A.Sc.T.  
MADRONE ENVIRONMENTAL SERVICES LTD.  
1081 Canada Avenue, Duncan, BC, V9L 1V2**

**February 24, 2012**

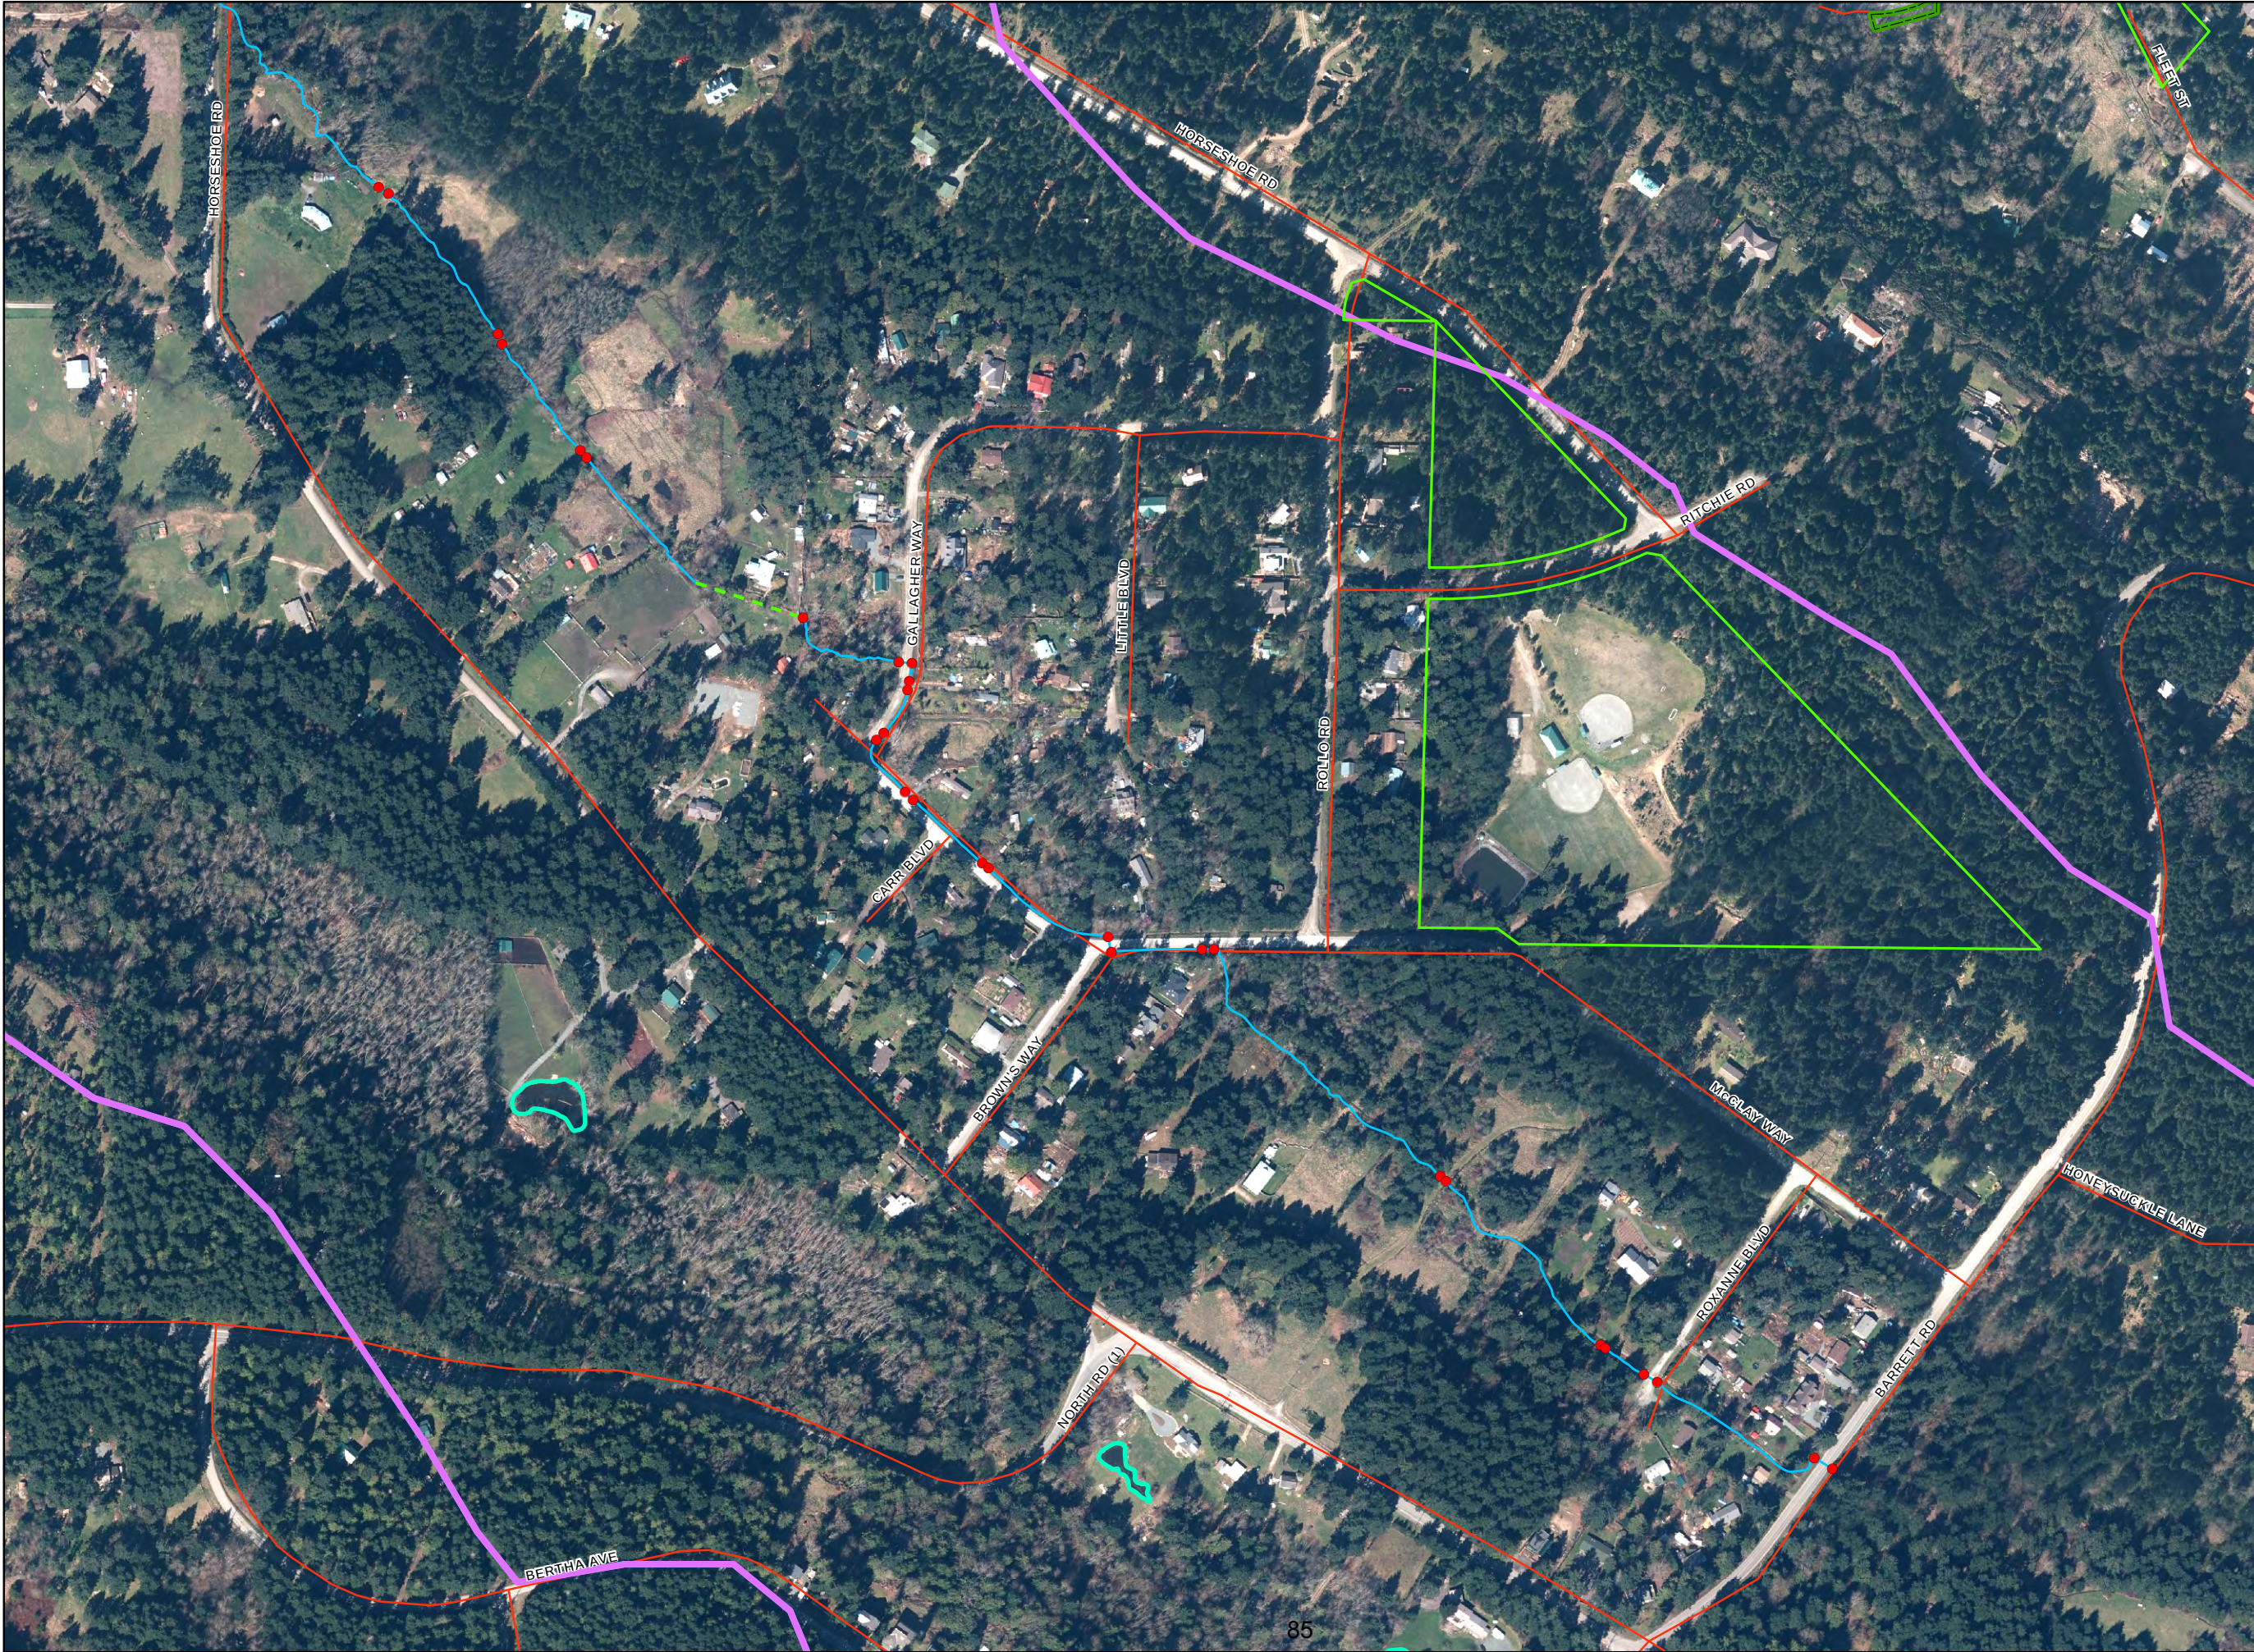
**Figure 3B:**  
McClay Creek

Approximately 50 m upstream of Barrett Road, the drainage has been altered by development of a small gravel access road. Placement of the road across the drainage has resulted in water being held back to create a small pond. It should be noted that during high flows, water breaches the road and seeps through the forest floor. No channel or continuous stretch of surface flow could be followed between the pond and Barrett Road. The topography of the area is subdued with water observed flowing subsurface and pooling within many forest floor depressions. At Barrett Road, water collects in the roadside ditch system and flows under the road from the east.

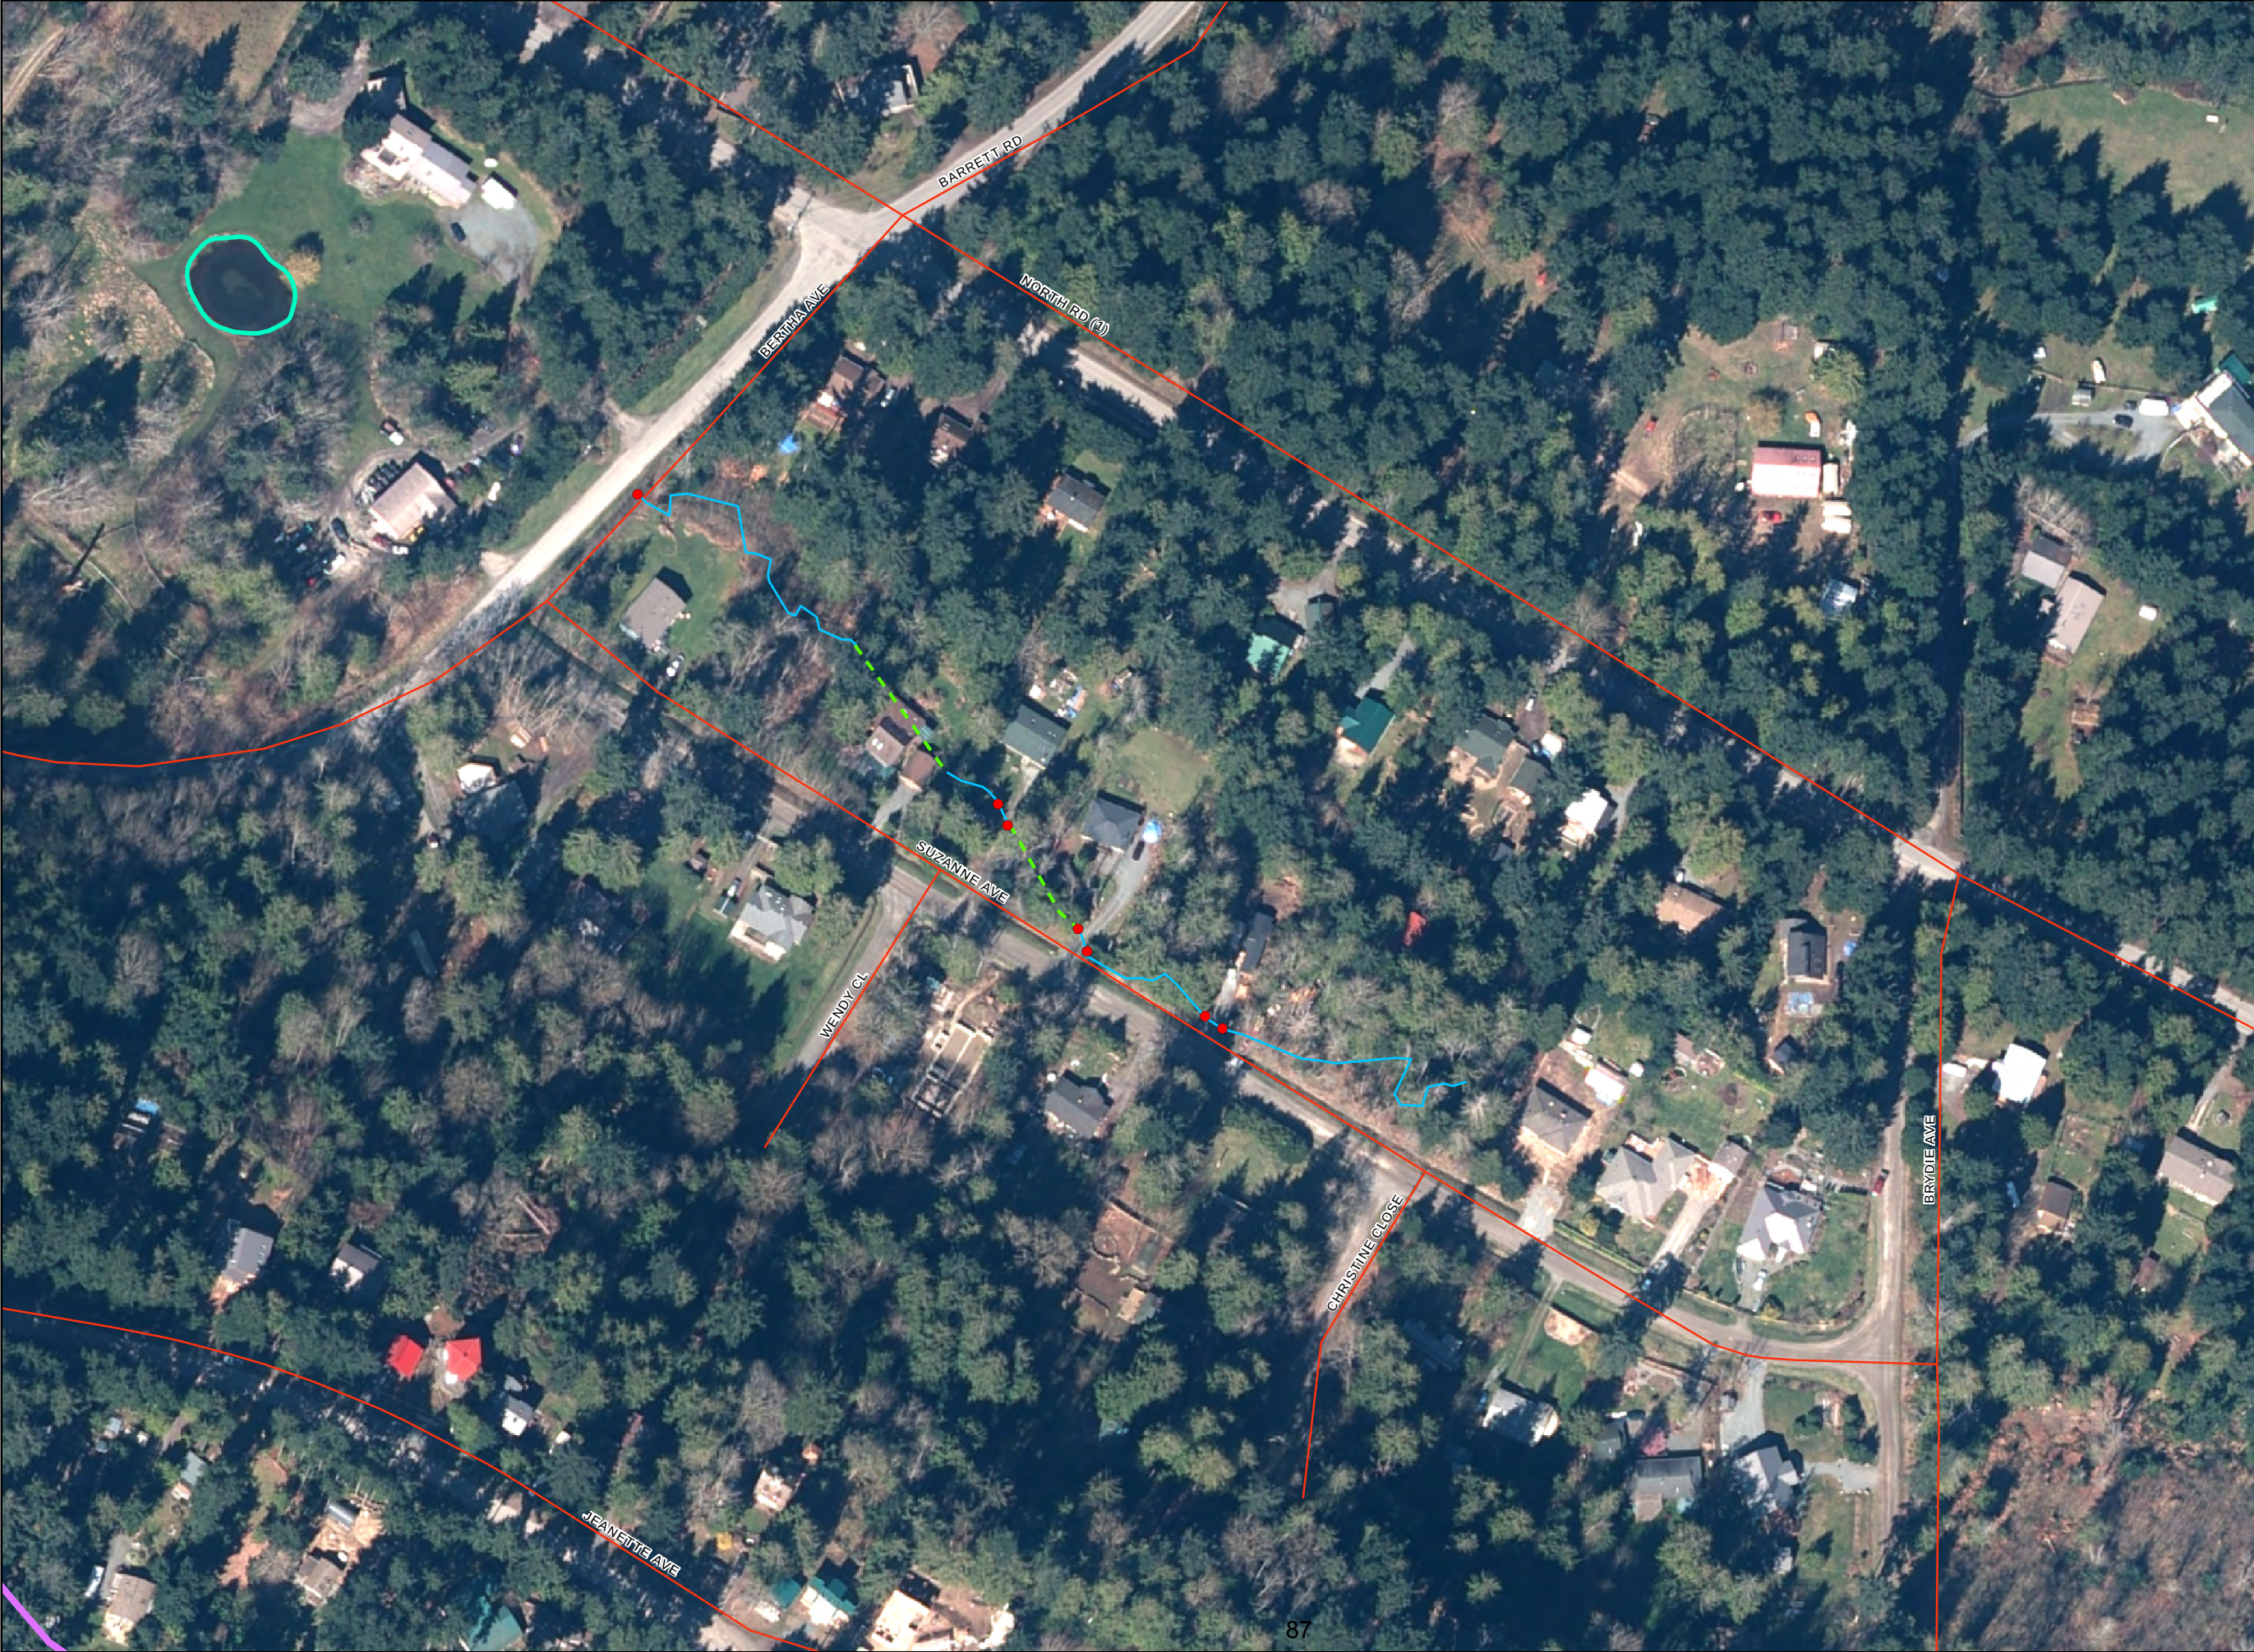
**Figure 4:**  
Castell Creek Tributary

This extremely poorly defined watercourse joins the main Castell Brook drainage at the inflow of the culvert under Bertha Road. The watercourse, which flows through residential properties and under driveways, has been ditched and is less than 0.5m wide. Surface water flow was followed up to the origin of the drainage, which consists of a seepage area supporting vegetation indicative of moist areas, such as water parsley (*Oementhe sarmentosa*), skunk cabbage (*Lysichiton americanum*) and salmonberry.

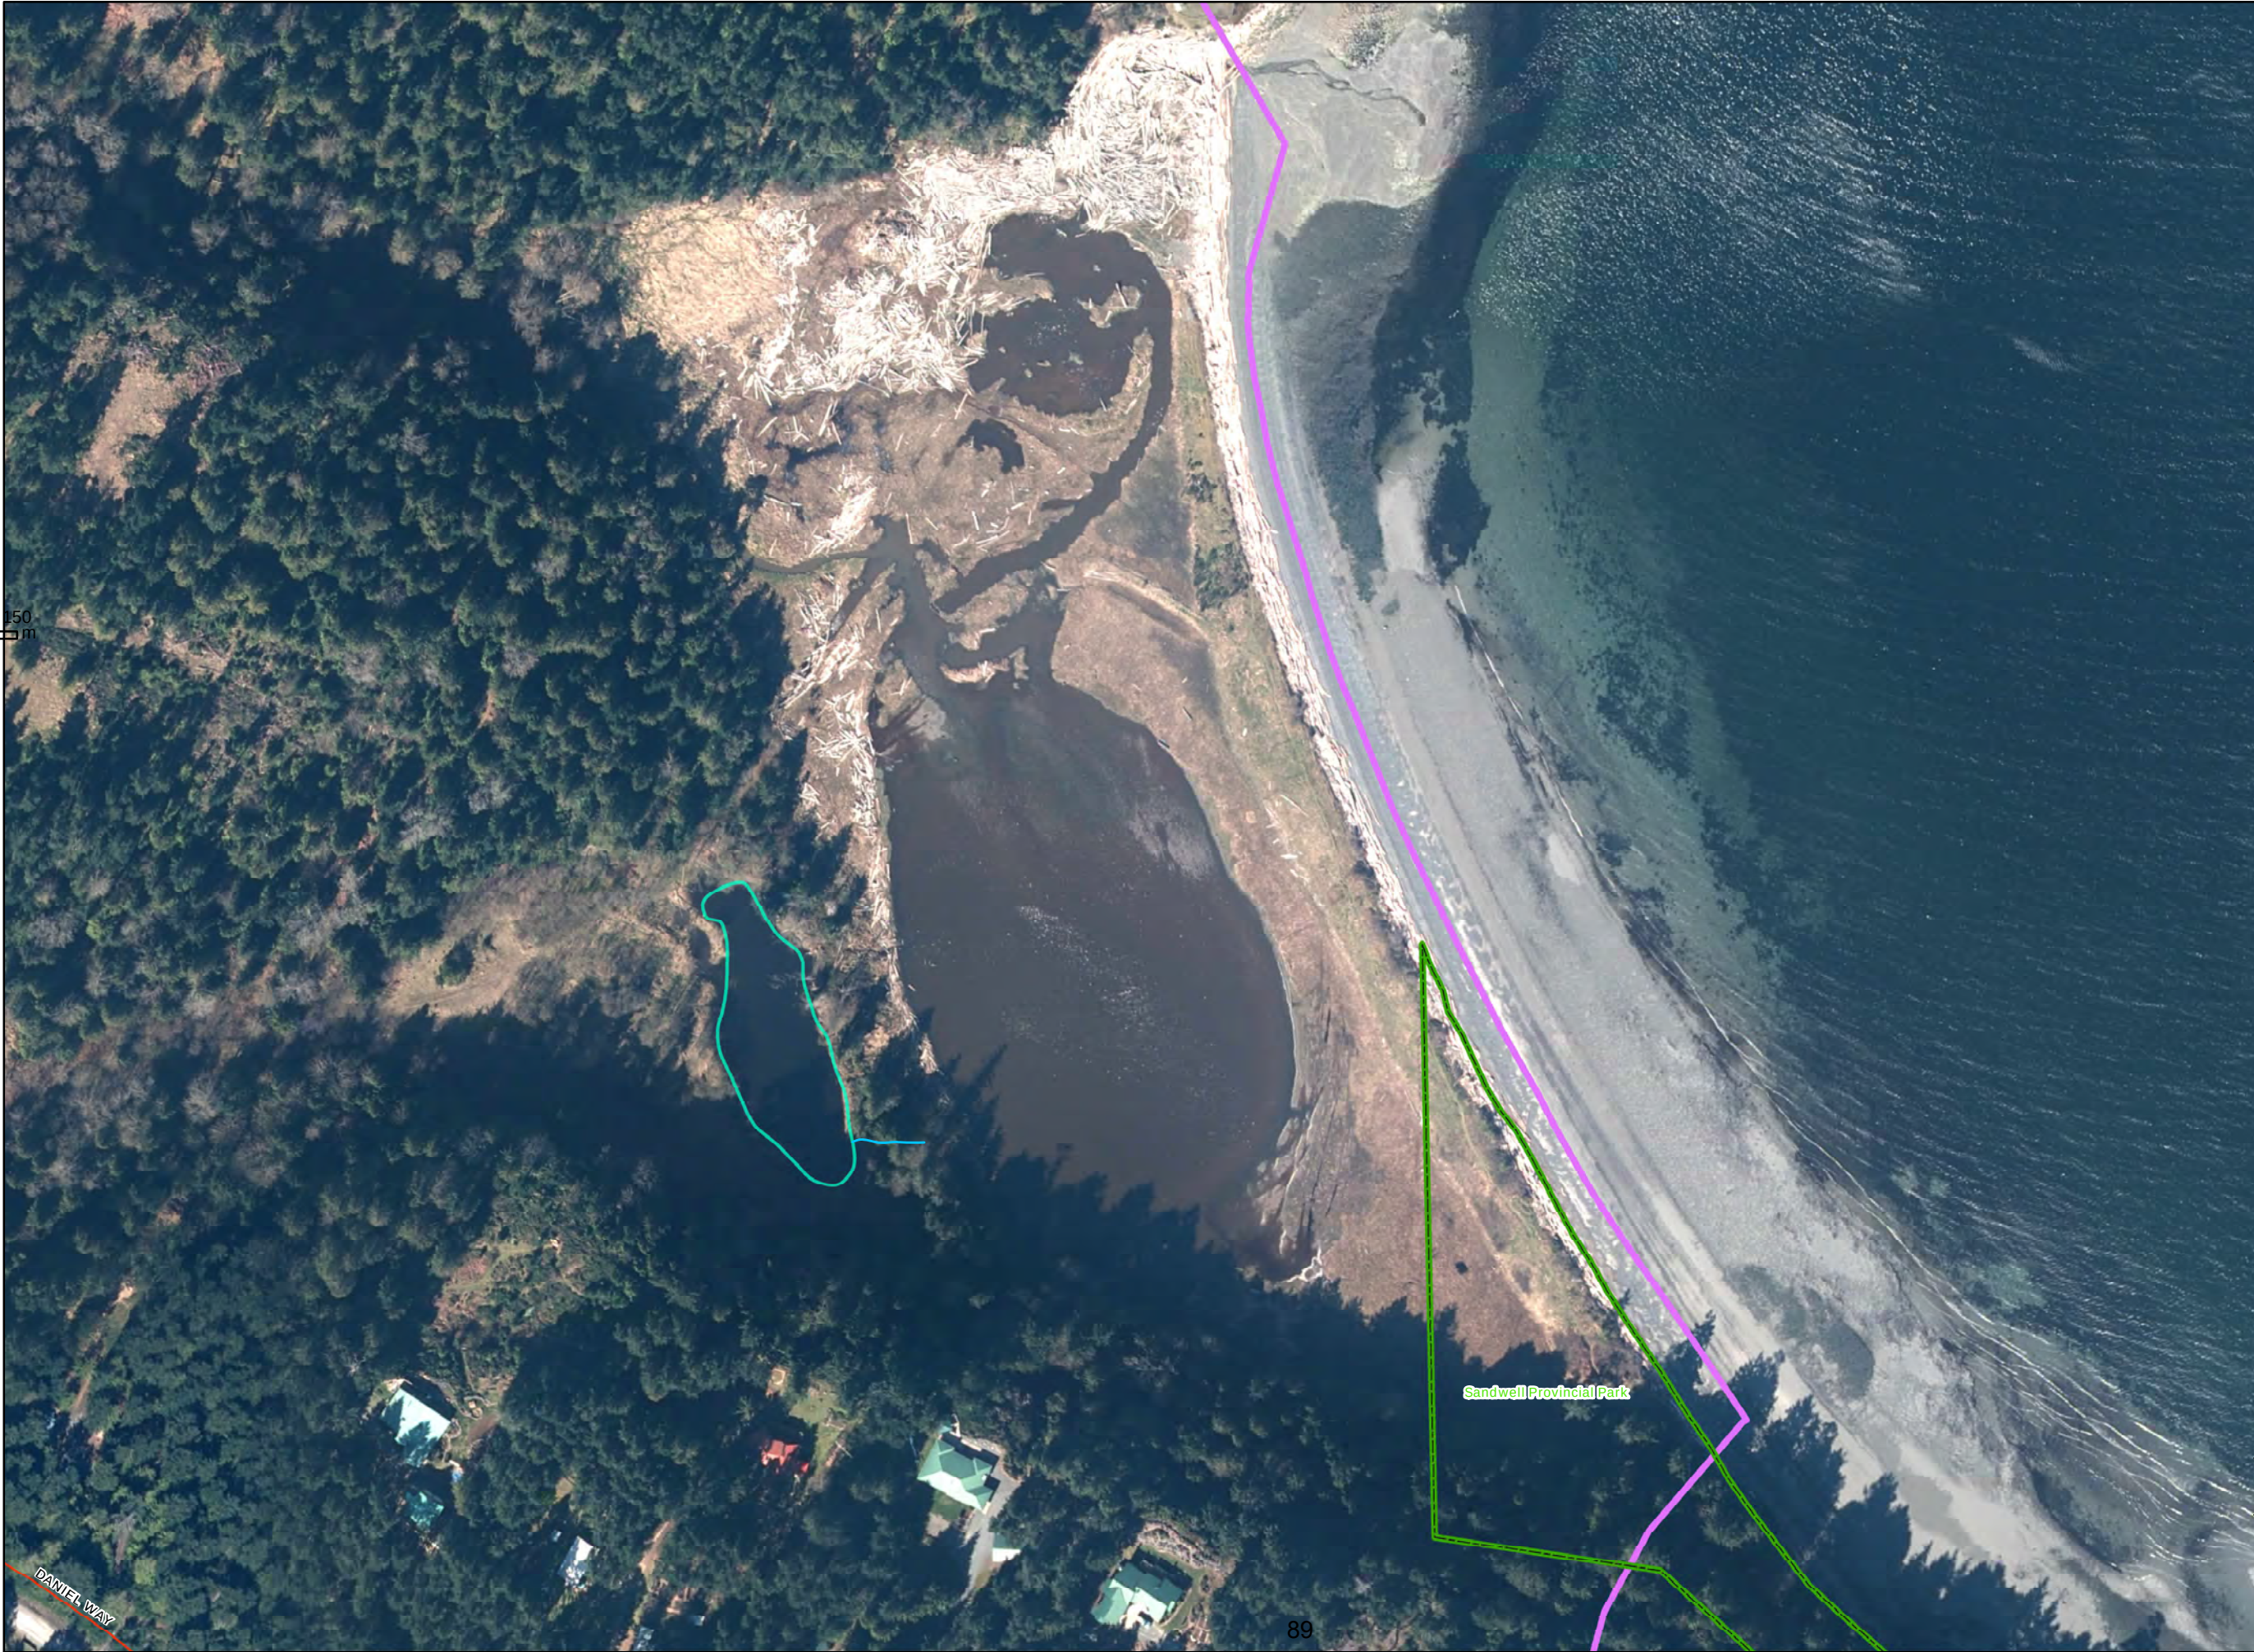
Figure 5:  
Daniel Way Pond

The pond has the potential to support fish, due to the fact that it holds water year round and the connection (albeit temporary) to the ocean. In addition, LWD is abundant within the pond and will contribute by providing cover and security habitat for fish. The majority of the LWD is a product of extensive beaver activity in the area. It should be noted that a previous RAR survey from 2010 conducted by an independent biologist indicated the presence of fish (species unknown) in the pond.

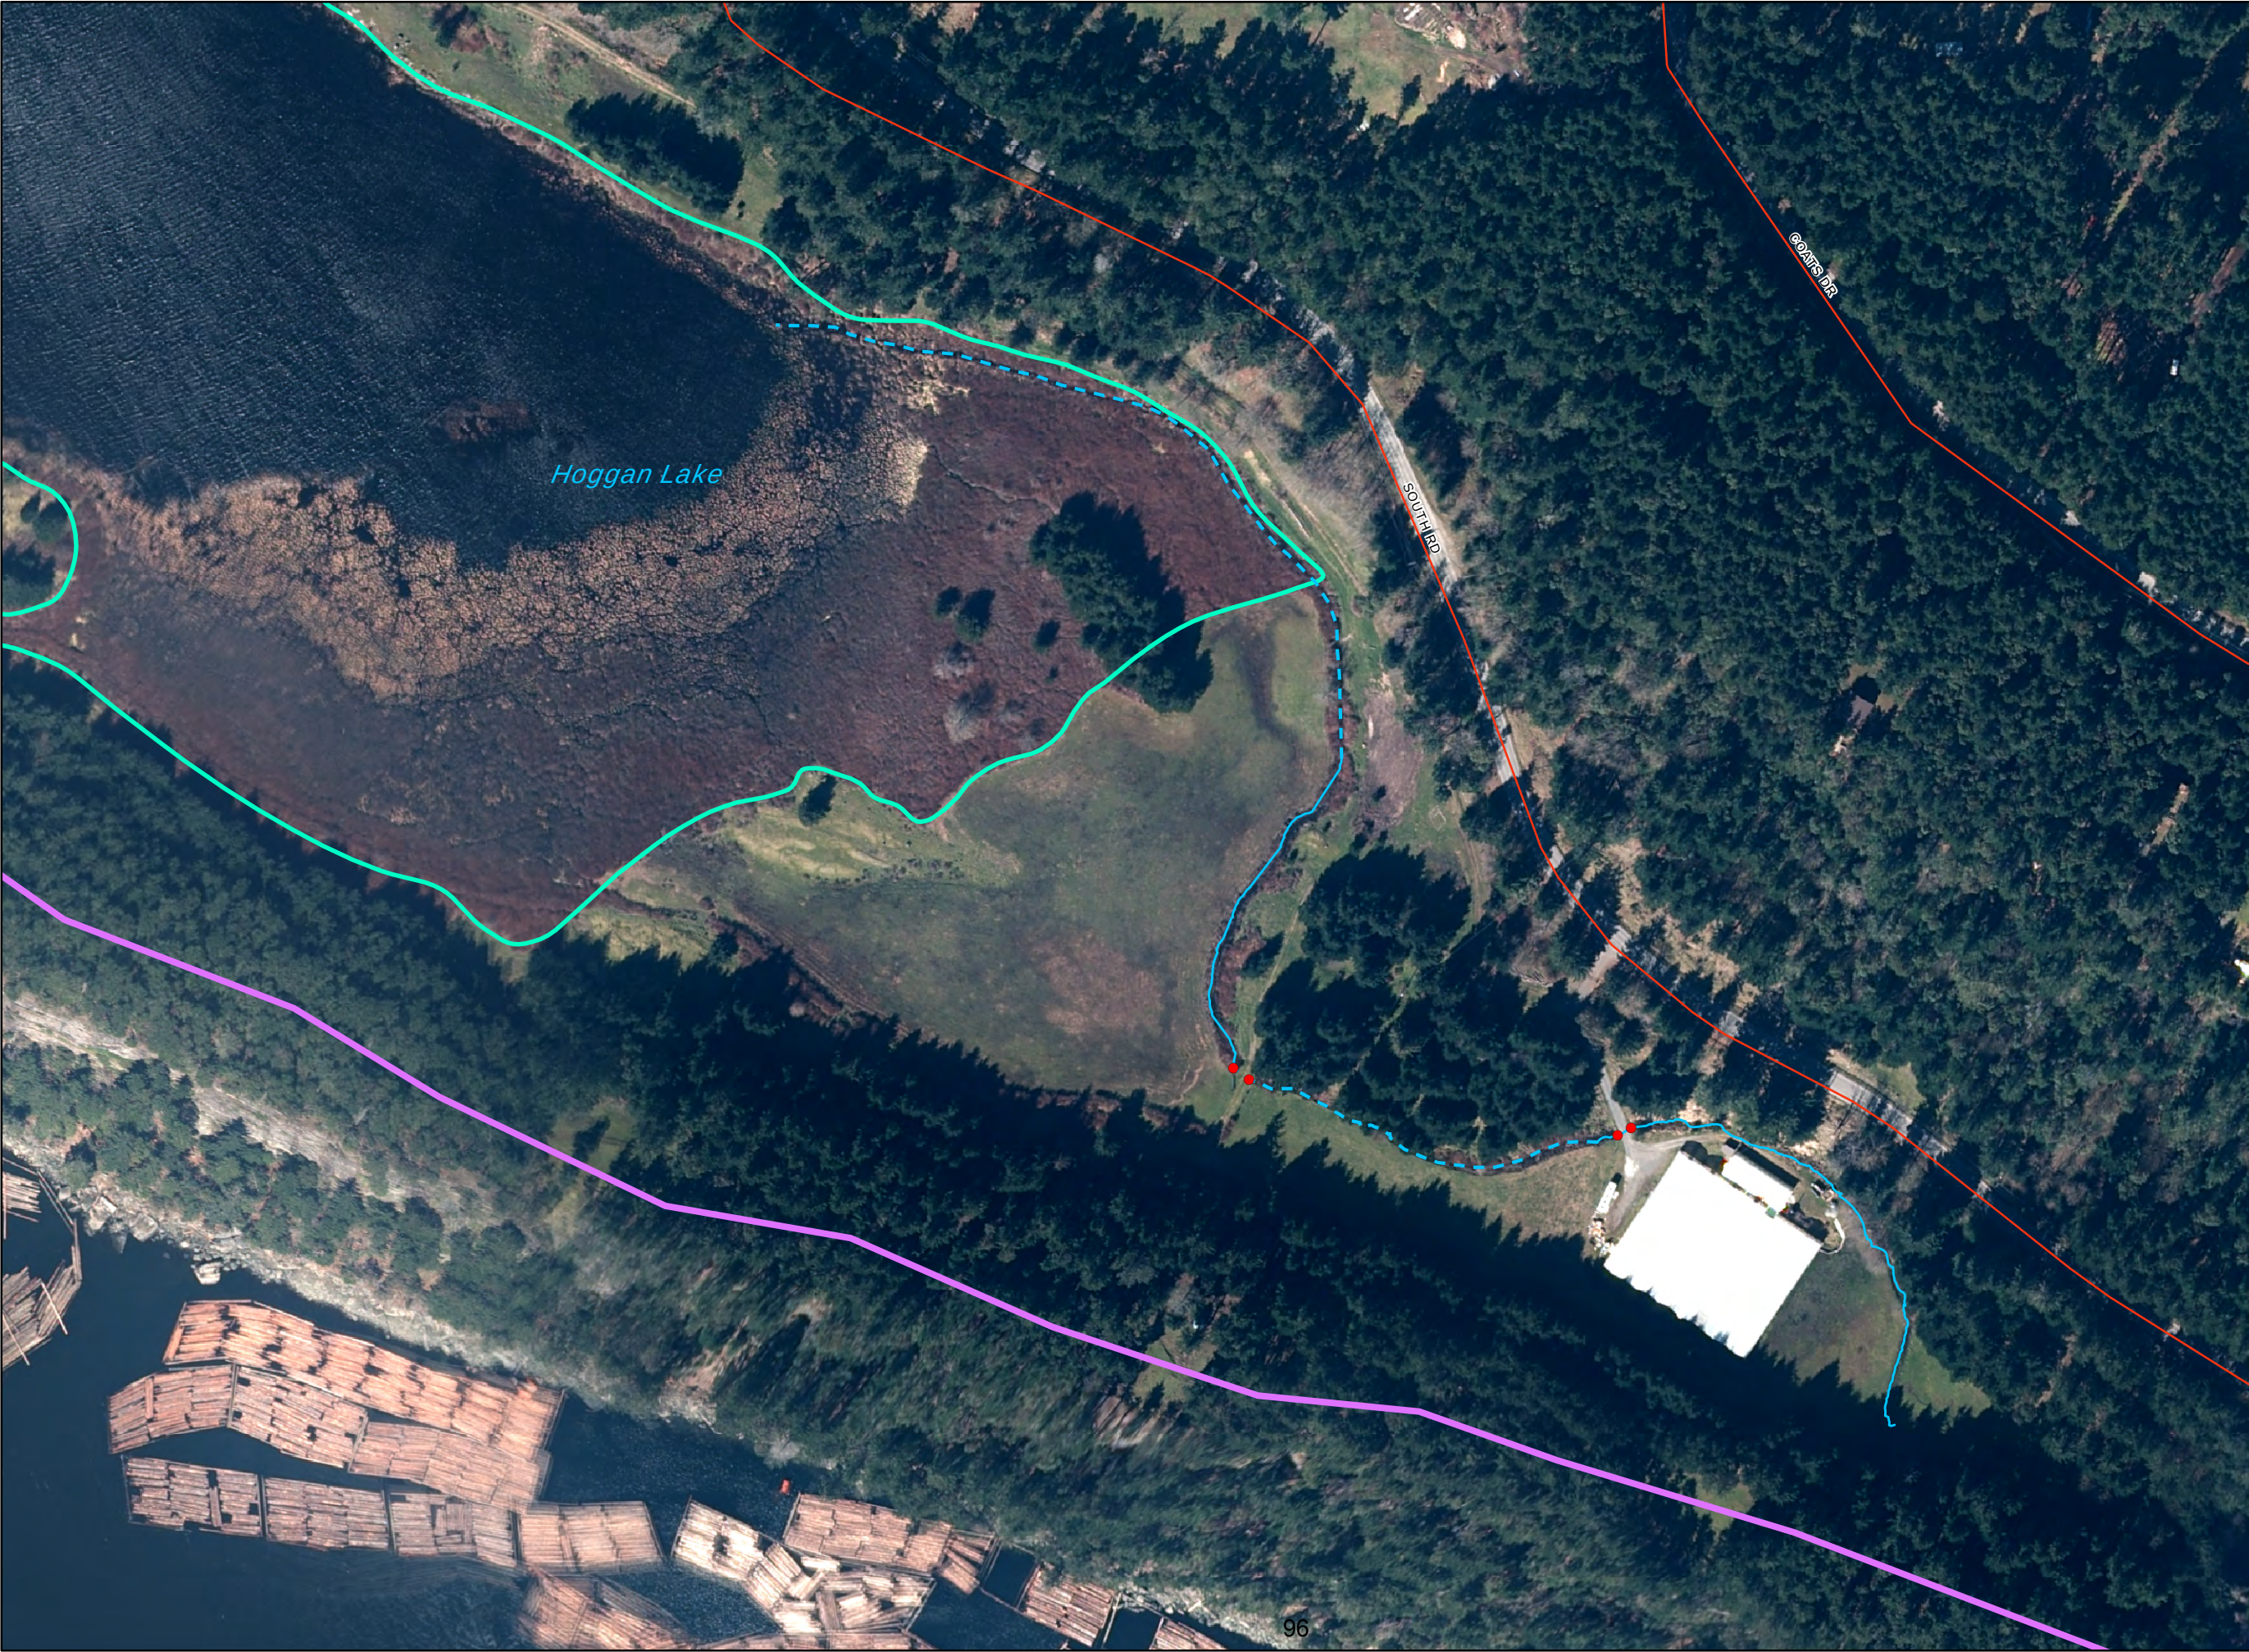
**Figure 7:**  
**South Road Creek**

This watercourse originates as a spring in agricultural land to the east of Hoggan Lake. A straight ditch has been excavated, which concentrates the flow of water to the north and west. The drainage has no fish habitat values at the origin, as it is functioning as a field drain.

The excavated ditch deepens approximately 250 m from Hoggan Lake, at which point fish could potentially be present, based on the direct connectivity with the lake. Fish habitat values are lacking, however, due to a lack of natural sinuosity, absence of spawning habitat and lack of instream cover. The ditch flows to the northwest through the moist hardhack-dominated margins of Hoggan Lake prior to entering the south eastern tip of the lake. The deeper portion of the ditch supports dense concentrations of hardhack.

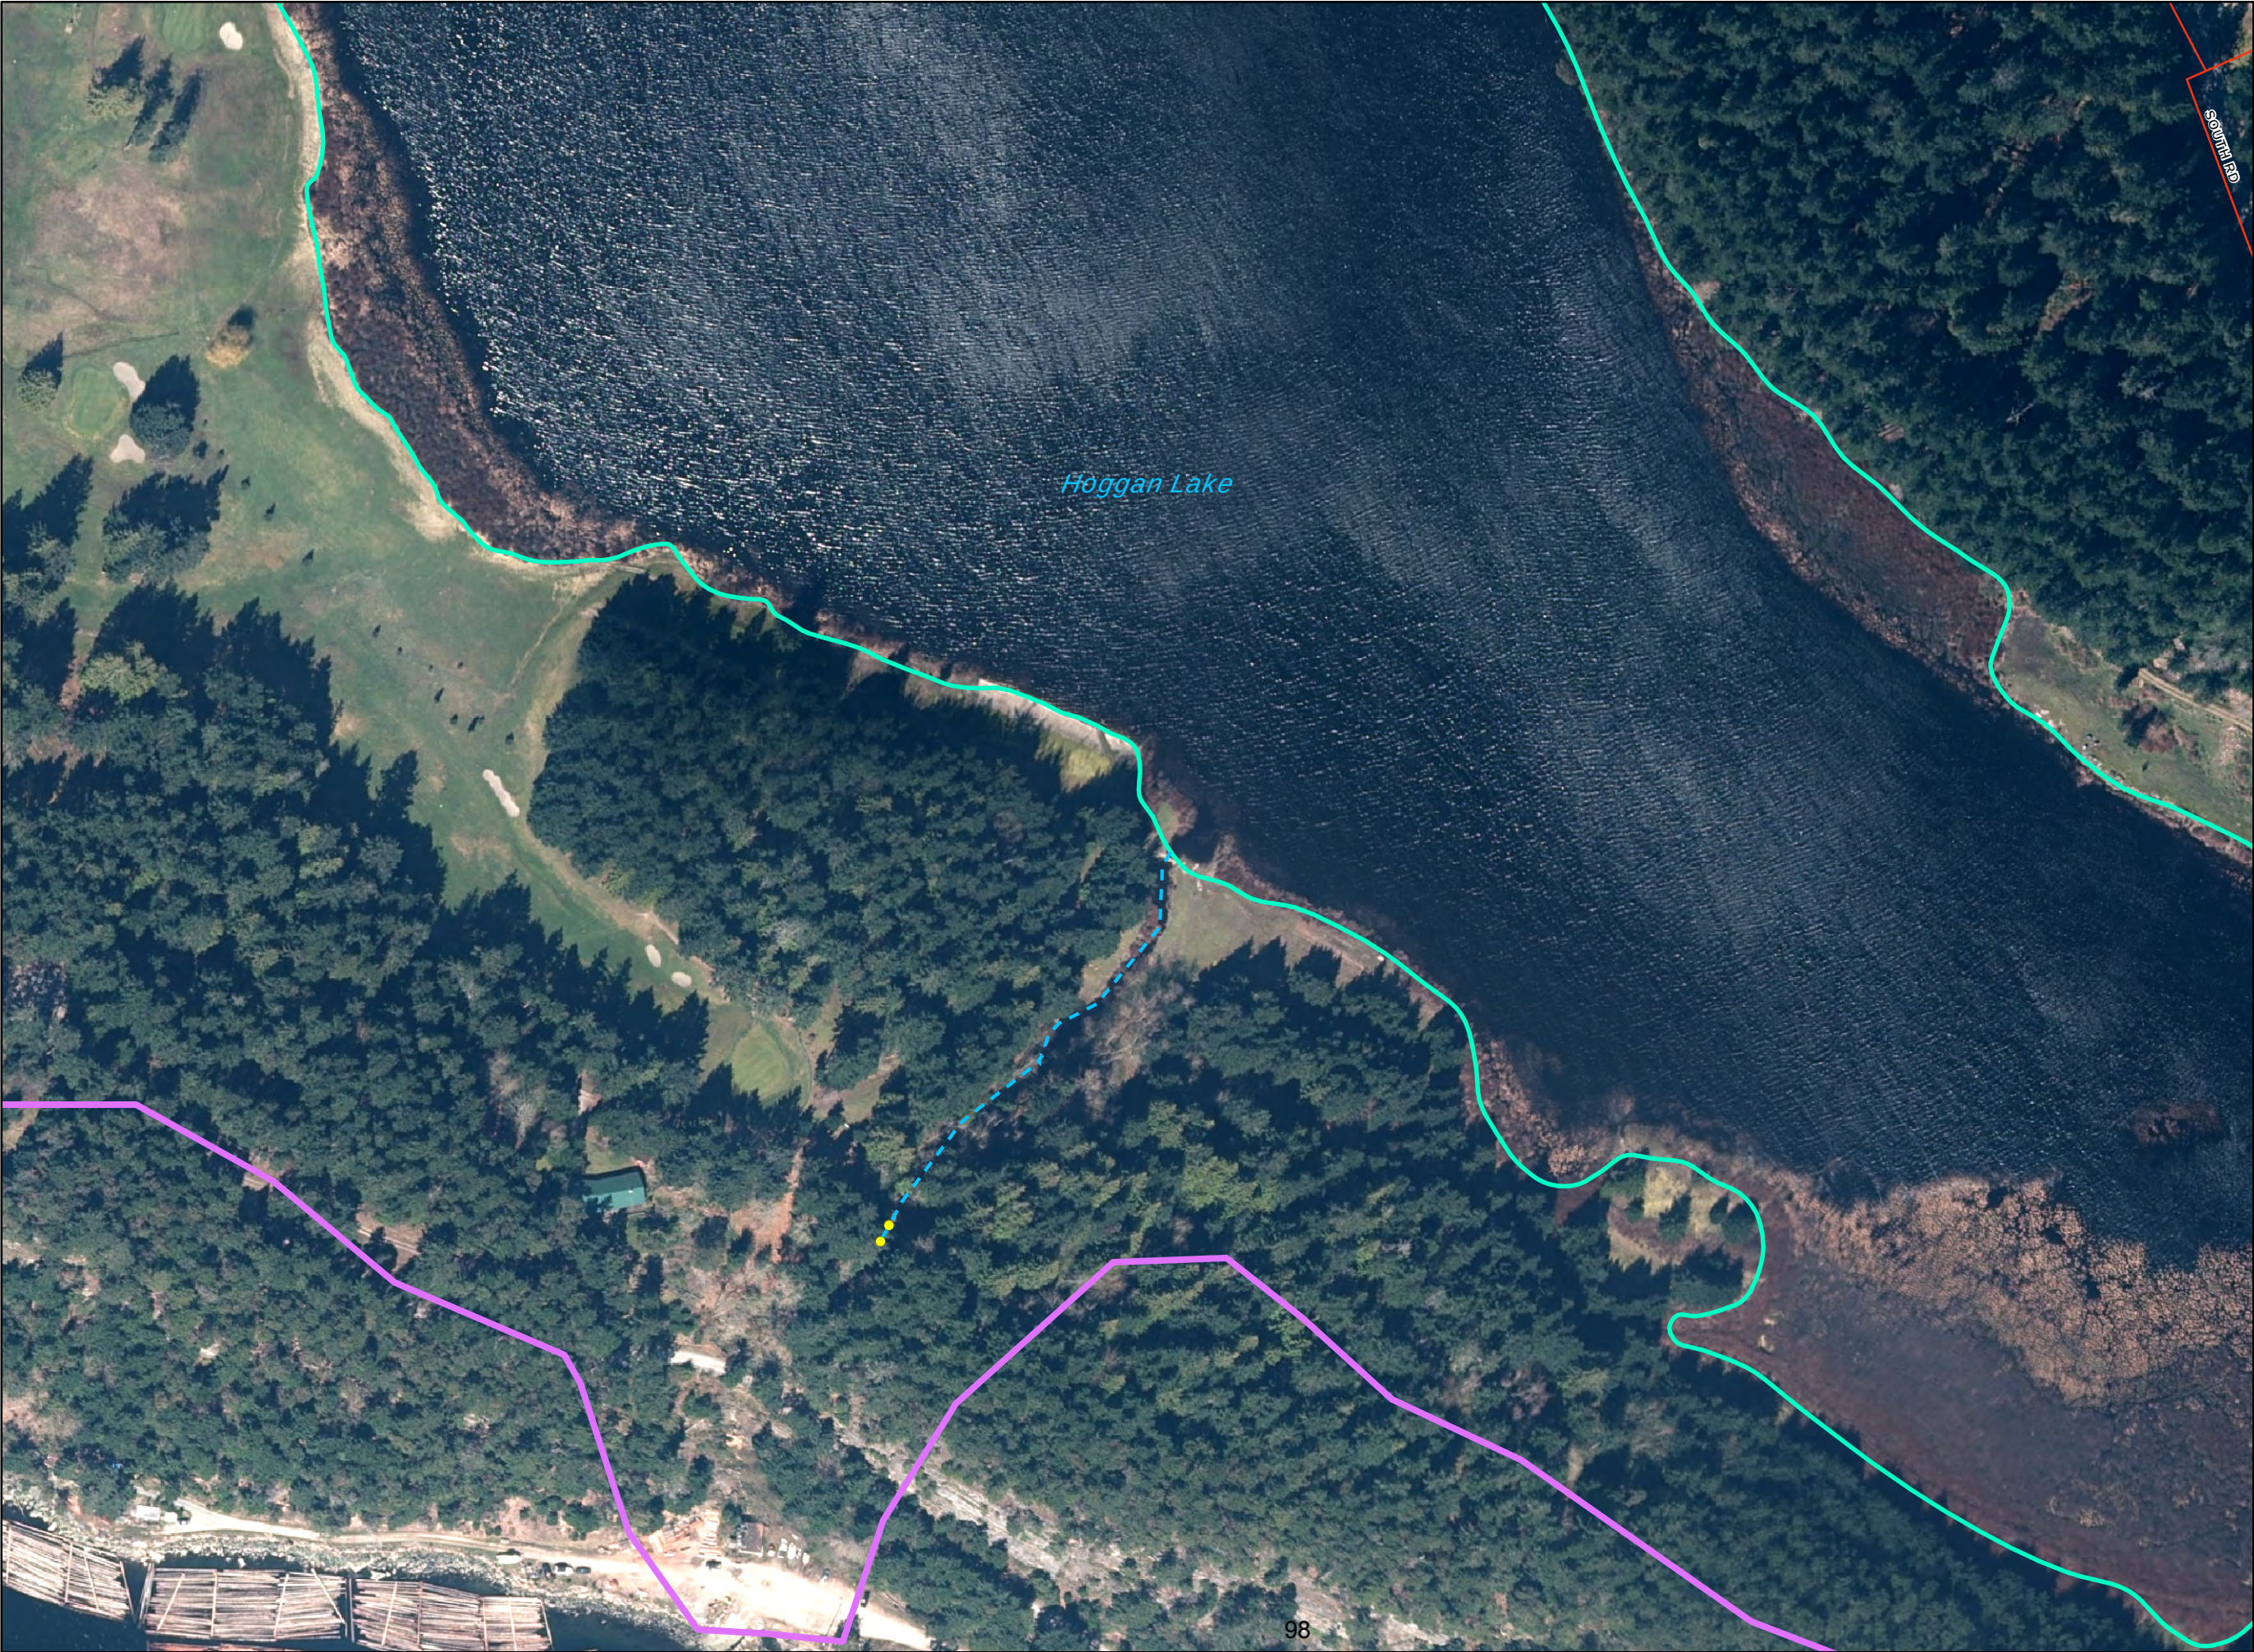
**Figure 8:**  
*Hoggan Creek*

The location of this outflow stream from Hoggan Lake is marked by a concrete box culvert at the edge of the lake. The outlet drainage is deep (in excess of 2 m) and approximately 3 m wide. The gradient of the stream is low (0.5%), with minimal surface flow. Fish habitat values are good in the first 150 m from the lake, due to the depth and presence of submerged vegetation, which provides cover. During the assessment, shoals of three-spine stickleback (*Gasterosteus aculeatus*) were observed. These fish represent a potential food source for piscivorous fish such as rainbow and cutthroat trout. Riparian vegetation consists of overhanging hardhack in the immediate riparian fringe and young red alder and Douglas-fir beyond.

Approximately 150 m from the lake, a dam has been constructed for hydro-electric power generation. A weir is located near the base of the dam, which is breached during periods of high flows. Potential fish habitat in the outflow drainage is truncated by the dam/weir structure. A pipe draws water that backs up behind the dam down a 100% gradient slope towards the ocean. There is no potential for the survival of fish downstream of the dam, even if fish were to be carried over the weir, due to the steep gradient and lack of a defined natural channel.
