**GABRIOLA ISLAND RIPARIAN AREA  
REGULATION STREAM IDENTIFICATION  
UPDATED REVISED VERSION FEBRUARY 24, 2012**

**Chloe Fox  
Island Planner (Gabriola Island Local Trust Committee)  
700 North Road, Gabriola Island, BC, V0R 1X3**

**Trystan Willmott, B.Sc. A.Sc.T.  
Justin Lange, B.Sc., B.I.T., A.Sc.T.  
MADRONE ENVIRONMENTAL SERVICES LTD.  
1081 Canada Avenue, Duncan, BC, V9L 1V2**

**February 24, 2012**

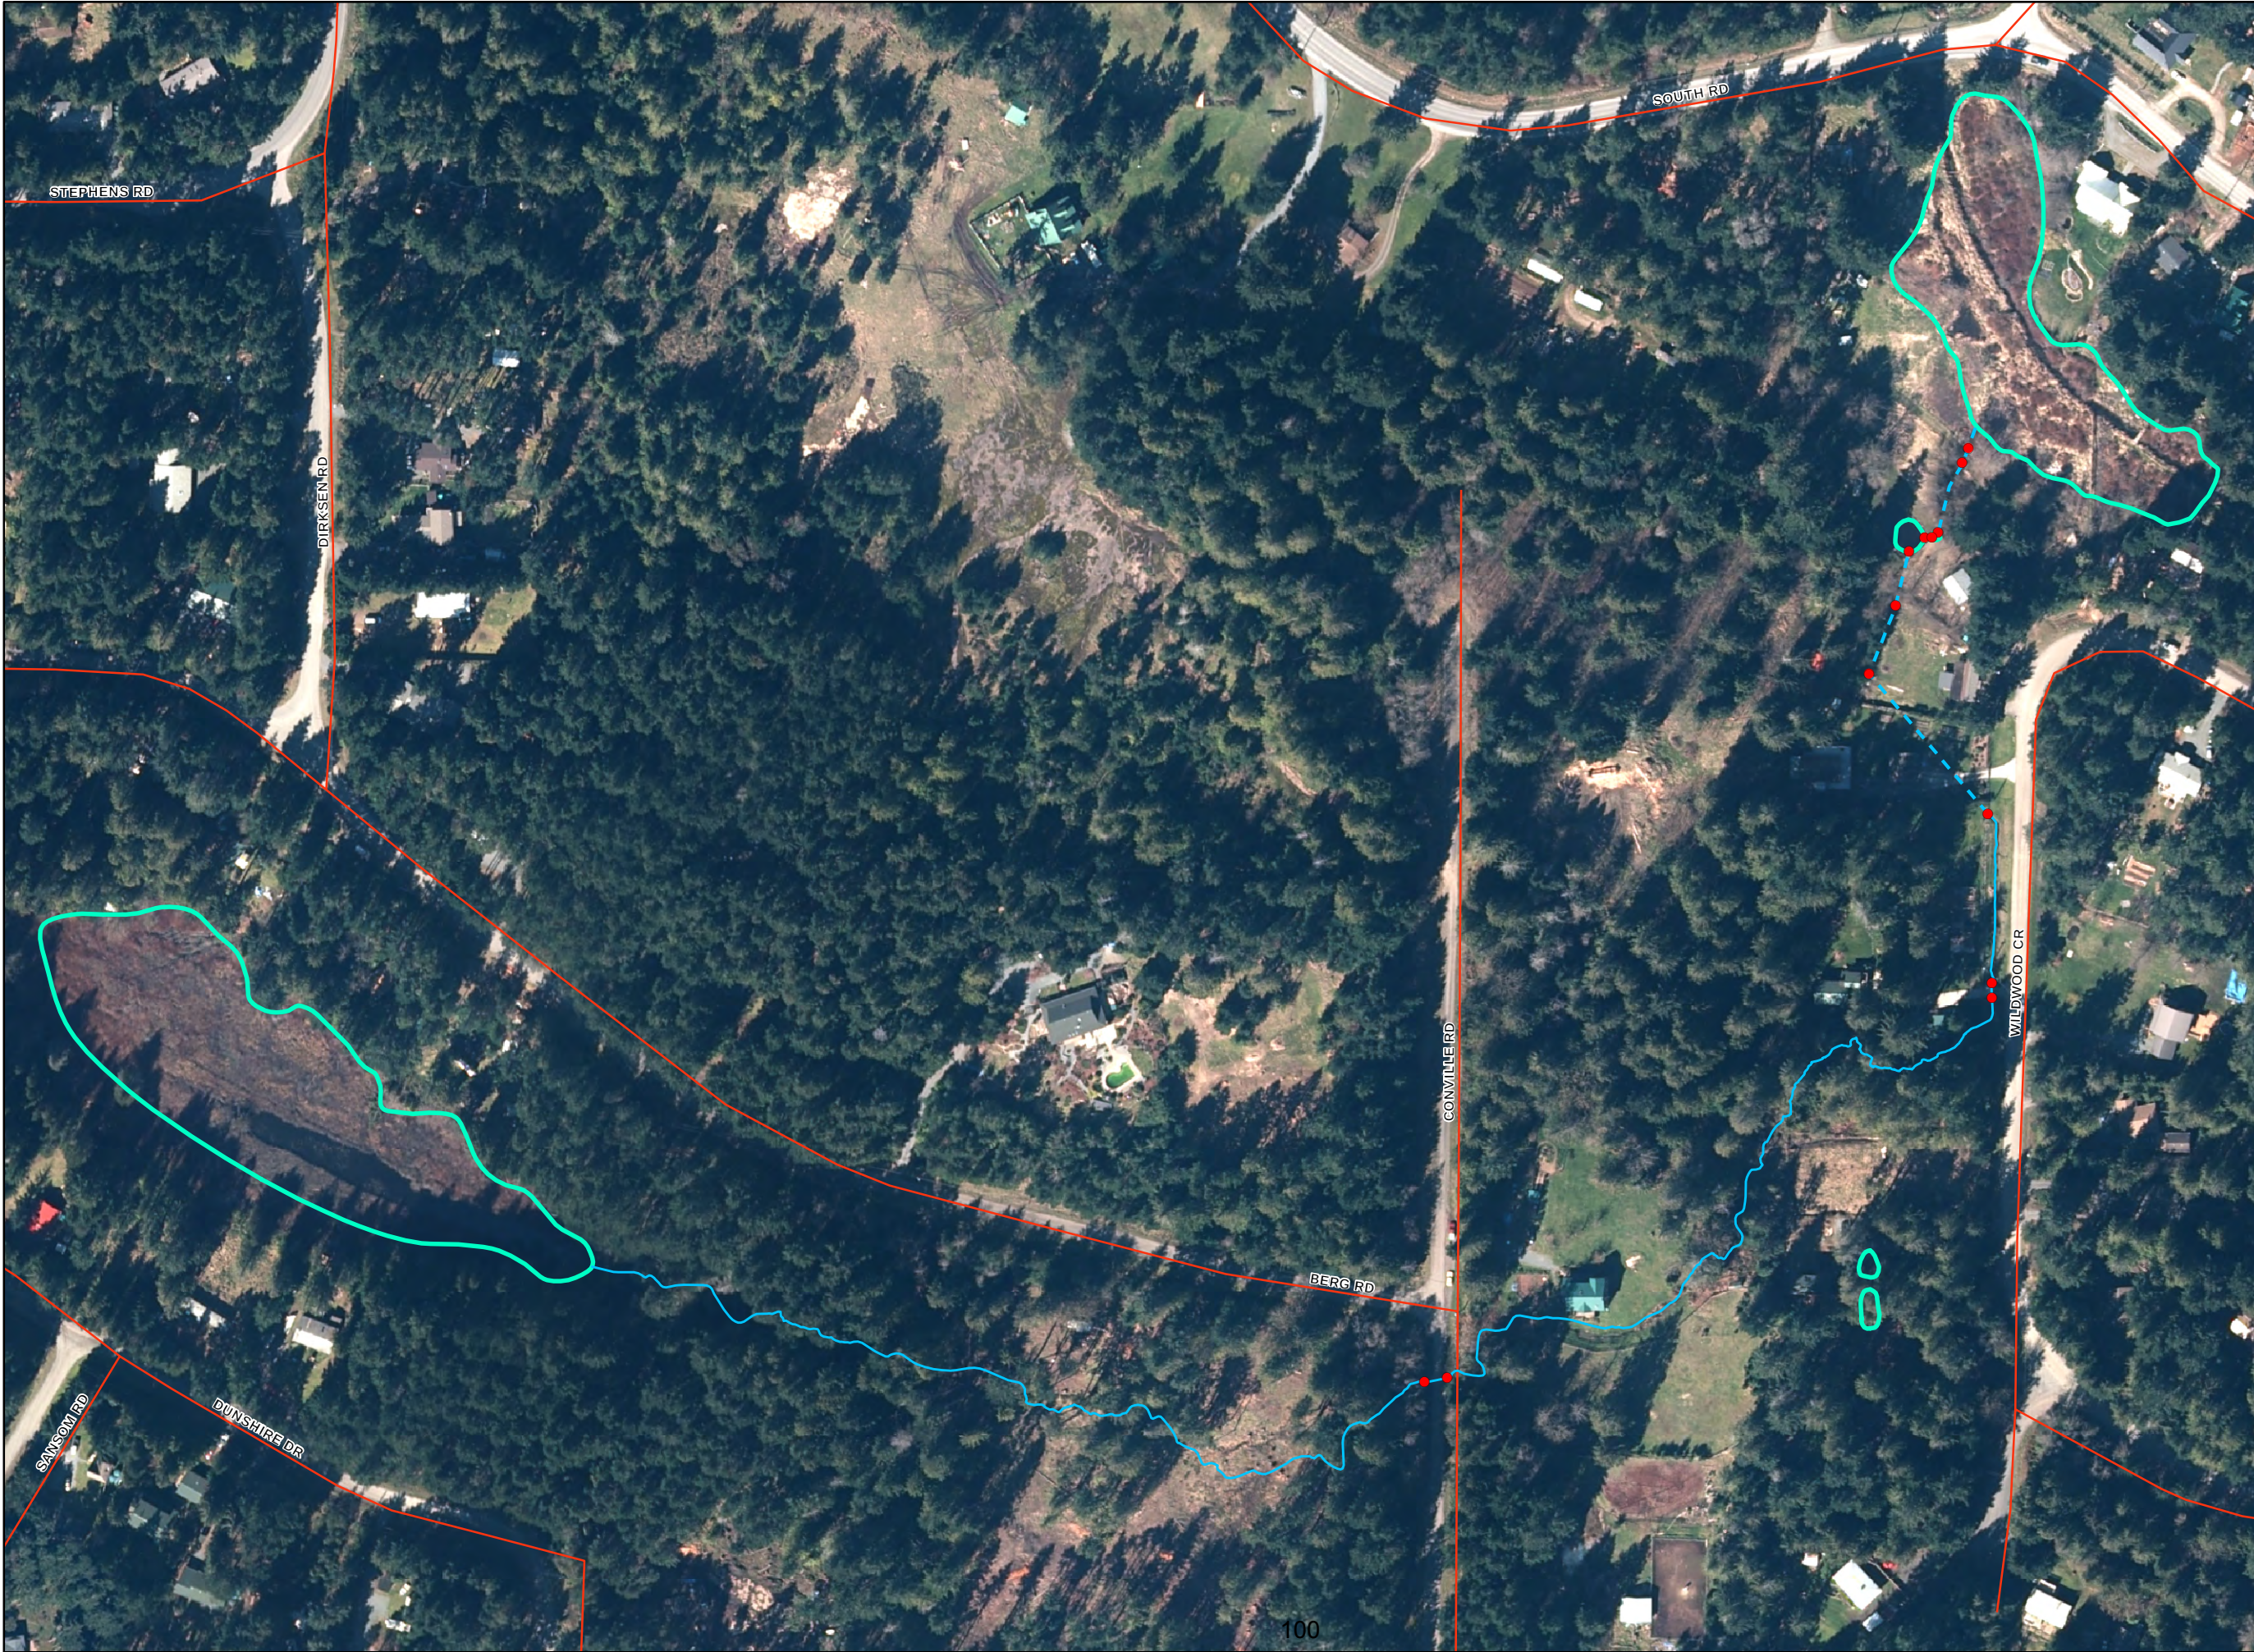
**Figure 9:**  
Eppler Creek

The drainage continues under Conville Road. To the west of the road, the drainage lacks a defined channel, with water spreading out and flowing over grass and rushes for approximately 50 m before entering a roadside ditch. Upstream of the roadside ditch, the drainage has been ditched through residential properties. The ditch is approximately 1.5 m wide and 1 m deep, with a slope of 1% – 2%.

The origin of the drainage is a wetland adjacent to Dole Road (known locally as “Epps Pond”). The wetland is approximately 30 m wide and 75 m long with a dense fringe of hardhack and willow. A deep pocket of open water occurs within the centre of the wetland. Riparian vegetation adjacent to the wetland is intact and dense, providing biological function to connected downstream fish habitat. The tree layer is composed of Douglas-fir, western redcedar and red alder. Dense salal growth dominates the understory shrub layer. Salmonberry, snowberry and oceanspray were also noted. The herb layer is sparse and composed mainly of sword fern.

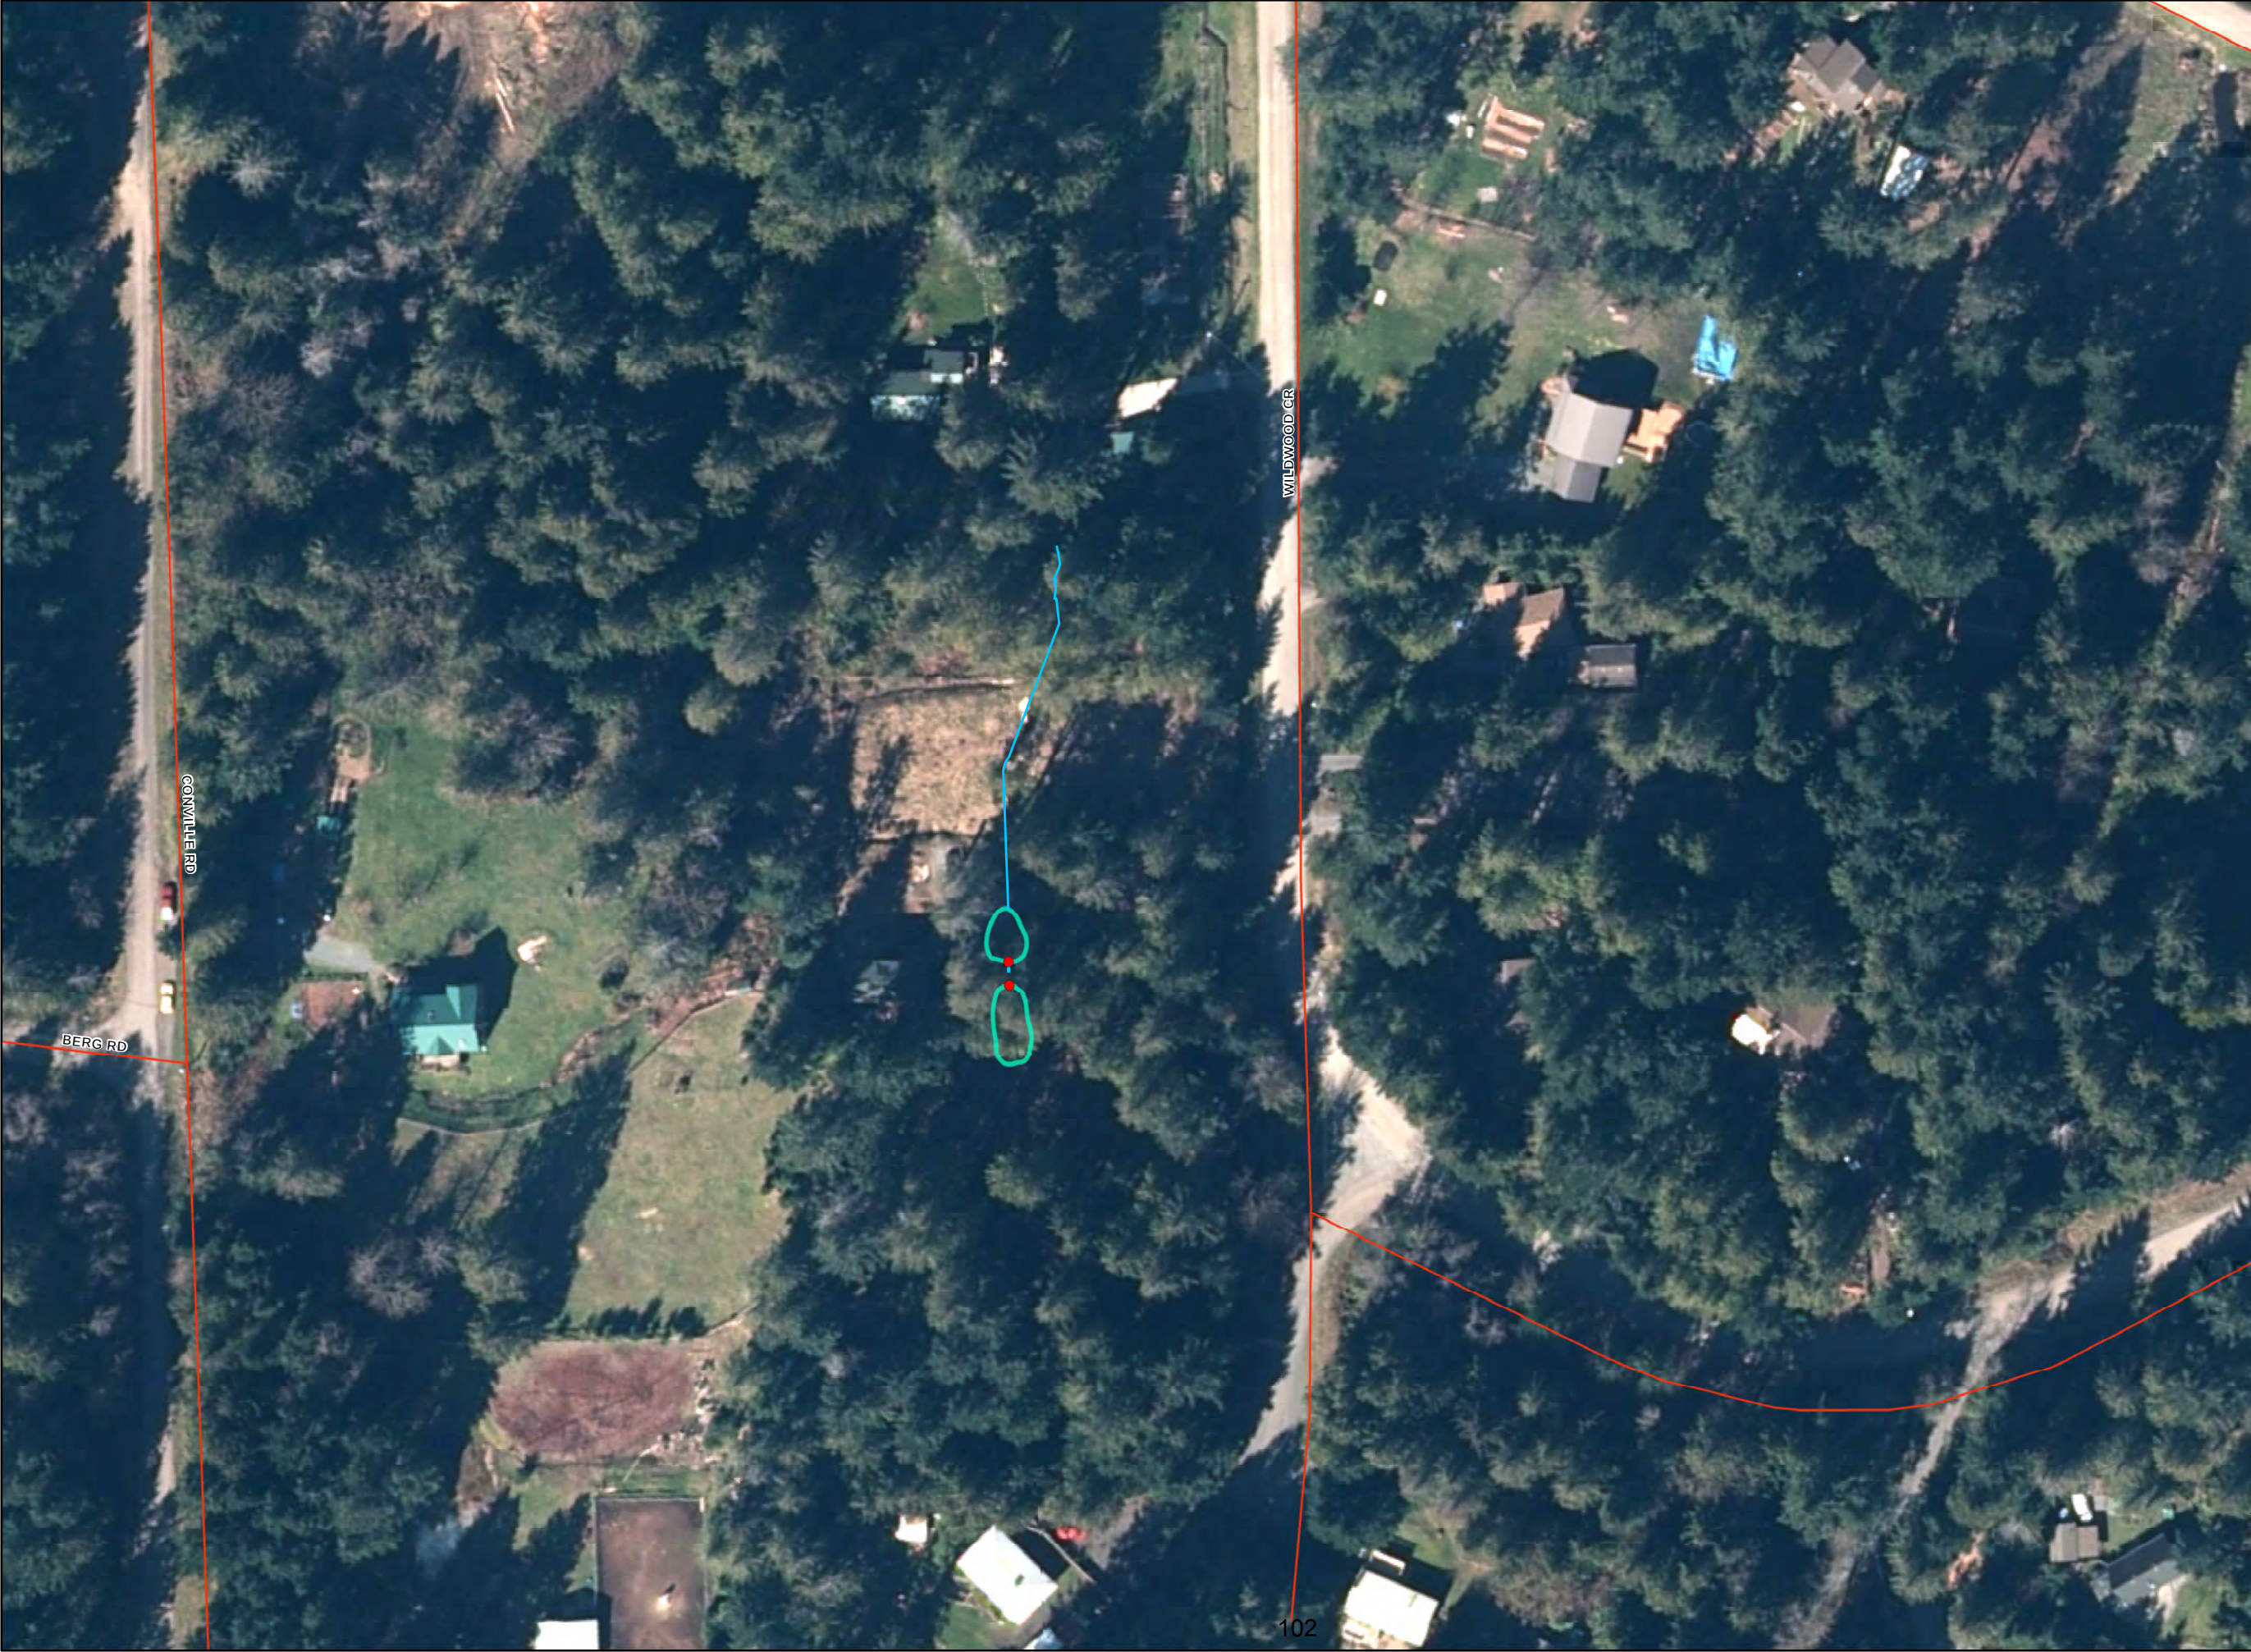
**Figure 10:**  
Wildwood Crescent Stream

Approximately 30 m from Wildwood Crescent, a small constructed drainage ditch flows from the south into Eppler Creek. Upstream (south) of the confluence, the ditch flows through two residential properties for approximately 40 m to a pond, which represents the origin of the stream. On average, the ditch is 0.5 m wide and 0.5 m deep, with a slope of 1% – 2%. Substrate within the ditch is comprised of soft organic material.

Functioning riparian vegetation is lacking, as newly established lawn extends up to the edge of the ditch. Adjacent to the pond, numerous western redcedar line the bank. In the centre of the pond, a gravel access road dissects the pond in two; however, a culvert provides connectivity under the road.

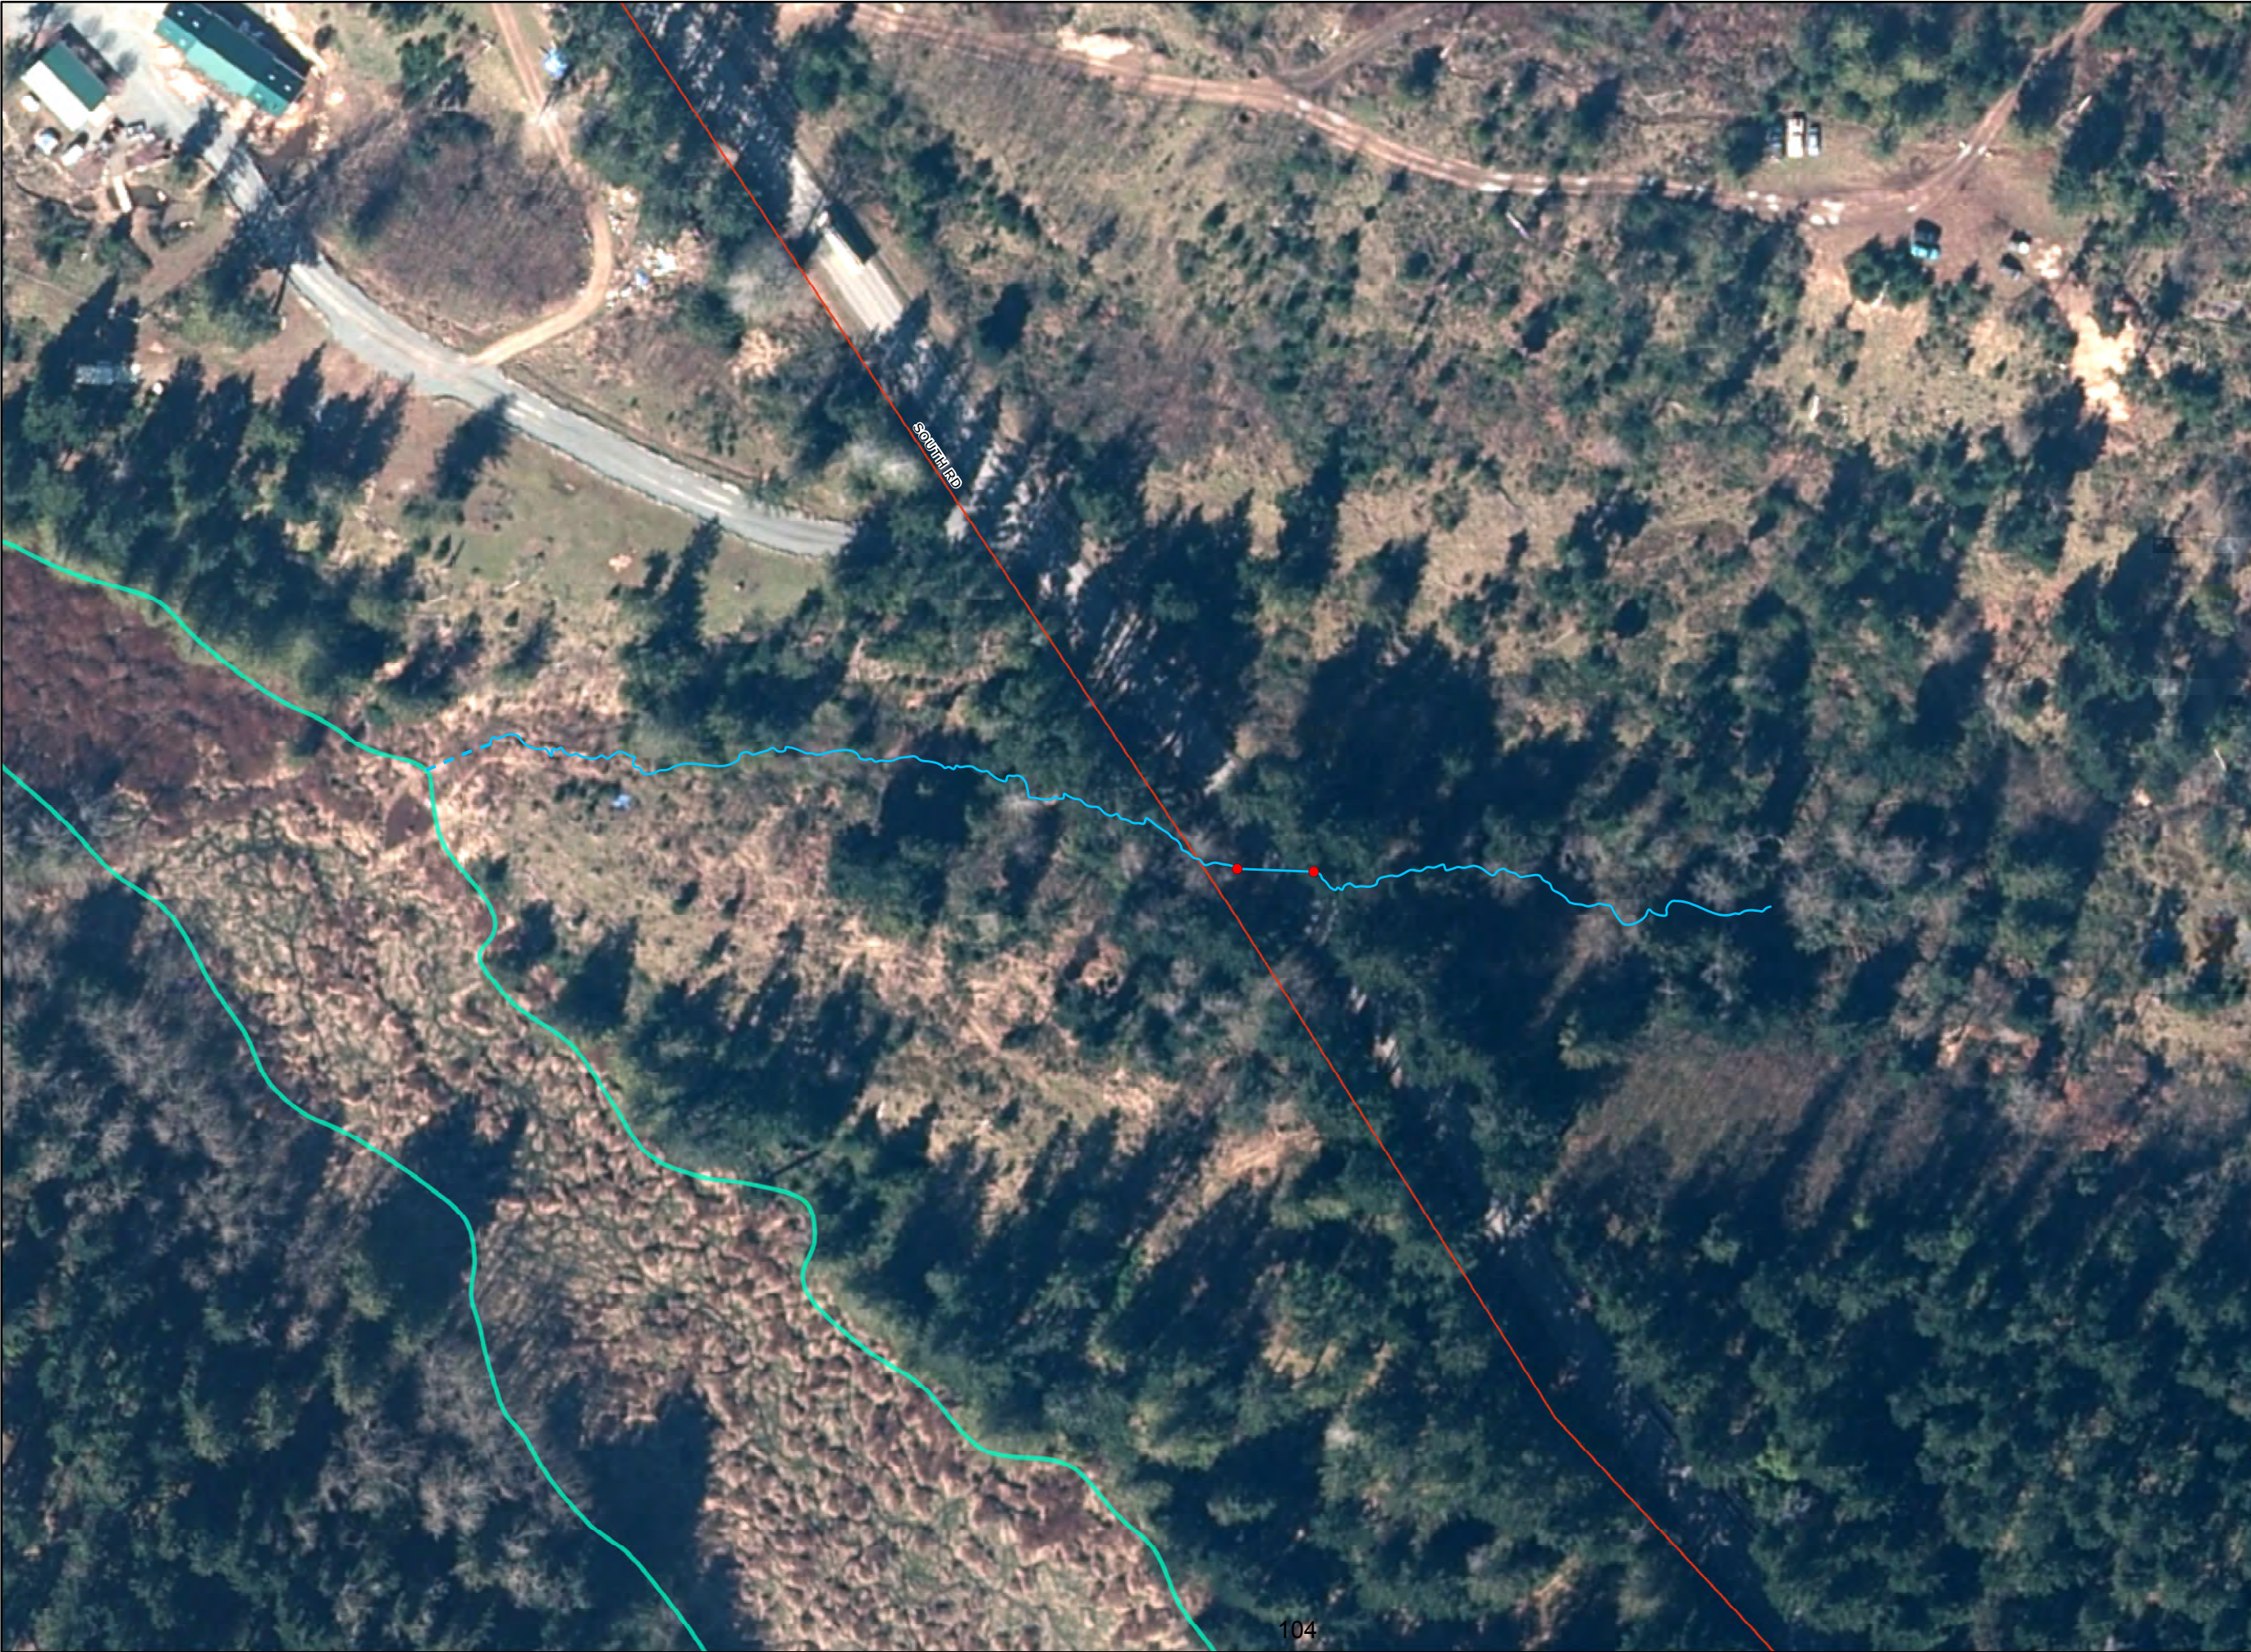
**Figure 11:**  
**South Road Stream A**

This drainage enters the first linear wetland located upstream of the golf course on Goodhue Creek. The stream is poorly defined and does not provide habitat suitable for fish. As noted previously, it is unlikely that fish would be present at this point in the system, based on the fact that fish originating from Hoggan Lake would be unable to navigate through the wetland habitat.

The stream has a gradient of 3% over an organic substrate, which increases to 6% immediately downstream of South Road. Vegetation consists of dense salmonberry and Himalayan blackberry, with young coniferous forest adjacent. The drainage is carried under South Road via a culvert, and from the inlet of the culvert, the stream becomes extremely poorly defined.

Approximately 70 m upstream of the road, the stream could not be followed. At this point, water seeps out of the slope in multiple locations and collects to form the stream. The seepage occurs in an area supporting a relatively dry vegetation assemblage, with salal and sword fern dominating. No hydrophytes or wetland characteristics were noted at the origin of the stream.

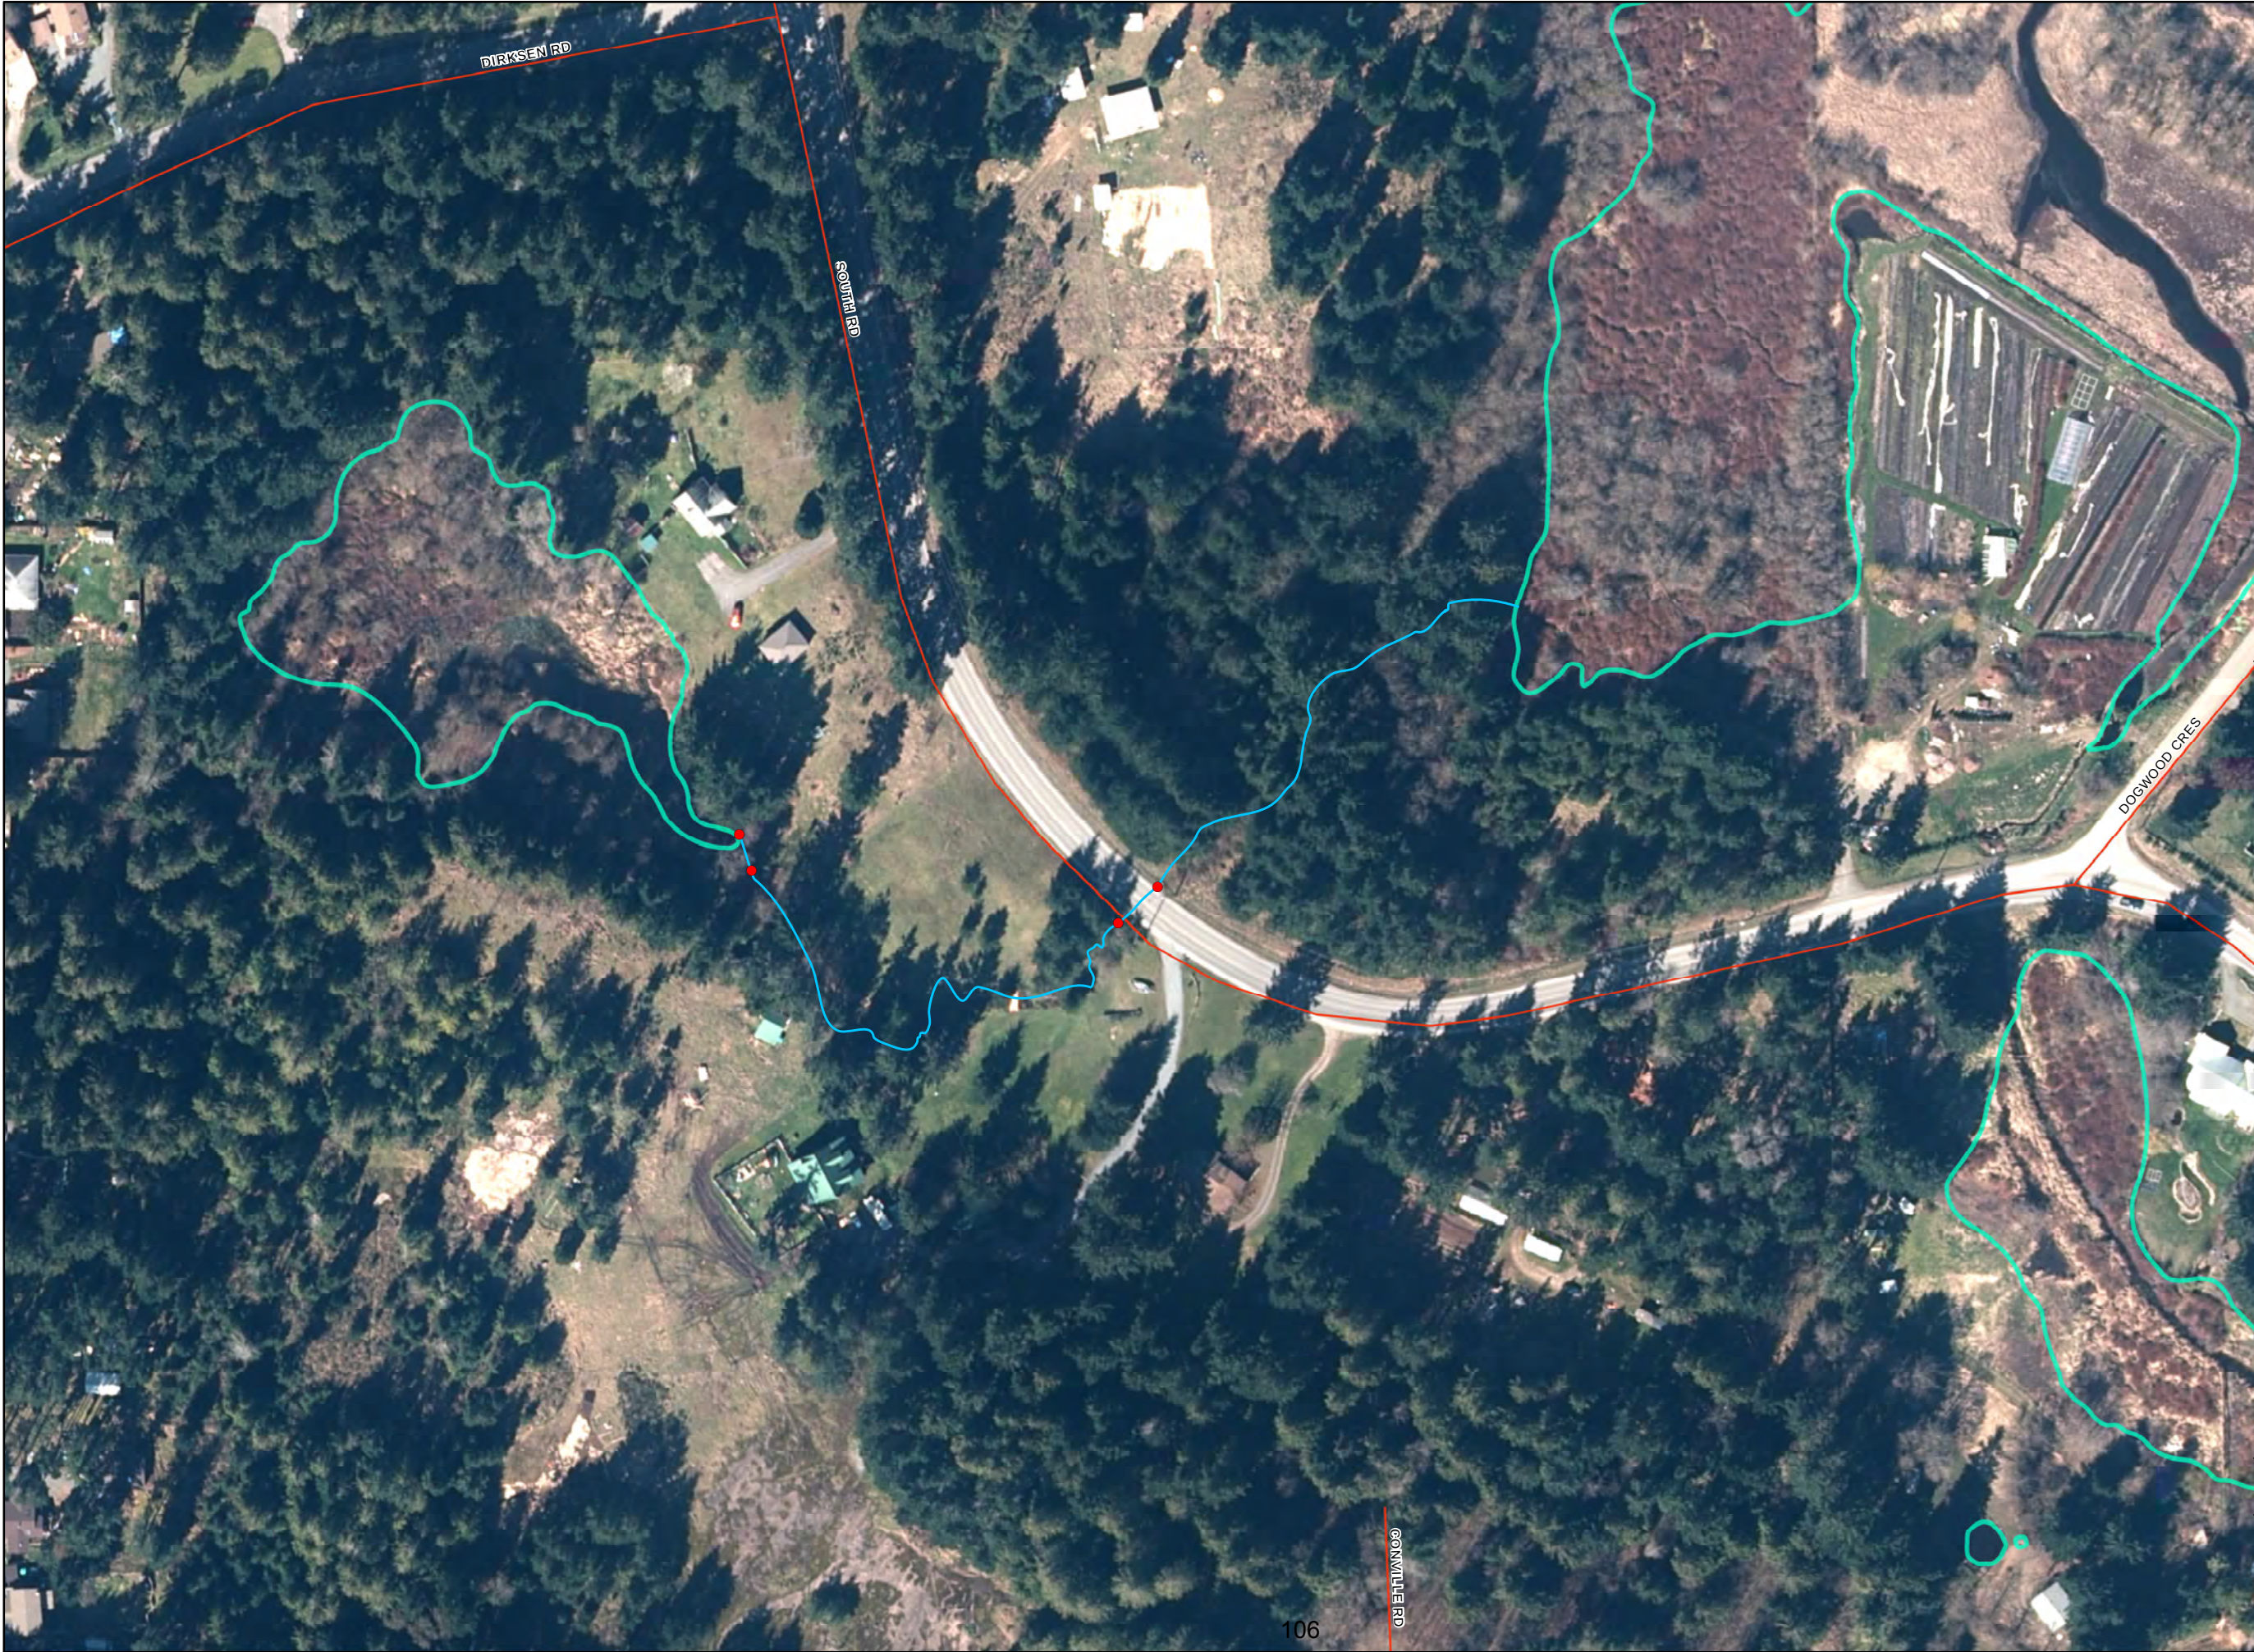
Figure 12:  
South Road Stream B

The origin of the drainage is a pond located on residential property. The pond is approximately 30 m wide and 75 m long and retains water on a perennial basis. The pond will feed the connected ditch only when the pond level reaches the height of the outflow culvert. Vegetation immediately adjacent to and in the pond consists mainly of reed canary grass, hardhack, common rush and red alder saplings. As the area has been subject to historical anthropogenic disturbance, grasses also extend up to the edge of the pond.

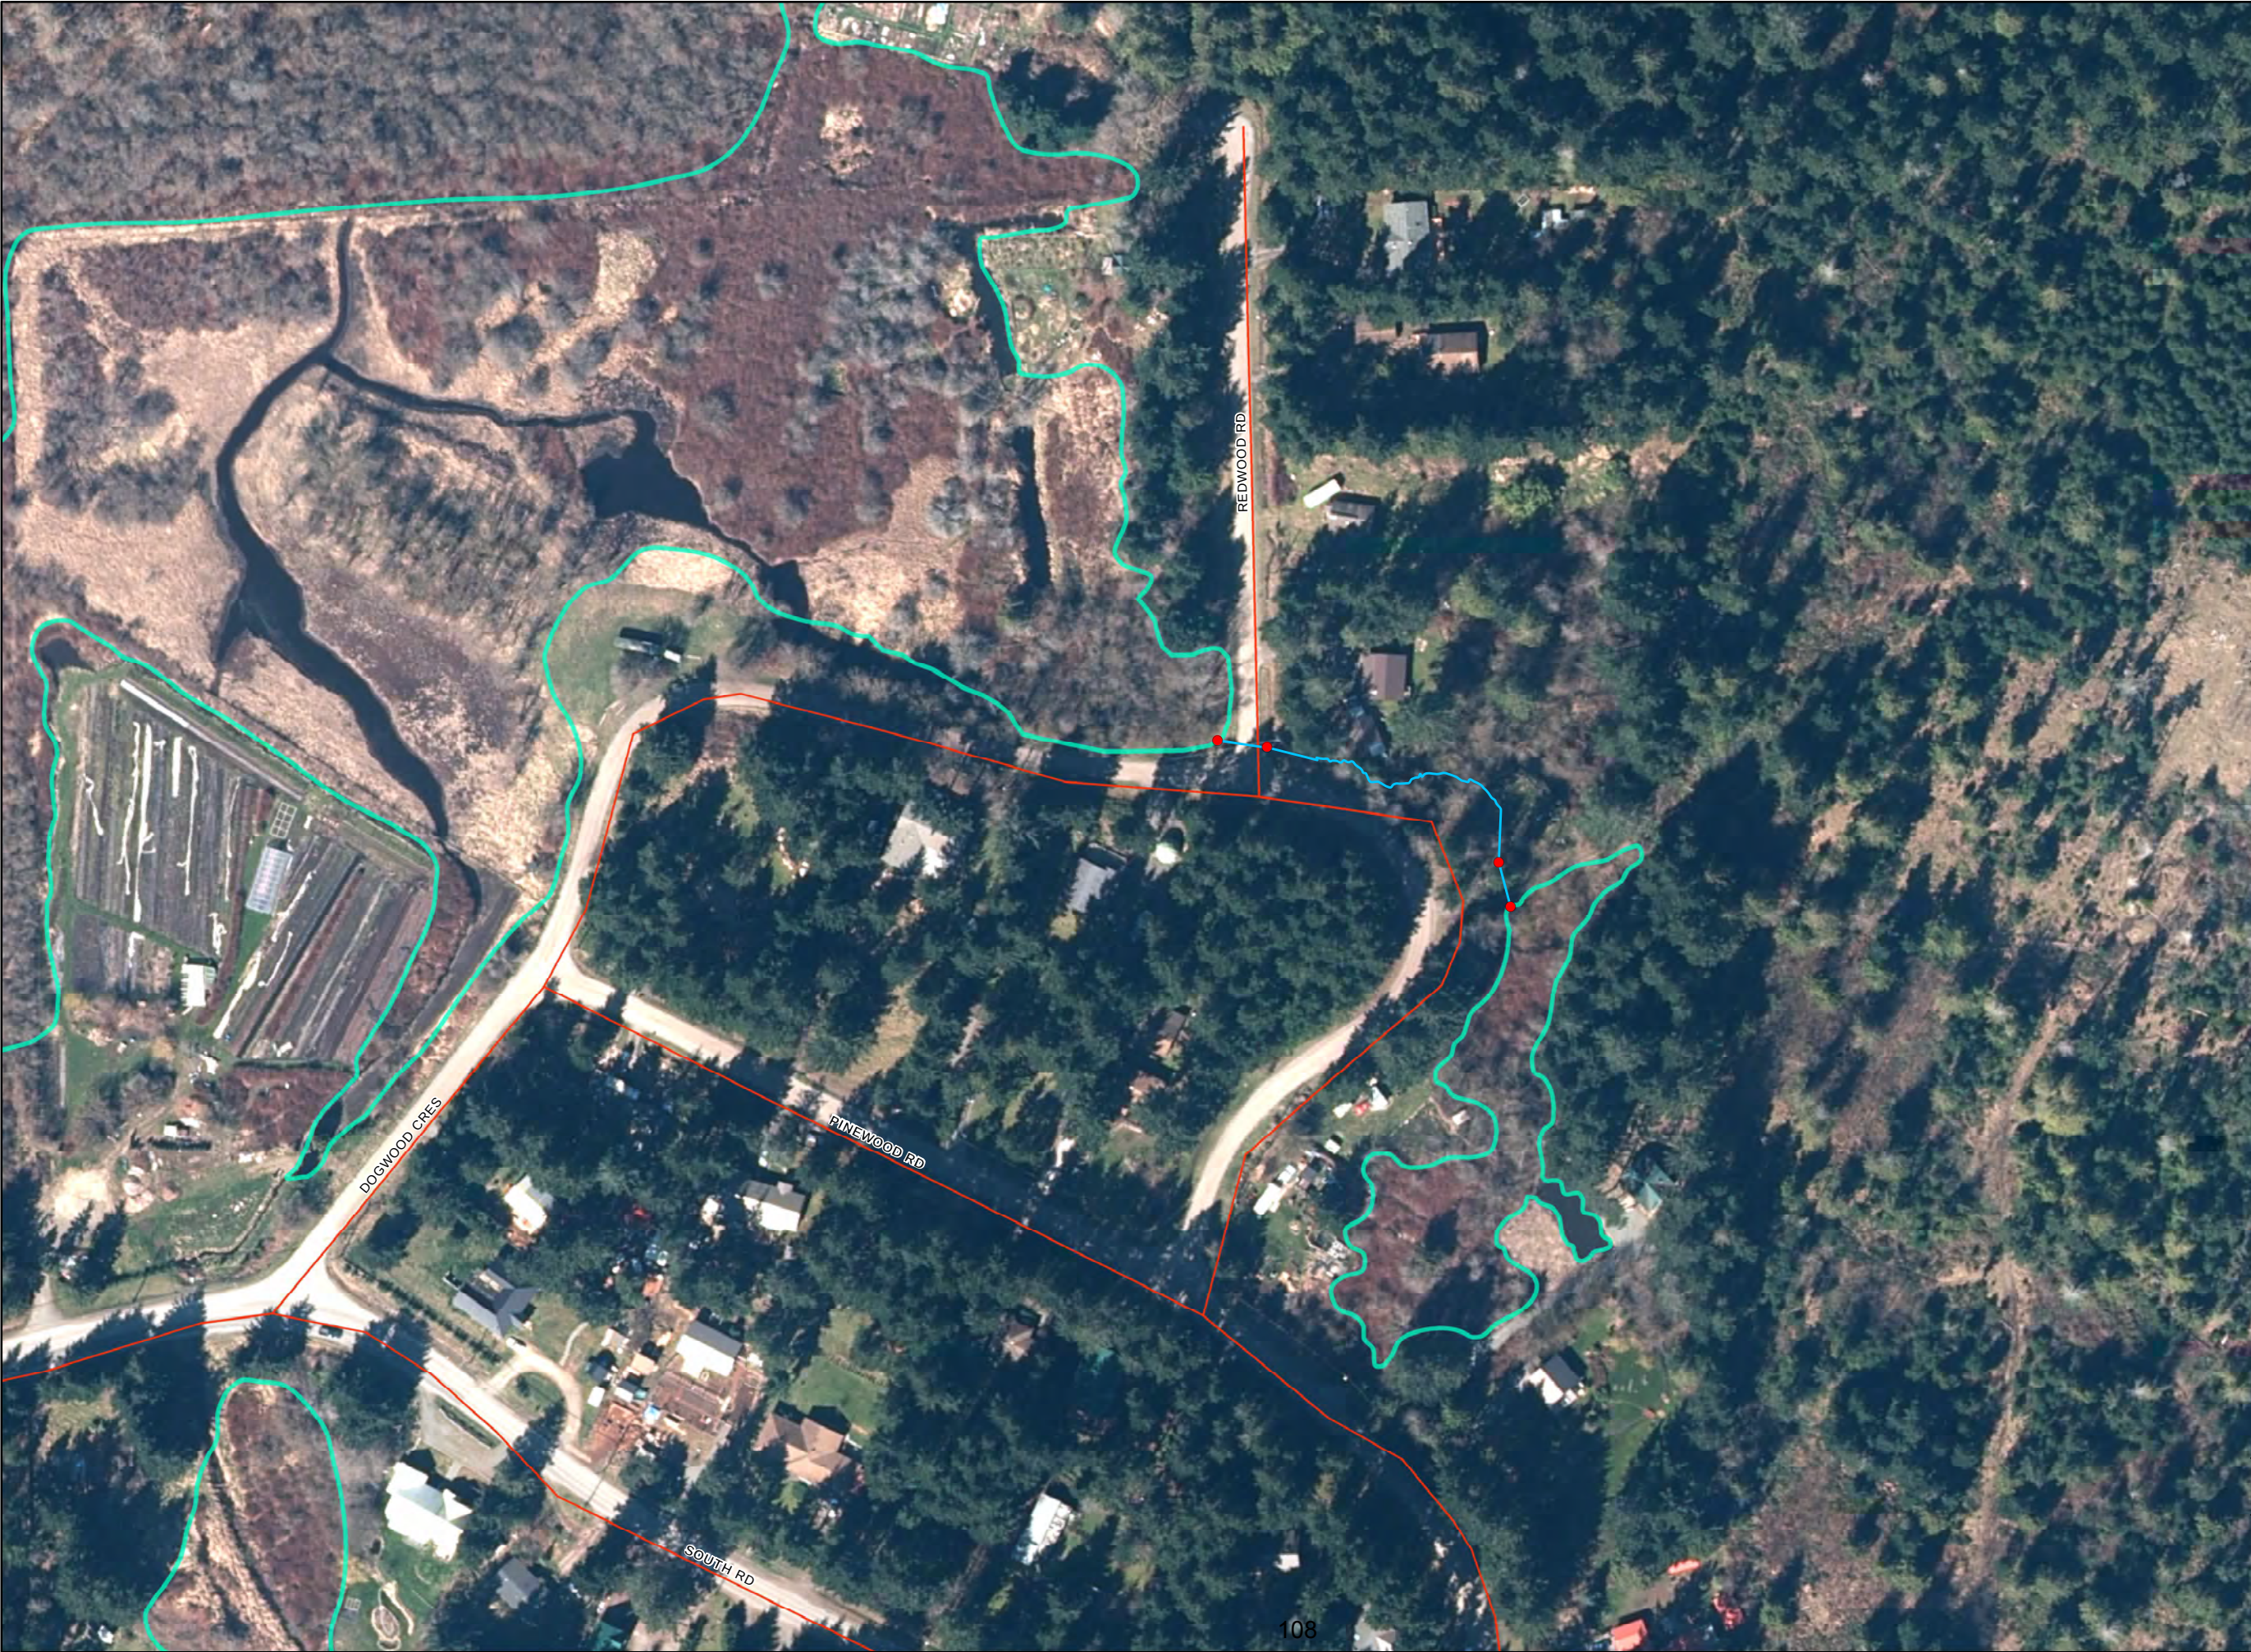
**Figure 13:**  
Dogwood Crescent Stream

This poorly defined stream flows into the extensive wetland located immediately upstream of South Road on Goodhue Creek. The stream will not support fish, due to the fact that it is located upstream of the likely upper limit of fish distribution on Goodhue Creek and also due to a complete lack of fish habitat attributes.

The drainage enters the wetland complex via a culvert under Redwood Road. Upstream of the confluence with the wetland, the drainage deepens and widens through private property prior to flowing underneath a driveway. Upstream of the driveway, the drainage represents an extensive wetland complex consisting of hardhack and willows. Upstream of the wetland that parallels Dogwood Crescent, an excavated pond has been built, above which the drainage could not be practically followed, as it represents an undefined shallow depression over lawn.
