**GABRIOLA ISLAND RIPARIAN AREA  
REGULATION STREAM IDENTIFICATION  
UPDATED REVISED VERSION FEBRUARY 24, 2012**

**Chloe Fox  
Island Planner (Gabriola Island Local Trust Committee)  
700 North Road, Gabriola Island, BC, V0R 1X3**

**Trystan Willmott, B.Sc. A.Sc.T.  
Justin Lange, B.Sc., B.I.T., A.Sc.T.  
MADRONE ENVIRONMENTAL SERVICES LTD.  
1081 Canada Avenue, Duncan, BC, V9L 1V2**

**February 24, 2012**

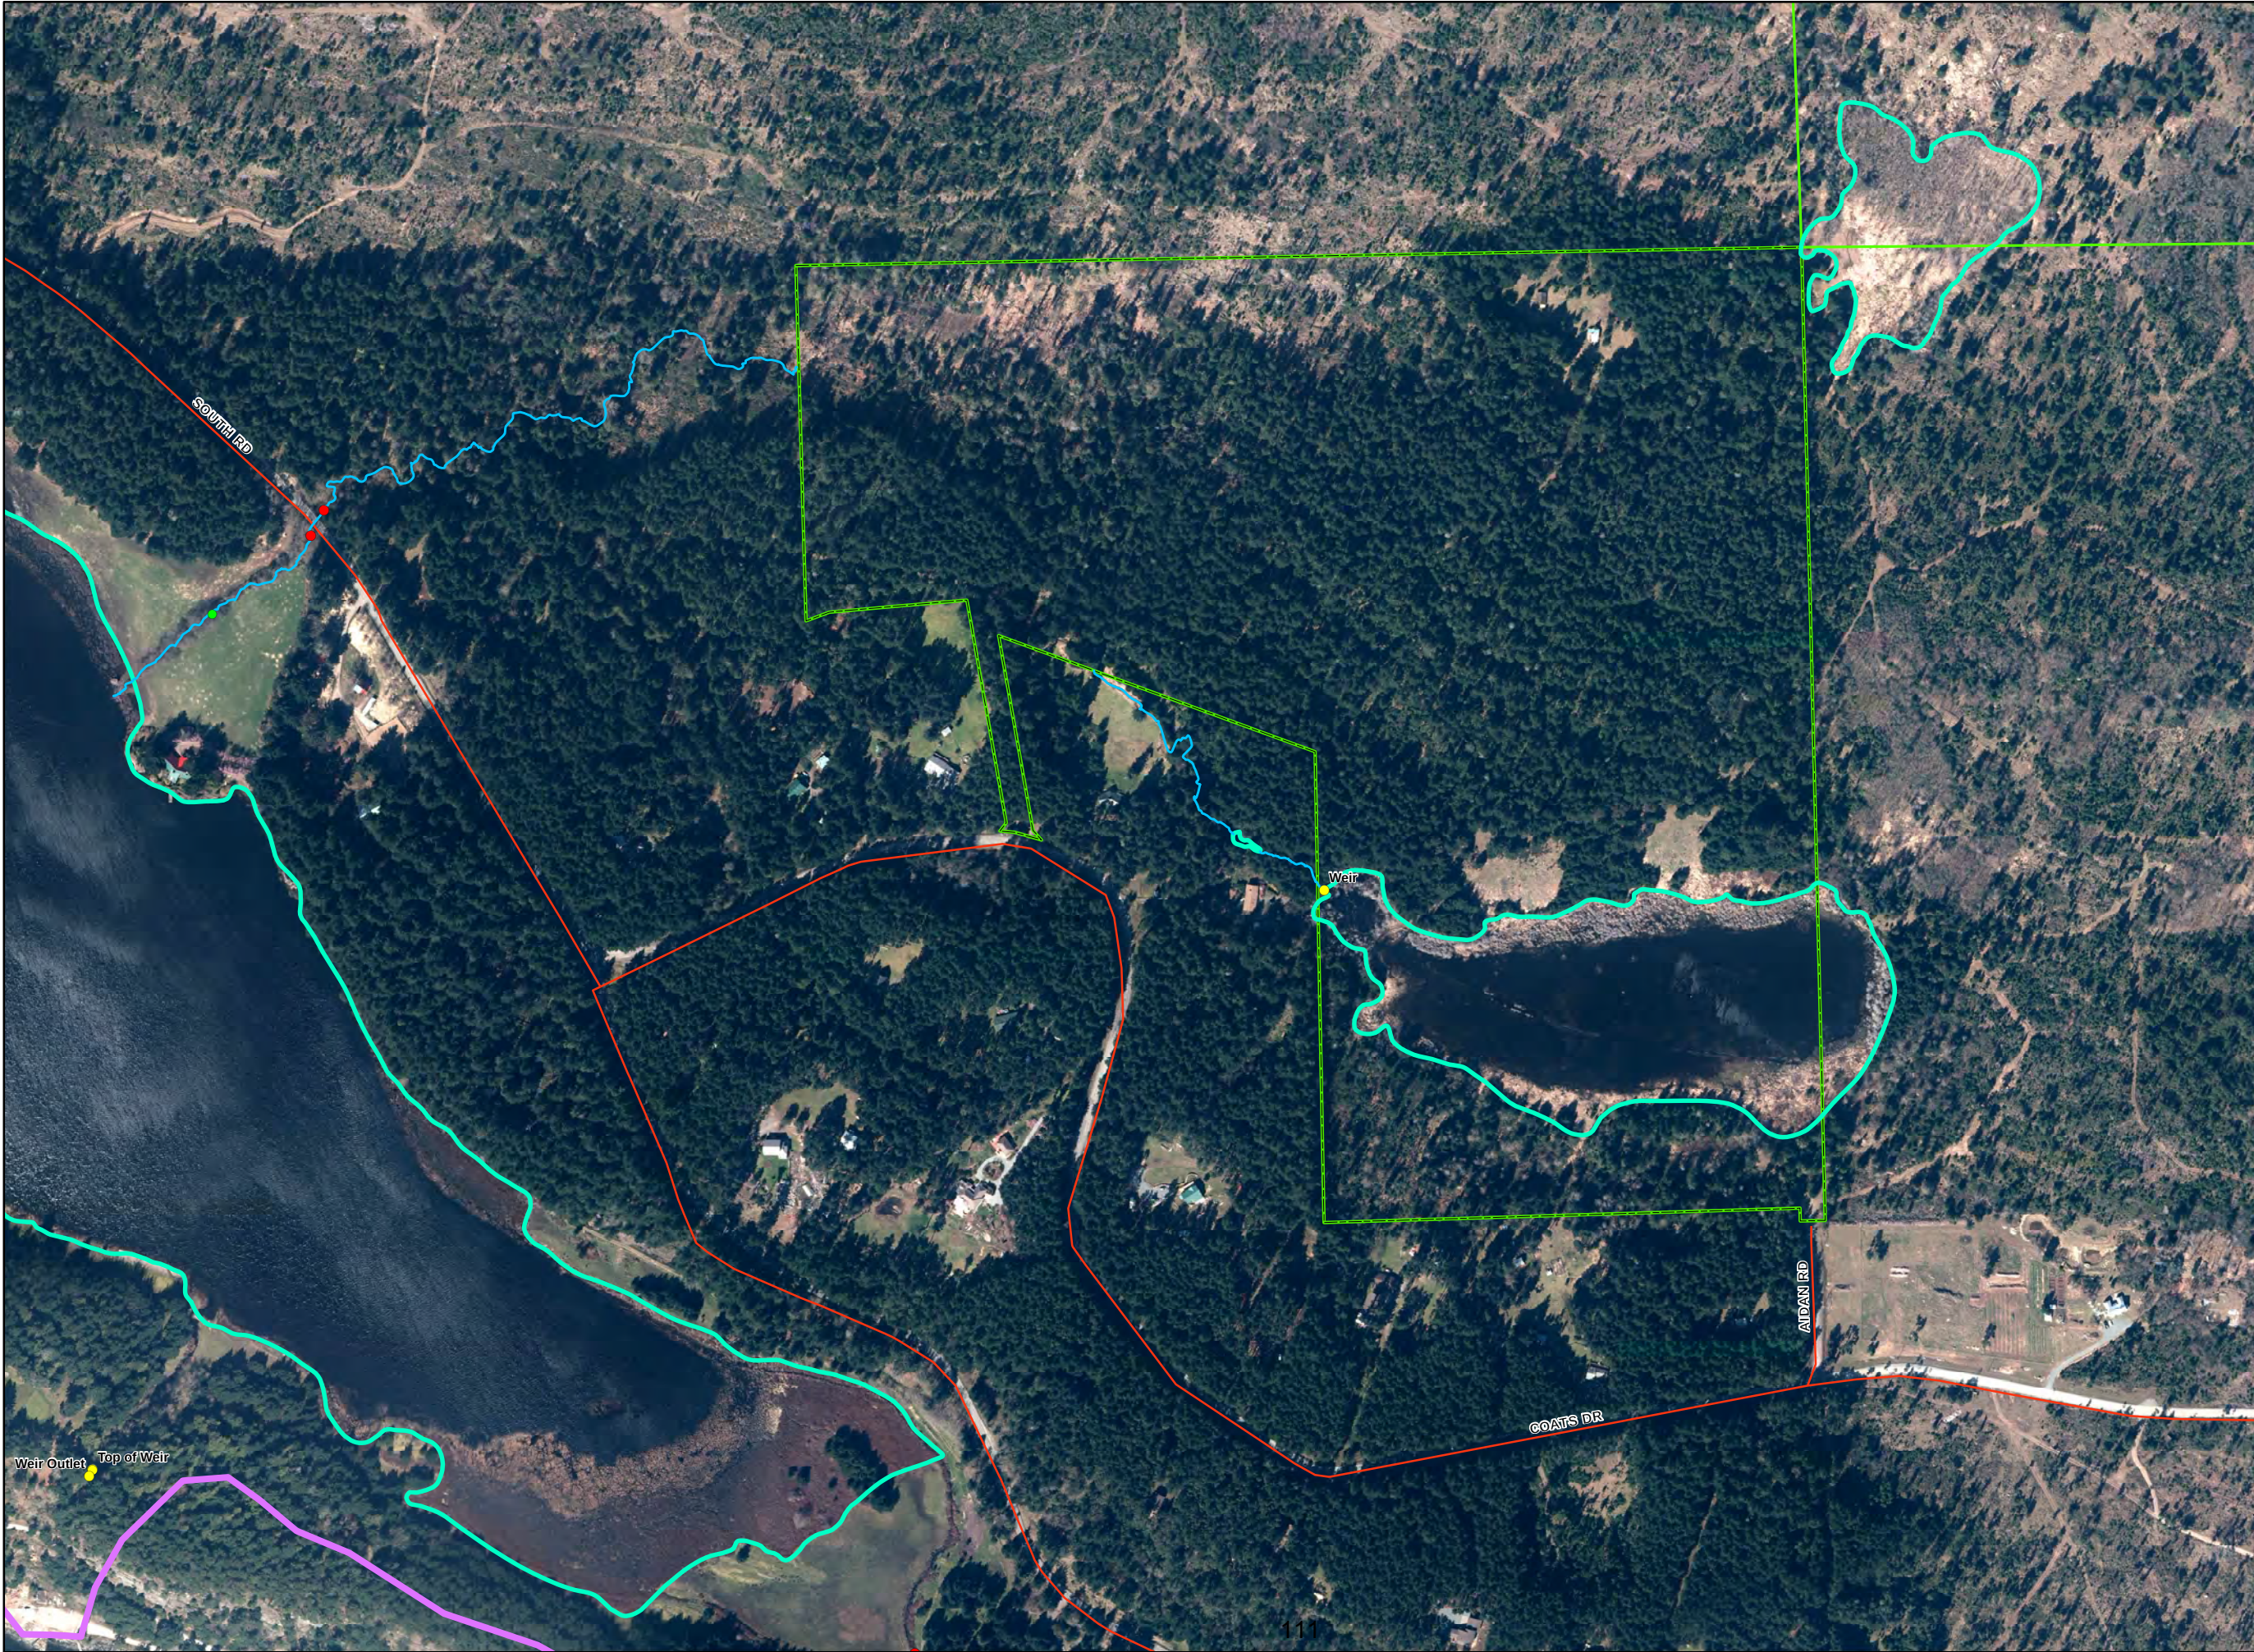
Figure 14:  
Coats Marsh Outflow Stream

Despite not supporting fish (as defined in the RAR), the wetland ecosystem known as Coats Marsh will provide an important habitat feature for a range of wildlife. The wetland also supports a unique range of hydrophytic plant assemblages adapted to living in moist conditions. The forested fringe surrounding the wetland adds to the habitat diversity, as it creates functional “edge” habitat.

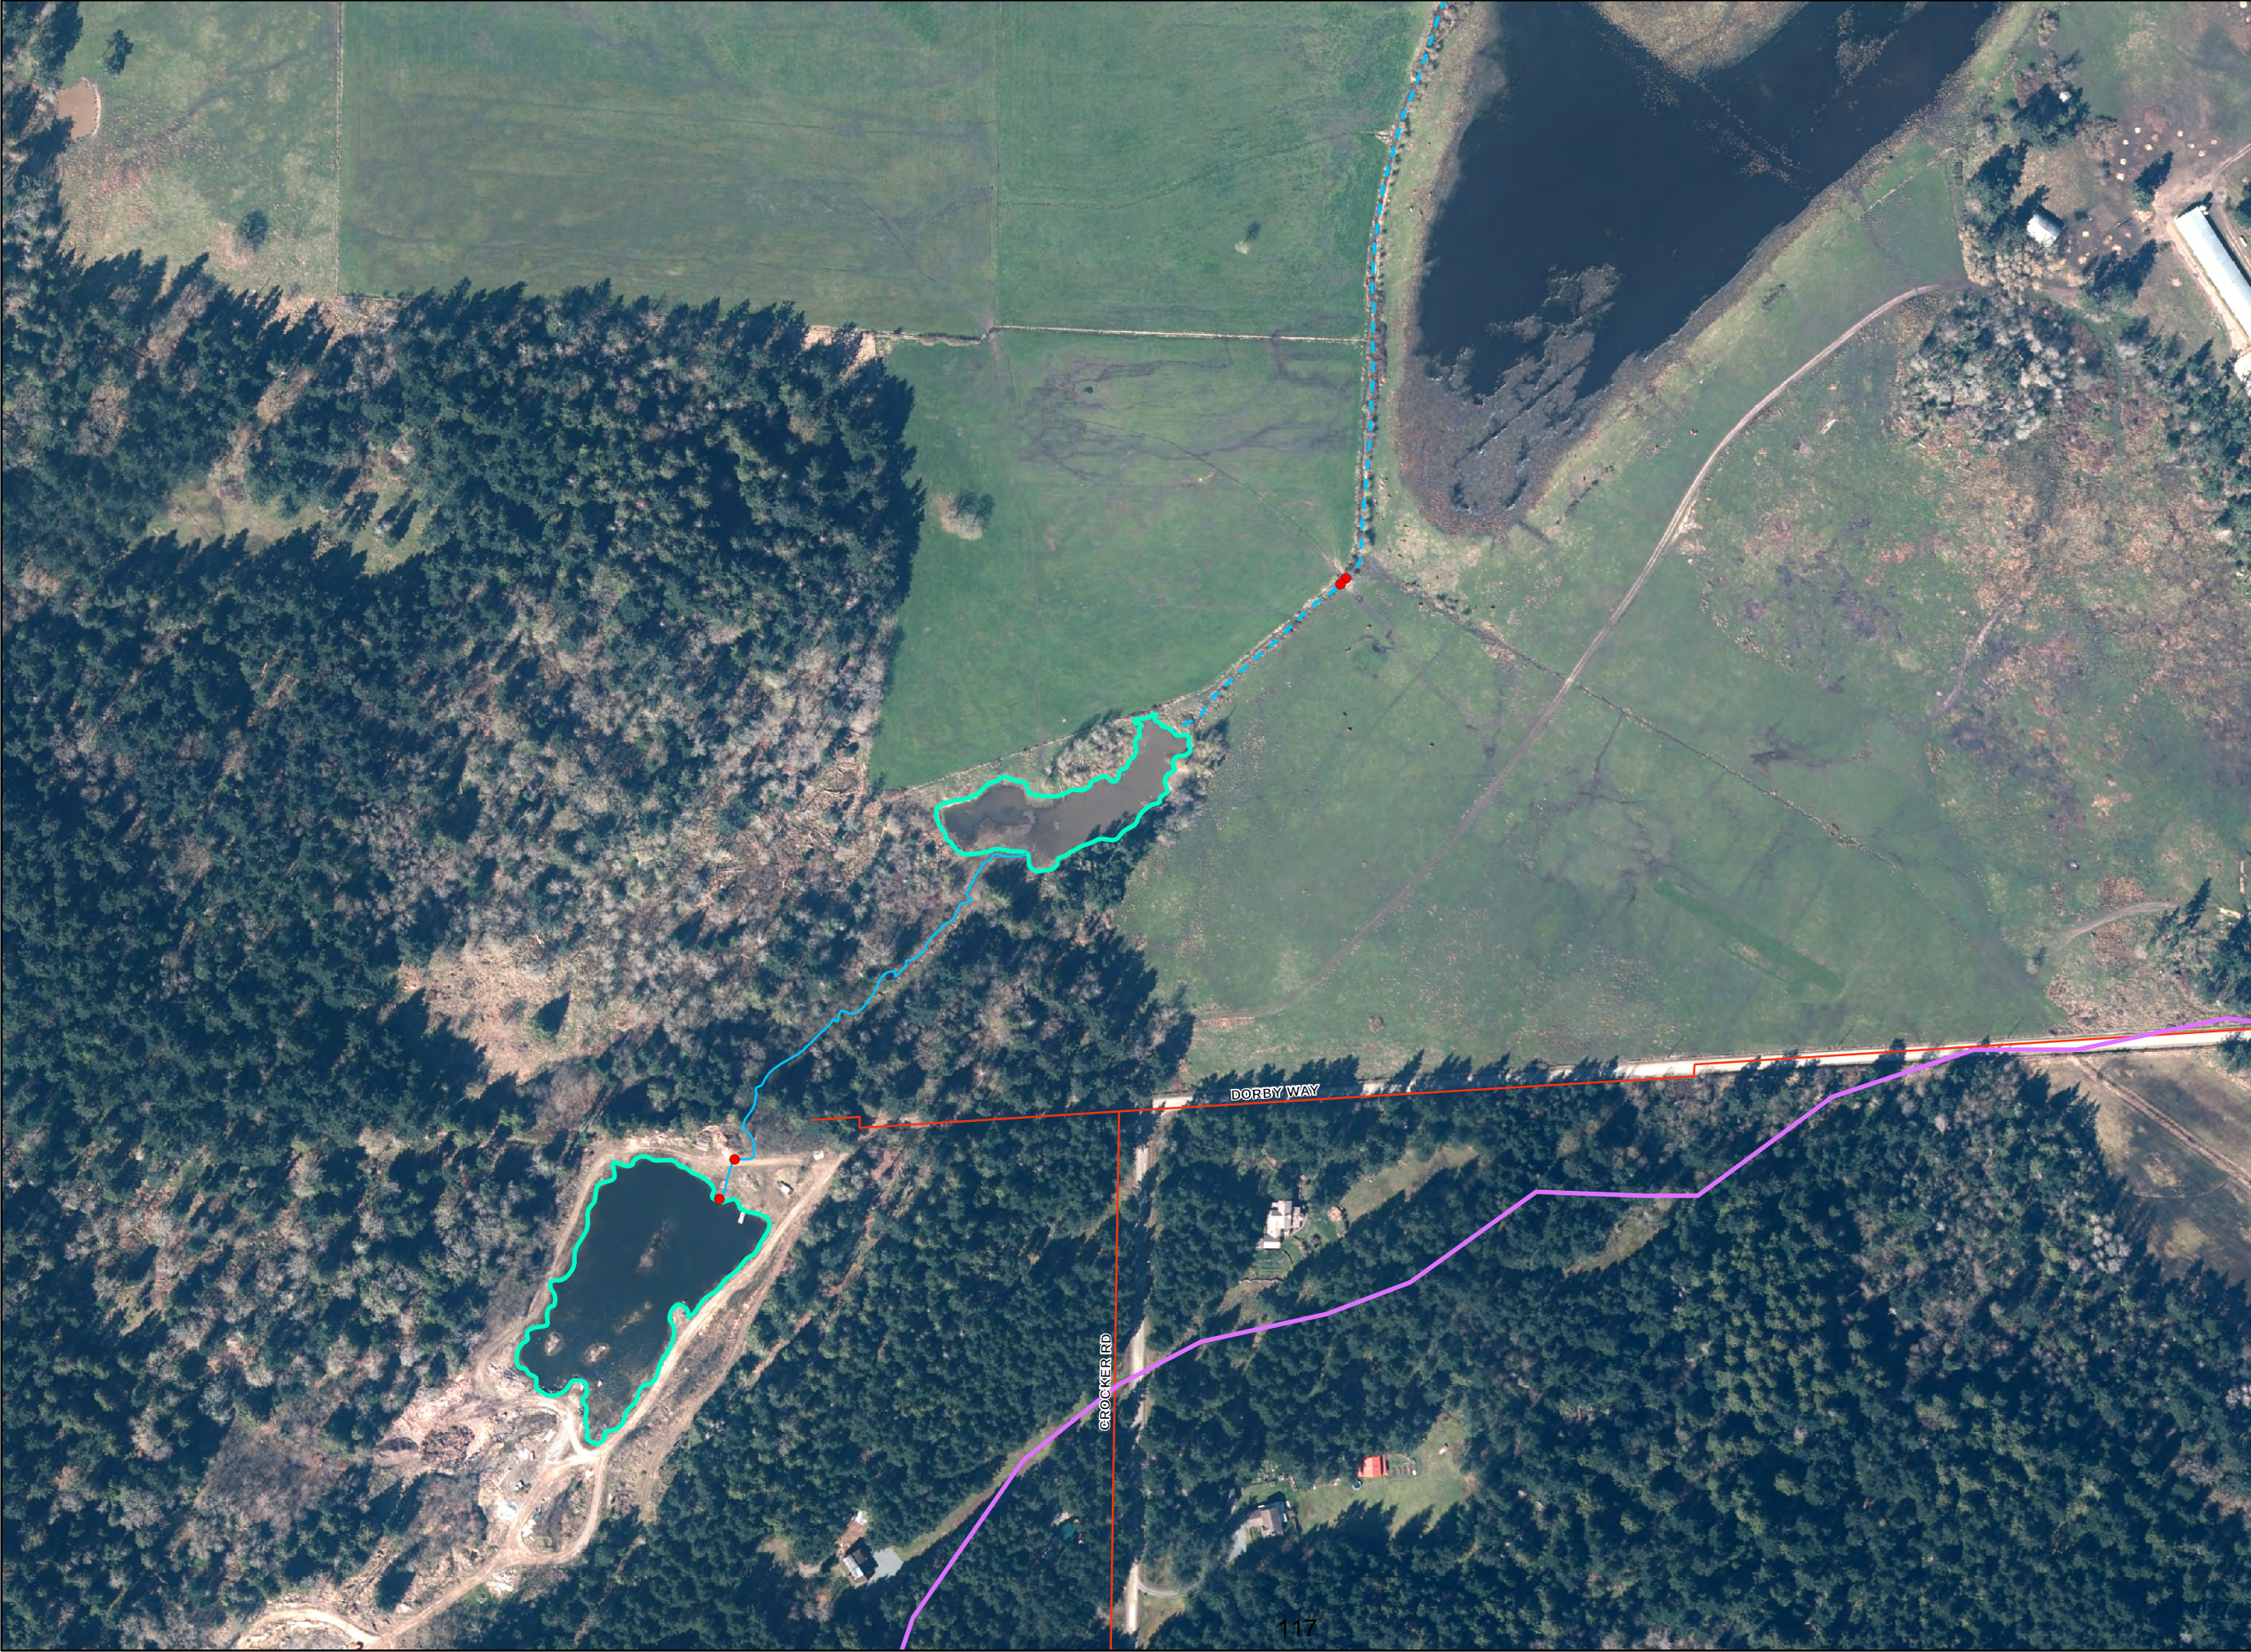
**Figure 15C:**  
Dick Brook

At North Road, the stream flows through a culvert that has recently been put in place. The reach between North Road and Cresta Roca Road has characteristics consistent with a natural stream. It should be noted, however, that some areas

adjacent to the stream have been encroached upon. Garbage and other scrap materials (*i.e.*, cars and construction materials) were observed scattered throughout the riparian zone.

On average, the width of the stream upstream of North Road is 2 m – 3 m. The gradient is approximately 4%, typical of a riffle-pool system. Substrate throughout this reach consists of a mixture of gravel, small cobbles, and organic material. Riparian vegetation adjacent to the stream is composed of a regenerating second growth forest that is providing biological function. Tree species observed include Douglas-fir, western redcedar, red alder, and bigleaf maple. The shrub layer is dense and composed of Pacific ninebark, snowberry, willow, salmonberry, Nootka rose (*Rosa nutkana*) and salal. The herb layer contains skunk cabbage, sword fern, bracken fern and slough sedge.

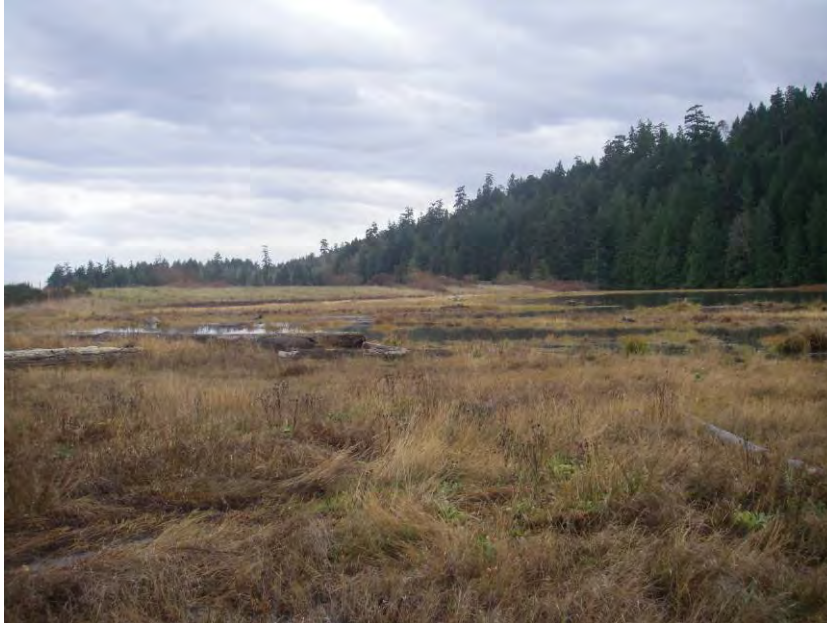
Looking southeast at the estuarine marsh adjacent to Sandwell Park. Castell Brook flows into the northwestern portion of the marsh.

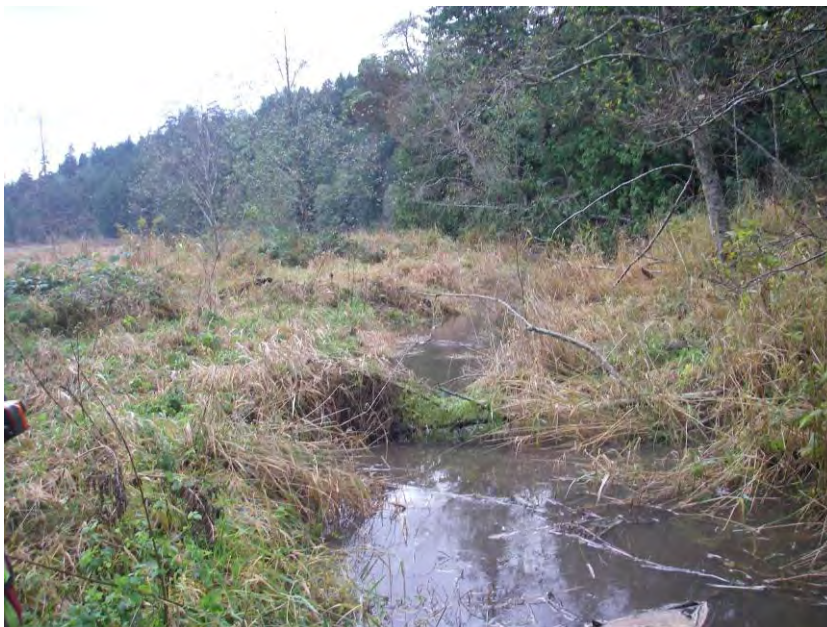
Lower reach of Castell Brook prior to its entry into the estuarine marsh. During periods of high tides, there is potential for anadromous fish species to enter the creek.

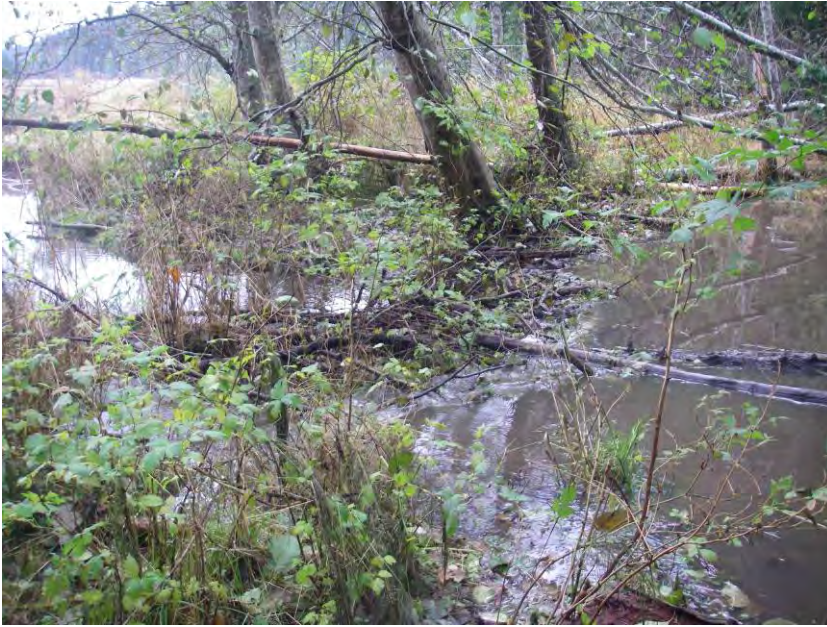
Wildlife activity in the lower reach of Castell Brook was abundant. Note the dam, which was recently created by beavers.

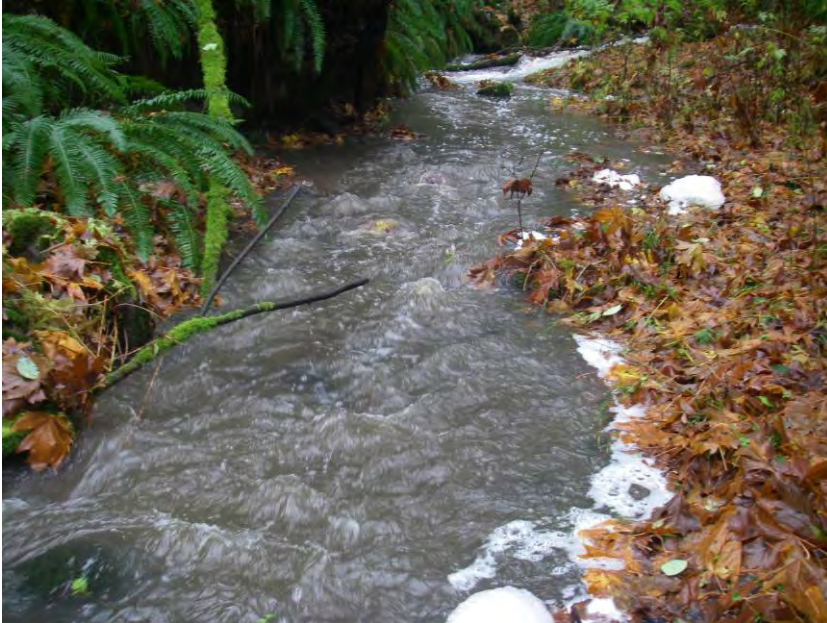
Typical morphology of the creek was consistent with a riffle pool system.

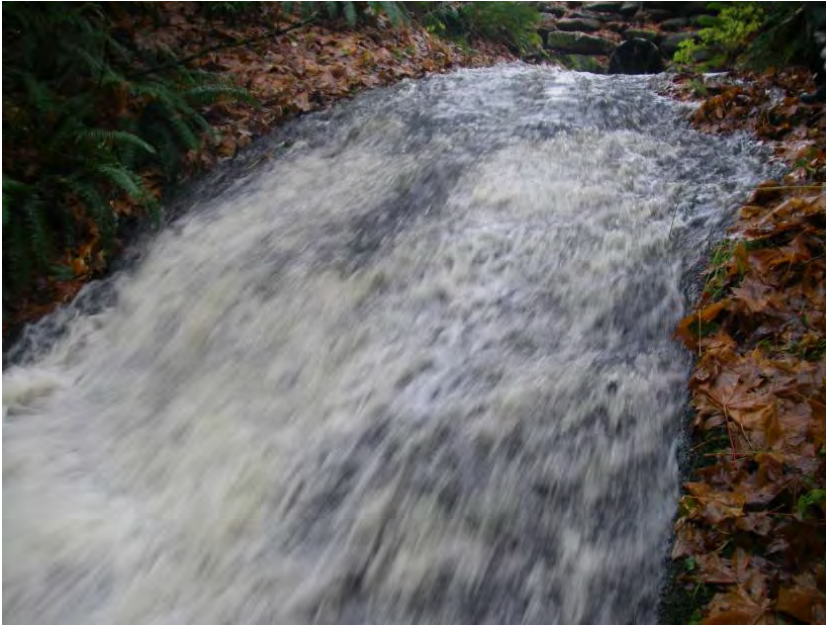
Looking west at the upper bedrock step forming part of the step sequence that is a barrier to the upstream movement of fish on Castell Brook.

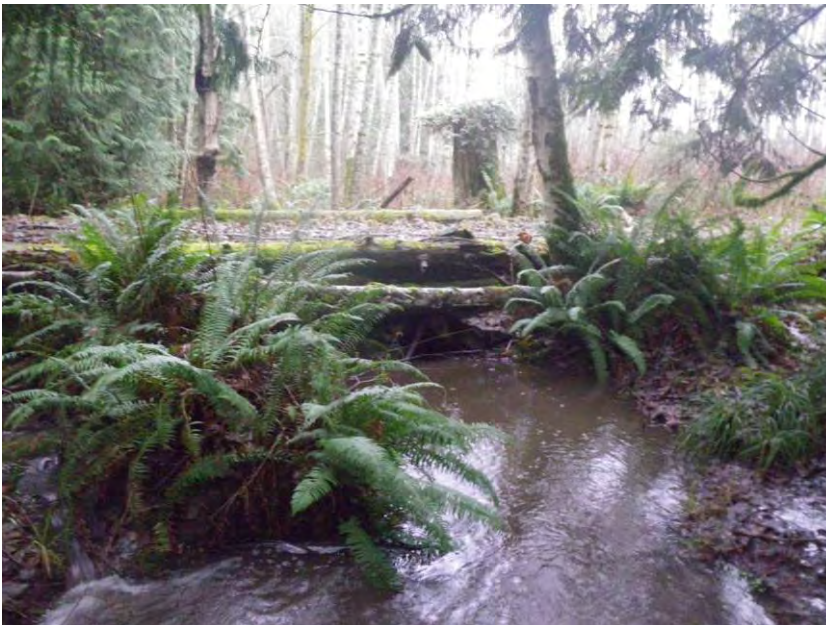
Looking north west (downstream) at the point where the stream traverse re-commenced at the edge of the farm property that could not be accessed.

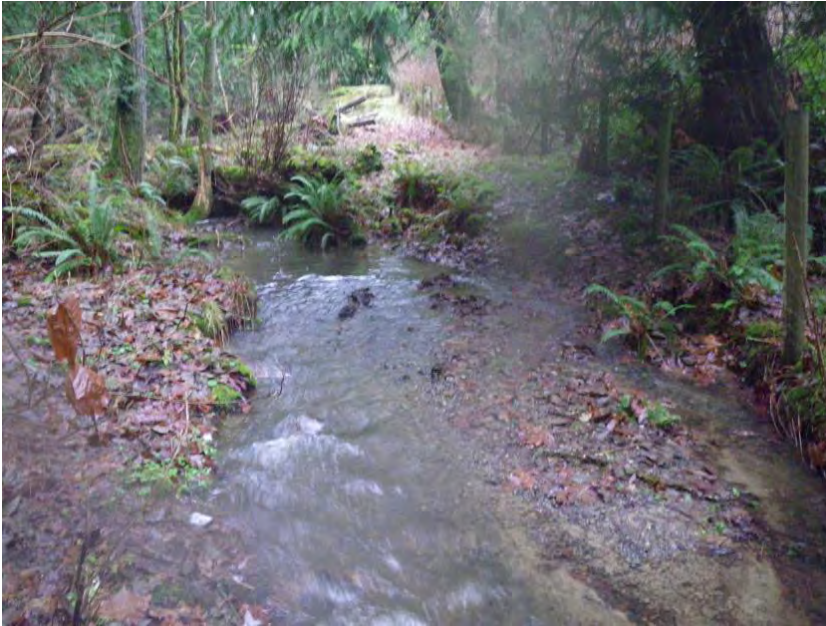
Short sections of natural sinuosity and alluvial deposits occurred along Castell Brook between sections that had been historically straightened.

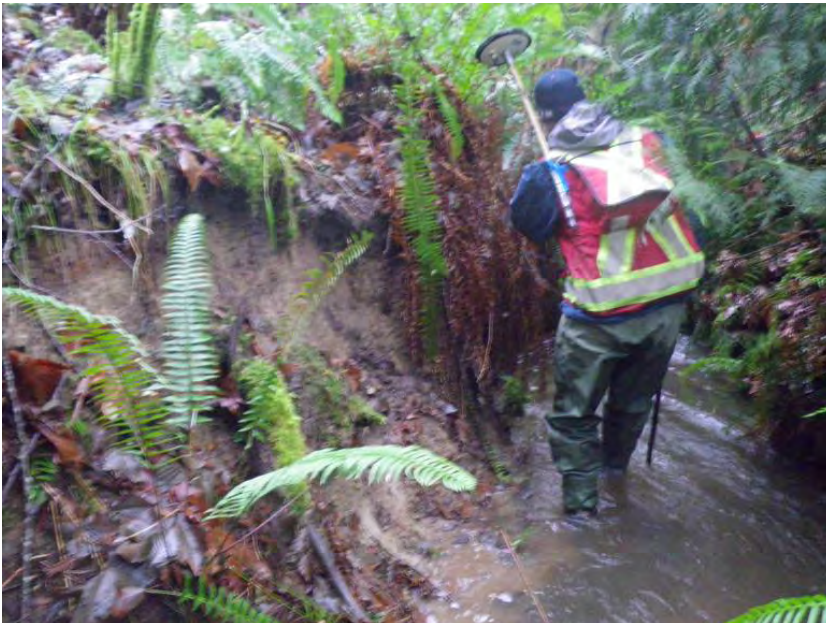
Typical over-steepened banks associated with historical channel straightening on Castell Brook.

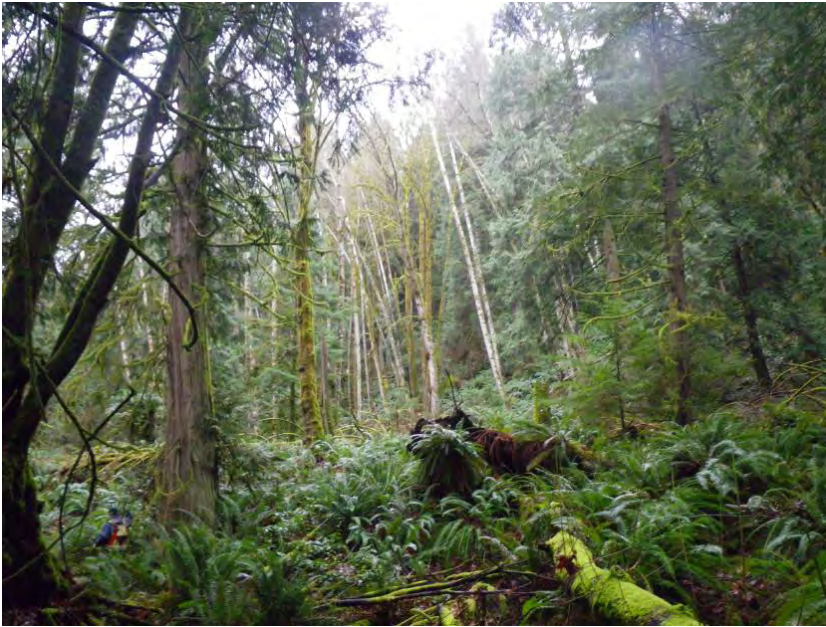
Intact riparian vegetation typical on Castell Brook downstream of North Road.

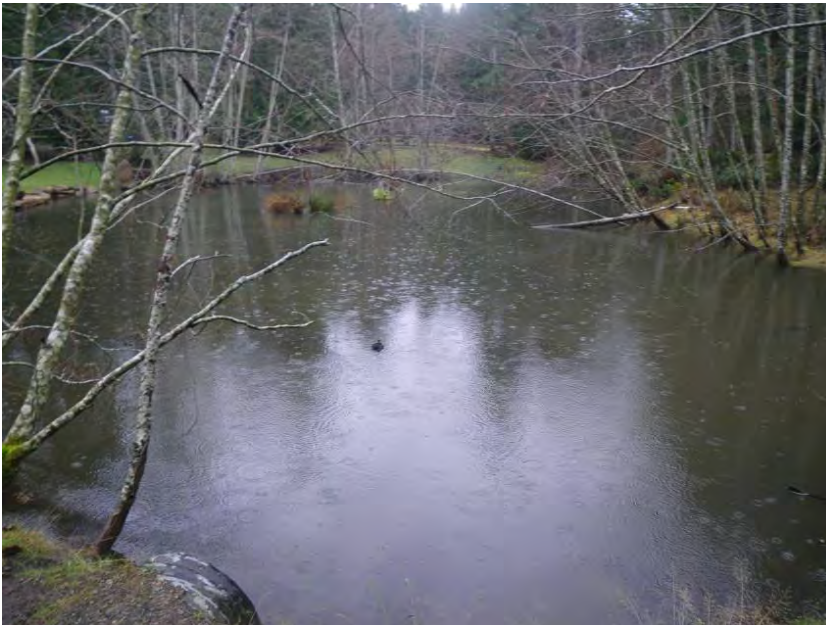
Looking south east (downstream) over the first pond located along Castell Brook.

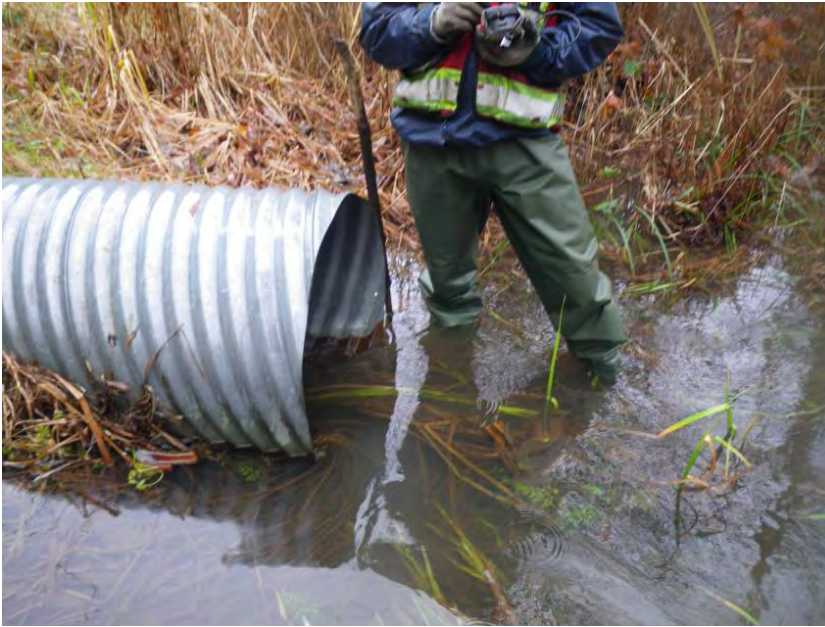
Inflow of culvert upstream of North Road.

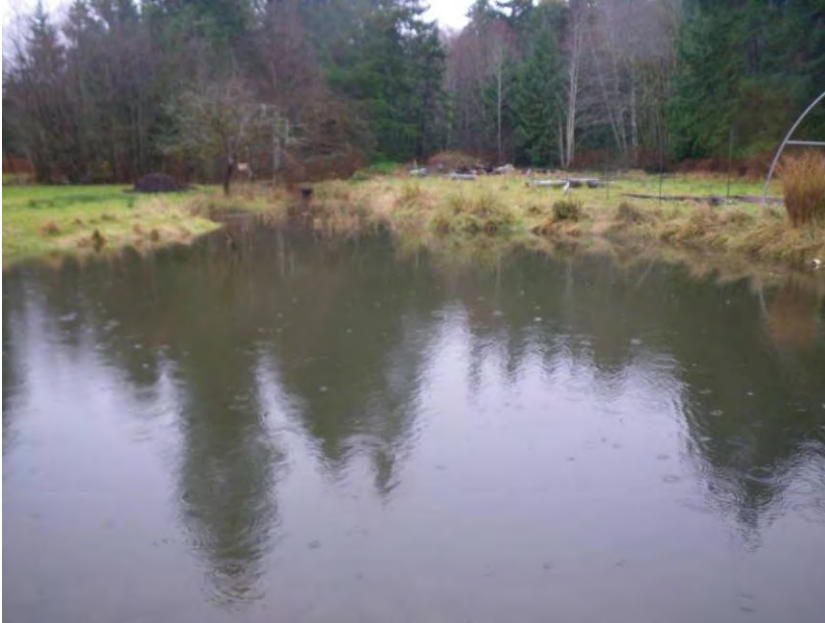
Looking northwest (downstream) over the second pond located immediately upstream of North Road.

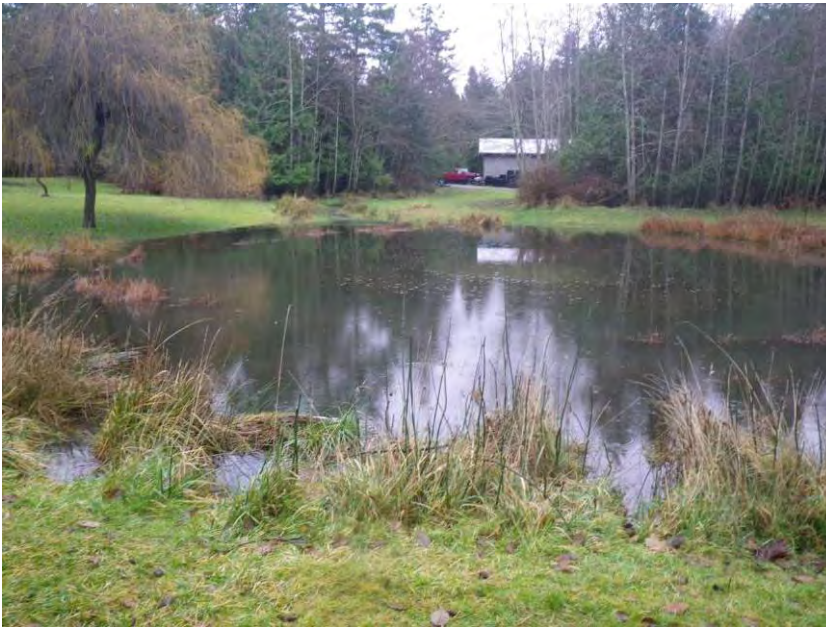
Looking south-east (upstream) over the third pond located on Castell Brook.

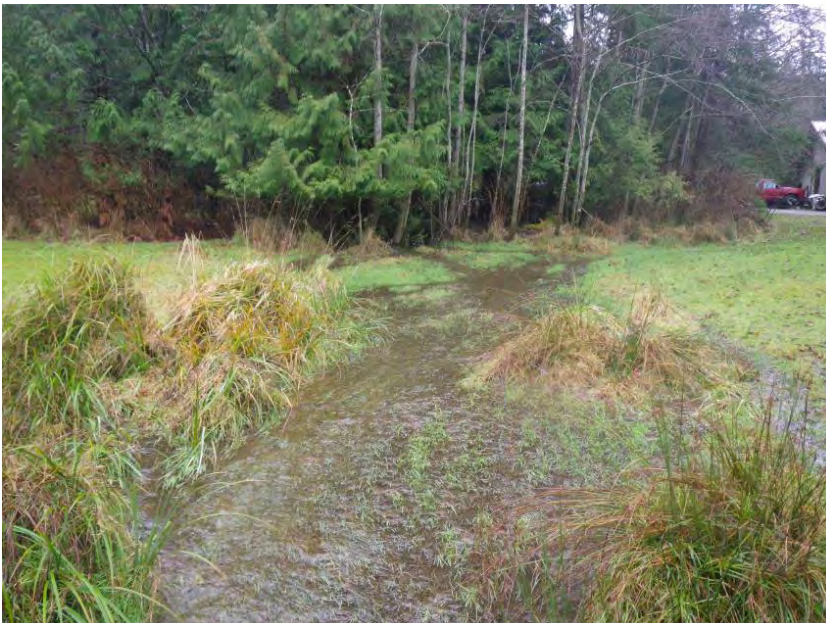
Looking south east (upstream) along inflow of the pond pictured above. Note lack of a defined channel.

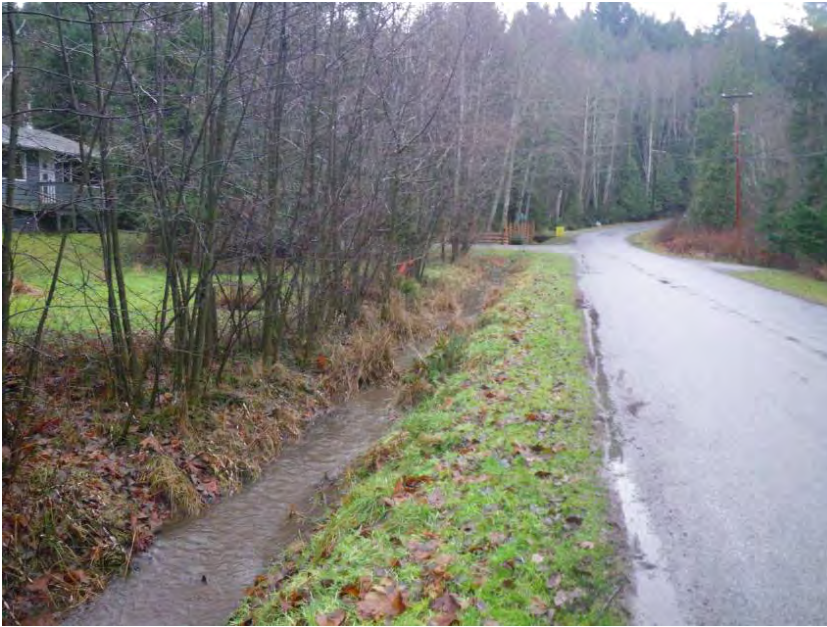
Looking upstream (south west) along Castell Brook where it flows as a roadside ditch adjacent to Bertha Road.

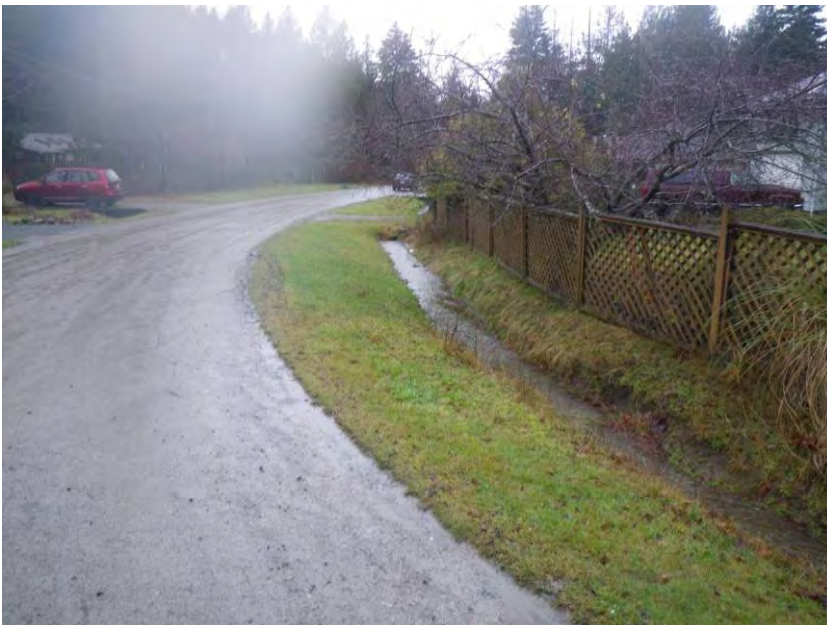
Looking downstream (north west) along Castell Brook where it flows as a roadside ditch adjacent to Suzanne Road.

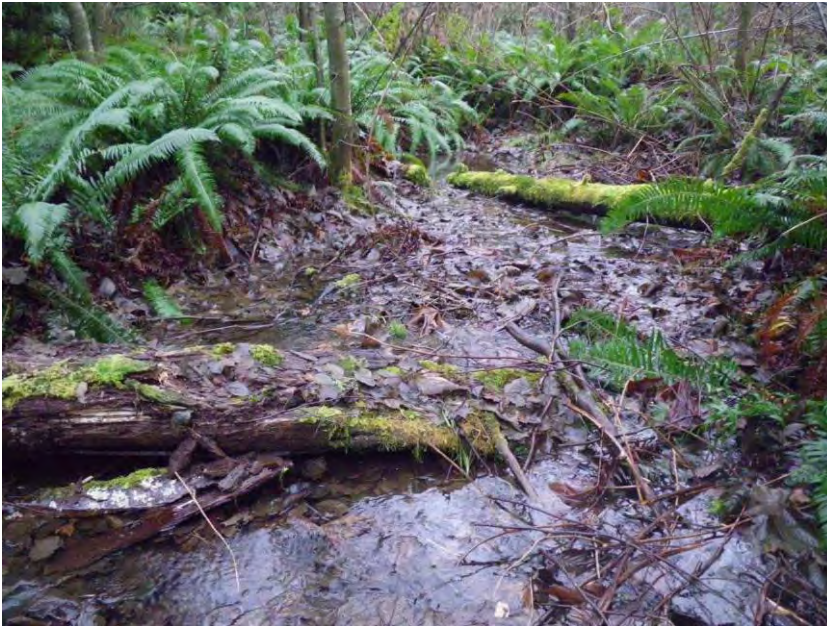
Surface flow over an organic substrate represented the upper “origin” of Castell Brook to the east of Brydie Road.

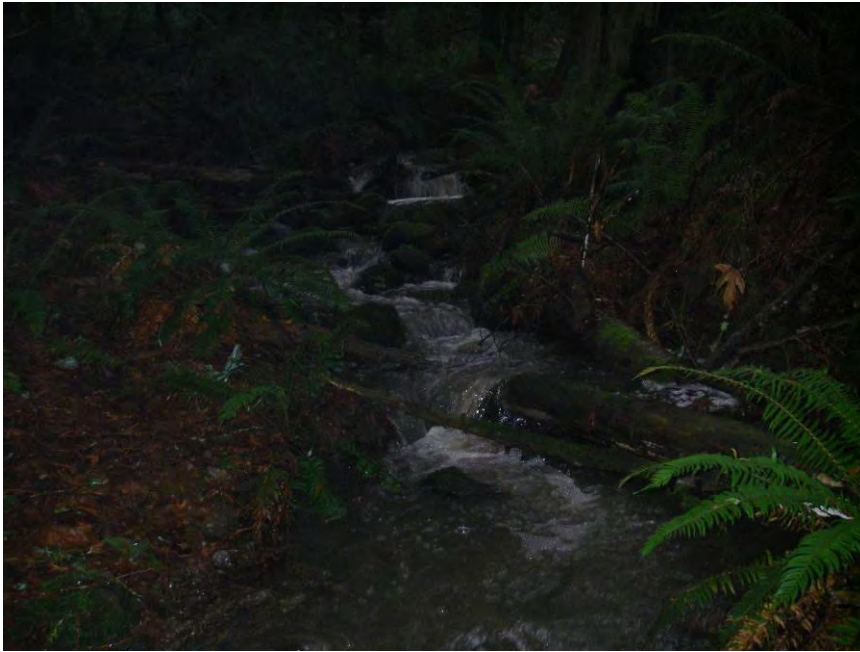
Typical stream conditions upstream of Daniel Way.

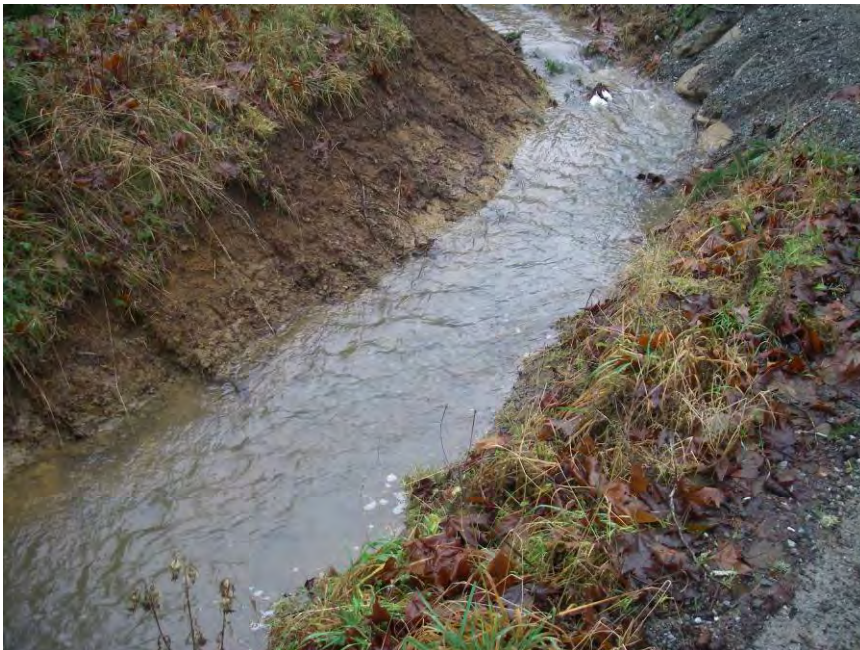
Typical roadside ditch located along upper reaches of McClay Creek.

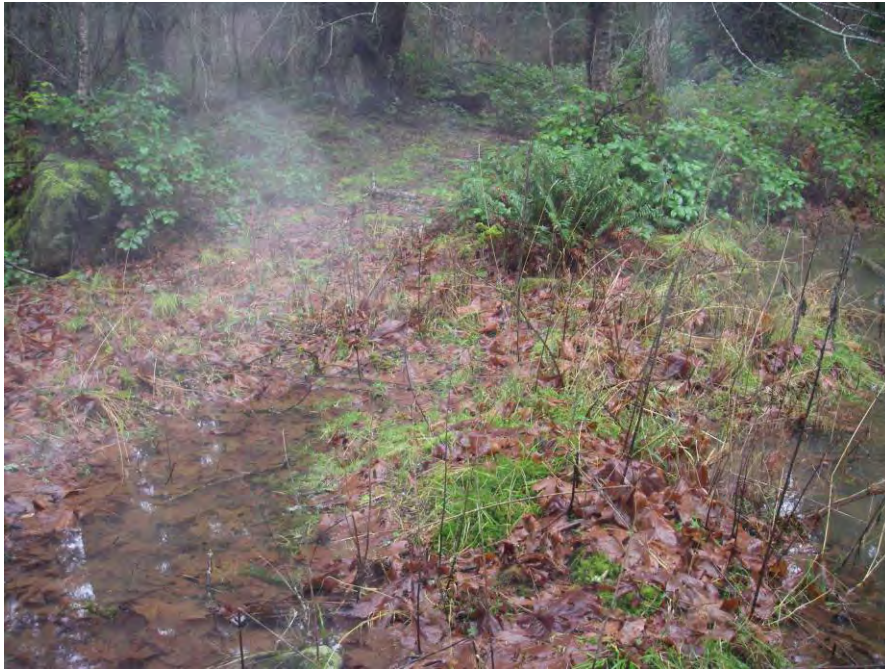
Collection of surface water over the forest floor upstream of Barret Road.

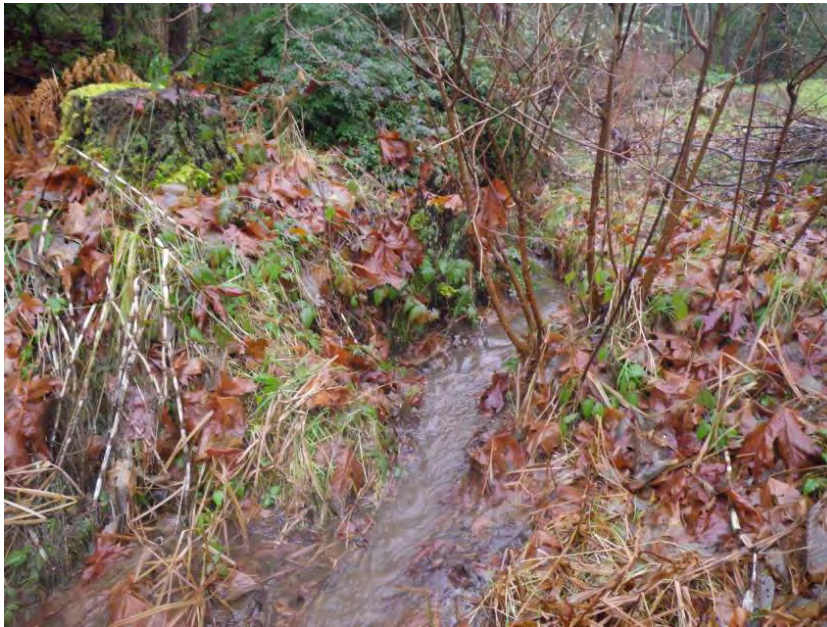
Looking south east from Bertha Road upstream along the tributary drainage. Note poorly defined nature of the watercourse.

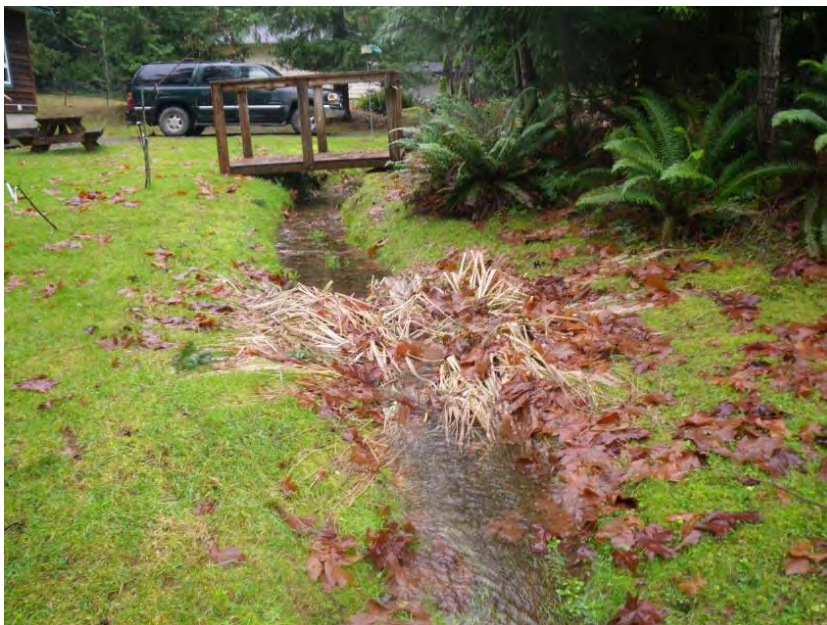
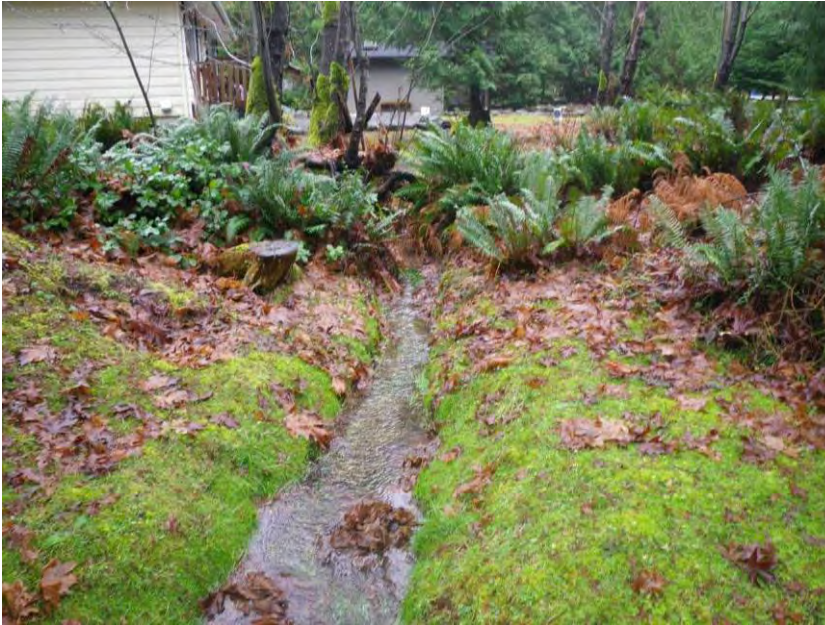
Above and below: typical morphology of the drainage upstream of Bertha Road.

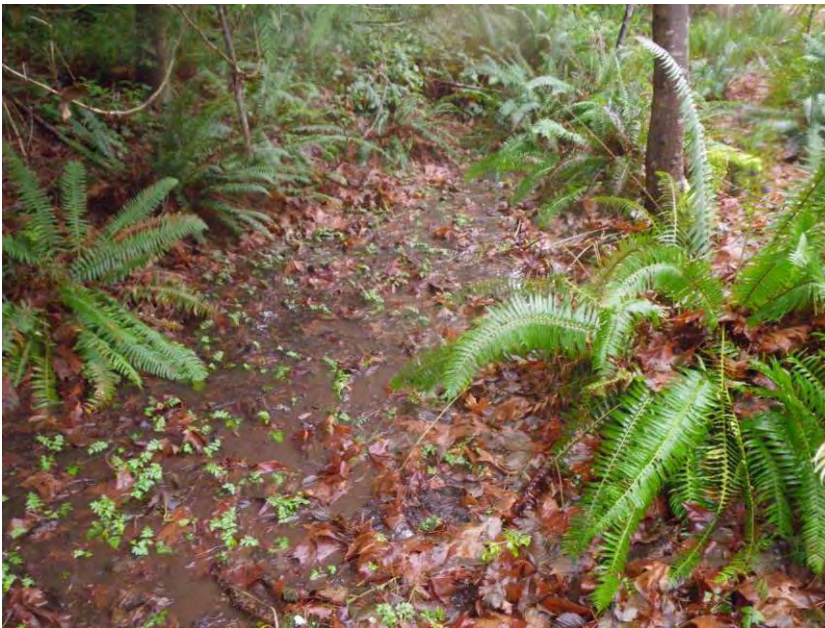
Seepage over organic substrate in a pocket of hydrophytic vegetation (water parsley in the centre of the photo) represents the origin of the tributary drainage next to Suzanne Road.

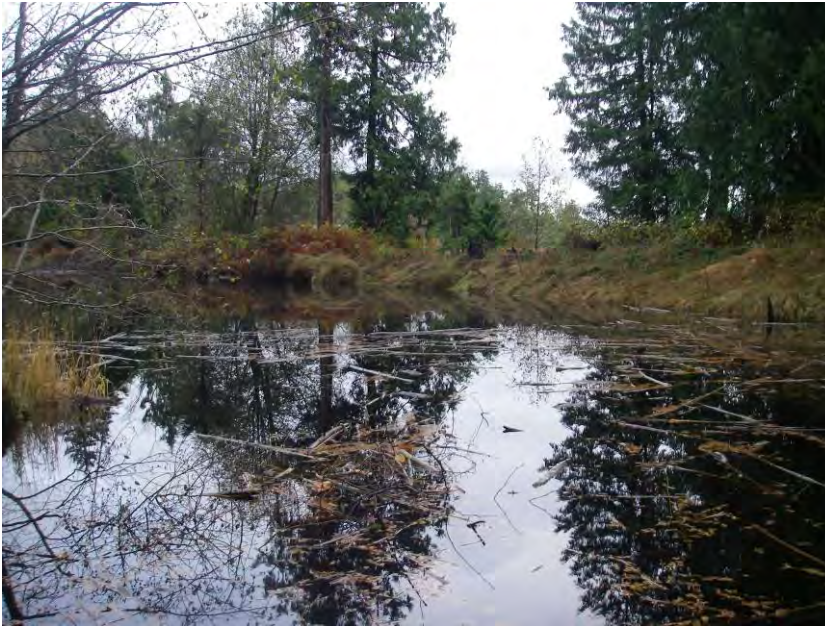
Looking northwest at the pond, which is adjacent to the Sandwell Park estuarine marsh. Note the remnants of the extensive beaver activity adjacent to and within the pond.

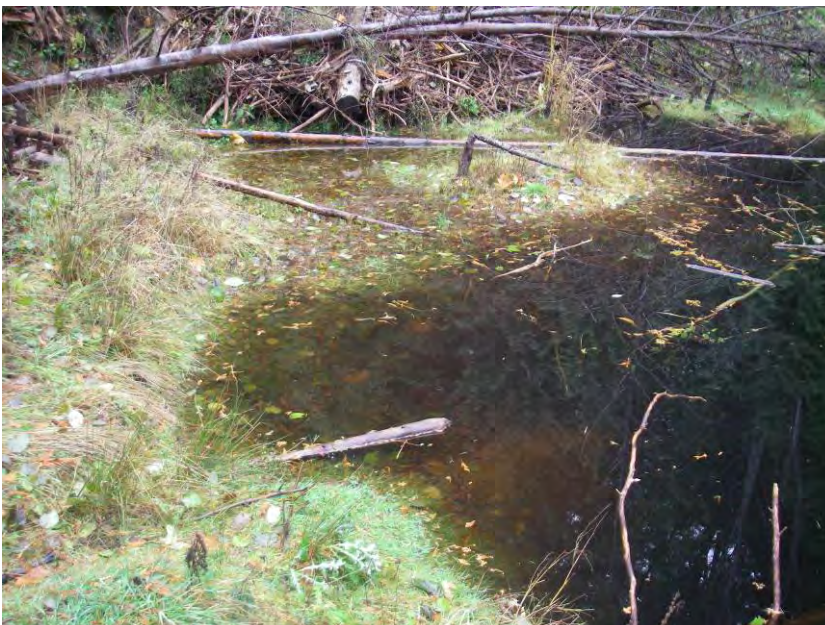
Looking at the northeastern corner of the pond. During high water events, water likely breaches the berm and flows into a ditch, connecting the pond via surface flow to the estuarine marsh adjacent to Sandwell Park.

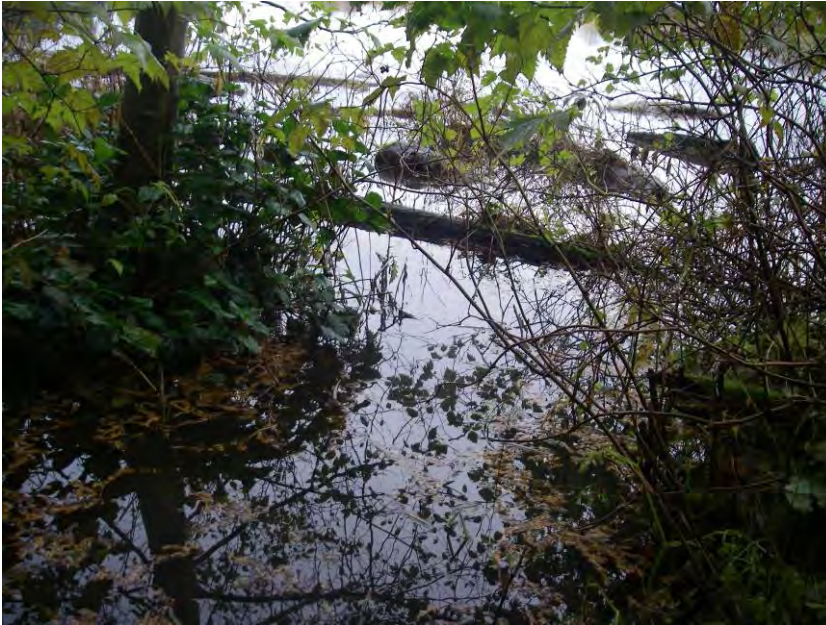
Looking at the ditch that connects the pond with the estuarine marsh during high flow events.
