**GABRIOLA ISLAND RIPARIAN AREA  
REGULATION STREAM IDENTIFICATION  
UPDATED REVISED VERSION FEBRUARY 24, 2012**

**Chloe Fox  
Island Planner (Gabriola Island Local Trust Committee)  
700 North Road, Gabriola Island, BC, V0R 1X3**

**Trystan Willmott, B.Sc. A.Sc.T.  
Justin Lange, B.Sc., B.I.T., A.Sc.T.  
MADRONE ENVIRONMENTAL SERVICES LTD.  
1081 Canada Avenue, Duncan, BC, V9L 1V2**

**February 24, 2012**

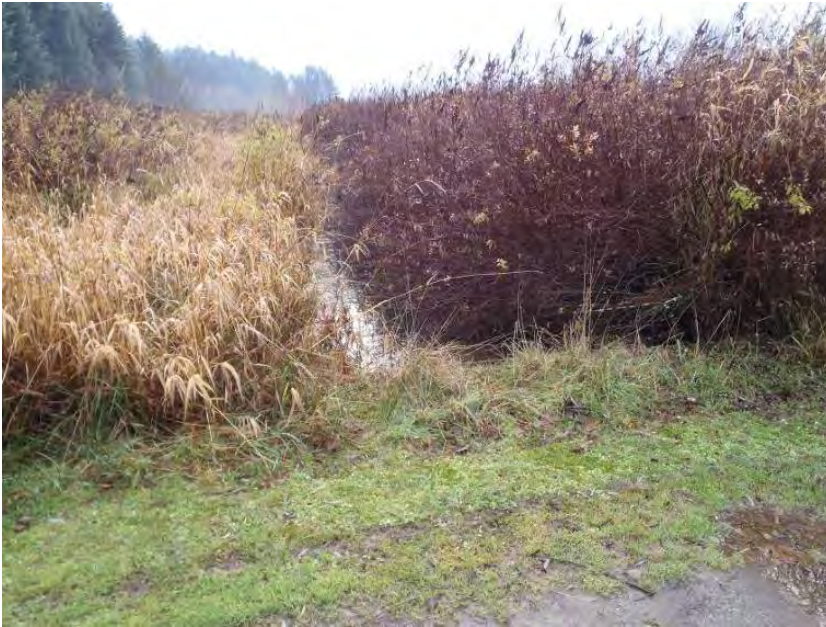
Looking south east at the confluence of Goodhue Creek with the hardhack-dominated margins of Hoggan Lake.

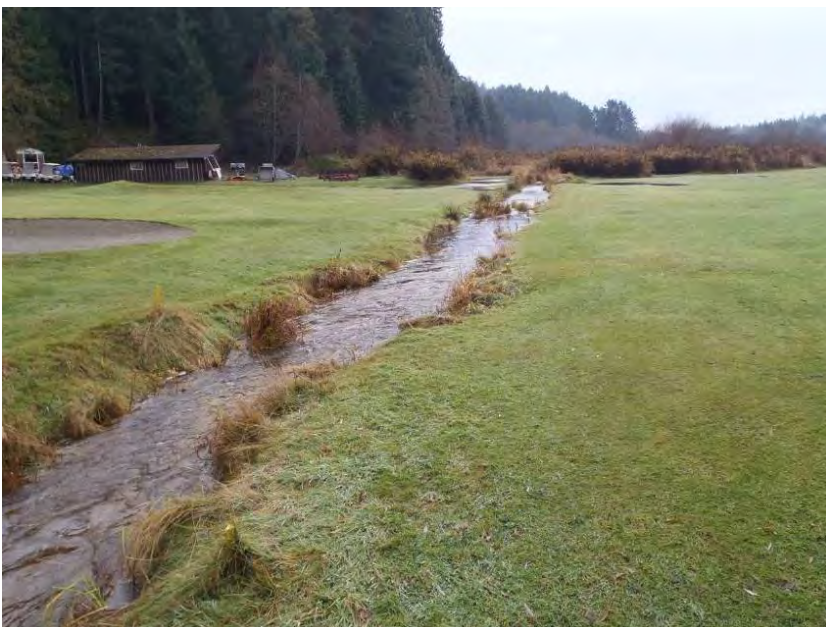
Looking south east along Goodhue Creek where it flows through the golf course. Note lack of natural sinuosity, riparian vegetation and cover/security habitat for fish.

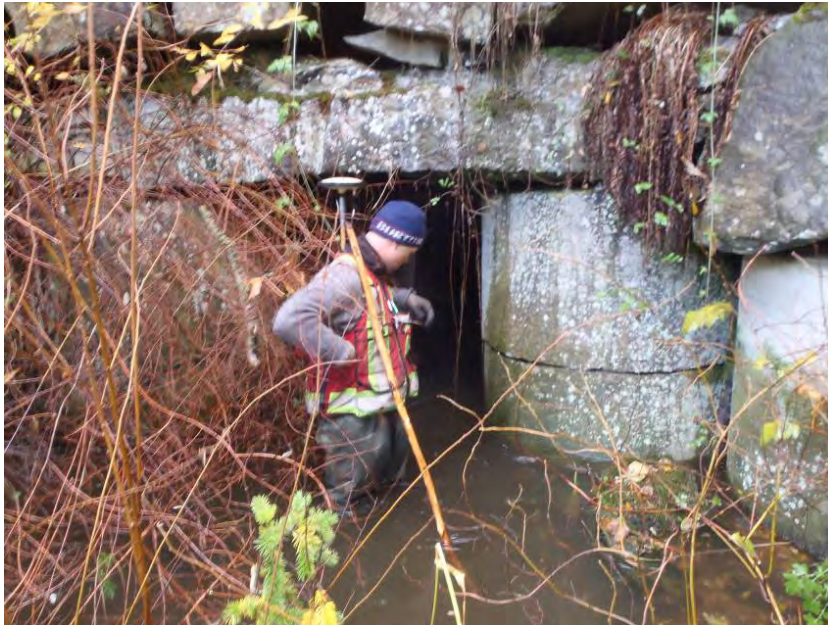
Concrete box-type culvert structure immediately upstream of the golf course on Goodhue Creek.

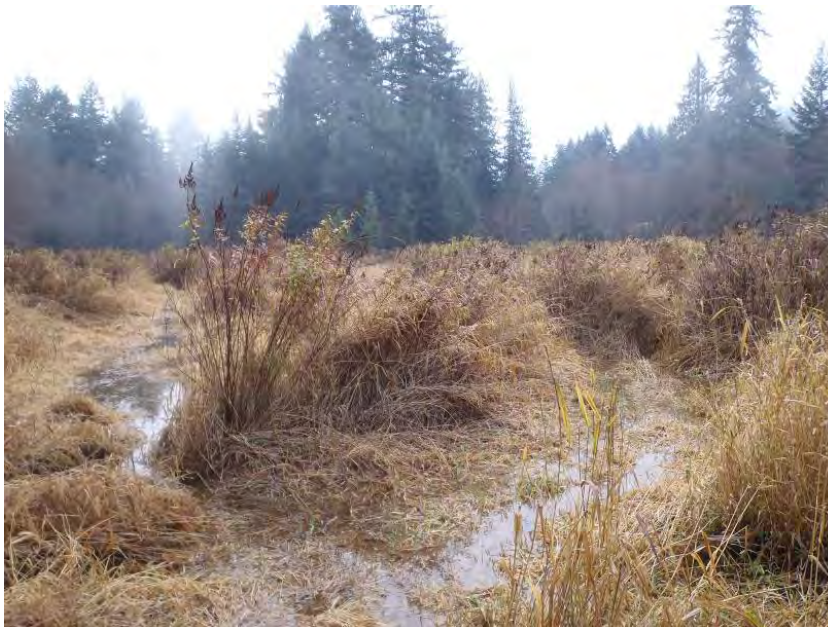
Looking north west over the first wetland ecosystem located along Goodhue Creek. This ecosystem is listed as SEI T1222 – FS. Note shallow water over an extensive area, which would limit the ability of fish moving up from Hoggan Lake to reach any further upstream in the system.

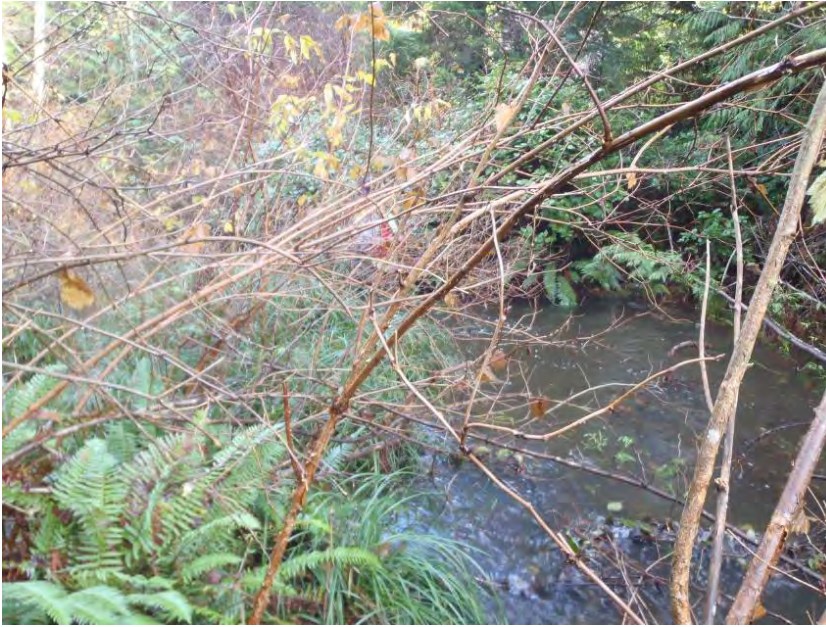
Looking at the inflow of the stream into the northwestern tip of the wetland picture above.

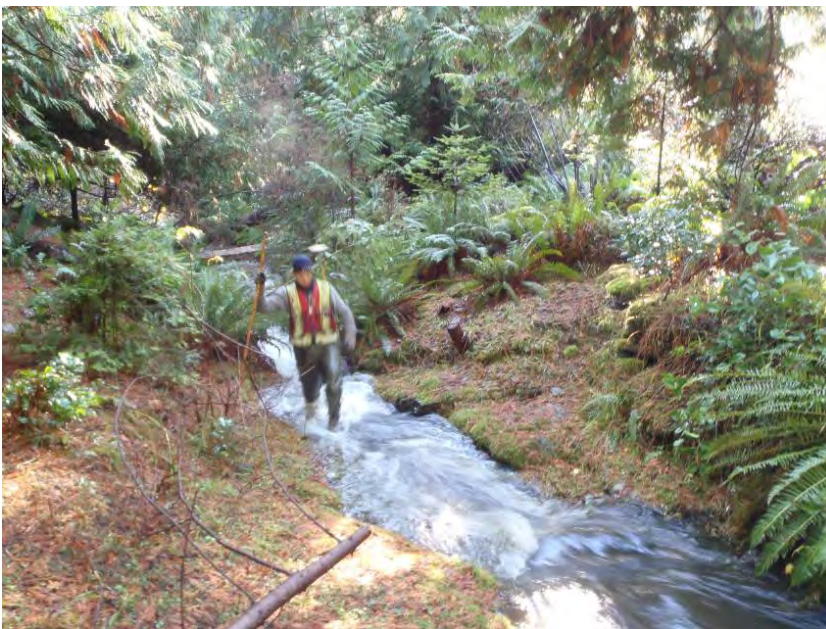
Typical morphology of Goodhue Creek downstream of the Crestwood Road crossing.

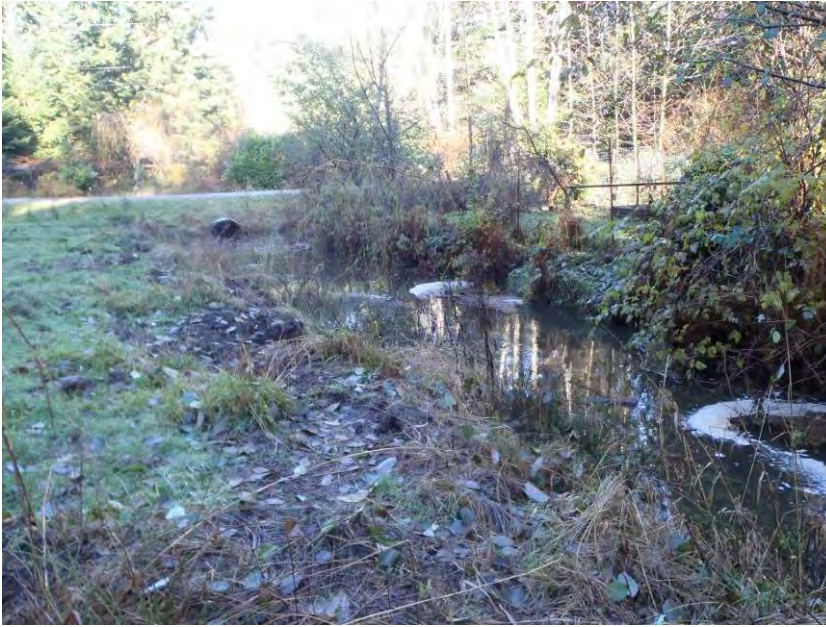
Looking north over a typical channelized section of Goodhue Creek upstream of Crestwood Road.

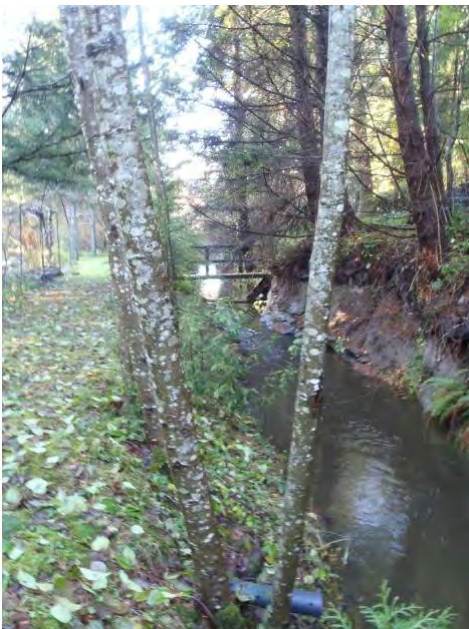
Looking north west over a historically ditched/straightened portion of the stream immediately downstream of the second wetland complex to the south east of South Road.

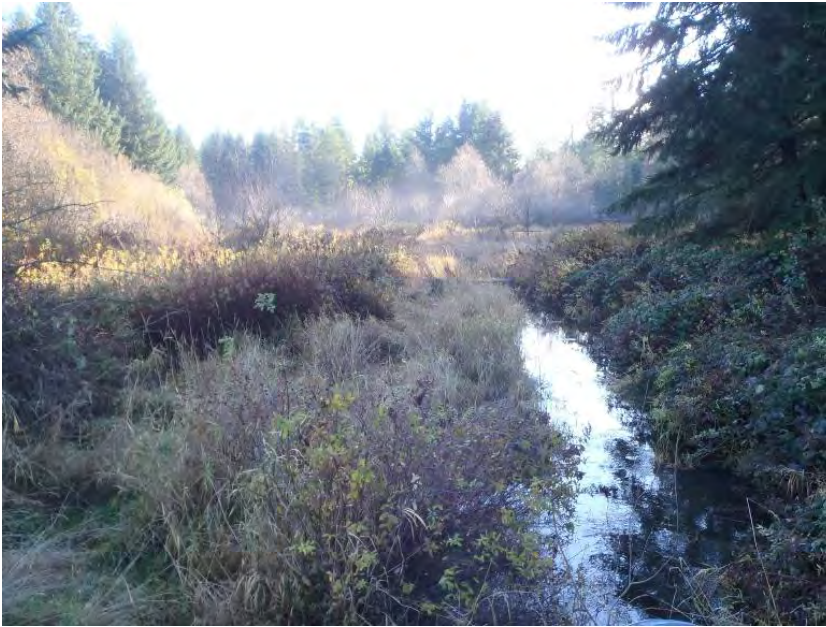
Looking north west over the wetland located immediately downstream of South Road on Goodhue Creek. This wetland is designated under the SEI (T1222C WN:fn).

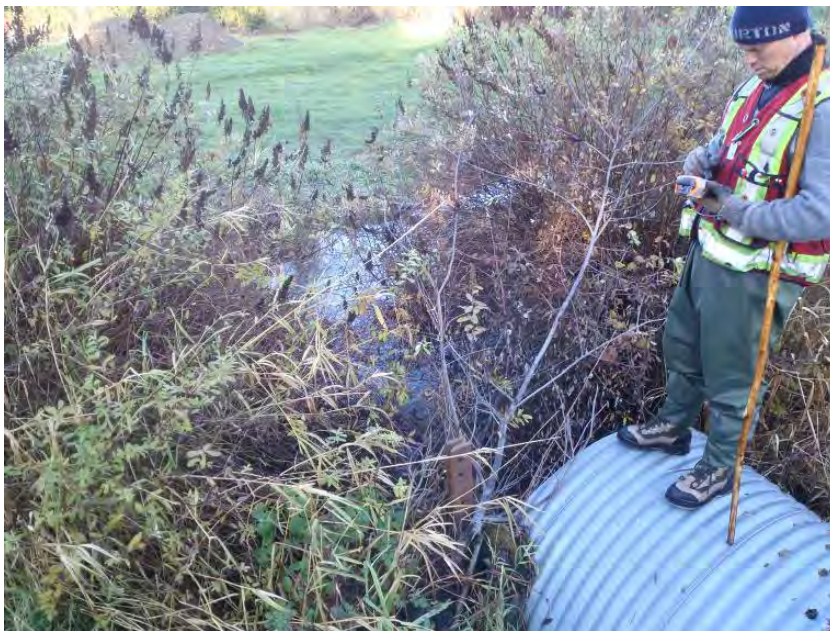
Looking at the inflow of the culvert under South Road on Goodhue Creek.

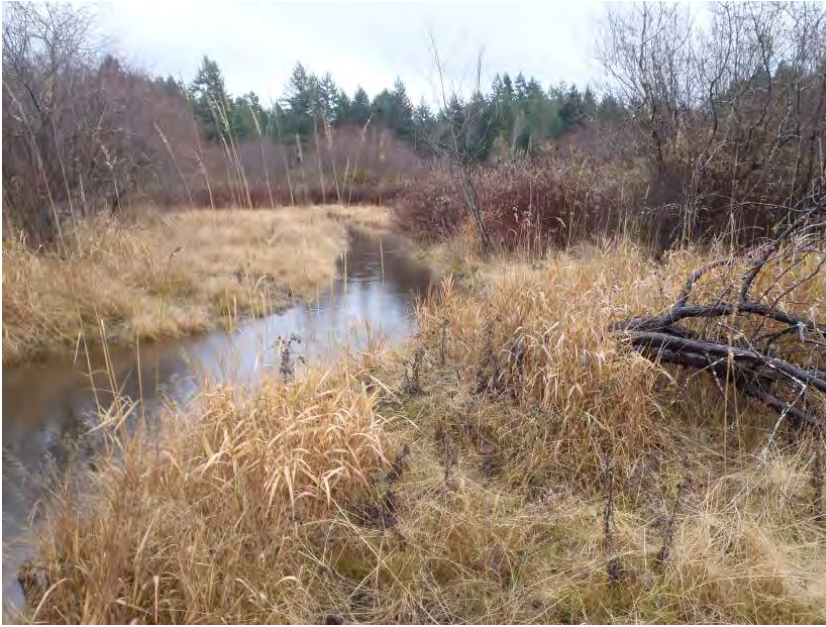
Looking north west over SEI wetland T1222A-R1 upstream of South Road. Note deep, channelized flow through the wetland complex.

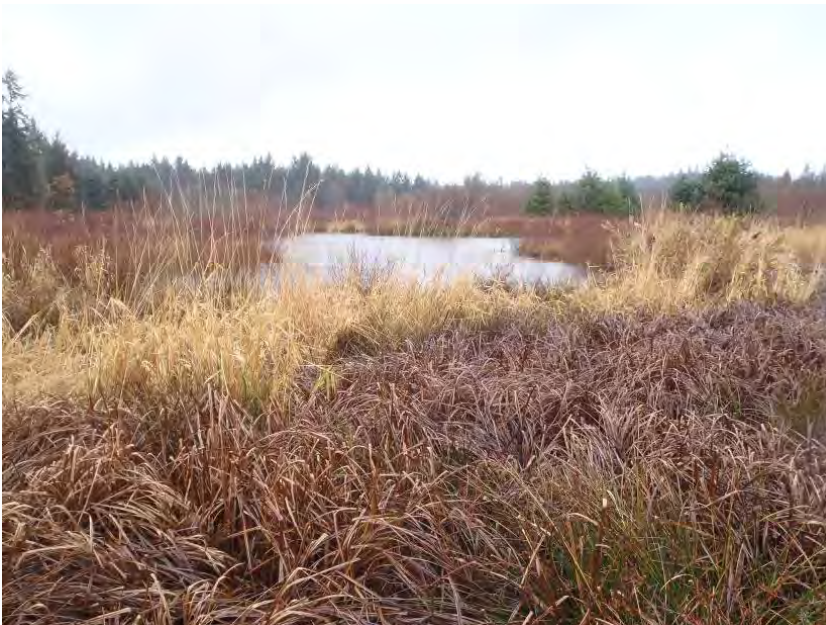
Looking south east over SEI wetland T1222A-R1.

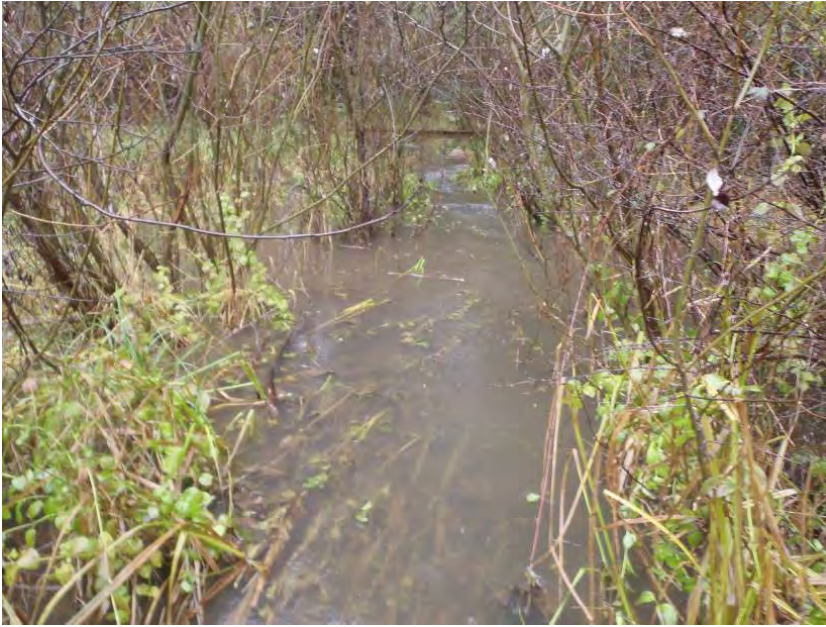
Looking north west along the poorly defined inflow into the extensive wetland located upstream of South Road (SEI wetland T1222A-R1). Note lack of a defined channel and the organic substrate.

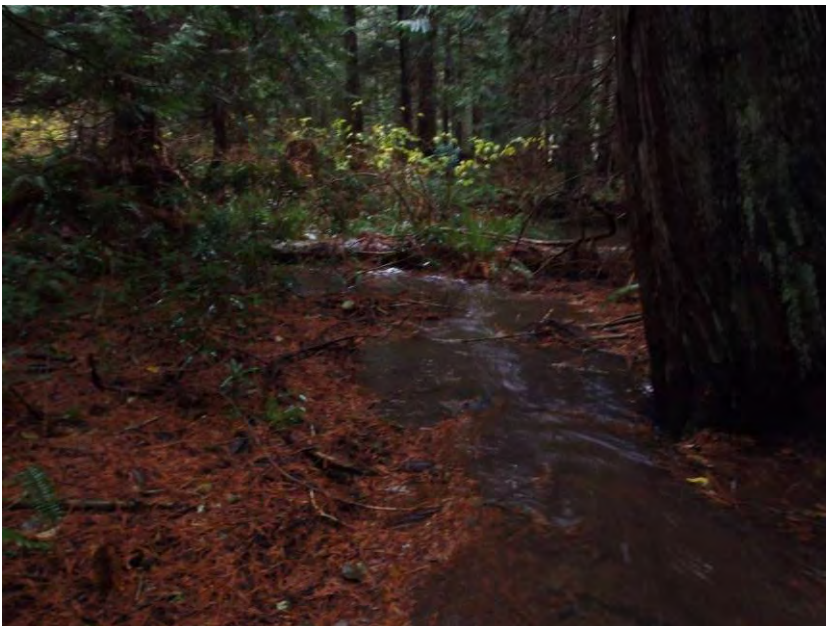
Typical characteristics of Goodhue Creek immediately upstream of the north eastern tip of SEI wetland T1222A-R1. Note poorly defined nature of the watercourse as it flows over the forest floor.

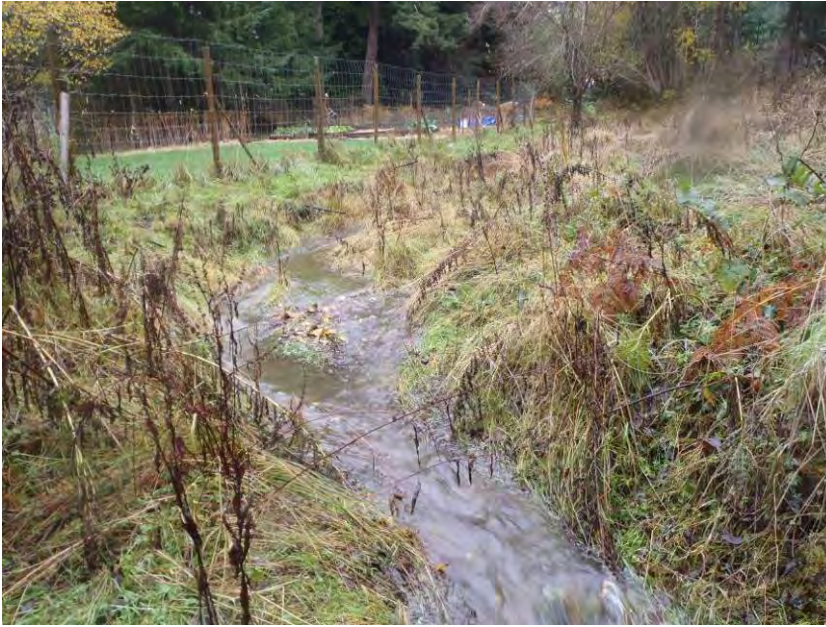
Typical characteristics of Goodhue Creek in its middle reaches.

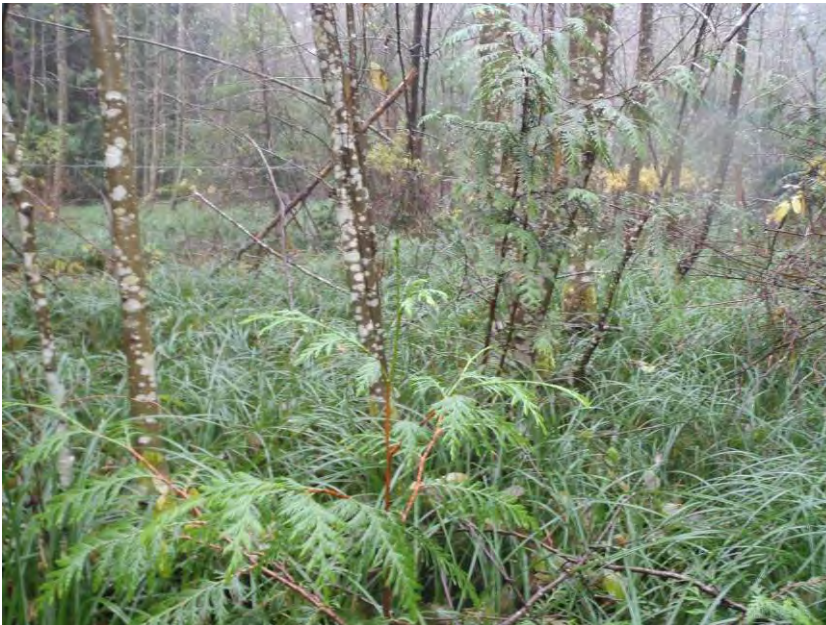
Looking south east over the slough sedge dominated wetland complex located immediately downstream of Tansy Road on Goodhue Creek.

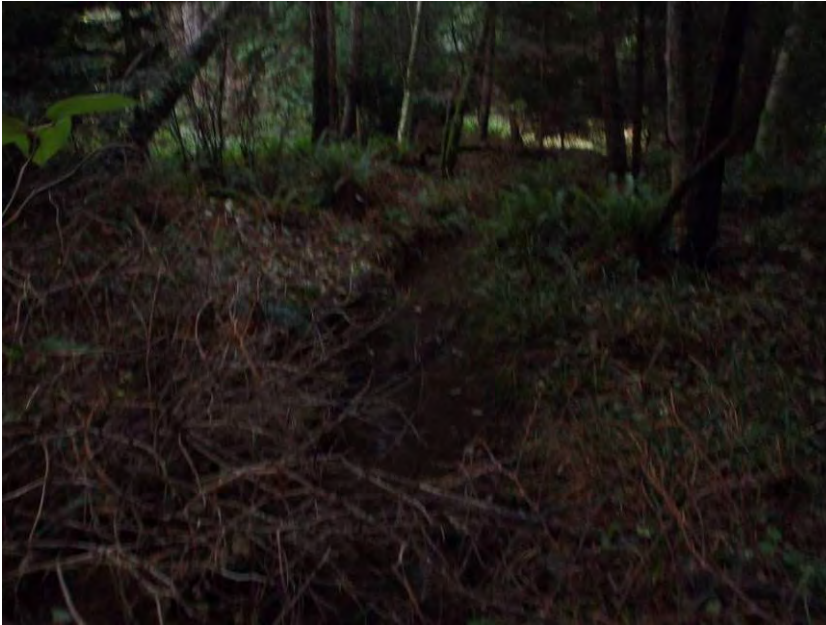
Looking east along a historically ditched portion of Goodhue Creek parallel to Tansy Road.

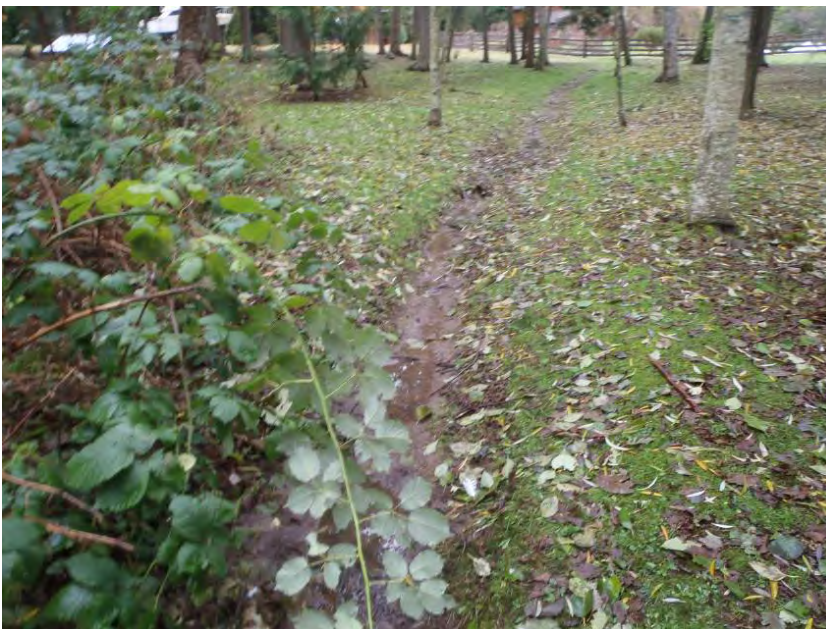
Above and below: typical characteristics of the extreme upper limit of Goodhue Creek.  
Note poorly defined “channel” and lack of surface flow, even after seasonal heavy rain.

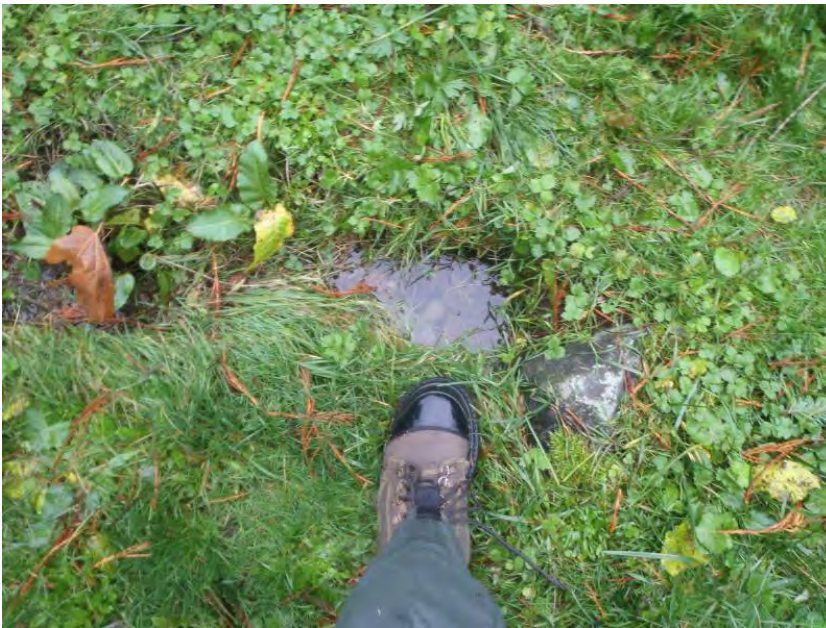
“Origin” of Goodhue Creek at the head of the linear depression pictured above. Note groundwater flow coming to the surface.

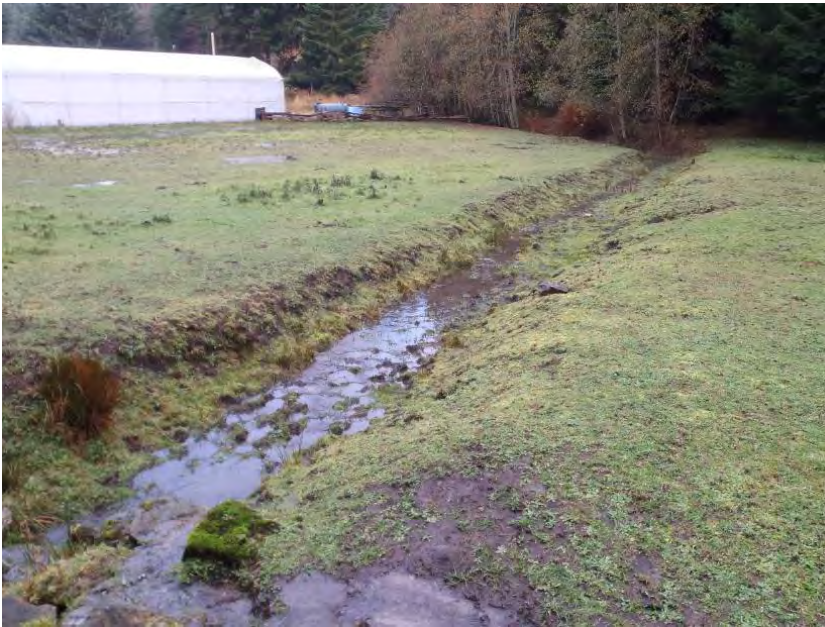
Looking north over the field ditch that collects and concentrates water emanating from a spring. This feature represents the origin of South Road Creek.

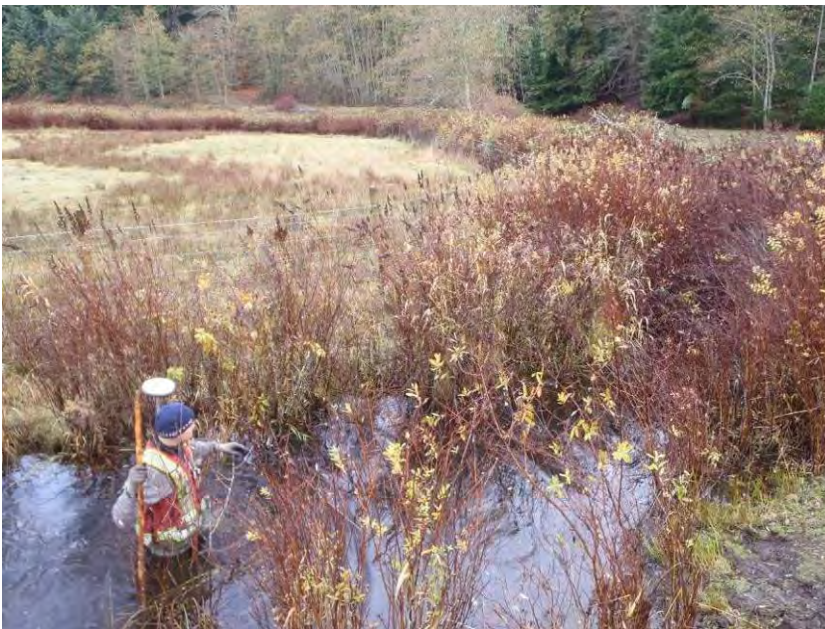
Typical characteristics of South Road Creek immediately prior to flowing into the vegetated margins of Hoggan Lake. Note significant water depth and dense vegetation.

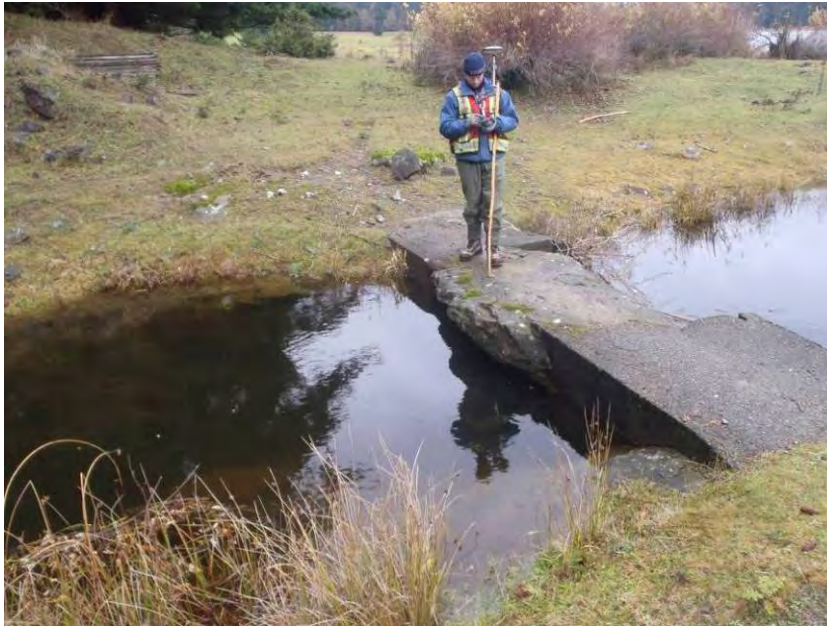
Looking at the stream where it exits Hoggan Lake and concrete box-type culvert located on the margins of the lake.

The location of this outflow stream from Hoggan Lake is marked by a concrete box culvert at the edge of the lake. The outlet drainage is deep (in excess of 2 m) and approximately 3 m wide. The gradient of the stream is low (0.5%), with minimal surface flow. Fish habitat values are good in the first 150 m from the lake, due to the depth and presence of submerged vegetation, which provides cover. During the assessment, shoals of three-spine stickleback (*Gasterosteus aculeatus*) were observed. These fish represent a potential food source for piscivorous fish such as rainbow and cutthroat trout. Riparian vegetation consists of overhanging hardhack in the immediate riparian fringe and young red alder and Douglas-fir beyond.

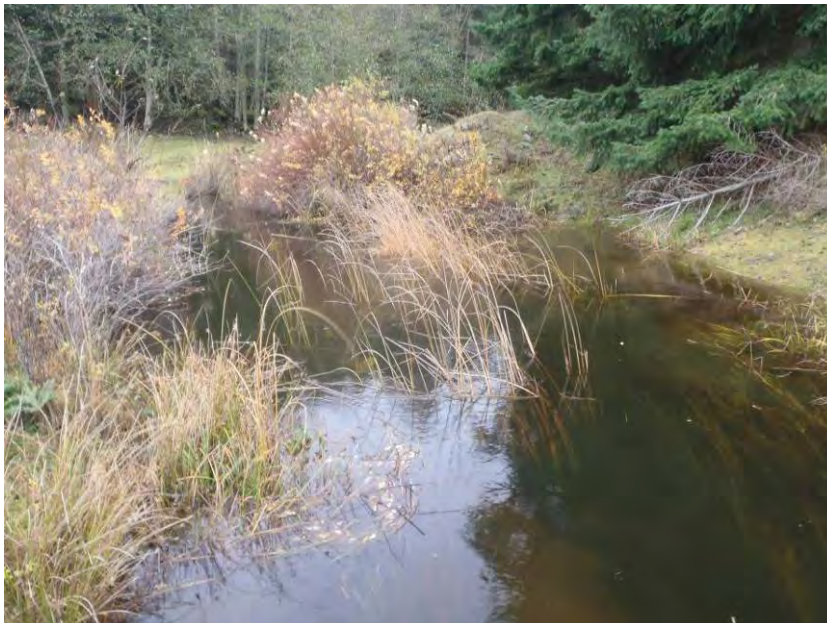
Looking downstream (south west) along Hoggan Creek. Note relative diversity of fish habitat values – adequate water depth, overhanging riparian vegetation and submerged vegetation.

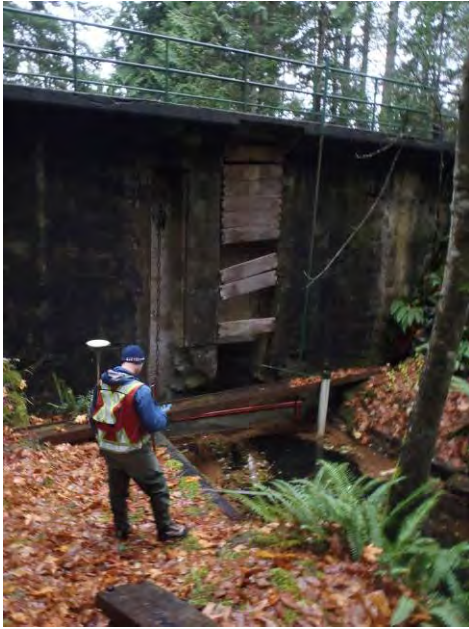
Looking at the upstream side of the dam and weir structure which backs up water on Hoggan Creek for hydro-electric power generation.

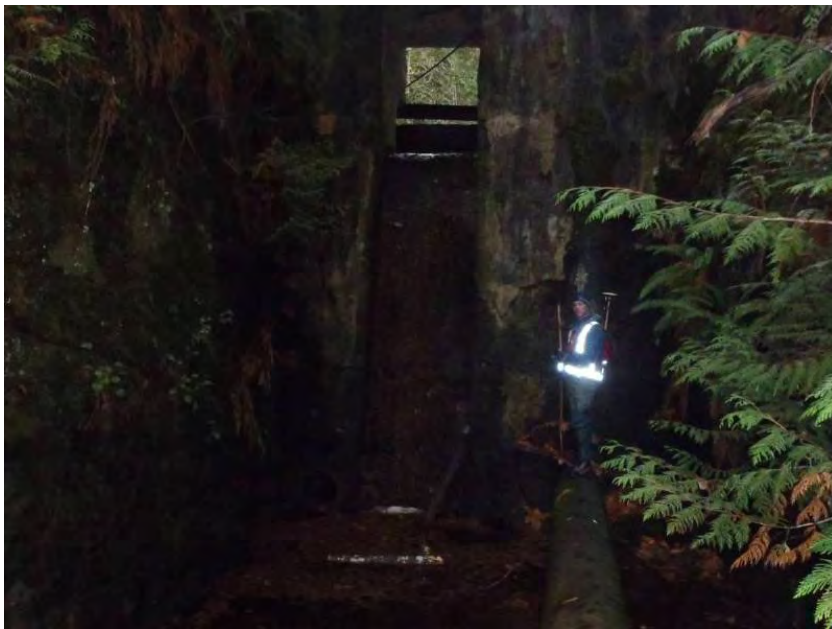
Looking at the downstream side of the dam and weir. Note lack of defined channel below the weir. The pipe takes water from behind the weir for power generation.

Approximately 150 m from the lake, a dam has been constructed for hydro-electric power generation. A weir is located near the base of the dam, which is breached during periods of high flows. Potential fish habitat in the outflow drainage is truncated by the dam/weir structure. A pipe draws water that backs up behind the dam down a 100% gradient slope towards the ocean. There is no potential for the survival of fish downstream of the dam, even if fish were to be carried over the weir, due to the steep gradient and lack of a defined natural channel.

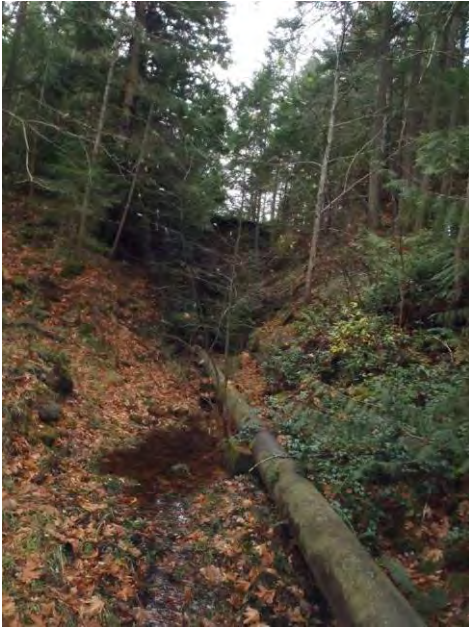
Looking north east towards the dam along the outlet pipe.

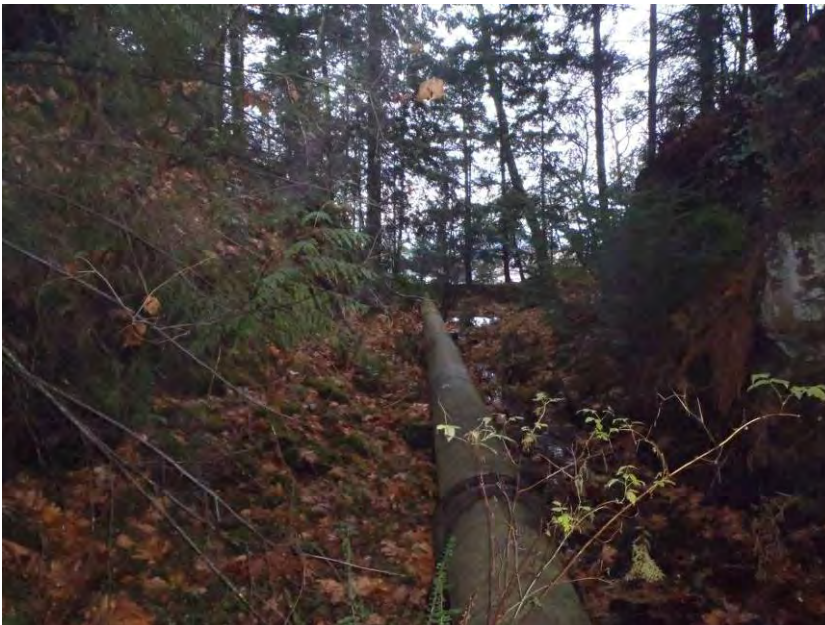
Looking south west from the dam along the outlet pipe. The pipe drops over a steep slope along the slope break in the approximate centre of the photo to the power generating facility.

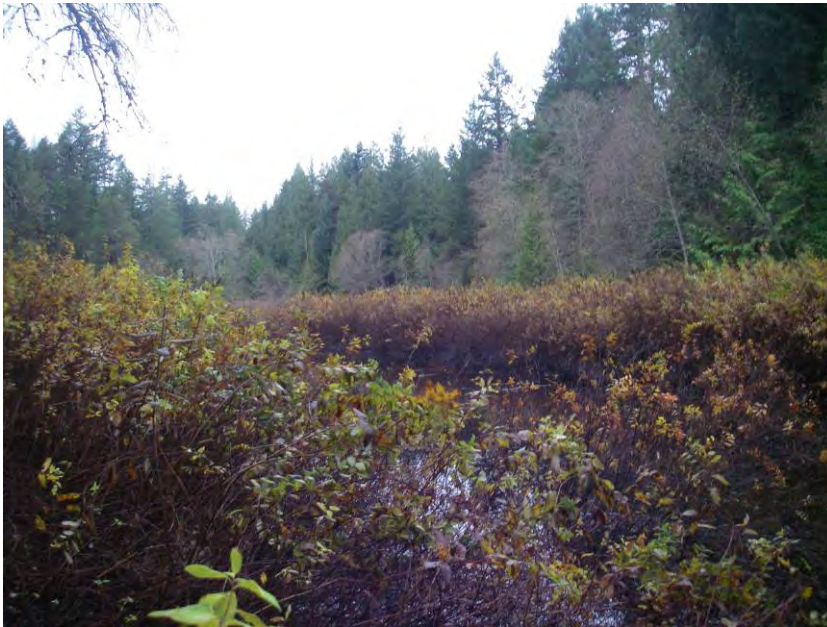
Looking west at the seasonally-inundated hardhack wetland which serves as the headwaters of the drainage (known locally as “Epps Pond.”)

The origin of the drainage is a wetland adjacent to Dole Road (known locally as “Epps Pond”). The wetland is approximately 30 m wide and 75 m long with a dense fringe of hardhack and willow. A deep pocket of open water occurs within the centre of the wetland. Riparian vegetation adjacent to the wetland is intact and dense, providing biological function to connected downstream fish habitat. The tree layer is composed of Douglas-fir, western redcedar and red alder. Dense salal growth dominates the understory shrub layer. Salmonberry, snowberry and oceanspray were also noted. The herb layer is sparse and composed mainly of sword fern.

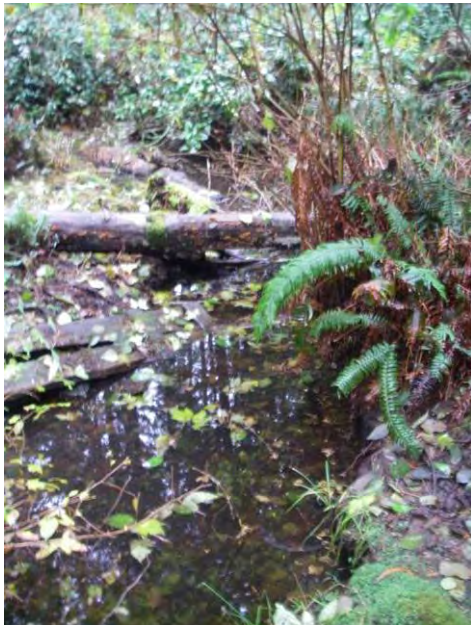
Looking at the excavated outlet channel near the headwaters (wetland) of Eppler Creek.

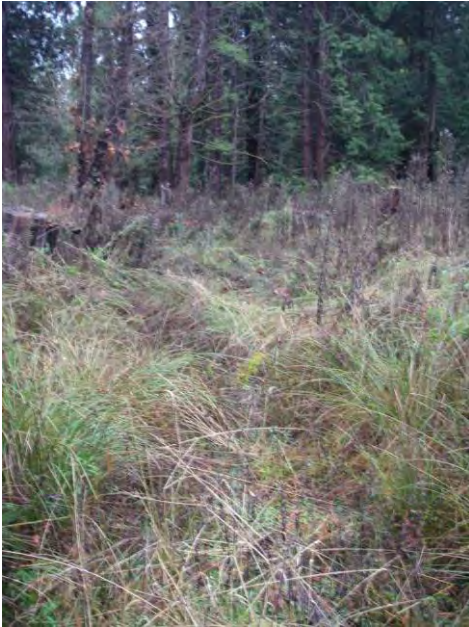
Poorly defined, organic channel representative of the drainage as it nears the west side of Dunshire Road.

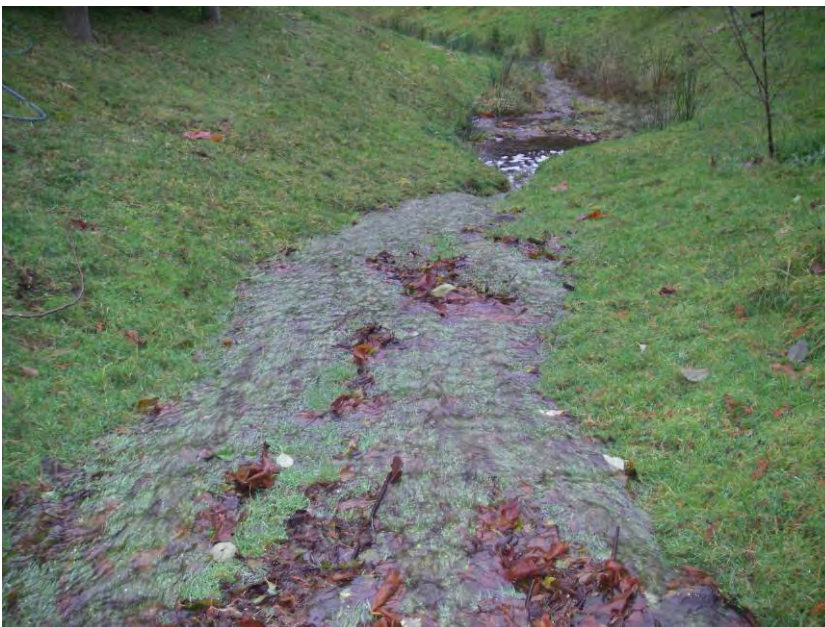
Looking east at the drainage as it flows over manicured lawn and through a depression on a residential property to the east of Dunshire Road.

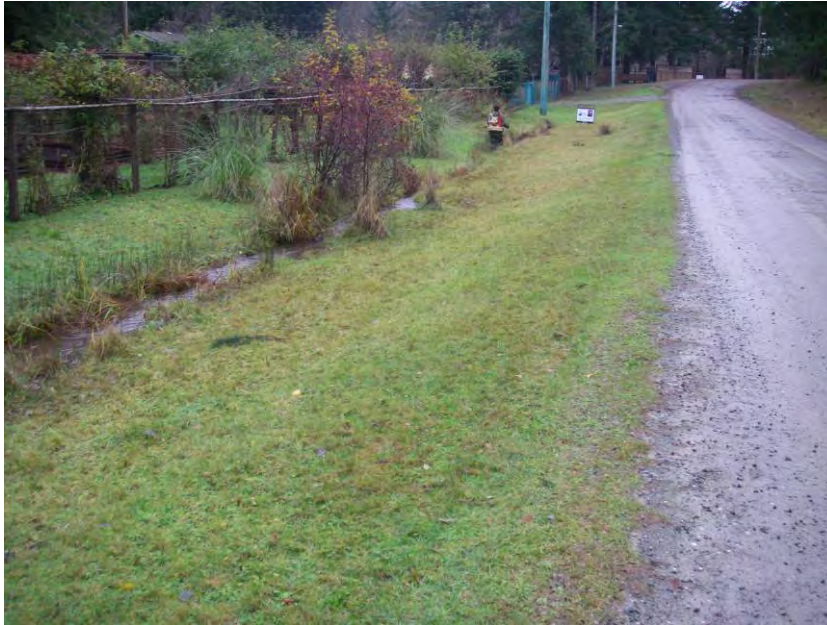
The middle section of the drainage (adjacent to Wildwood Crescent) consists of a roadside ditch.

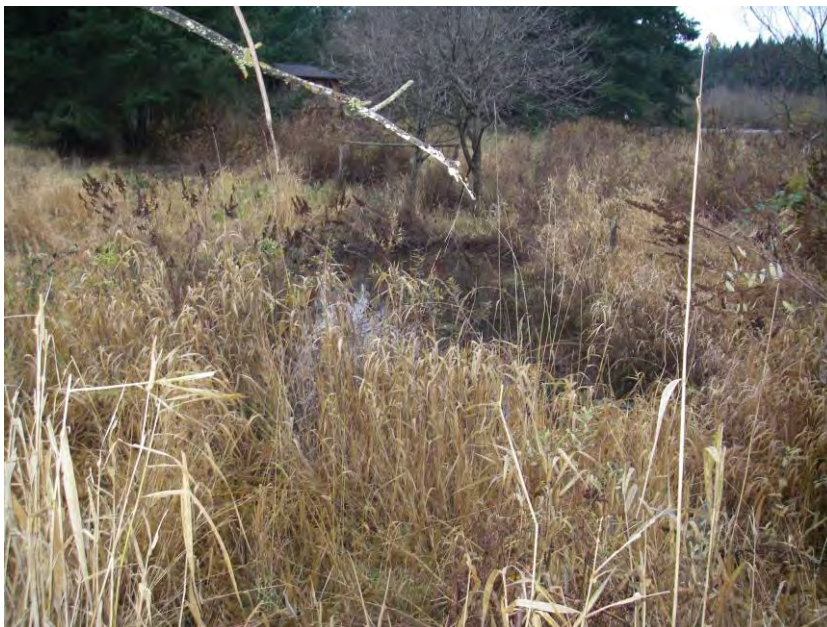
Looking northwest at the area where the drainage connects with the wetland located to the south of South Road, which forms part of Goodhue Creek.

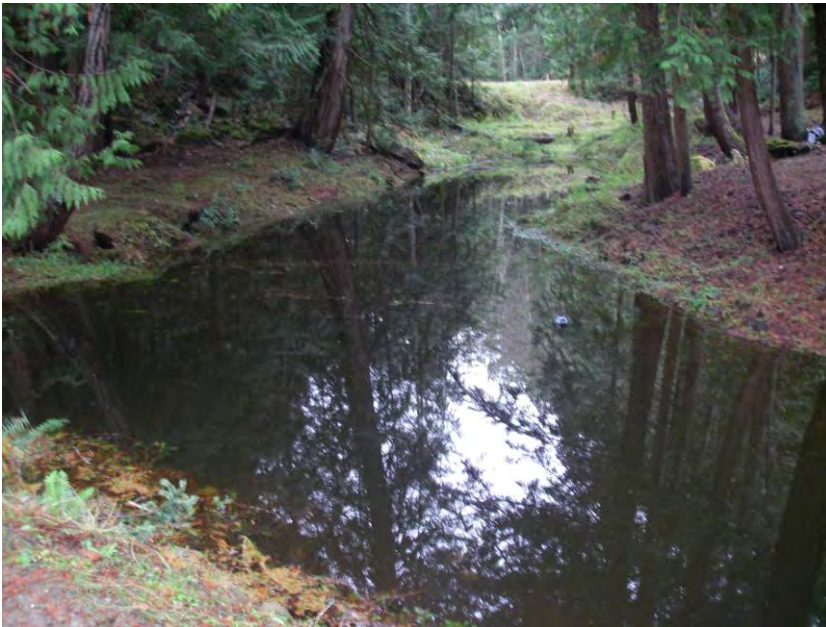
Looking south at a constructed pond, adjacent to Wildwood Crescent. This pond represents the origin of the Wildwood Crescent stream.

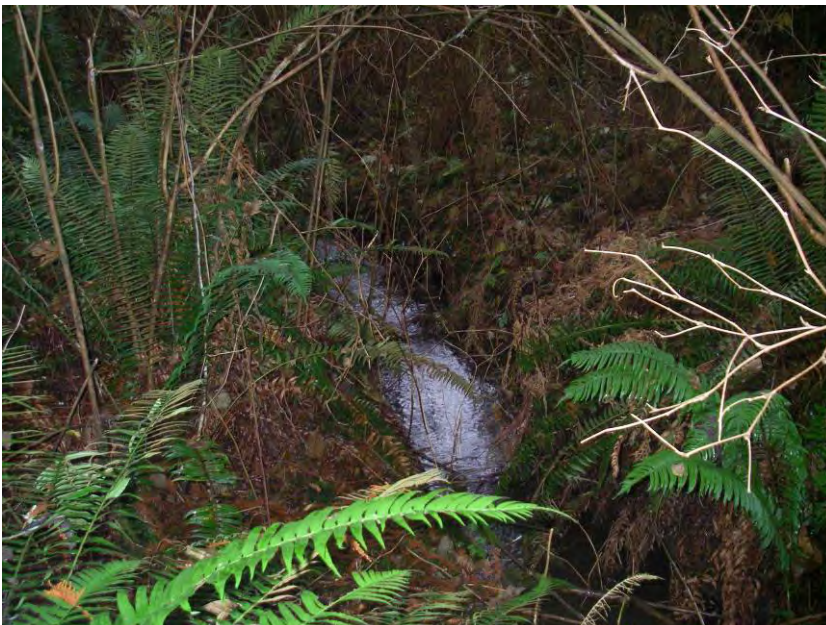
Looking upstream along the drainage ditch (Wildwood Crescent stream) downstream of the pond pictured above.

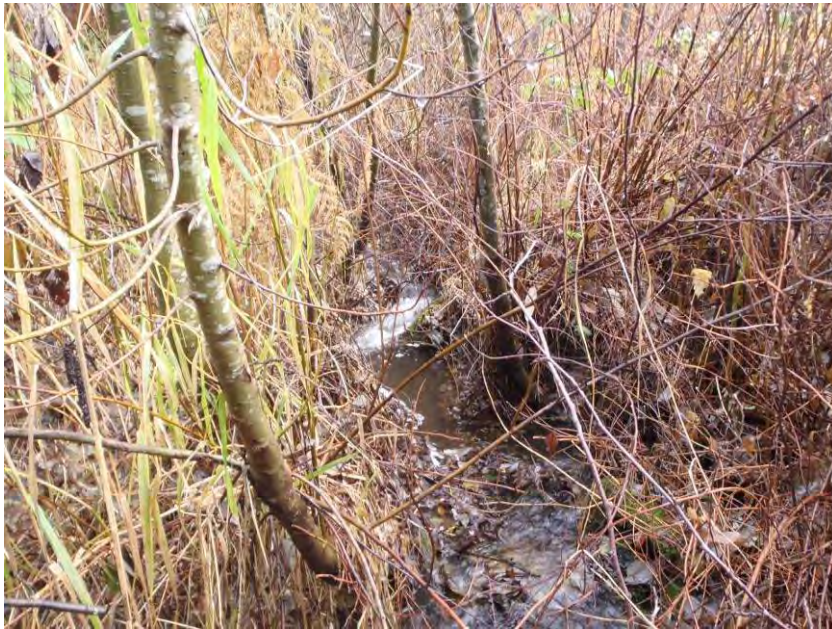
Looking north east (upstream) along the lower portion of the drainage where it joins the extensive wetland located upstream of the golf course (SEI T1222 – FS).

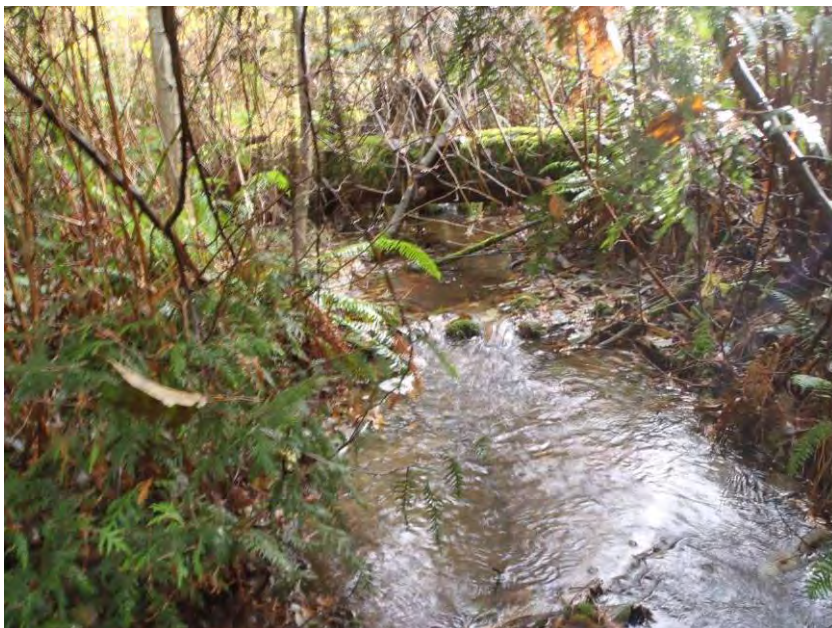
Looking north east (upstream) along the drainage downstream of South Road.

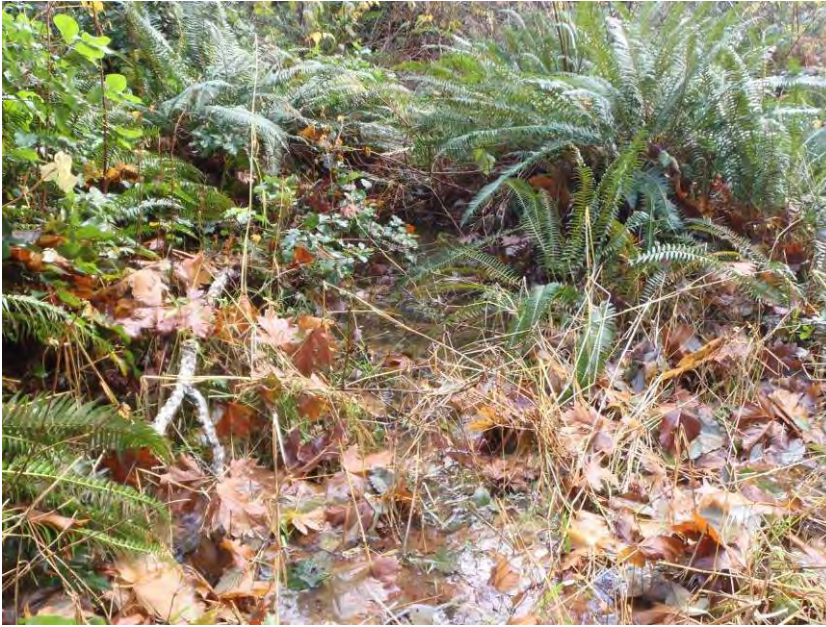
Above and below: water seeping out of the slope to the north east of South Road, which represents the origin of the drainage.

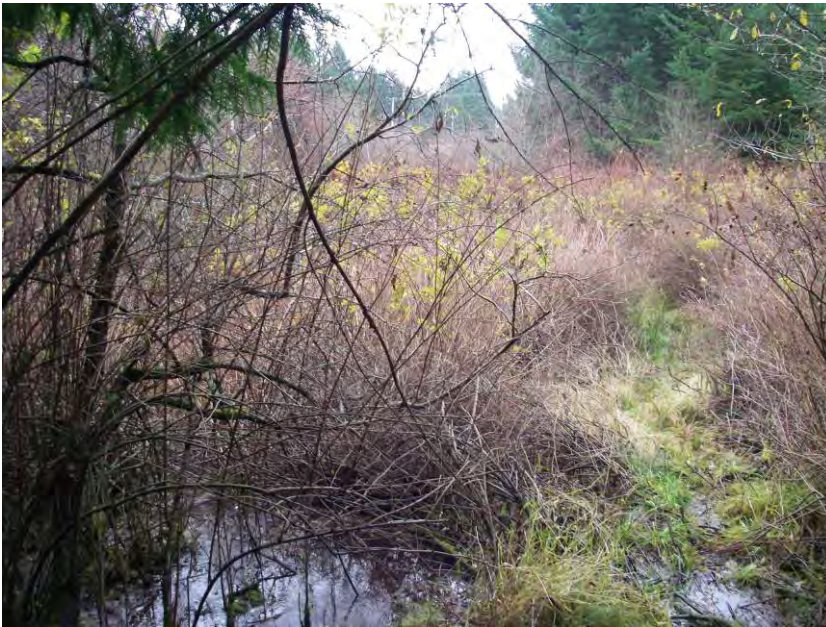
Looking north at the outlet of South Road stream B. It should be noted that water disperses throughout the area and drains into the extensive wetland located to the north of South Road (part of Goodhue Creek).

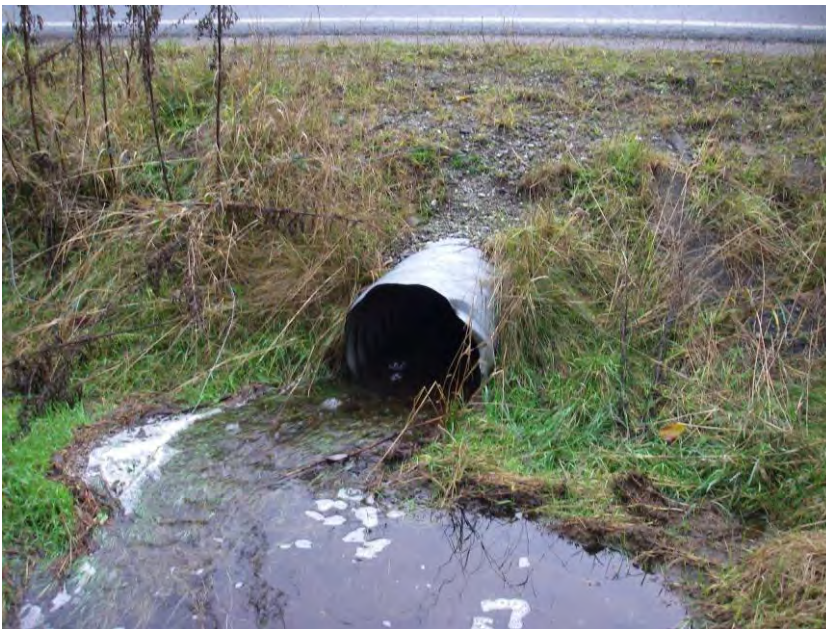
The outlet of the culvert that directs water under South Road.

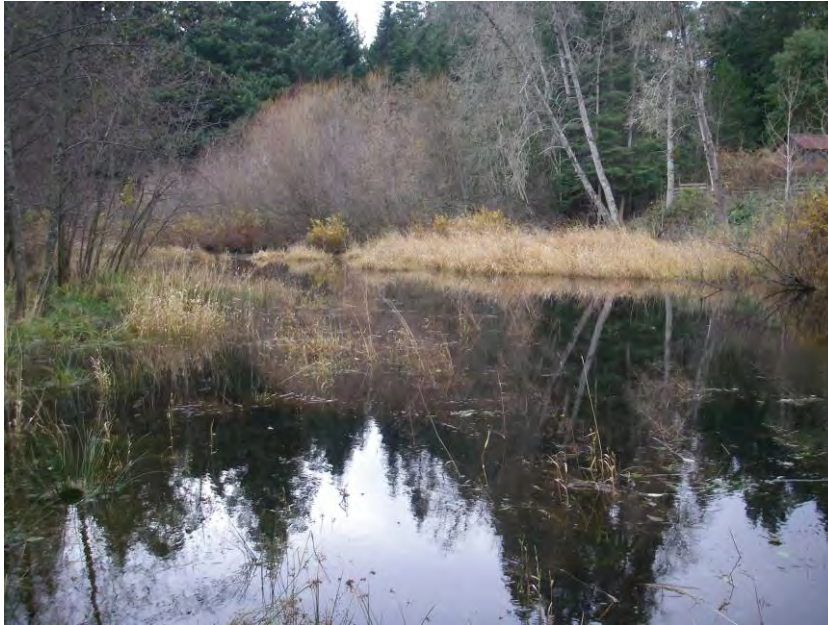
Looking south west at the wetland that represents the origin of South Road stream B.

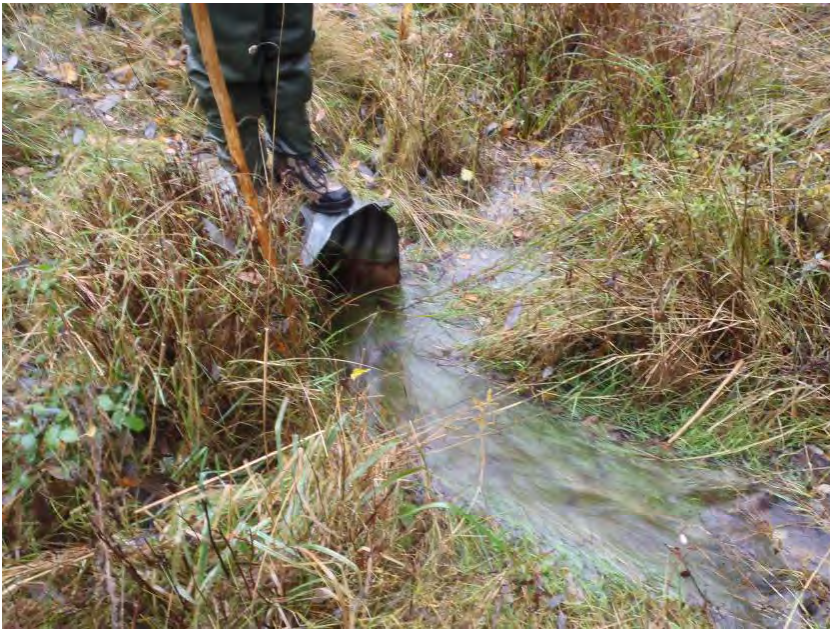
Inflow of the culvert under Redwood Road immediately upstream of the extensive wetland located to the north of South Road.
