**GABRIOLA ISLAND RIPARIAN AREA  
REGULATION STREAM IDENTIFICATION  
UPDATED REVISED VERSION FEBRUARY 24, 2012**

**Chloe Fox  
Island Planner (Gabriola Island Local Trust Committee)  
700 North Road, Gabriola Island, BC, V0R 1X3**

**Trystan Willmott, B.Sc. A.Sc.T.  
Justin Lange, B.Sc., B.I.T., A.Sc.T.  
MADRONE ENVIRONMENTAL SERVICES LTD.  
1081 Canada Avenue, Duncan, BC, V9L 1V2**

**February 24, 2012**

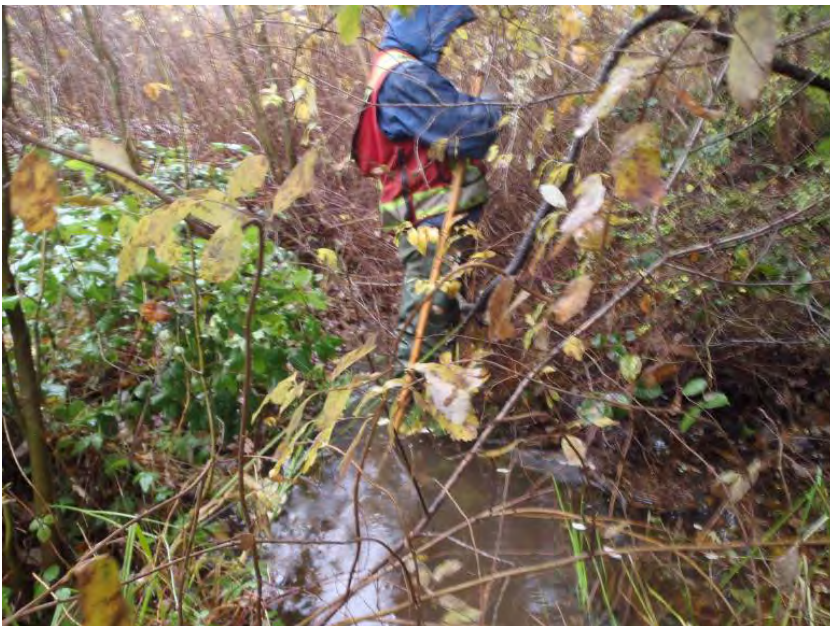
Typical poorly-defined characteristics of Dogwood Crescent stream.

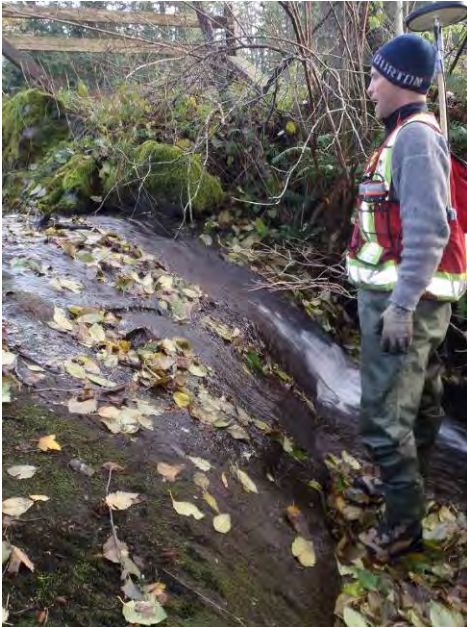
Bedrock step located downstream of South Road. Resident fish from Hoggan lake would not be able to move upstream of this feature. The gradient is too steep, no plunge pool exists and the water is shallow and fast over the smooth bedrock.

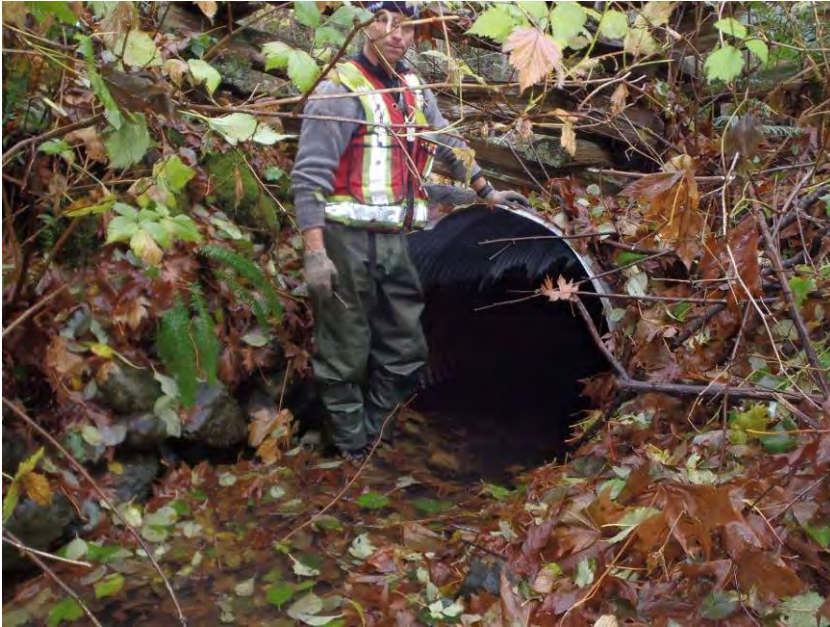
Outflow of the culvert under South Road.

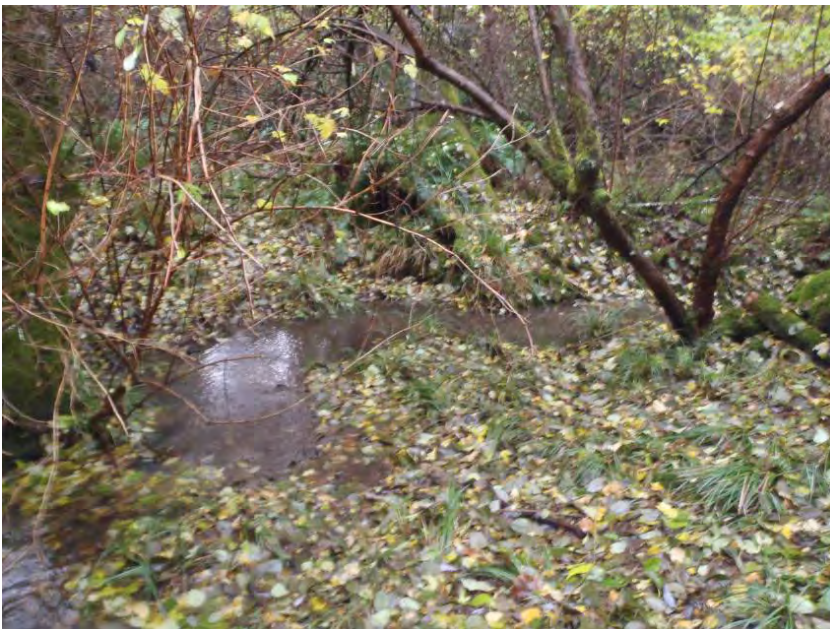
Above and below: typical conditions of the Coats Marsh outflow stream to the north (upstream) of South Road. Note general lack of channel definition.

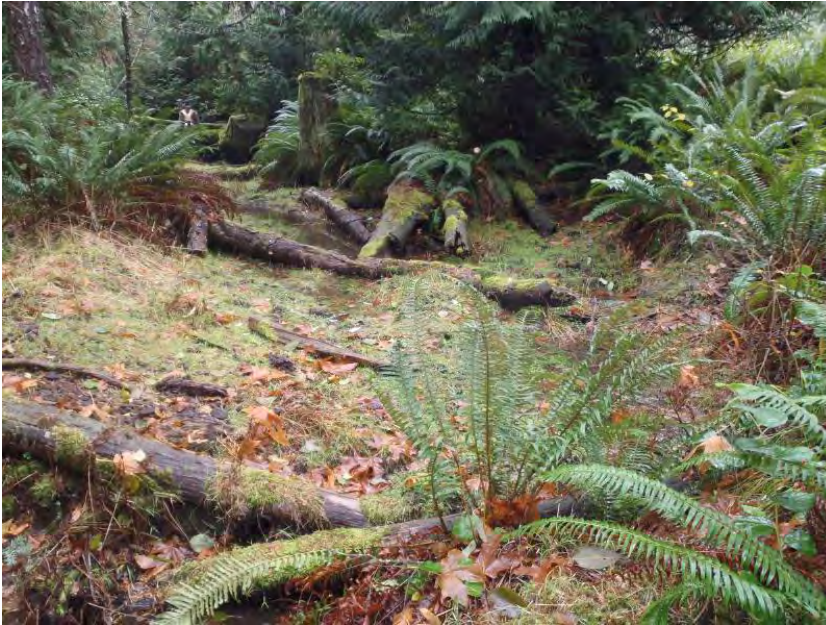
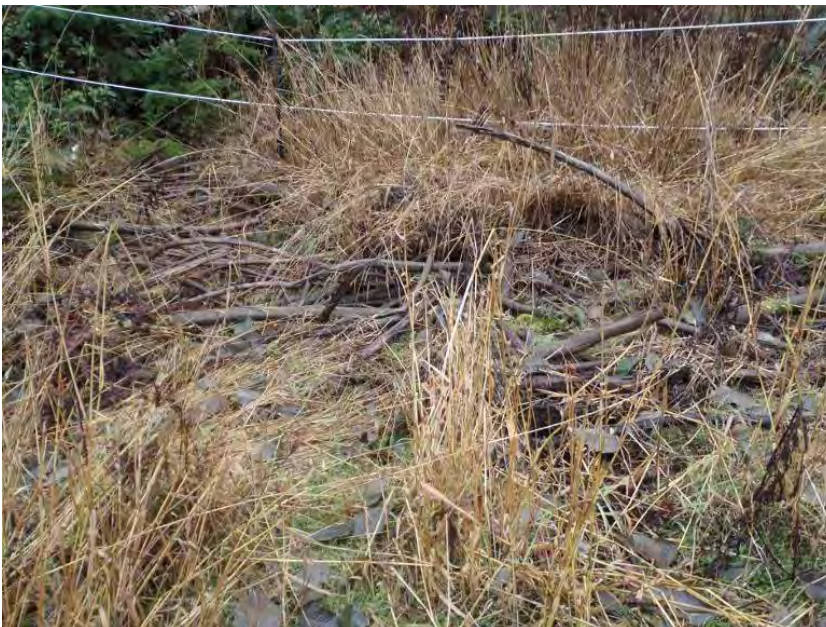
Above and below: extremely poorly defined characteristics of the stream at the point where it crosses the Coats Marsh park boundary.

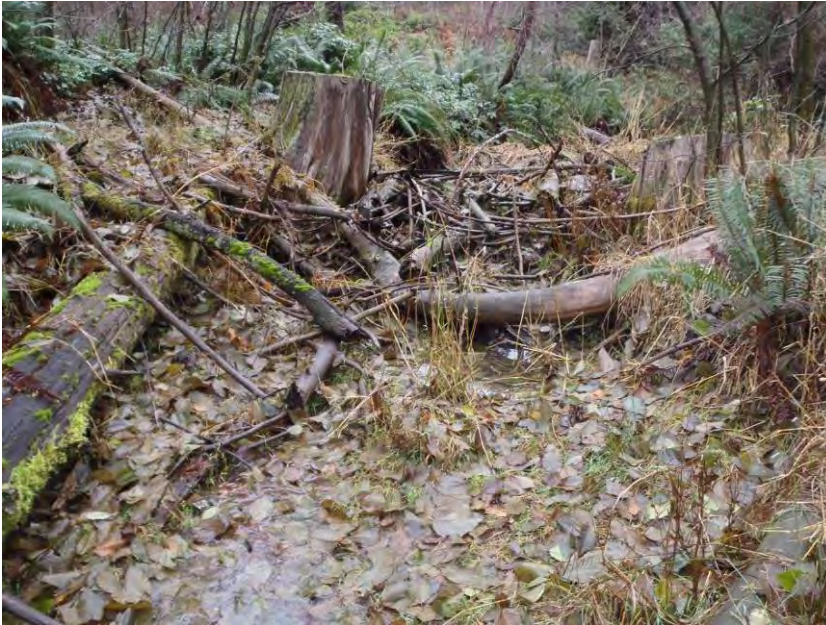
Looking downstream (north west) along the stream where it flows through residential property after emerging from the Coats Marsh park area.

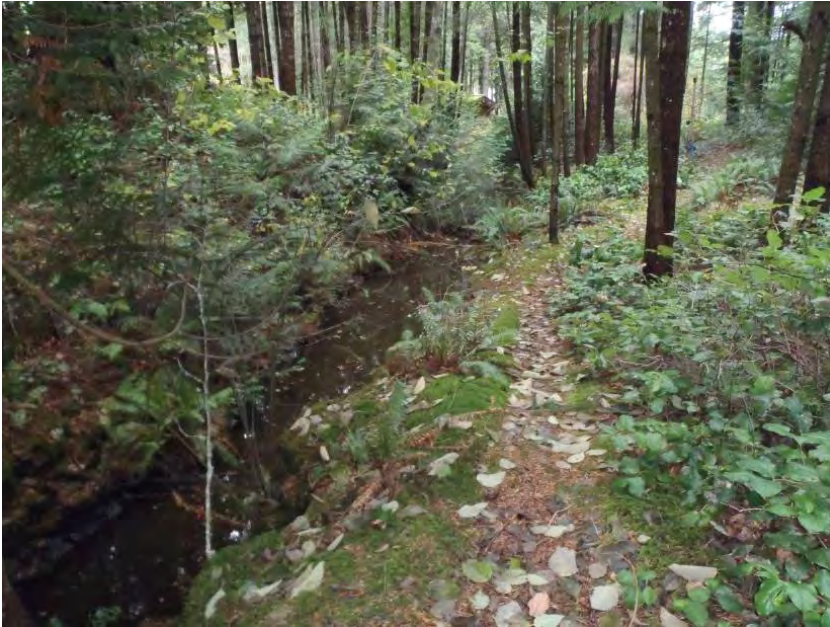
Looking downstream (north west) along the Coats Marsh outflow stream immediately below Coats Marsh. Note lack of natural sinuosity, resulting from historical straightening activities.

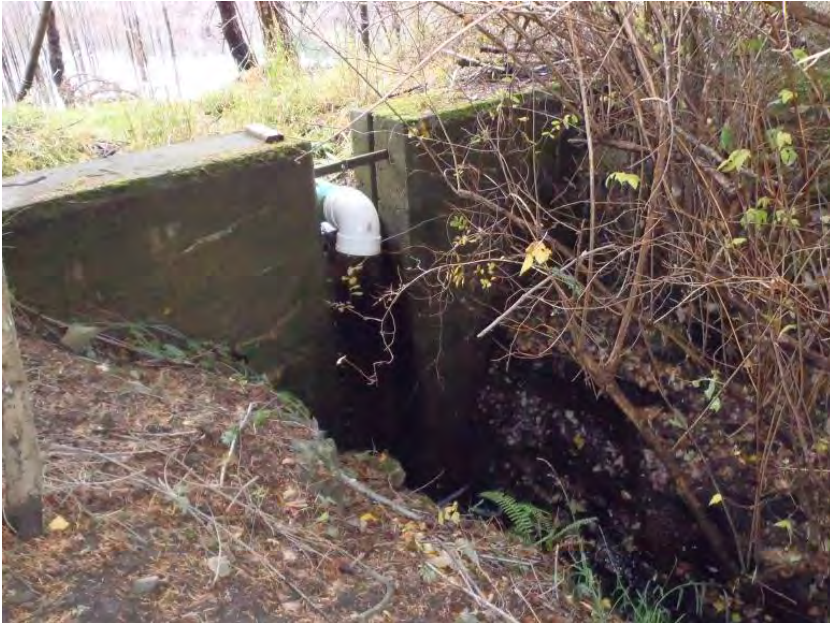
Weir and pond leveler representing the origin of the Coats Marsh outflow stream.

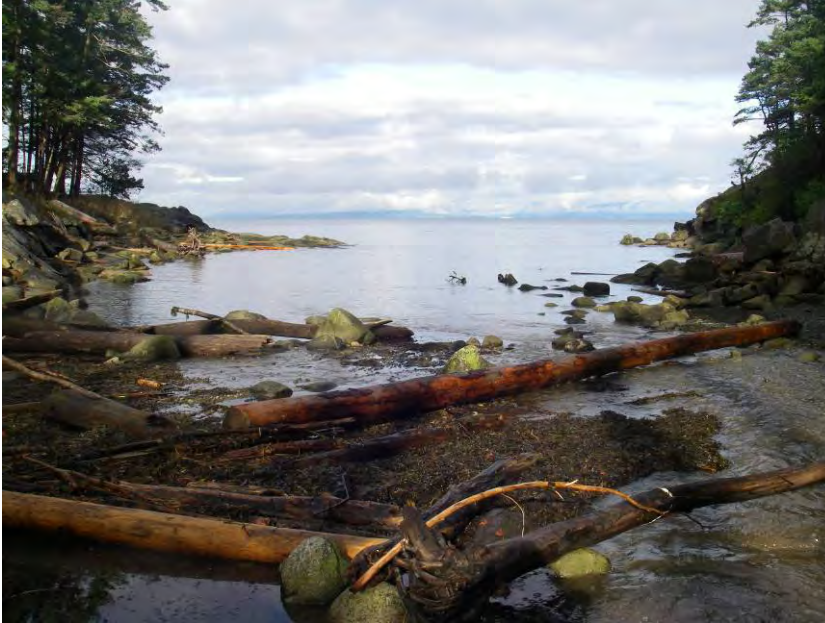
Looking north over the cove where Dick Brook flows into the Strait of Georgia.

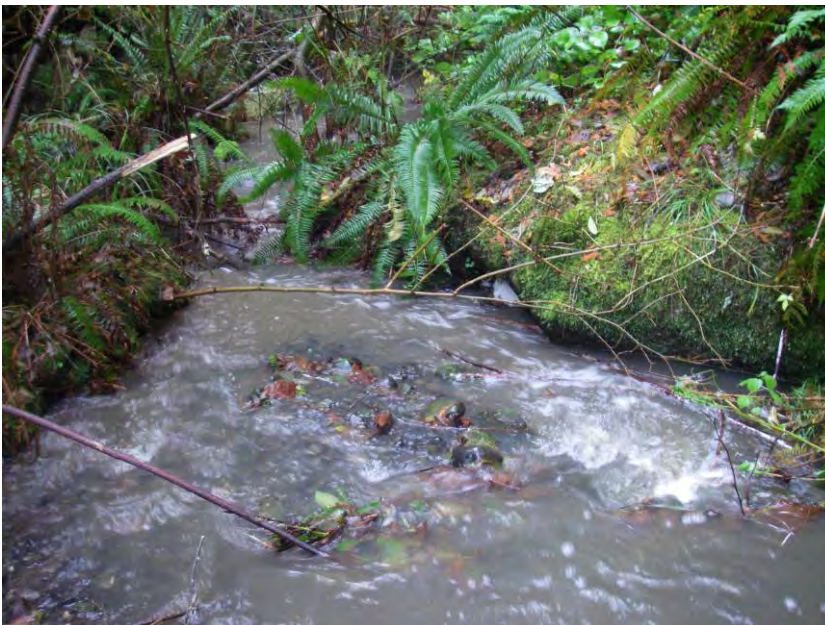
Typical substrate composition in the lower portion of Dick Brook.

On average, the width of the stream upstream of North Road is 2 m – 3 m. The gradient is approximately 4%, typical of a riffle-pool system. Substrate throughout this reach consists of a mixture of gravel, small cobbles, and organic material. Riparian vegetation adjacent to the stream is composed of a regenerating second growth forest that is providing biological function. Tree species observed include Douglas-fir, western redcedar, red alder, and bigleaf maple. The shrub layer is dense and composed of Pacific ninebark, snowberry, willow, salmonberry, Nootka rose (*Rosa nutkana*) and salal. The herb layer contains skunk cabbage, sword fern, bracken fern and slough sedge.

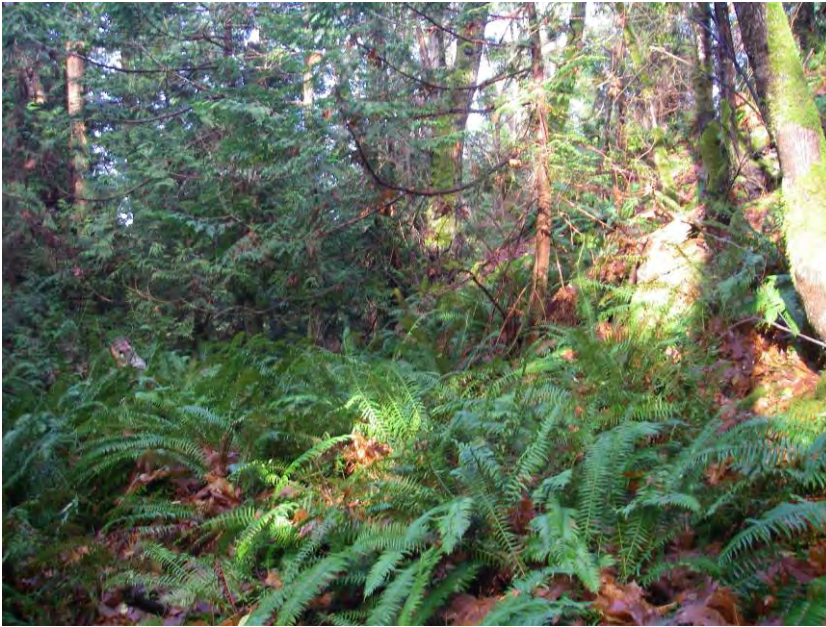
Typical composition of riparian vegetation adjacent to Dick Brook in areas with minimal disturbance.

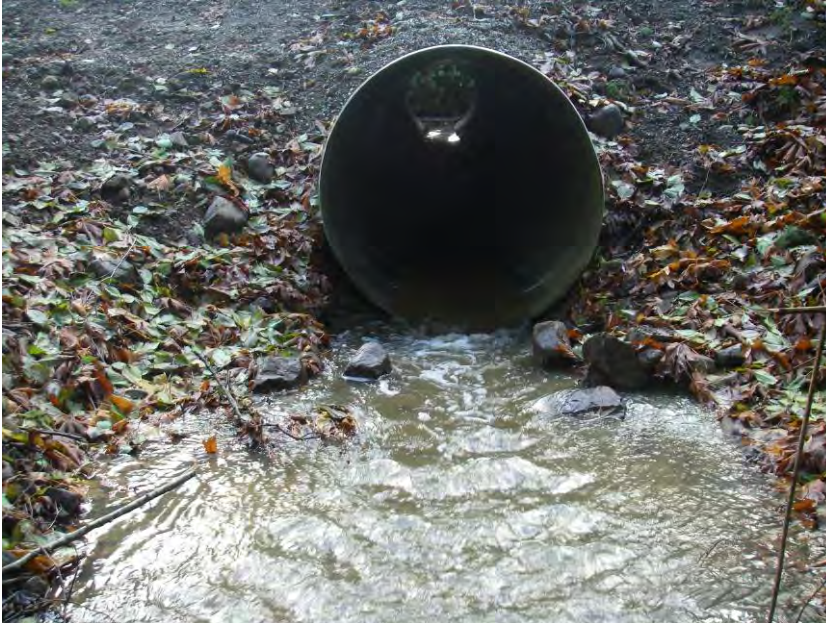
Outflow of the culvert positioned under North Road. It should be noted that this culvert has been recently installed (at the time of writing) as noted by the fresh gravel positioned at both the inlet and outlet of the culvert.

At North Road, the stream flows through a culvert that has recently been put in place. The reach between North Road and Cresta Roca Road has characteristics consistent with a natural stream. It should be noted, however, that some areas

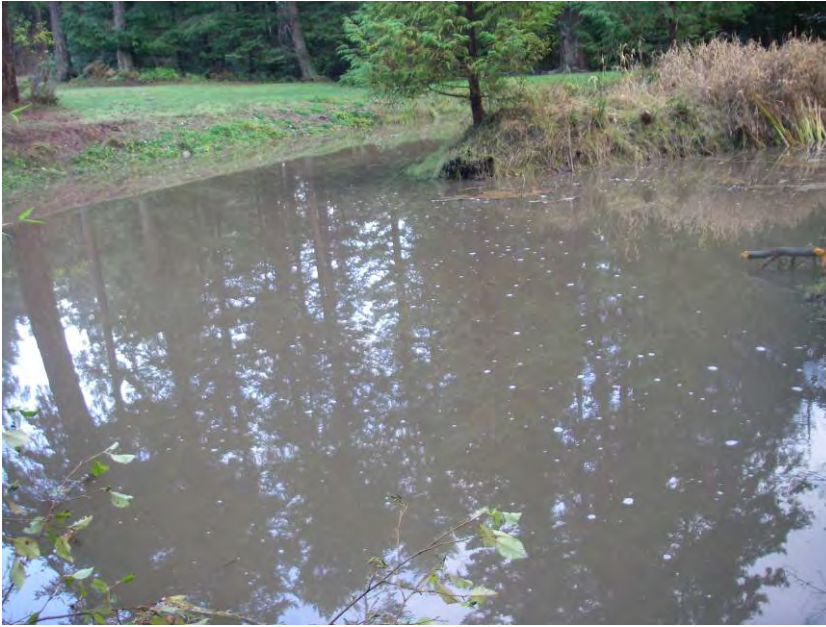
Looking east over an excavated pond that appeared to be constructed by altering the original channel of Dick Brook.

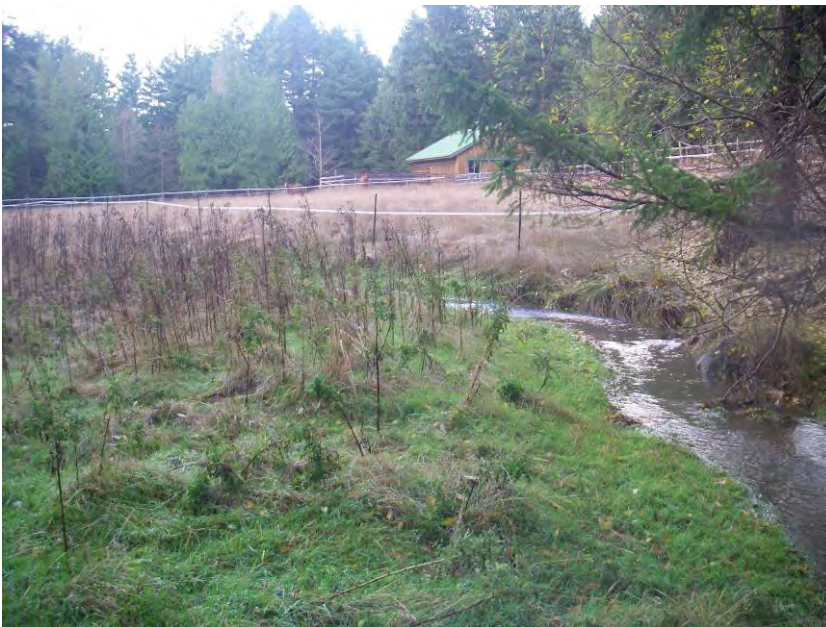
Looking west (upstream) at Dick Brook as it flows through agricultural properties. These portions of the drainage that flow on agricultural land have been historically channelized.

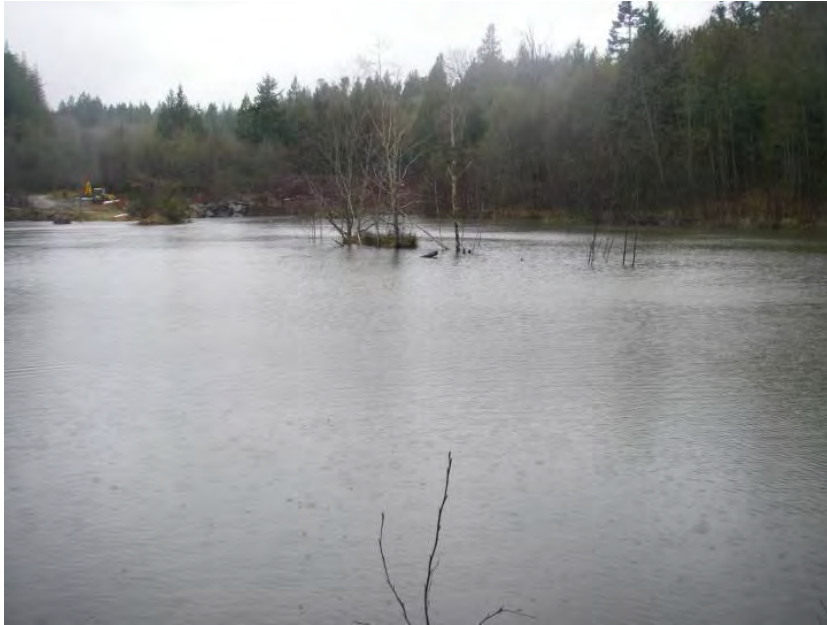
Looking north at the pond at the head of Dick Brook.

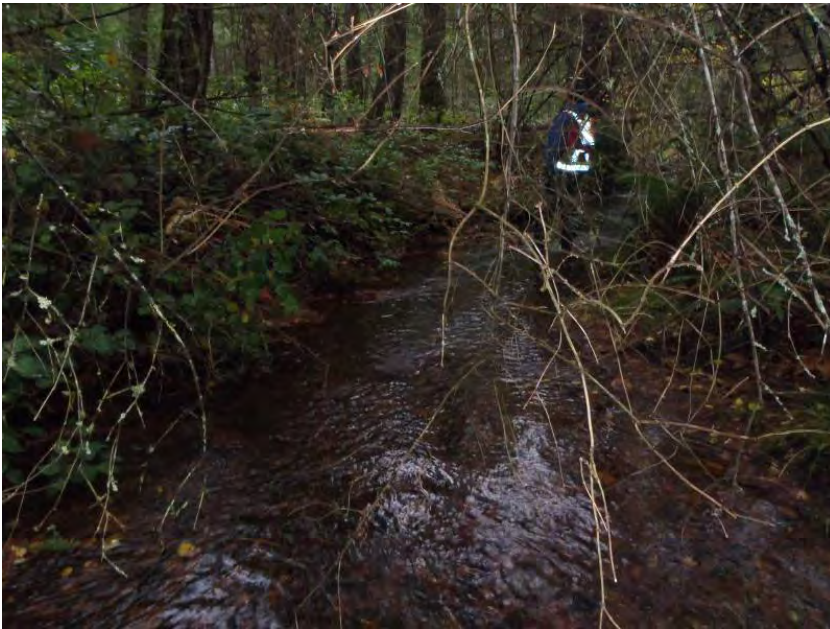
Looking east (downstream) along the outlet drainage of potential RAR watershed 2 (known locally as Jenkins Creek) immediately downstream of North Road.

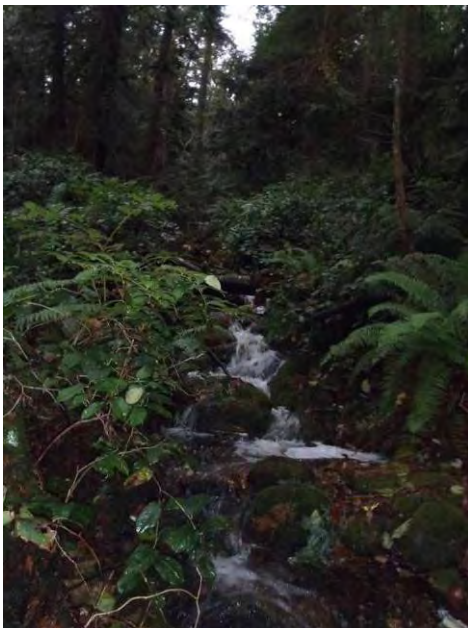
Looking west (upstream) along Jenkins Creek from a point immediately upstream of the ocean. Note significant gradient of the stream.

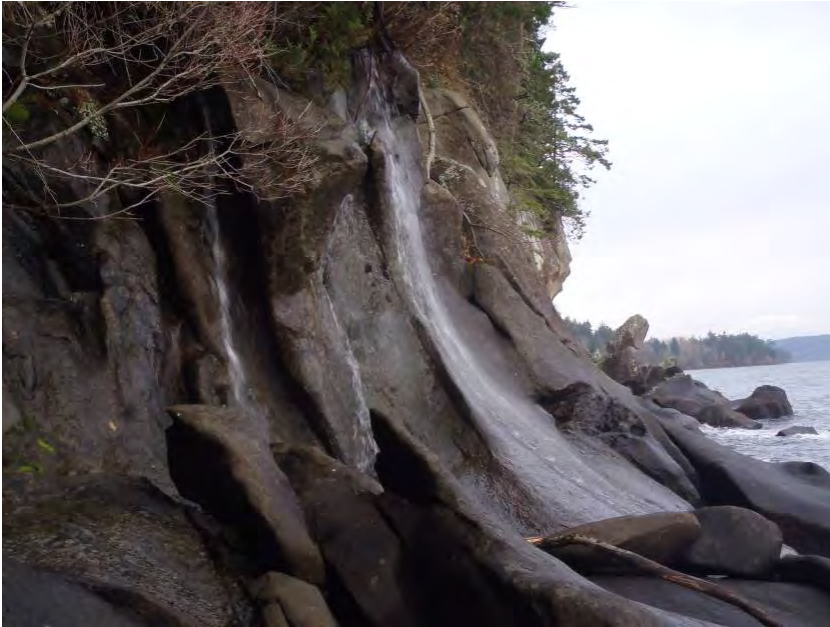
Entry of Jenkins Creek into the ocean (5 m vertical drop over a bedrock cliff). Note complete lack of accessibility for fish.

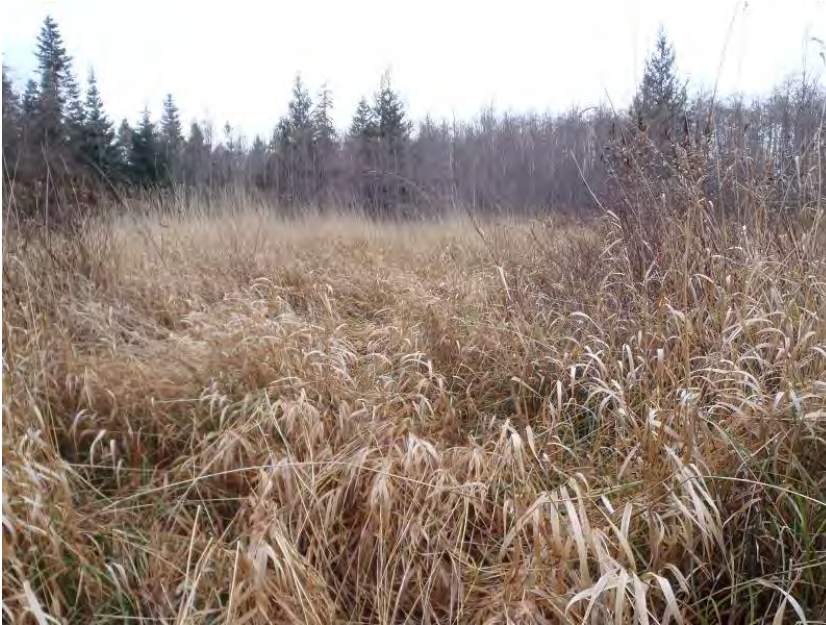
Looking north east over the dense reed canary grass comprising the vegetation of the Site 1 wetland.

This wetland extends to the east of the north-eastern corner of Coats Marsh Regional Park. Pockets of shallow water exist on a seasonal basis, with dense reed canary grass occurring throughout. In moister areas, patches of hardhack and sedges occur, but in general, it is difficult to define a definite wetland edge or typical high water mark.

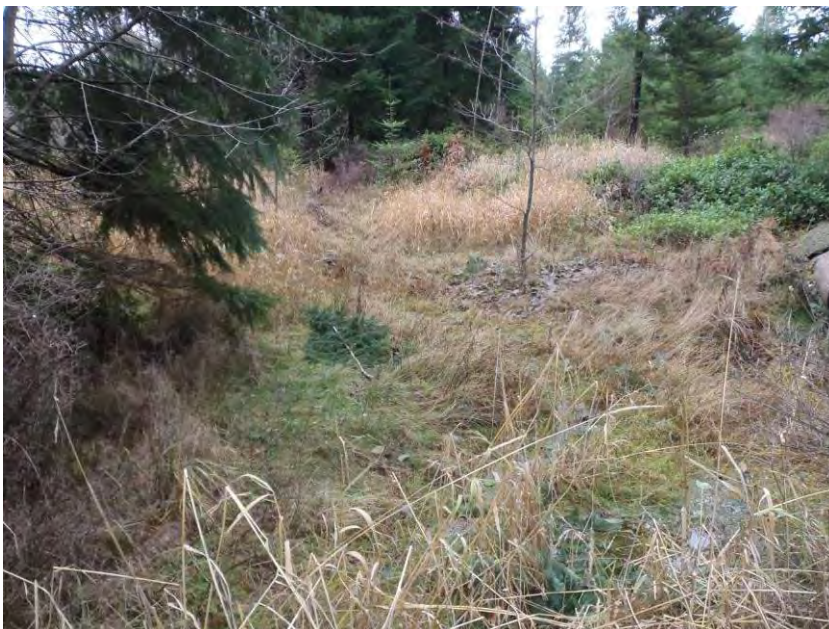
Looking north east along the point where surface water collects and drains out of the wetland during high flow events on the north side of the trail. Note lack of defined channel and lack of surface water, even after seasonal heavy rain.

During periods of extreme high water flow, water collects in shallow depressions and flows overland via a culvert located underneath a trail/driveway at the south-western tip of the wetland. No defined channel was observed, with surface flow occurring over the vegetation. From the culvert outflow, no defined channel could be followed, and any surface flowing water is intermittent (even during periods of extreme flow).

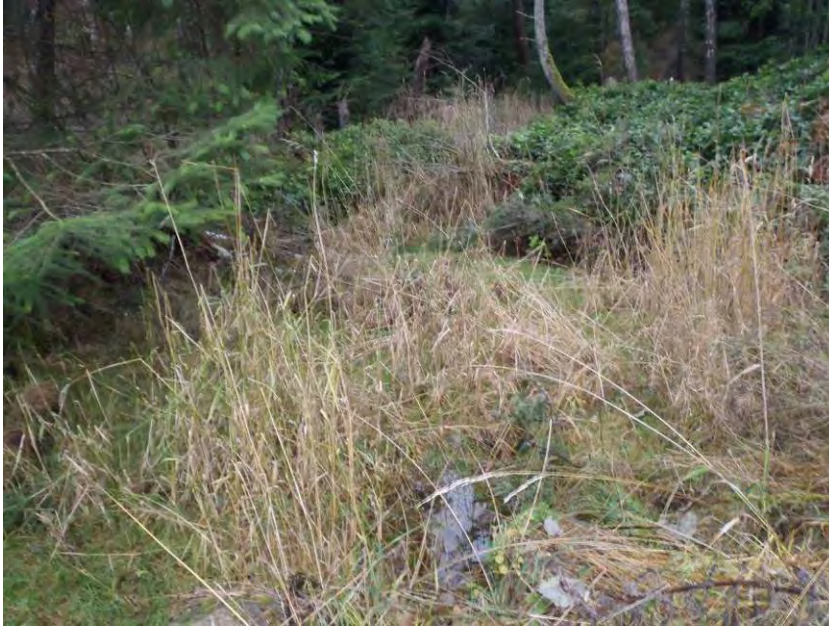
Looking south west along the area where surface water collects on the south side of the trail. Note lack of defined channel and lack of surface water.

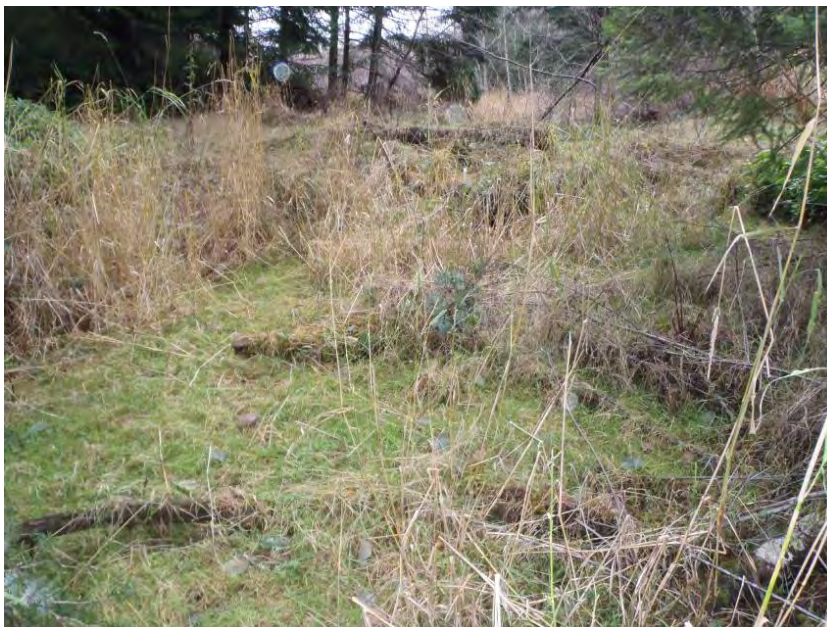
Looking north east towards the wetland immediately to the south of where surface water would collect and drain the wetland. Note lack of defined channel and lack of surface water.

Patches of hydrophytic vegetation exist to the south-west of the culvert outflow where water seeps over the surface. Between these patches of moisture, stretches of drier vegetation exist, with sword fern and salal occurring and no evidence of surface flow. Based on the lack of continuous surface flow and absence of a defined channel, there is no reasonable connectivity between the wetland area and any watercourses that could support fish.

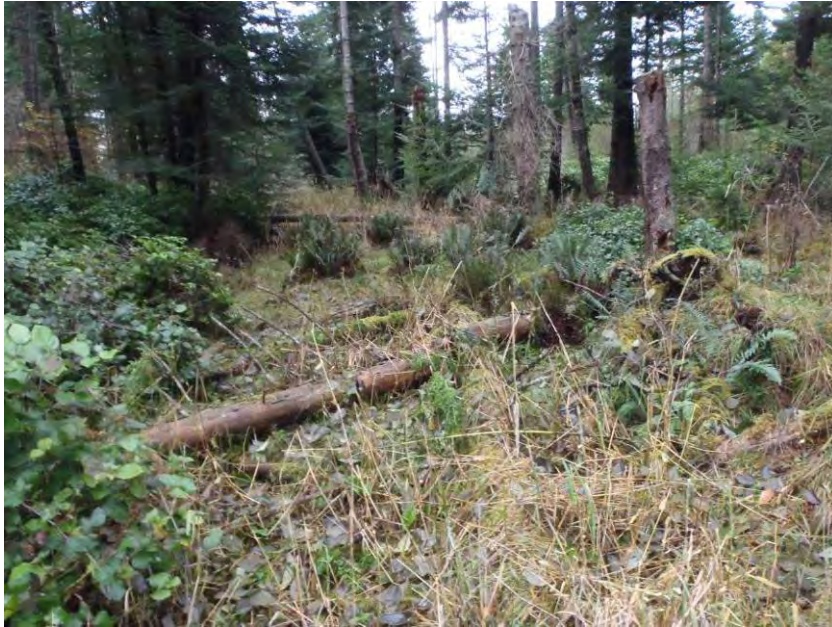
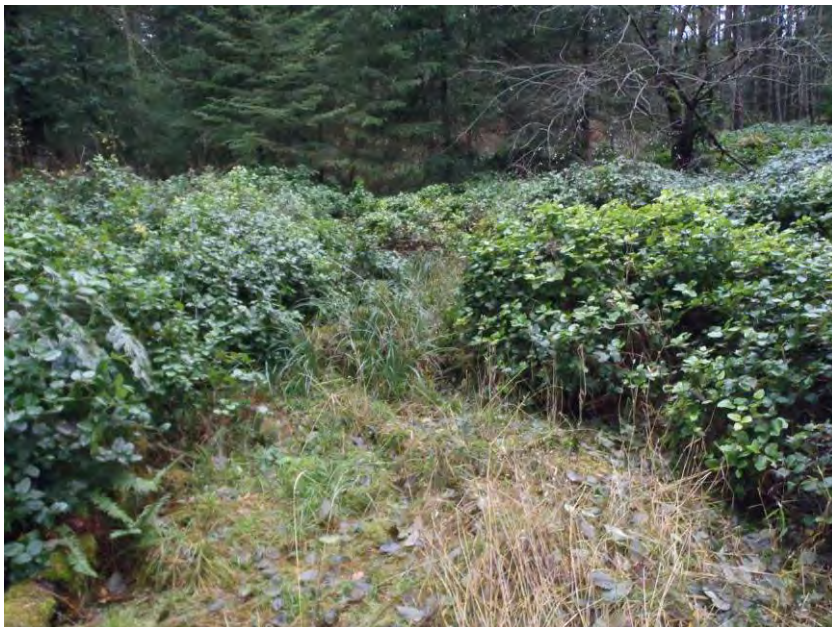
Above and below: isolated patches of hydrophytic vegetation (e.g. slough sedge) interrupted by drier vegetation types (salal and sword fern). These vegetation assemblages occur to the south of the area where surface water collects and drains out of the wetland during high flow events. Note lack of defined channel and “stream” characteristics.
