## Regular Meeting Revised Agenda

Date: December 1, 2022  
 Time: 10:30 am  
 Location: Gabriola Arts & Heritage Centre  
 476 South Road, Gabriola Island, BC

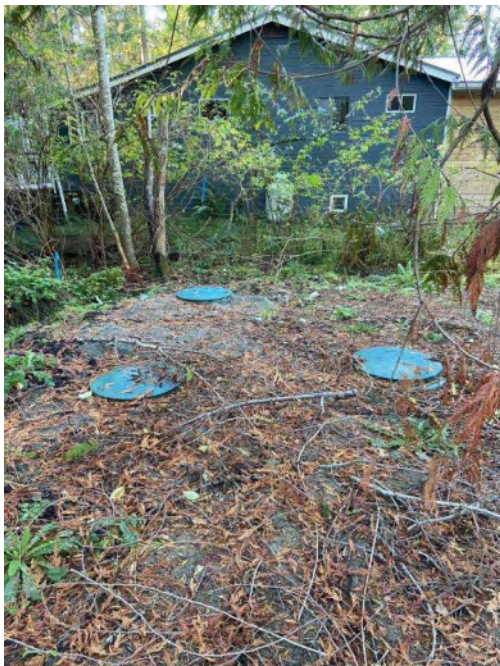
View west of septic tanks adjacent to wetland boundary (blue ribbons)

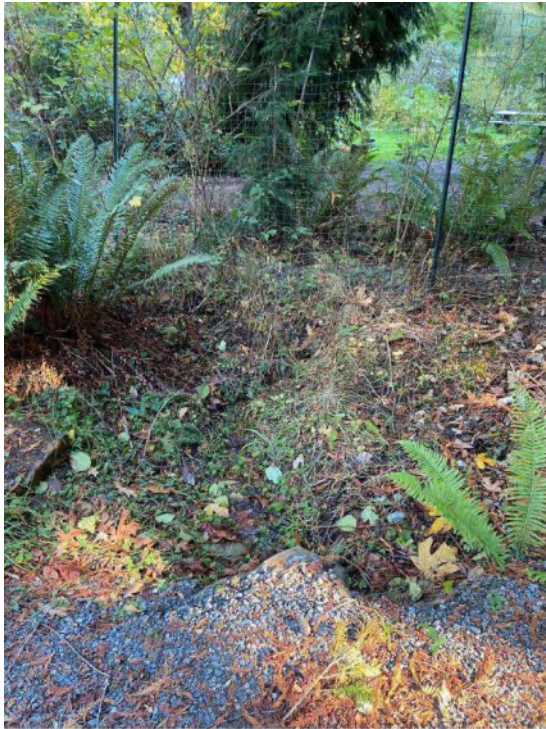
View east of drainage ditch leading to  
culvert under the driveway

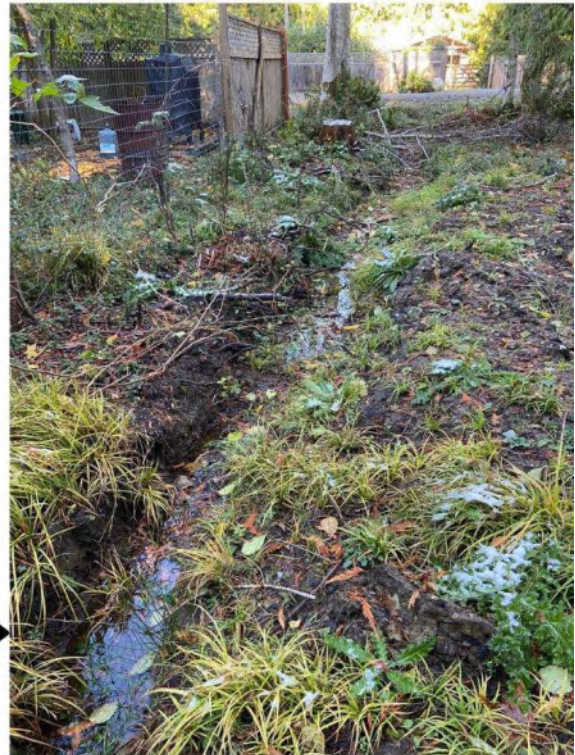
View north of wetland drainage ditch

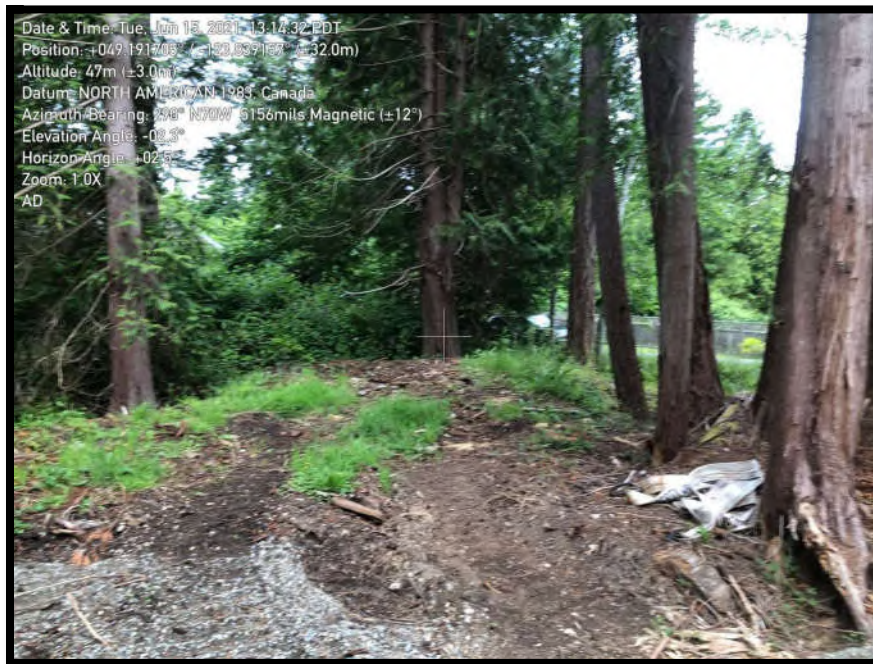
Figure 2: View from edge of proposed driveway to the North-West over the proposed disposal field.

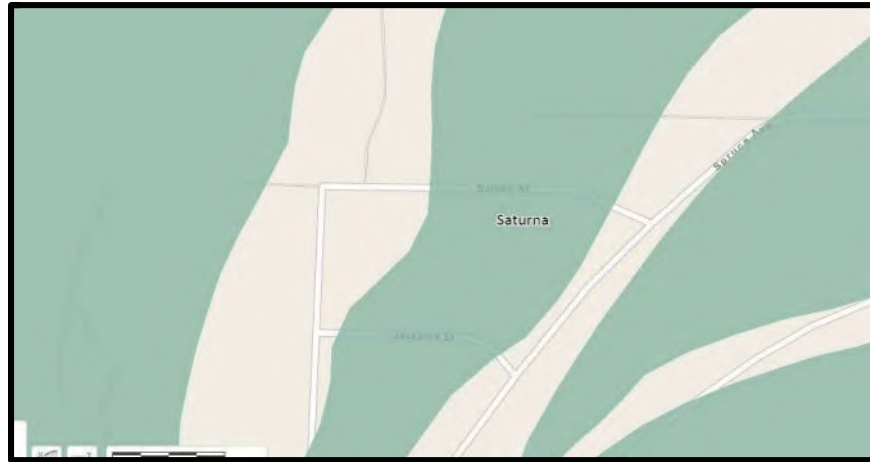
Figure 4: Soil Classification of subject property (from IMapBC). North is towards the top of the page. Do not scale.

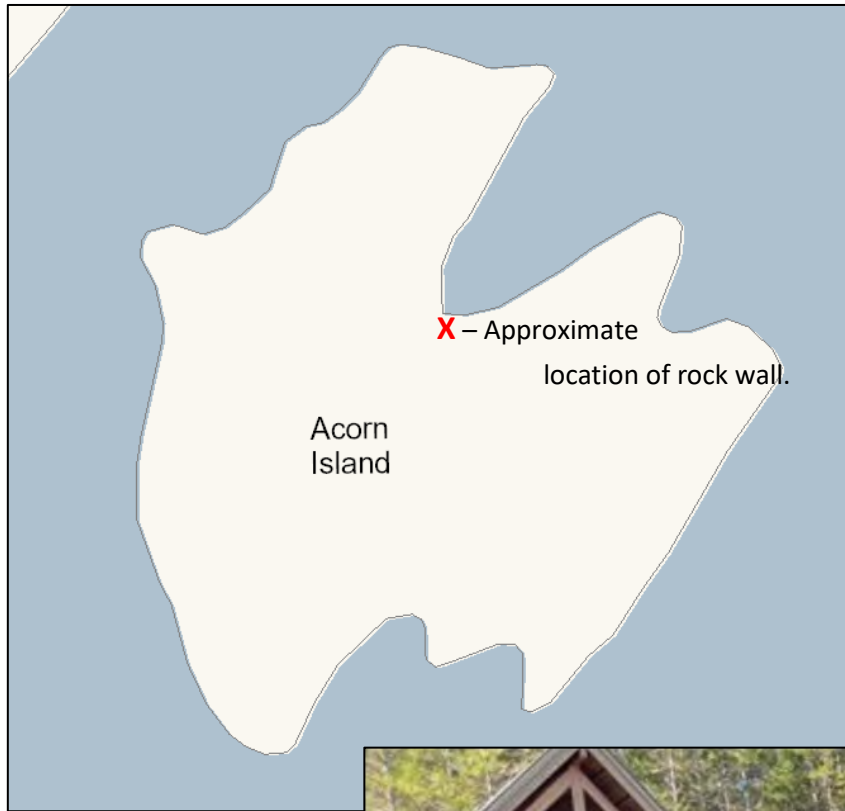
*Figure 1 Rock Retaining Wall, also referred to as "Riprap Wall," in front of the house.*

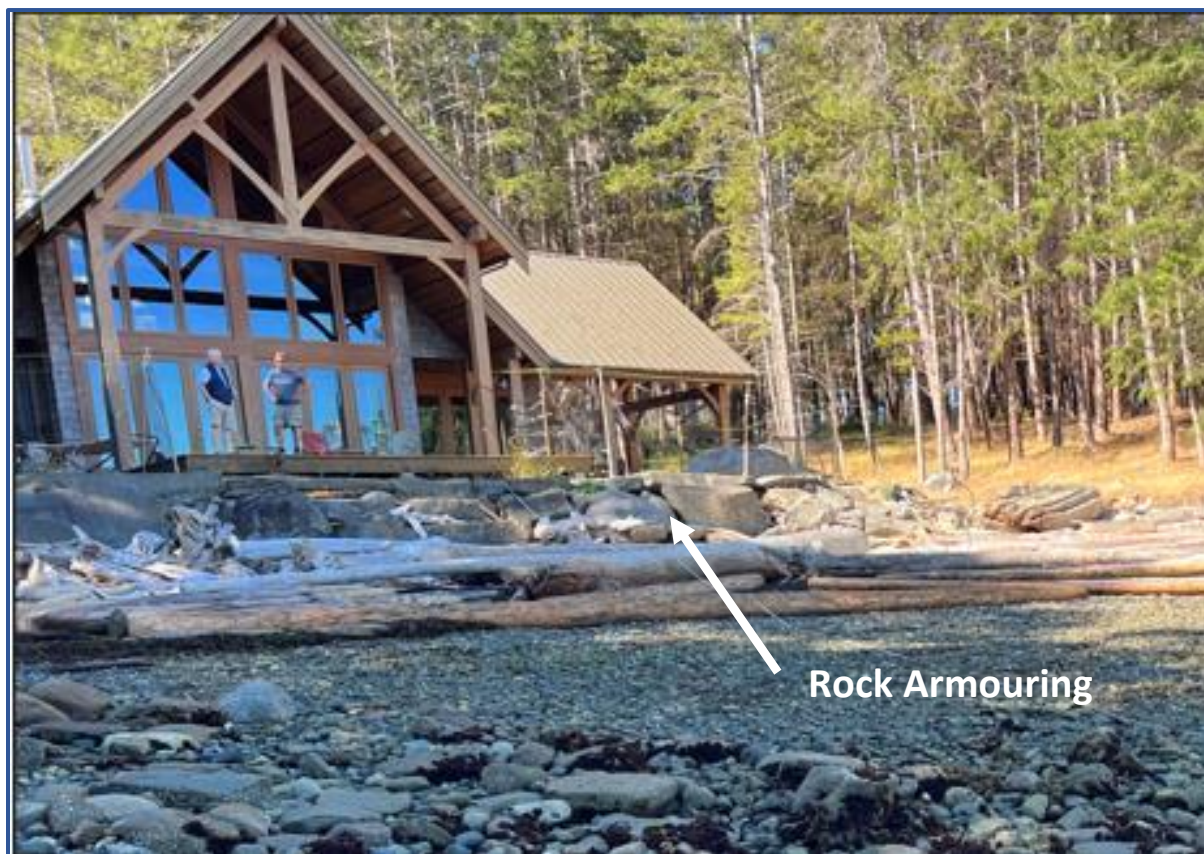
**Photo 1** Photograph looking at the rock armouring and upper beach.

The rock armouring was constructed at the southwest end of the cove and provides protection of the backshore soils from storm induced shoreline erosion and wave run-up. The site photos and satellite images show a significant natural accumulation of woody debris in front of the shoreline (Photo 3). The photos and images do not show any sign of scour development or shore profile irregularity. There are exposed soils at the southwest corner of the cove where there is no rock armouring.

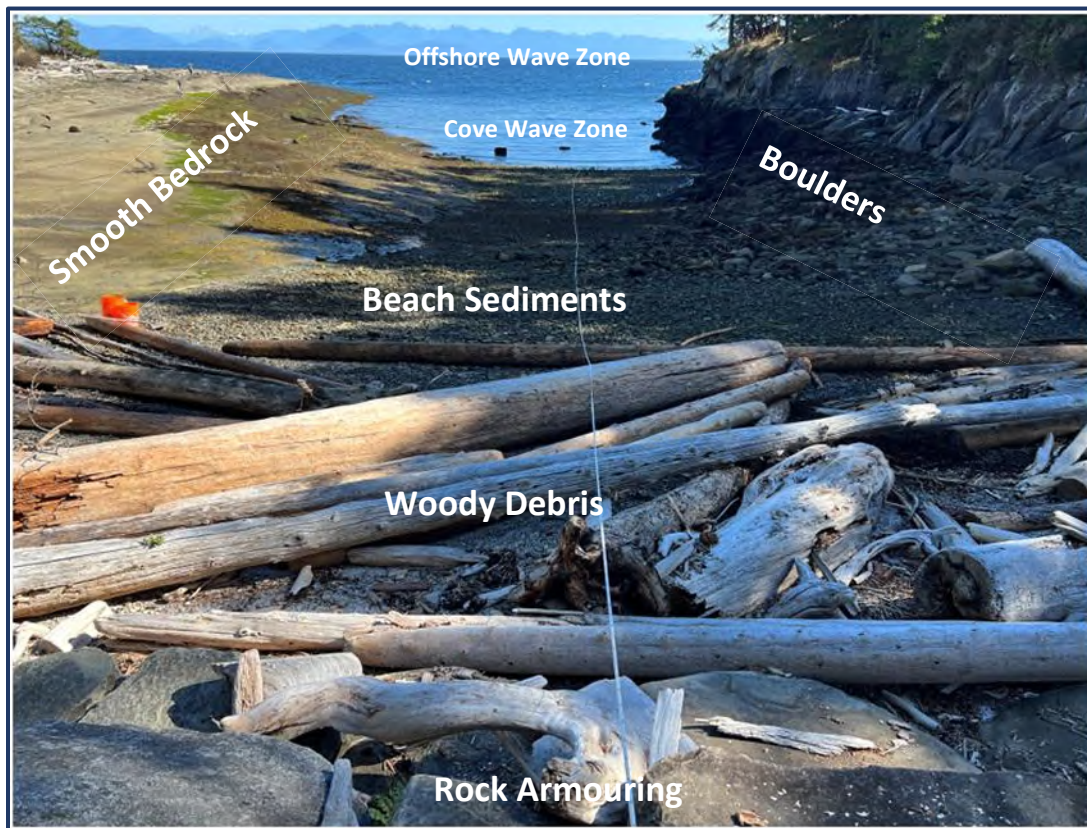
**Photo 2**      Photograph looking offshore at the beach comprised of a mixed size of materials.

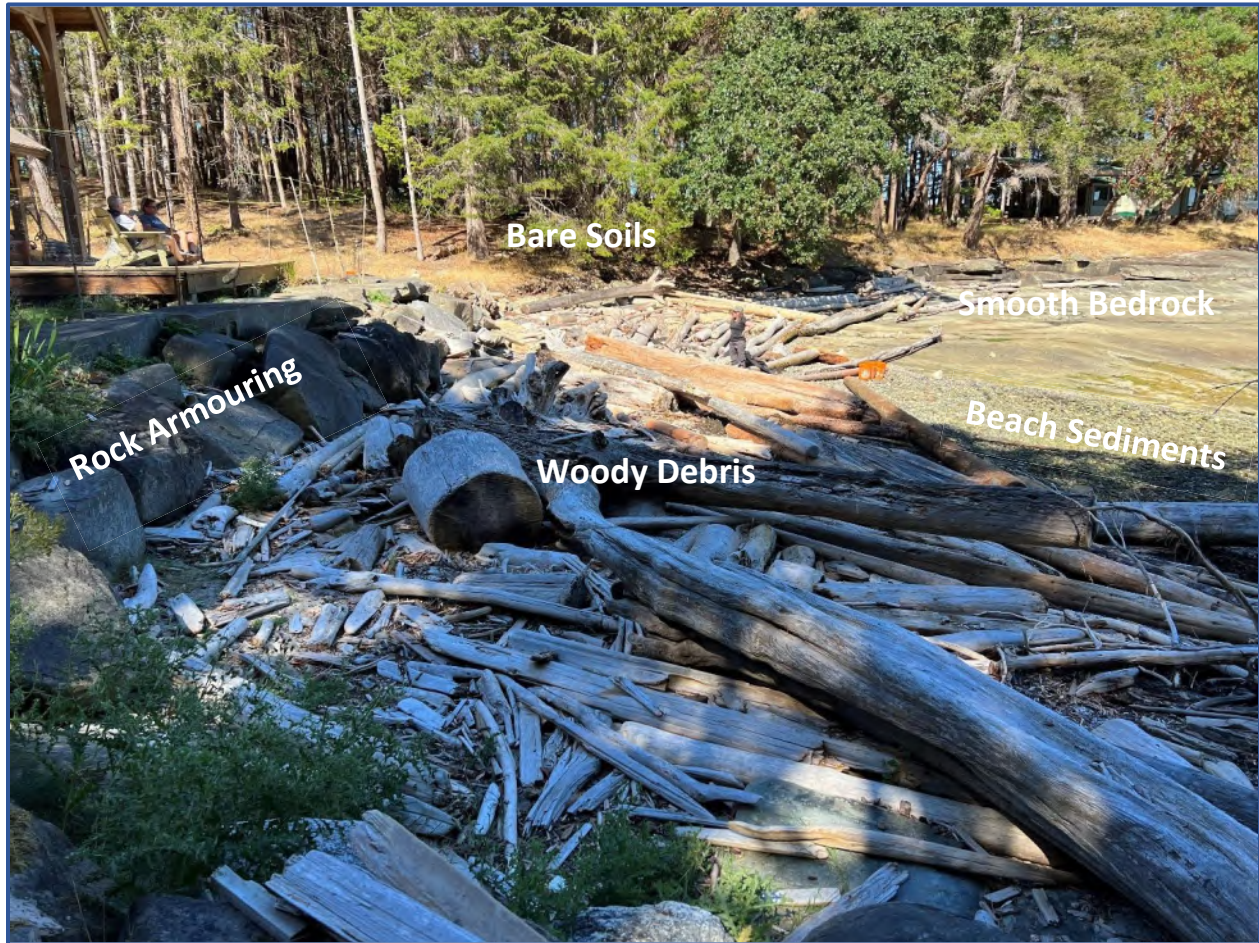
**Photo 3** Photograph looking northwest across the upper beach in the vicinity of the rock armouring.

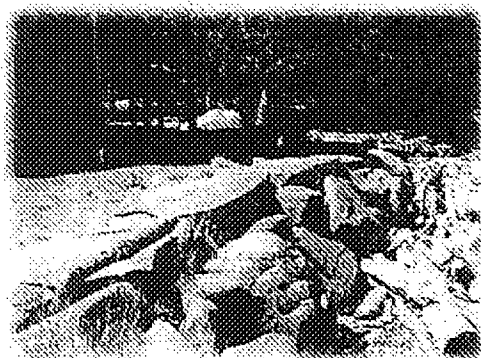
Photo 4. Riprap rock wall built on backshore between the deck and beach.

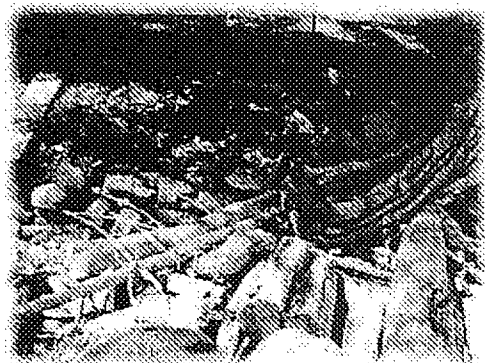
Photo 13. Minor erosion is evident on the backshore adjacent to the riprap wall.
