## Gabriola Island Local Trust Committee

### Regular Meeting Agenda

Date: May 23, 2024  
Time: 10:30 am  
Location: Gabriola Arts & Heritage Centre  
476 South Road, Gabriola Island, BC

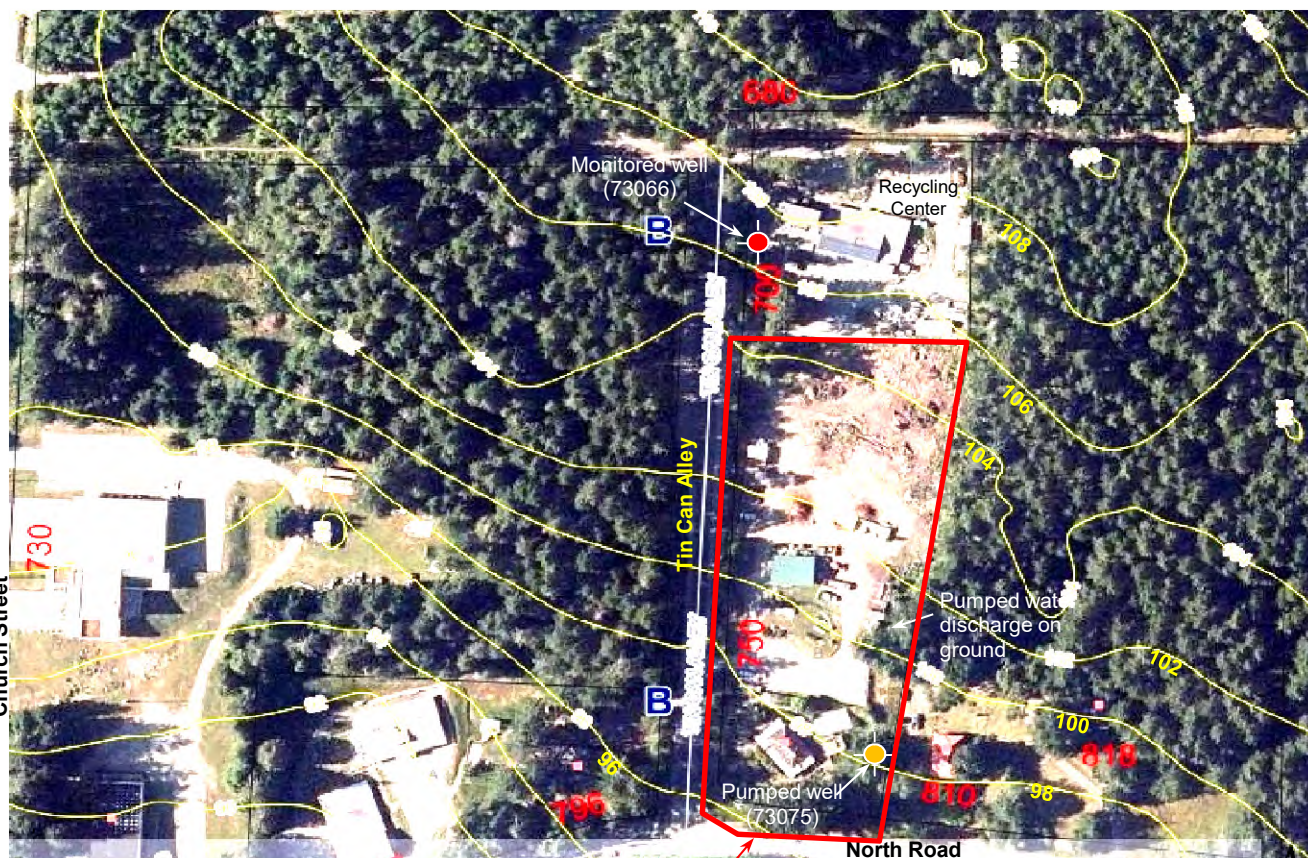
Church Street

The Property

North Road

- 1) See location of Section on Fig. 2. and details of wells on Tables I and II.
- 2) A principal water bearing fracture zone was identified during the pump testing of Well 73075. See details on Fig. 8.

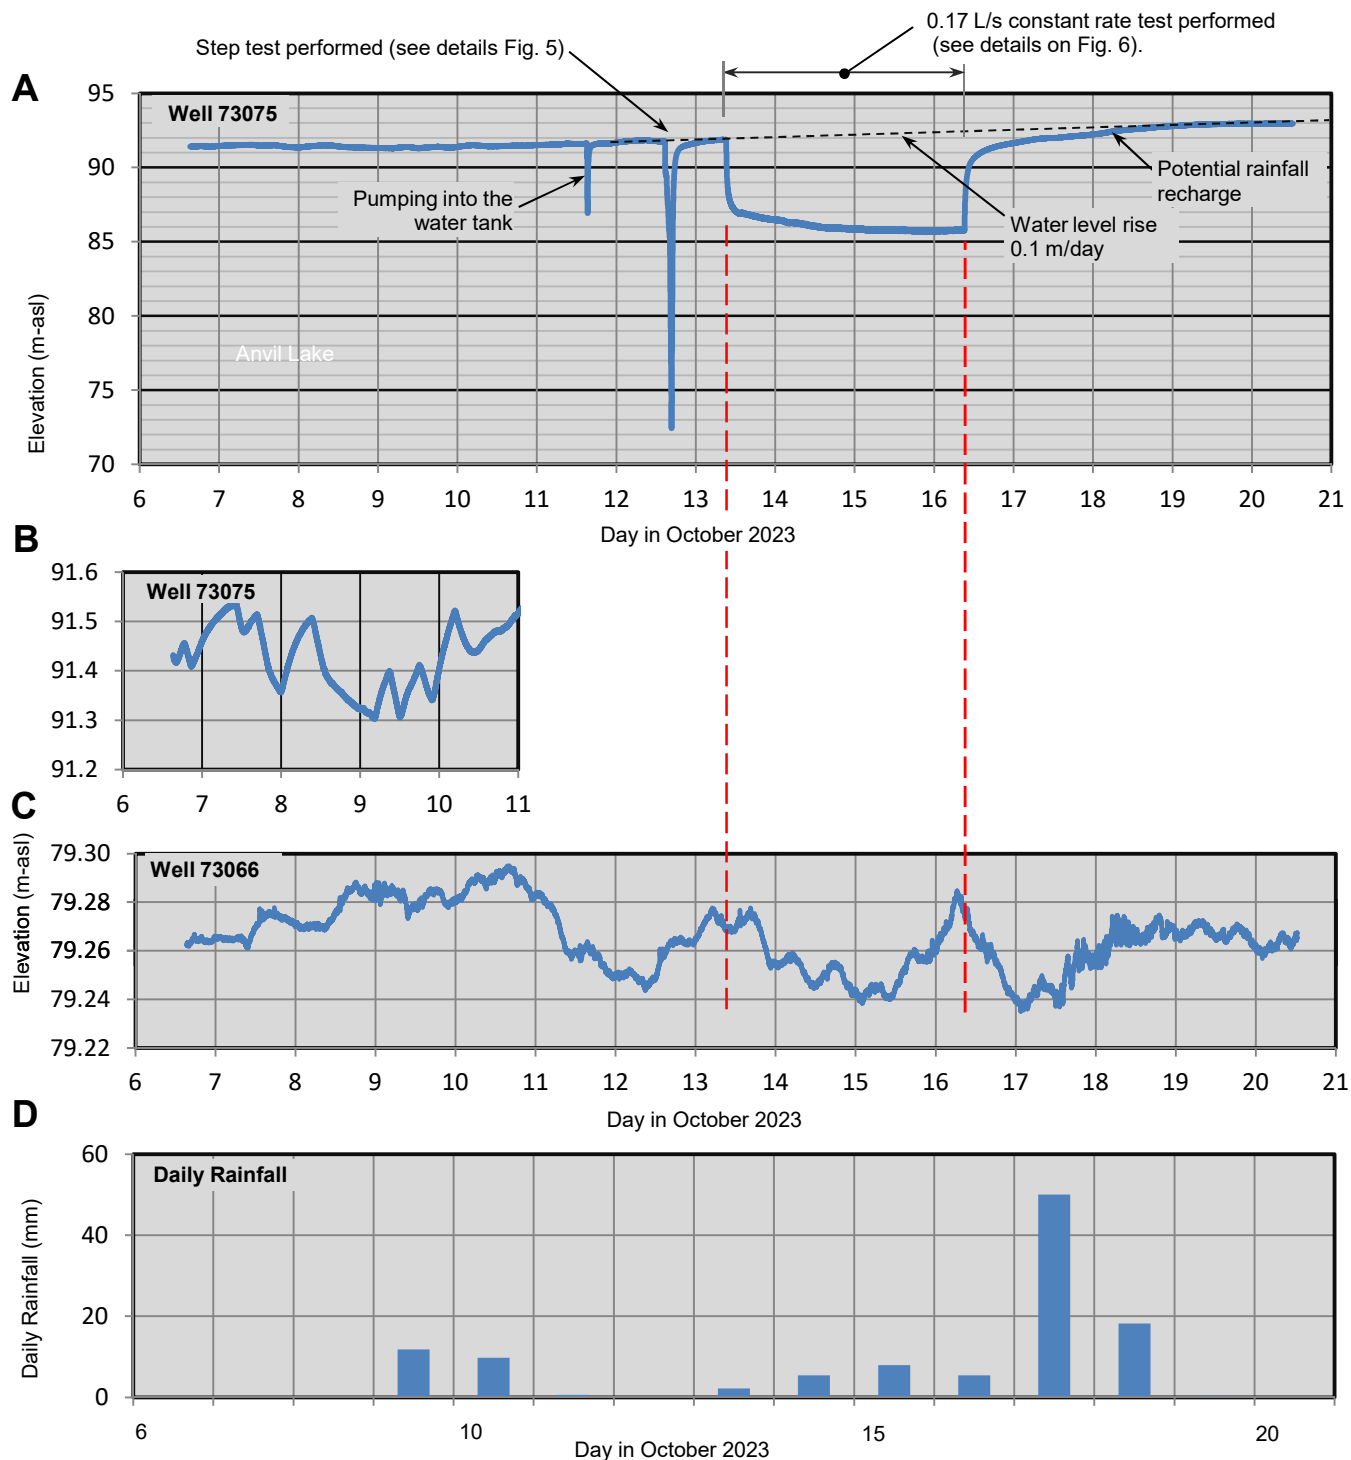
Fig. **7**

- 1) See location of wells on Figs. 1 and 2
- 2) Water level trends based on 1-minute interval data logger record.
- 3) Daily rainfall based on Environment Canada's Nanaimo City Yard station.

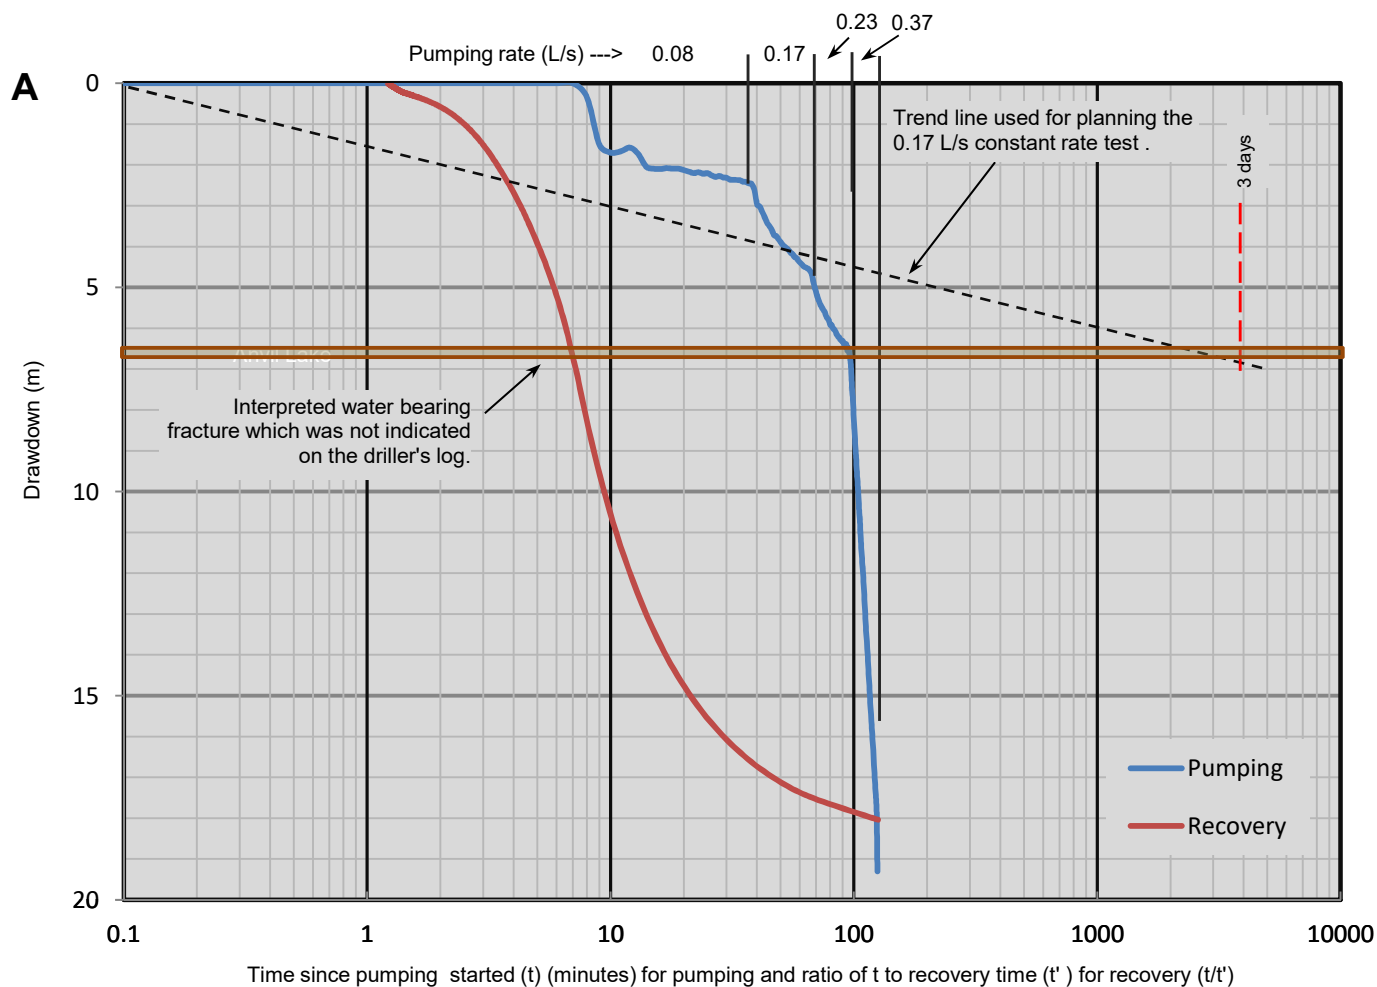
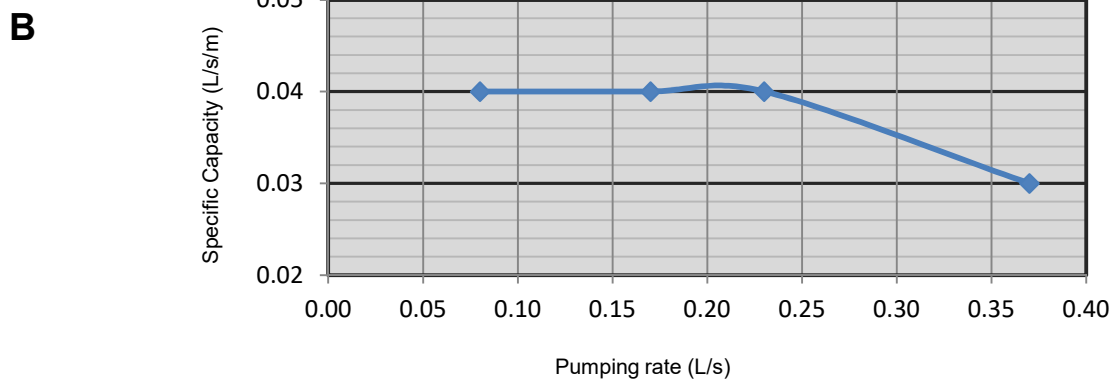
Fig. **8**

- 1) See location of well on Fig.2 and water level trends on Fig. 7.
- 2) Test was conducted on October 12, 2023
- 3) Data is based on 1minute data logger readings which was compared with manual depth to water measurements.

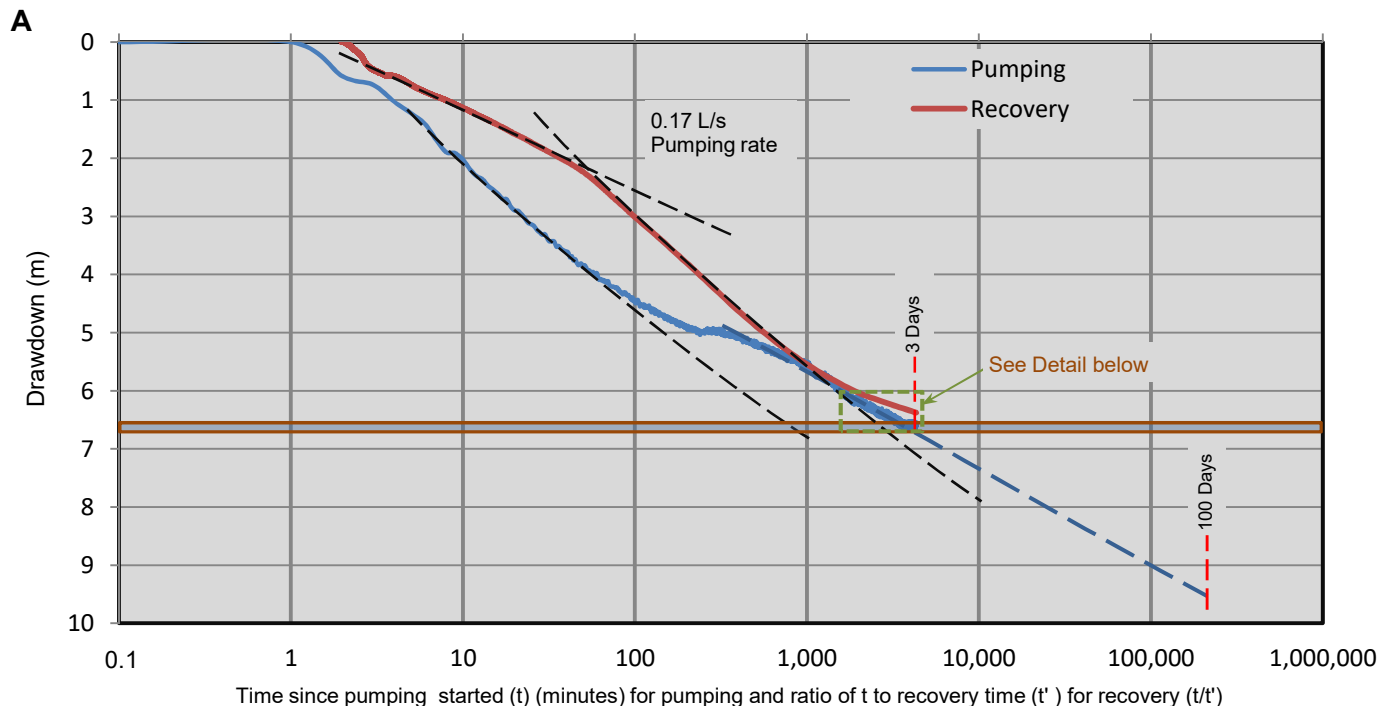
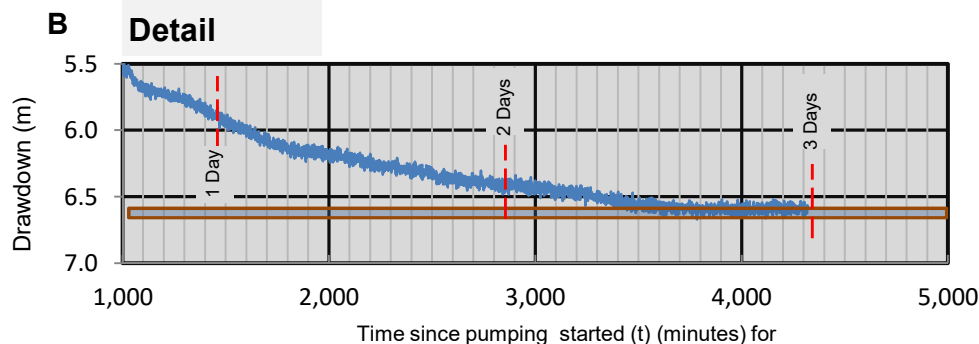
Available drawdown (m) =

Available drawdown (m) = 6.6

Upper fracture

- 1) Sustainable pumping rate based on constant rate pumping test analysis.
- 2) Transmissivity from second leg of constant rate test (see Fig. 9)
- 3) Gradient based on estimated piezometric trend indicated on Fig. 2
- 4) See capture zone dimension illustration below
- 5) Annual precipitation based on 30 year average for Nanaimo Airport
- 6) Infiltration factor typical for Saturna well drained soils.
- 7) See capture zone outlined on Fig. 2

- 1) Watering is based on 3 hours of watering with two garden hoses per day.
- 2) An analysis of the yield from the existing well is presented on Fig. 9.
- 3) The location of a potential future well (if required) is indicated on Fig. 2.

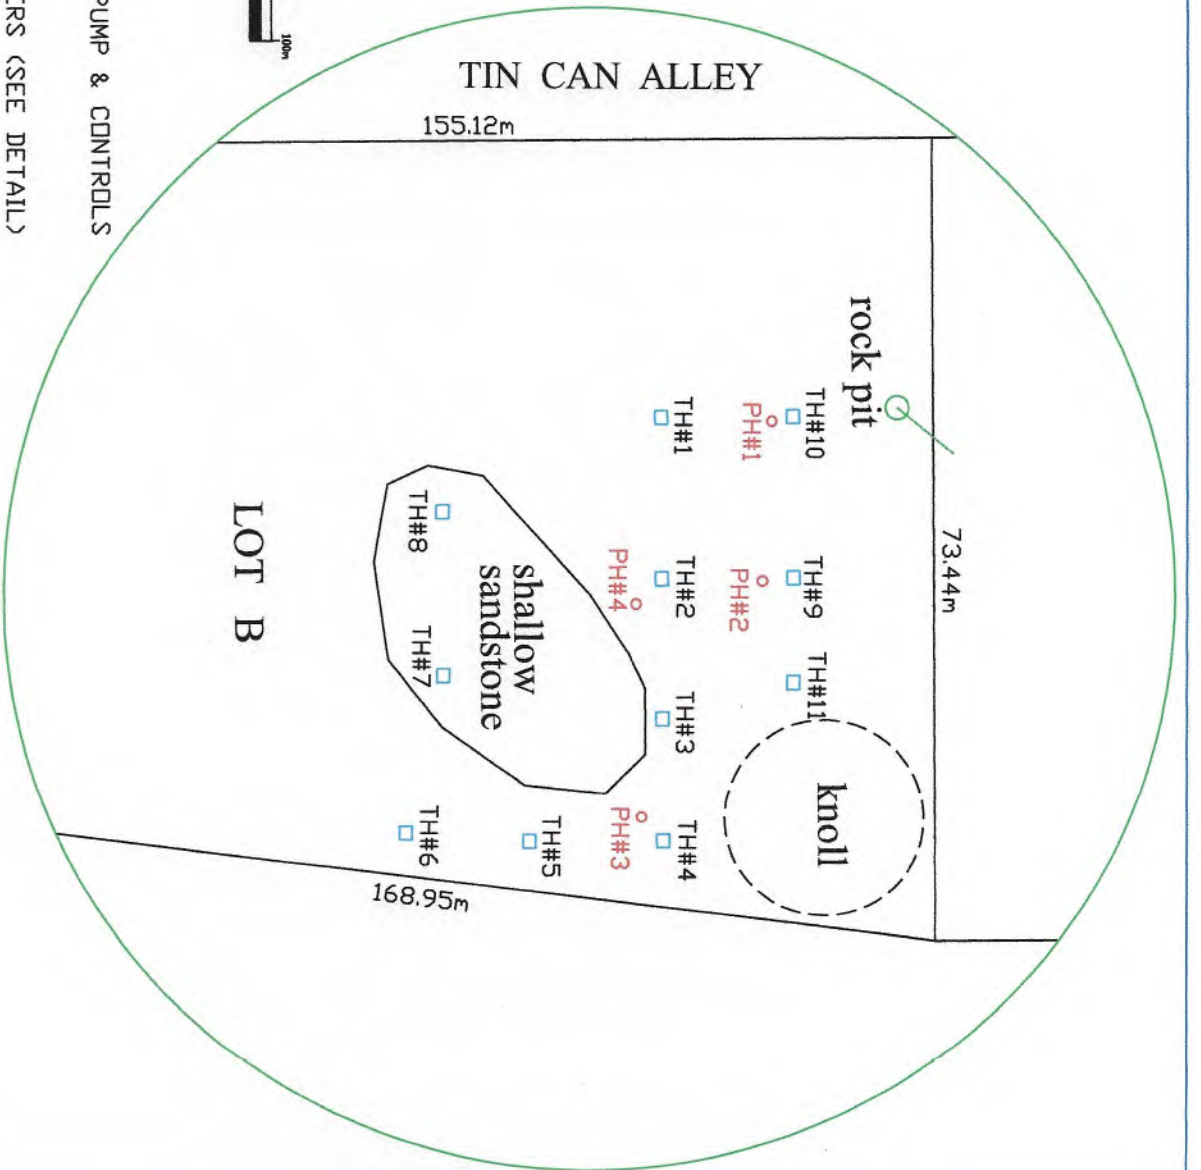
## SITE PLAN

- LEGEND:**
- ① EXISTING 600 I.G., SEPTIC TANK-ADD RISERS
  - ② PROPOSED CANWEST 300 I.G. PUMP TANK W/ PUMP & CONTROLS
  - ③ 50mmØ PVC SCH 40 TRANSPORT LINE
  - ④ INSTALL 18.29m & 9.75m PRESSURIZED CHAMBERS (SEE DETAIL)
  - ⑤ PROPOSED FLUSH-DUTS AT DISTAL ENDS
  - ⑥ 100mmØ PVC SCH 40 TRANSPORT SEWER
- DENOTES 4' TEST HOLE LOCATION  
○ DENOTES PERK TEST LOCATION

NOTE: ALL PIPE TO BE SCH. 40 PVC UNLESS OTHERWISE SHOWN

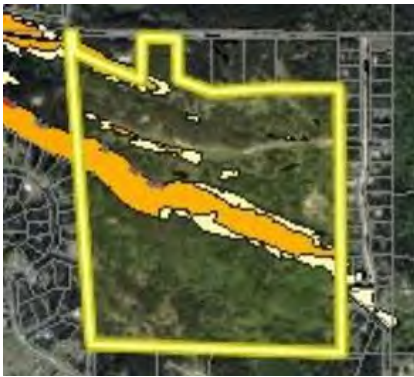
**Figure 1 –Subject Parcel and approximate location of DP 6.**

The subject property is 45 hectares (110 acres) in size as shown in Figure 1. The DP-6 (Steep Slopes) areas on the property includes two locations where the steep slopes exceed 80% grade. The applicant is proposing tree removal

within some of the areas of DP-6 to prepare the parcel for subdivision. The subject property contains several recorded archaeological sites, protected under the *Heritage Conservation Act*. The applicant is not proposing any tree removal or works within the recorded archaeological sites. Further information about the subject property is contained within the 'Site Context' and 'Mapping' documents (Attachments 4,5). A Forest Stand Assessment (Attachment 8) identifies over 1900 trees to be removed on the subject property, not all within the steep slopes DPA. A Geotechnical Hazard Assessment was prepared by Stantec in 2021 and is attached in full to this report as 'Attachment 10'. An updated memo from the geotechnical engineer was prepared by Lewkowich Engineering on July 10, 2023 (Attachment 10) and identifies low to very low risk to slope stability with the removal of ~1900 trees across the site and primarily in areas B and D (Figure 2).

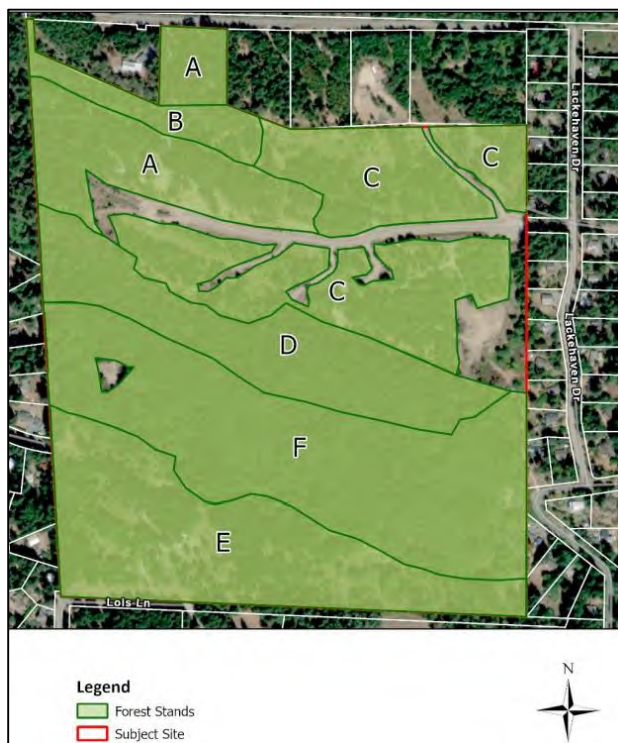
**Figure 2 –Proposed Tree Removal Areas B and D**

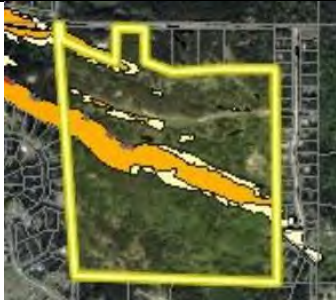
| Hazard Areas | <p><a href="#">Schedule C of the Gabriola Island Official Community Plan</a> indicates hazardous conditions on the property:</p> <p style="text-align: center;"> DP-6 ESCARPMENT, Slope &gt; 80% </p> <p>Islands Trust mapping indicates areas of moderate risk steep slopes on the subject property (orange).</p> |

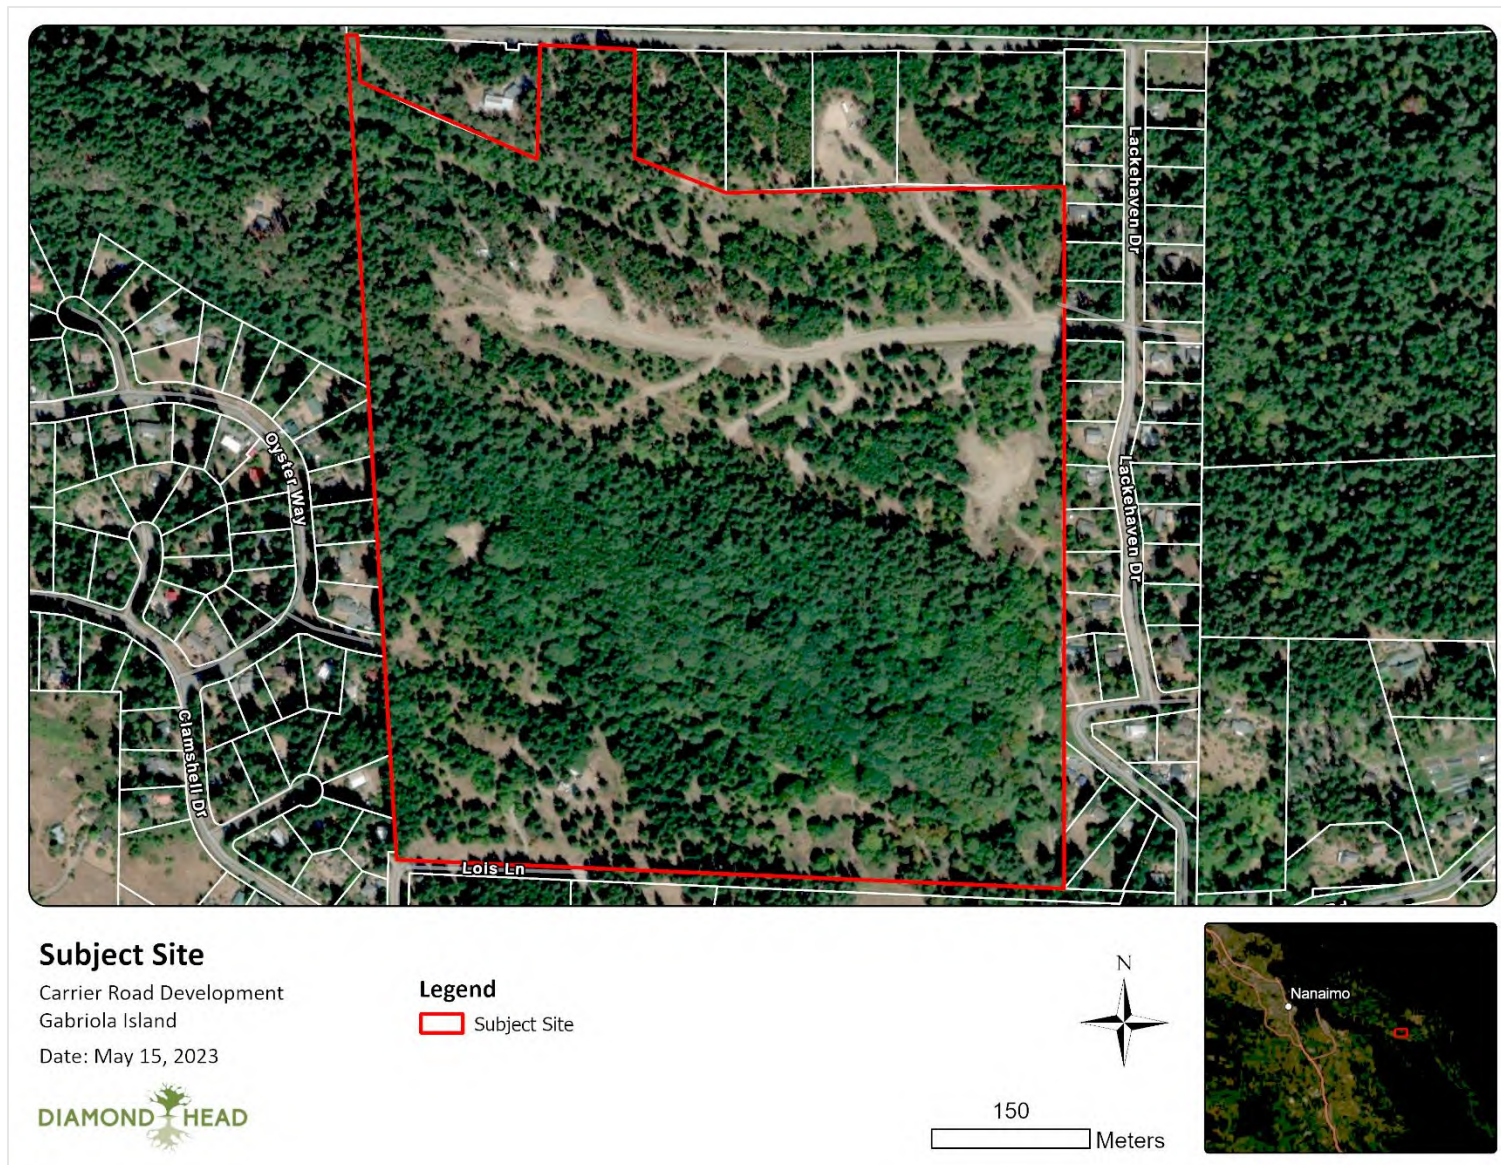
Figure 1. Development site on Carrier Road and adjacent land uses.

The development site is one parcel of land, totaling approximately 45 hectares, located near the southern coast of Gabriola Island. The site is bounded on the east by Lackehaven Drive, the west by Oyster Way and on the south by Lois Lane.

The subject site was historically harvested, at varying intensities and timeframes, evidenced by the presence of old forest roads, old skid trails, and old growth and second growth stumps. Trees on the site are recovering from that harvesting, in various states of regeneration. The site slopes to the south, bisected in the lower section by a 20m high rock bluff with steep to moderately steep colluvial slopes. Most of these colluvial slopes have slope gradients of <80%. Numerous small bedrock outcrops occur throughout the colluvial slopes. There is an additional distinct slope area in the NW portion of the site. An access road network runs through the northern and southern part of the property that partitions the continuous forest cover. The dominant canopy trees on site are estimated to be approximately 70 years old, with the exception of some older trees. The maximum height of the trees on site is 30 metres. Figure 1 shows the site and surrounding area.

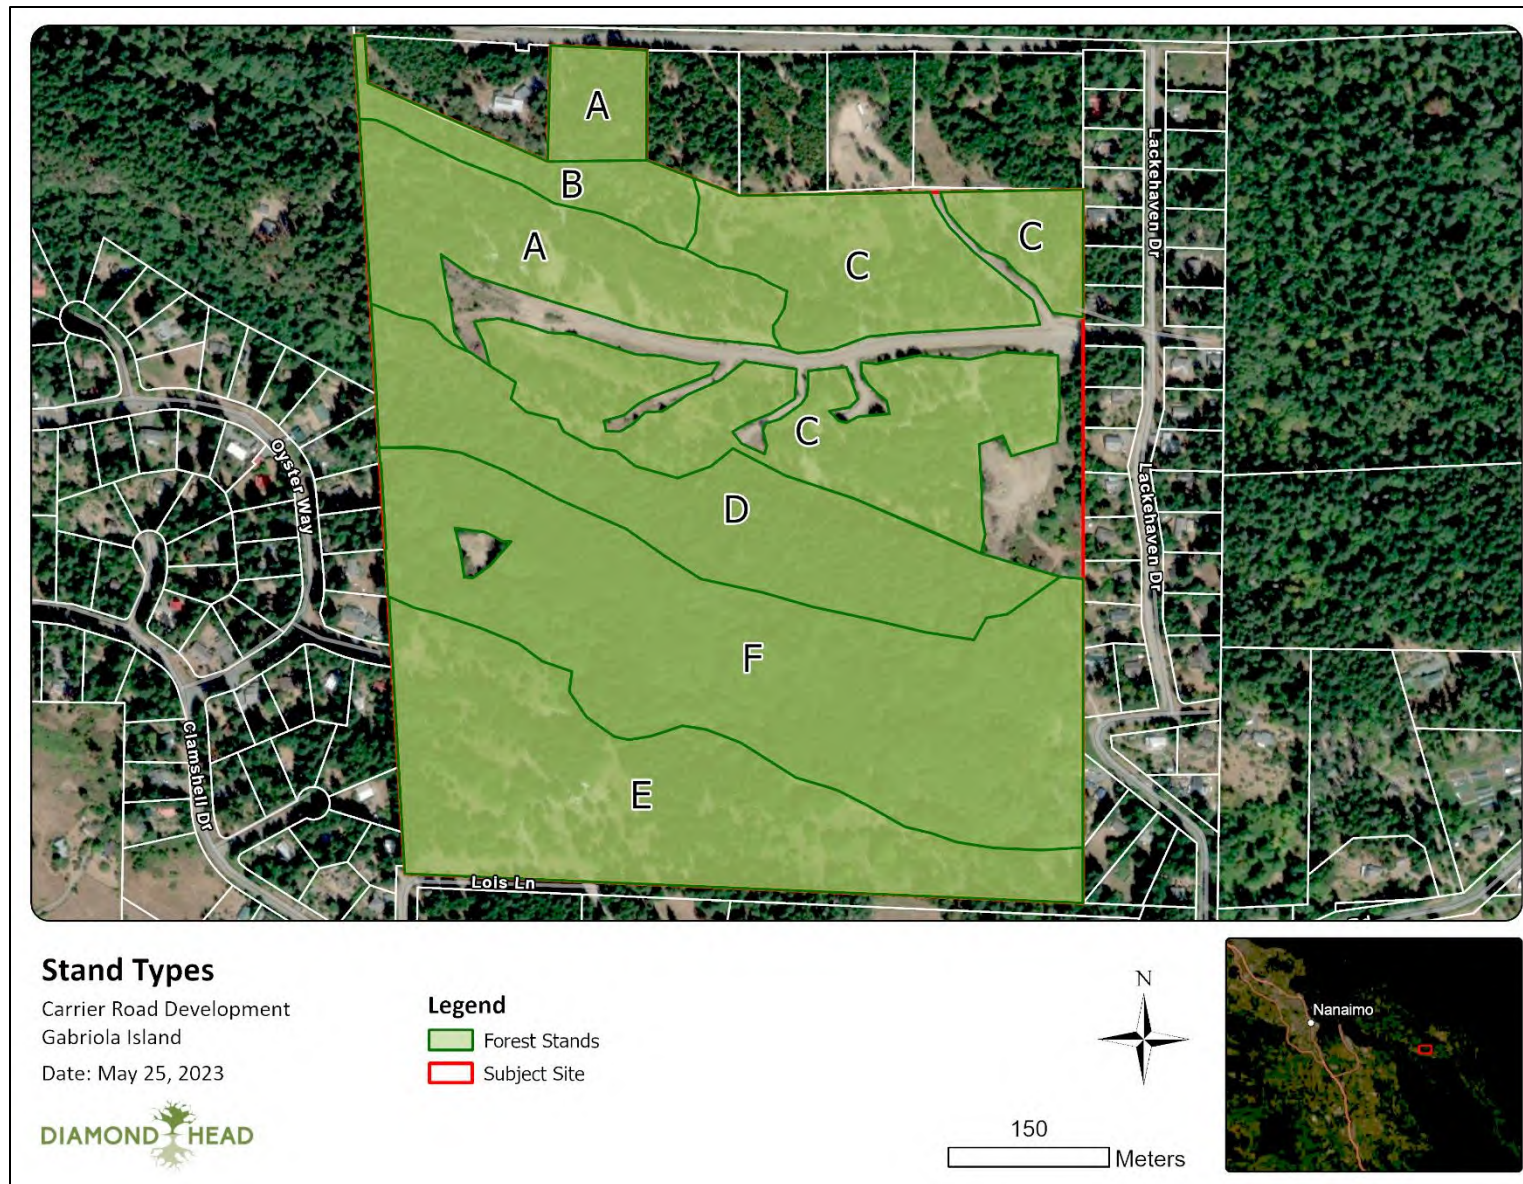
Figure 2. Stand types within forested areas.

Stands in the forest were stratified into distinct stand types. These stand types are forests with similar characteristics. Six stand types were identified on the site and are discussed in the following sections individually. Stand types are mapped in Figure 2.

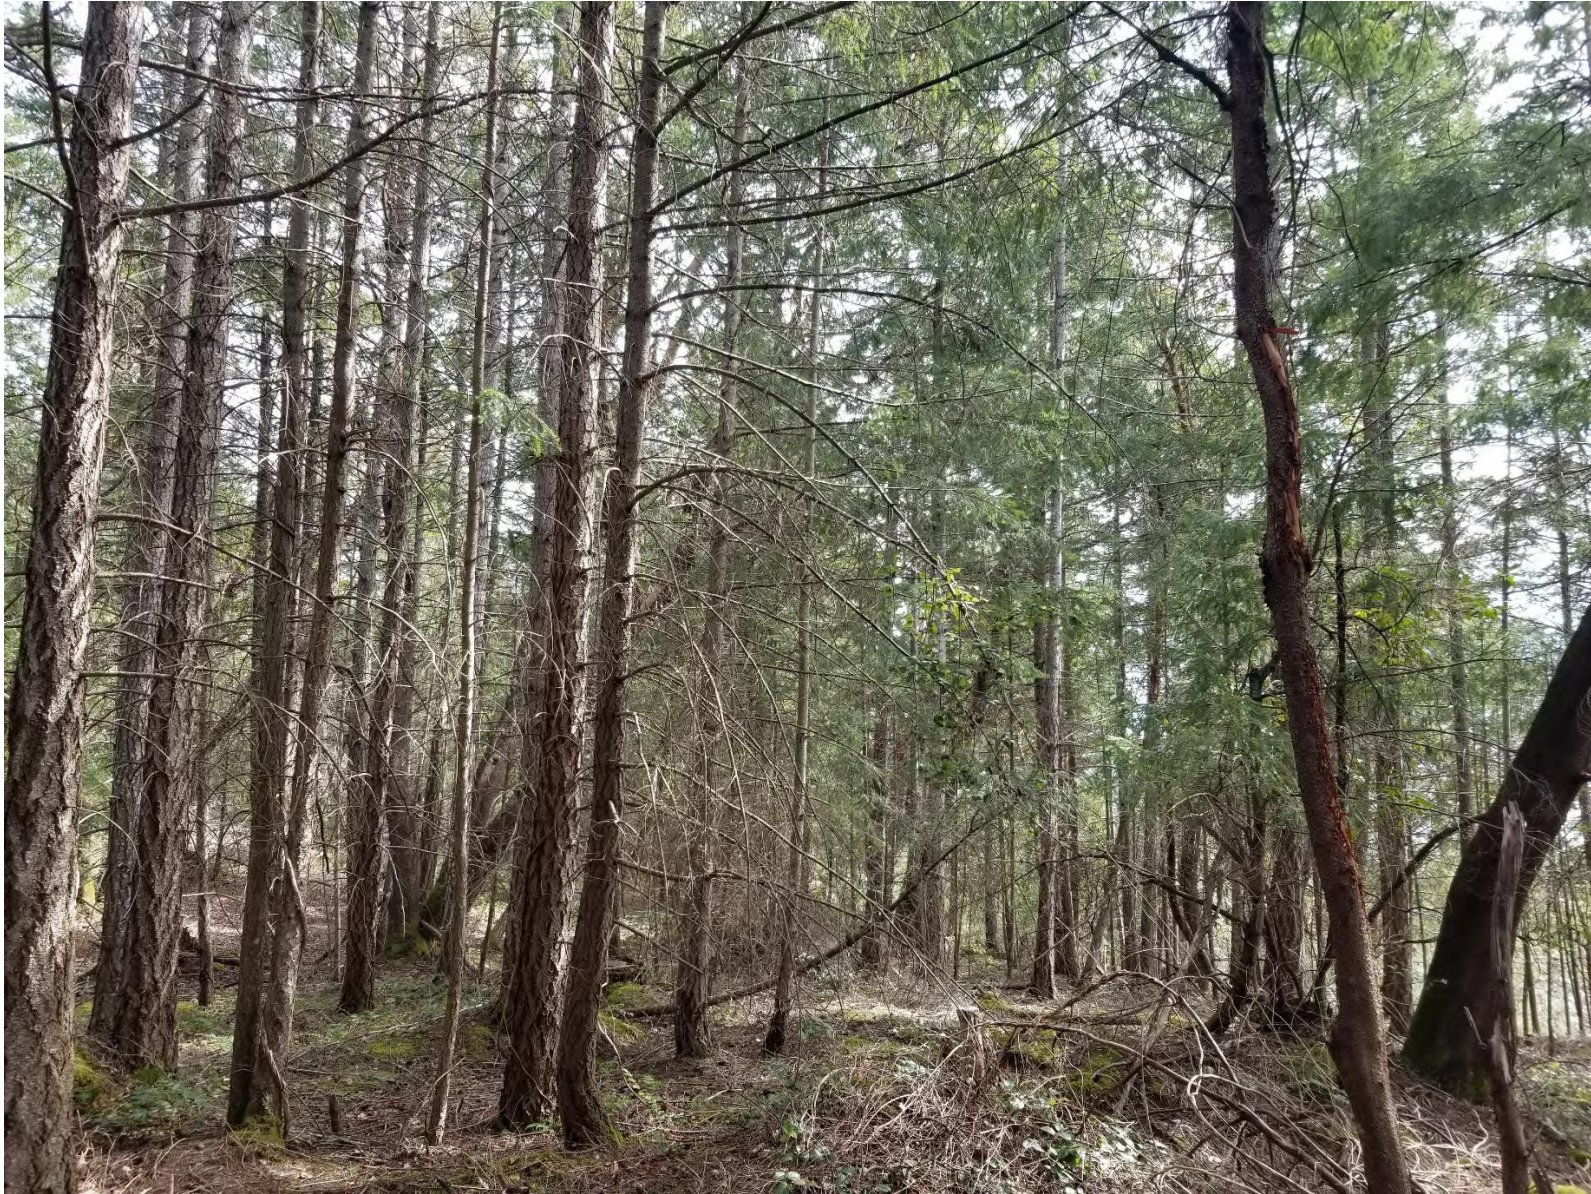
Photo 1. Typical stand conditions and structure for Stand Type A.

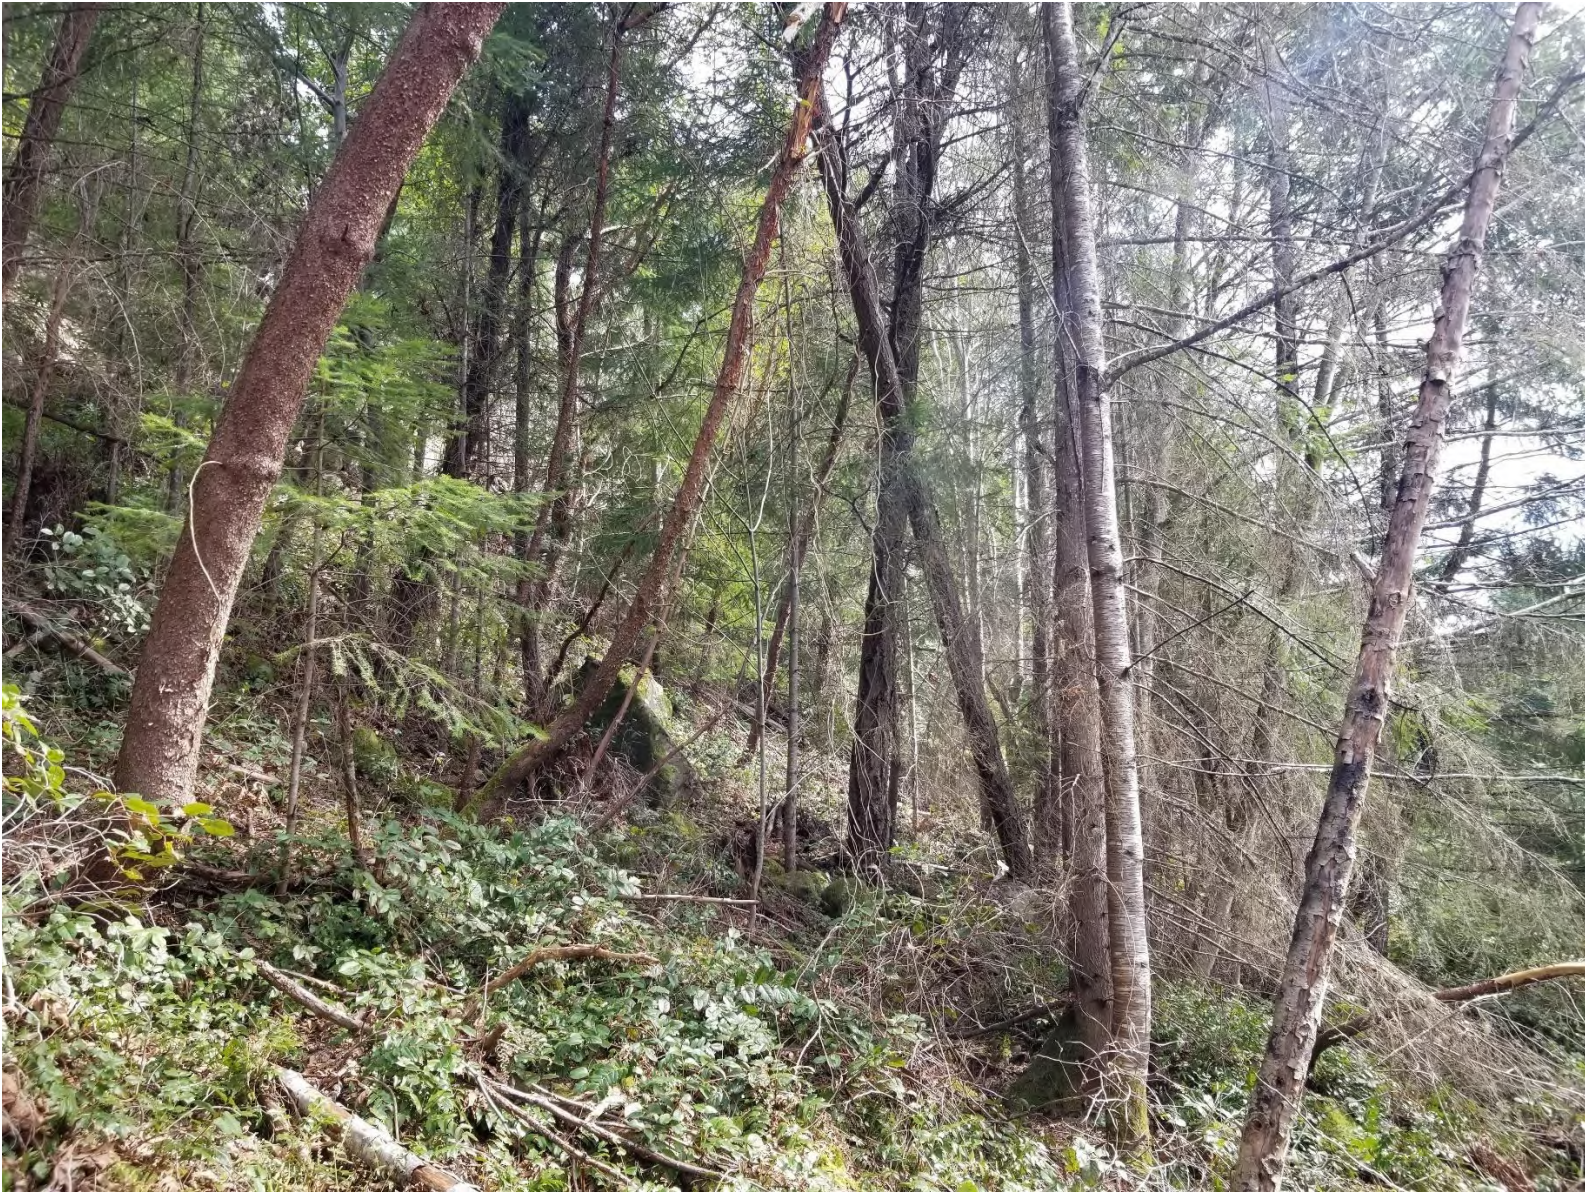
Photo 3. Typical stand conditions and structure for Stand Type C.

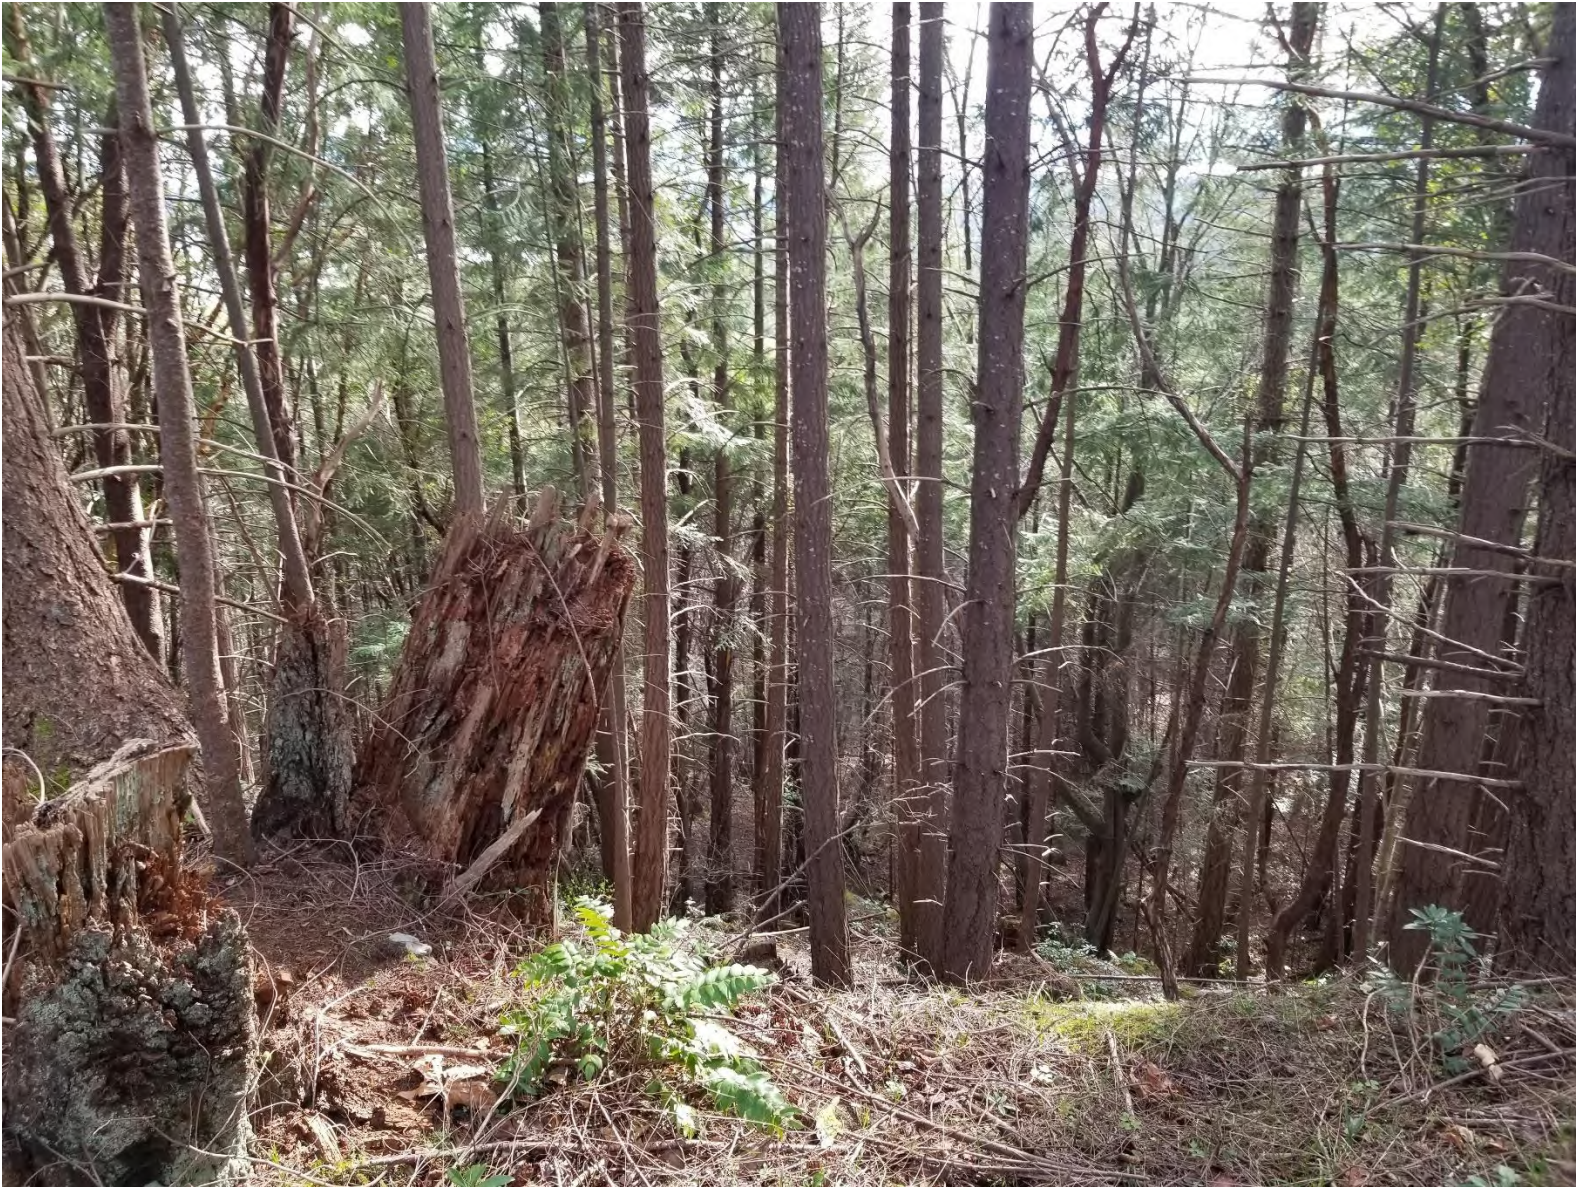
Photo 4. Typical stand conditions and structure for Stand Type D.

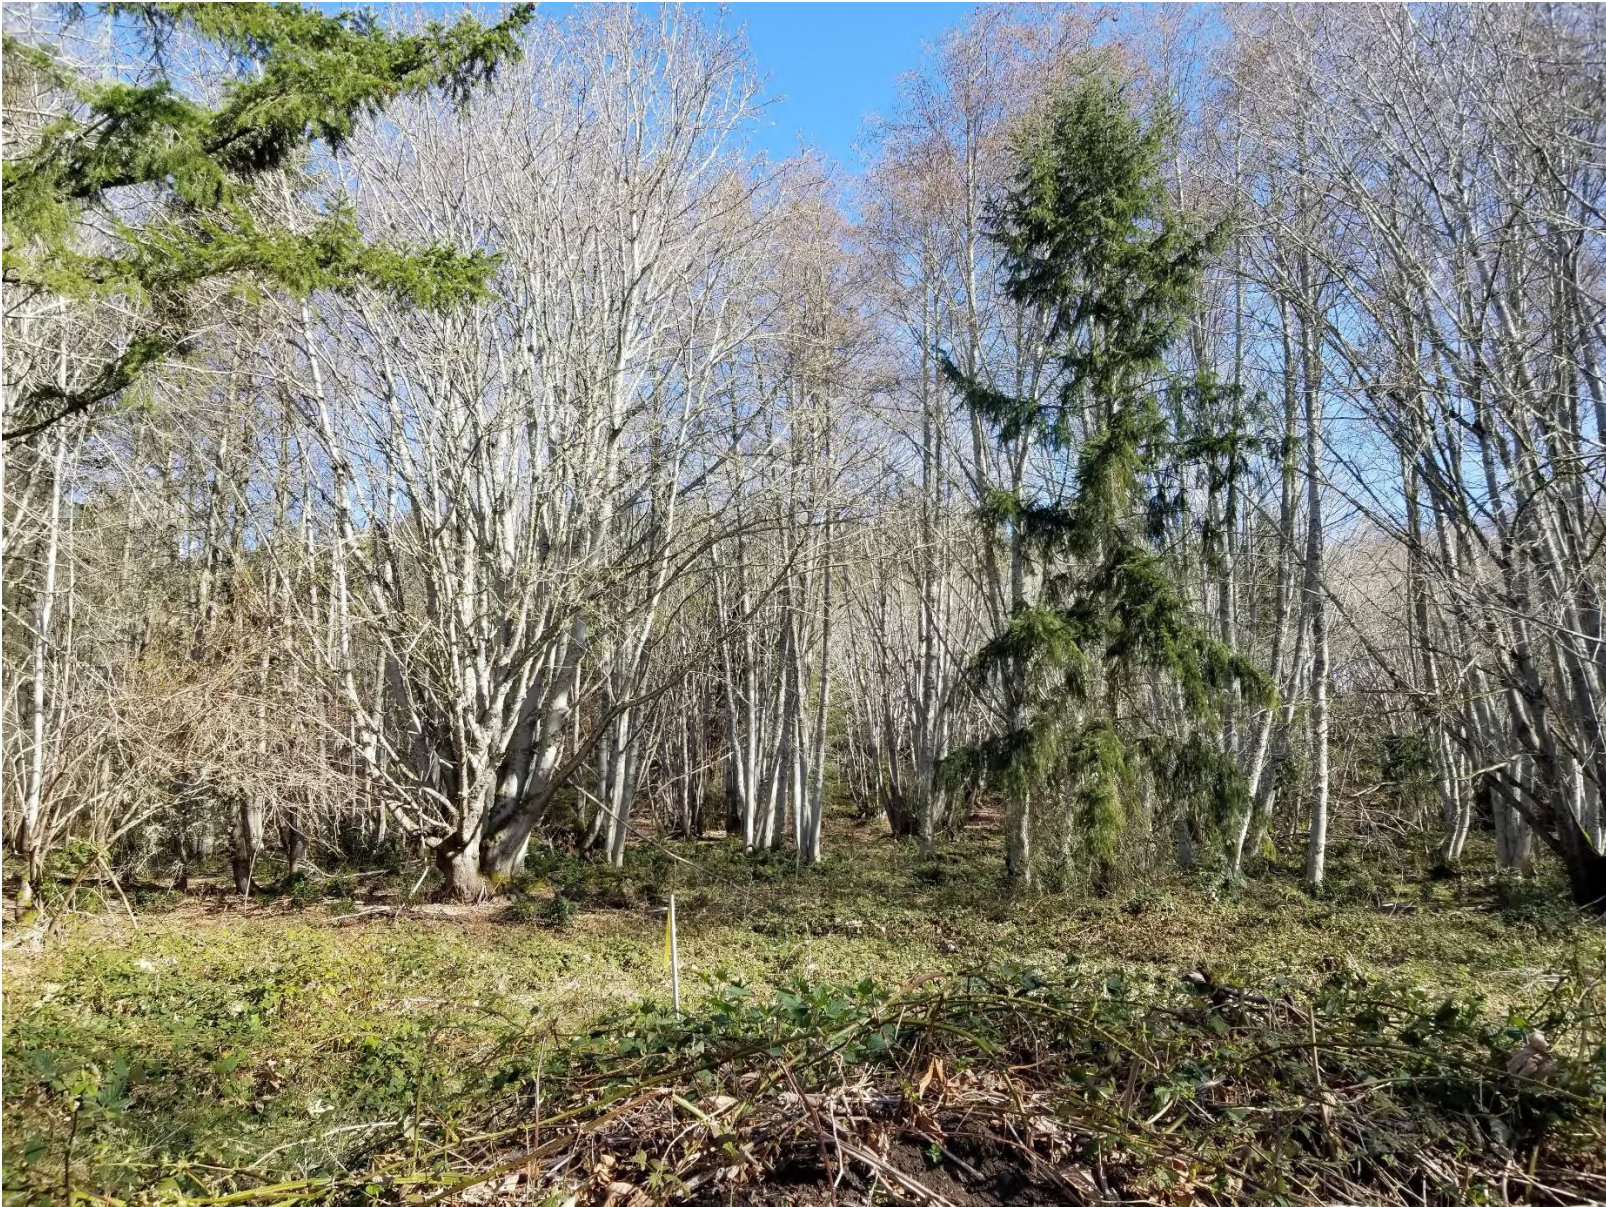
Photo 6. Typical stand conditions and structure for Stand Type F

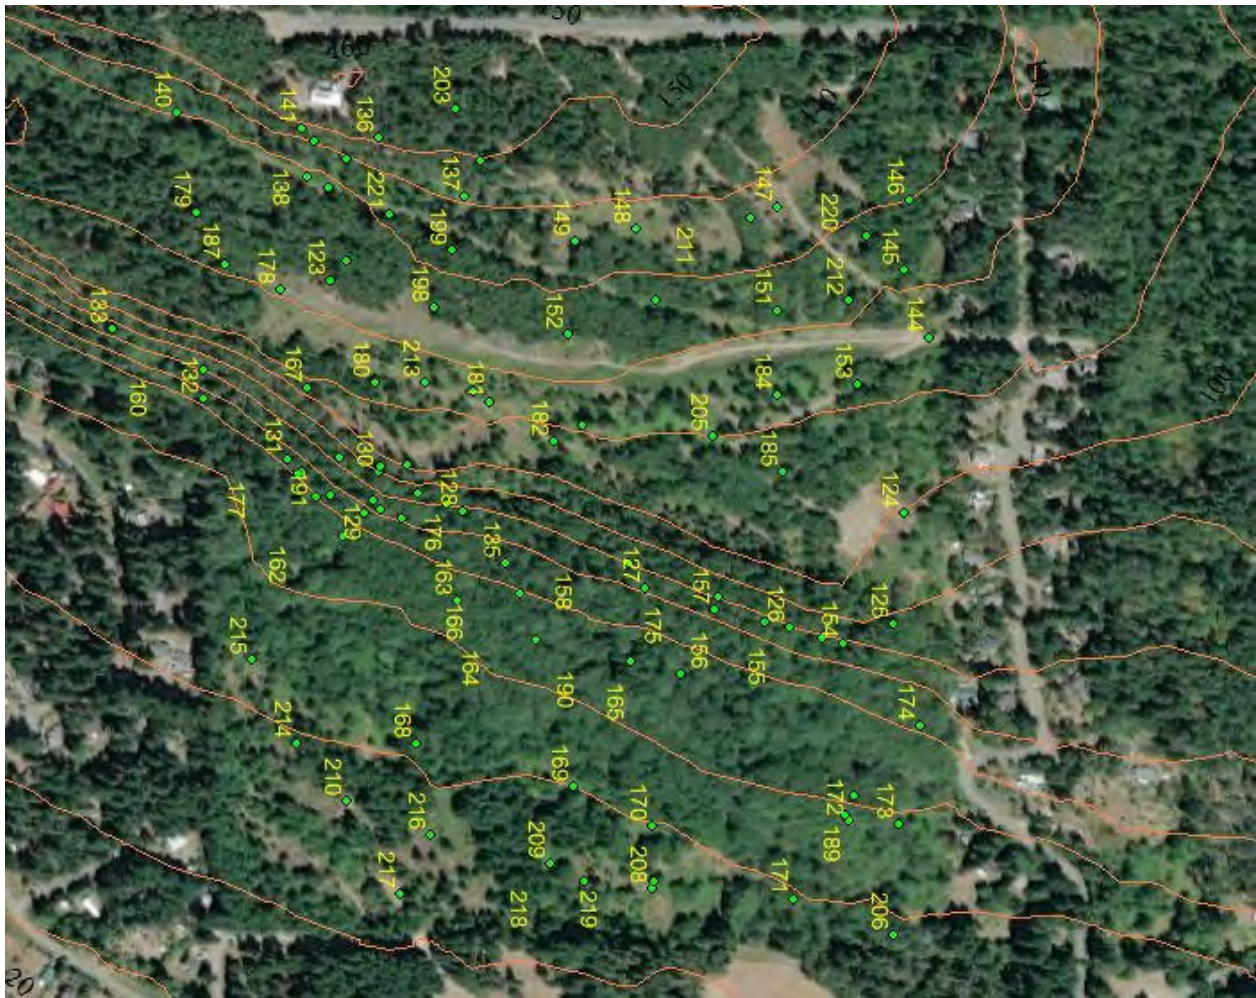
**Figure 1**      **Waypoint Locations (2020–2021 Field Reviews)**

NOTE: Due to scale and plotting limitations most waypoints, but not all waypoint numbers show on Figure 1. In some cases, waypoint numbers hide or are displaced away from the associated waypoint. North is at the top of the figure. The figure is not to scale; contours are at 10 m intervals.
