## Gabriola Island Local Trust Committee

### Regular Meeting Agenda

Date: May 23, 2024  
Time: 10:30 am  
Location: Gabriola Arts & Heritage Centre  
476 South Road, Gabriola Island, BC

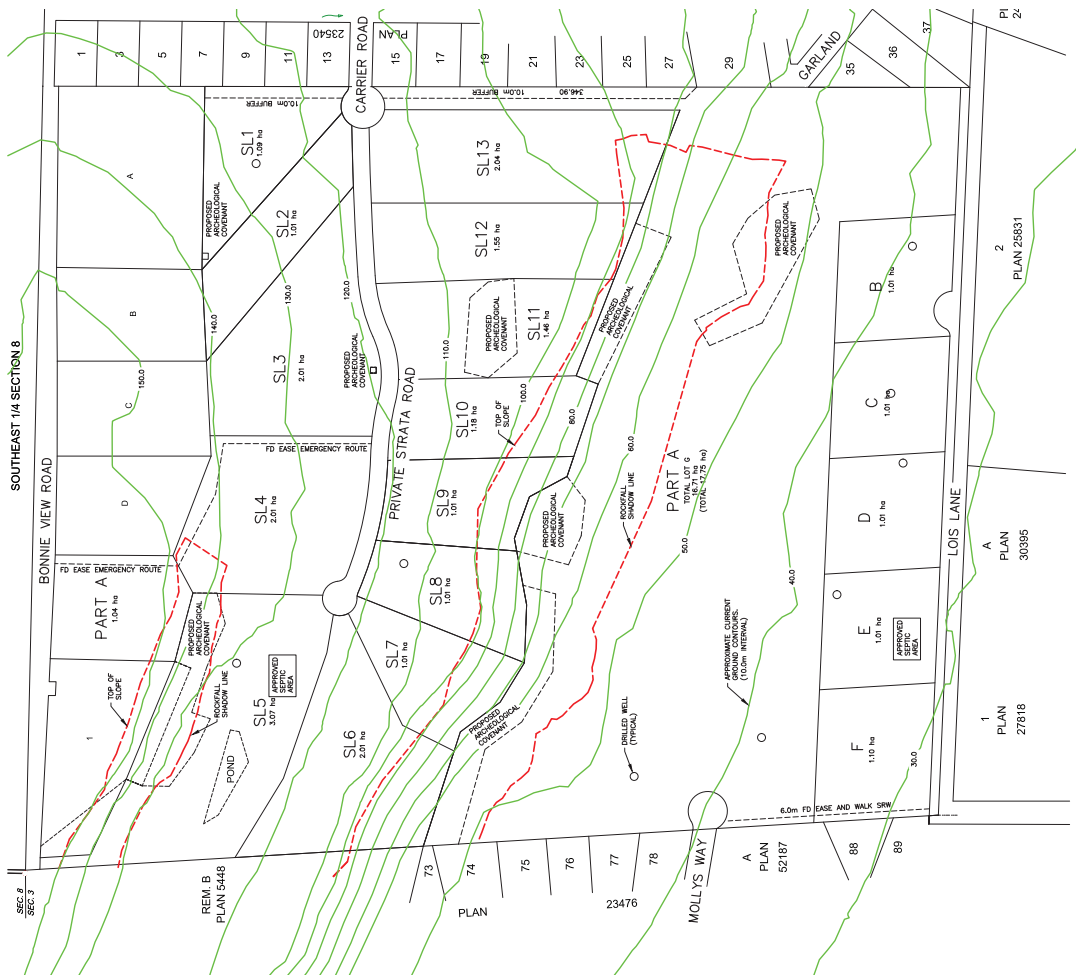
## **Subdivision Drawing**

| LEGAL DESCRIPTION | PART OF NORTH EAST 1/4 OF SECTION 3, EXCEPT PARCEL A (UD 73261) | | CLIENT | | CENTRE STAGE HOLDINGS LTD | |

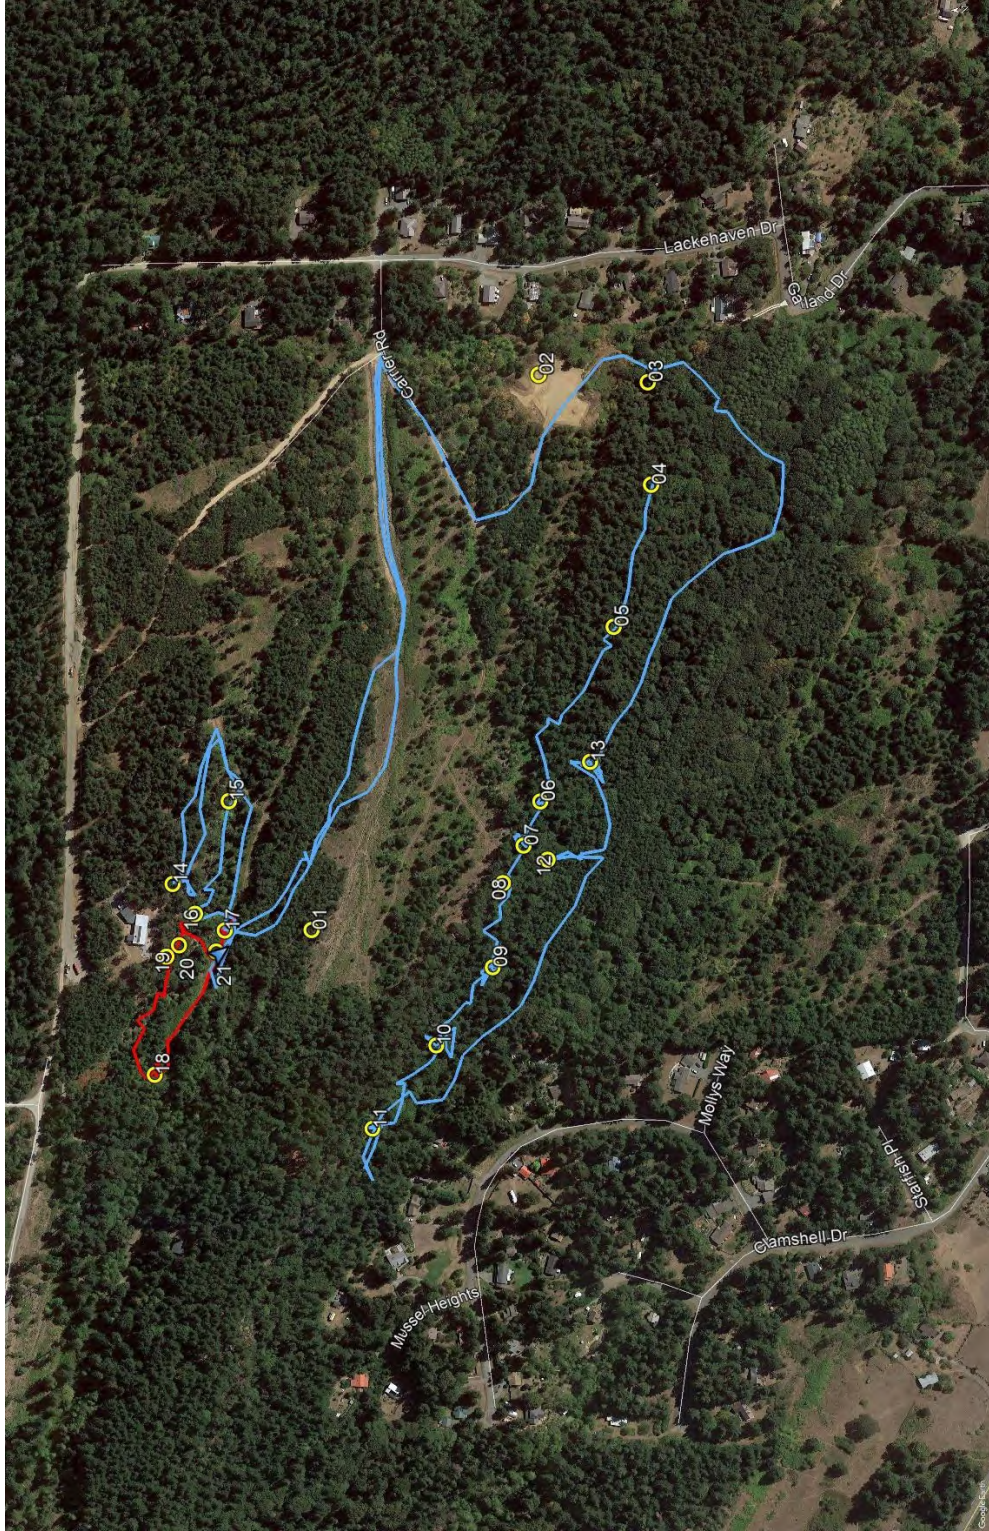
Figure 3 Field Traverse GPS Tracks and waypoints - May 27 and 30, 2020

Notes:  
 May 27 tracks – blue  
 May 30 track – red  
 North is towards the top of the figure.
