## Gabriola Island Local Trust Committee

### Regular Meeting Agenda

| 9.1 | GB-DP-2021.1 (Centre Stage Holdings) - Staff Report | | 31 - 154 |

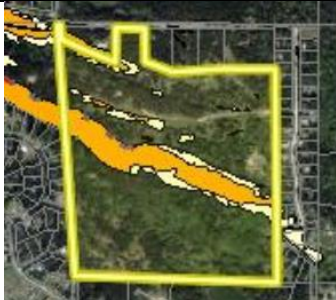
| Hazard Areas | <p><a href="#">Schedule C of the Gabriola Island Official Community Plan</a> indicates hazardous conditions on the property:</p> <p style="text-align: center;"> DP-6 ESCARPMENT, Slope &gt; 80% </p> <p>Islands Trust mapping indicates areas of moderate risk steep slopes on the subject property (orange).</p> |

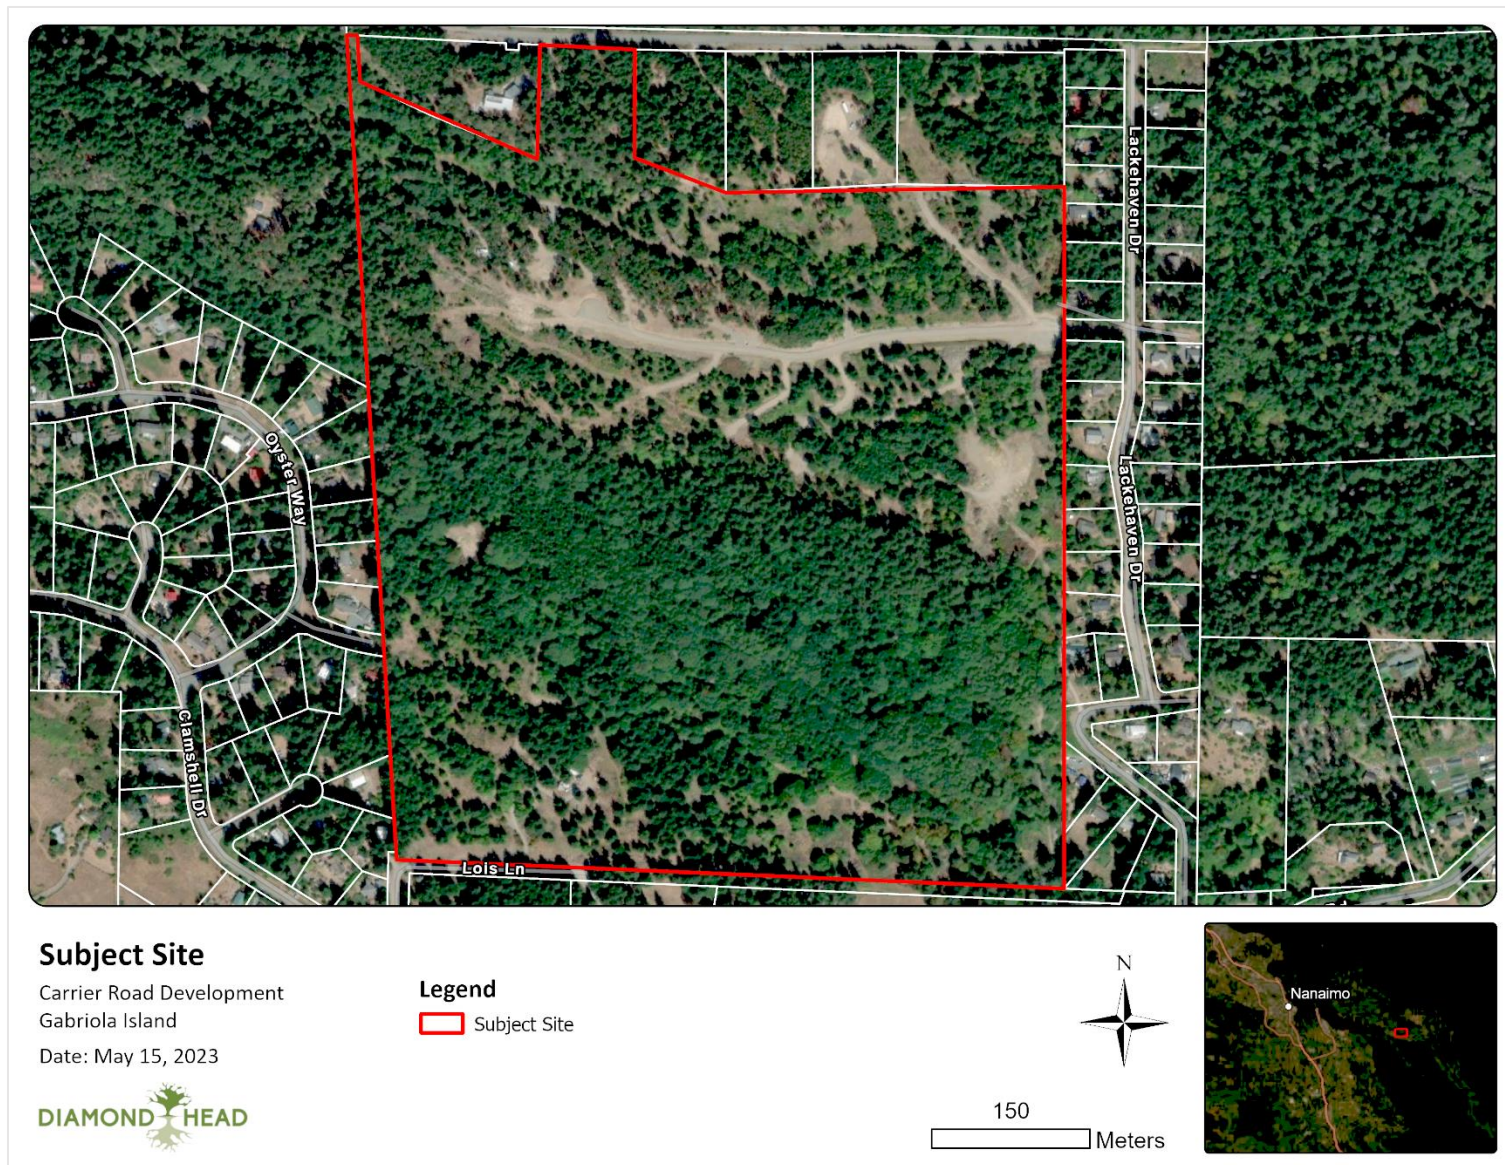
Figure 1. Development site on Carrier Road and adjacent land uses.

The development site is one parcel of land, totaling approximately 45 hectares, located near the southern coast of Gabriola Island. The site is bounded on the east by Lackehaven Drive, the west by Oyster Way and on the south by Lois Lane.

The subject site was historically harvested, at varying intensities and timeframes, evidenced by the presence of old forest roads, old skid trails, and old growth and second growth stumps. Trees on the site are recovering from that harvesting, in various states of regeneration. The site slopes to the south, bisected in the lower section by a 20m high rock bluff with steep to moderately steep colluvial slopes. Most of these colluvial slopes have slope gradients of <80%. Numerous small bedrock outcrops occur throughout the colluvial slopes. There is an additional distinct slope area in the NW portion of the site. An access road network runs through the northern and southern part of the property that partitions the continuous forest cover. The dominant canopy trees on site are estimated to be approximately 70 years old, with the exception of some older trees. The maximum height of the trees on site is 30 metres. Figure 1 shows the site and surrounding area.

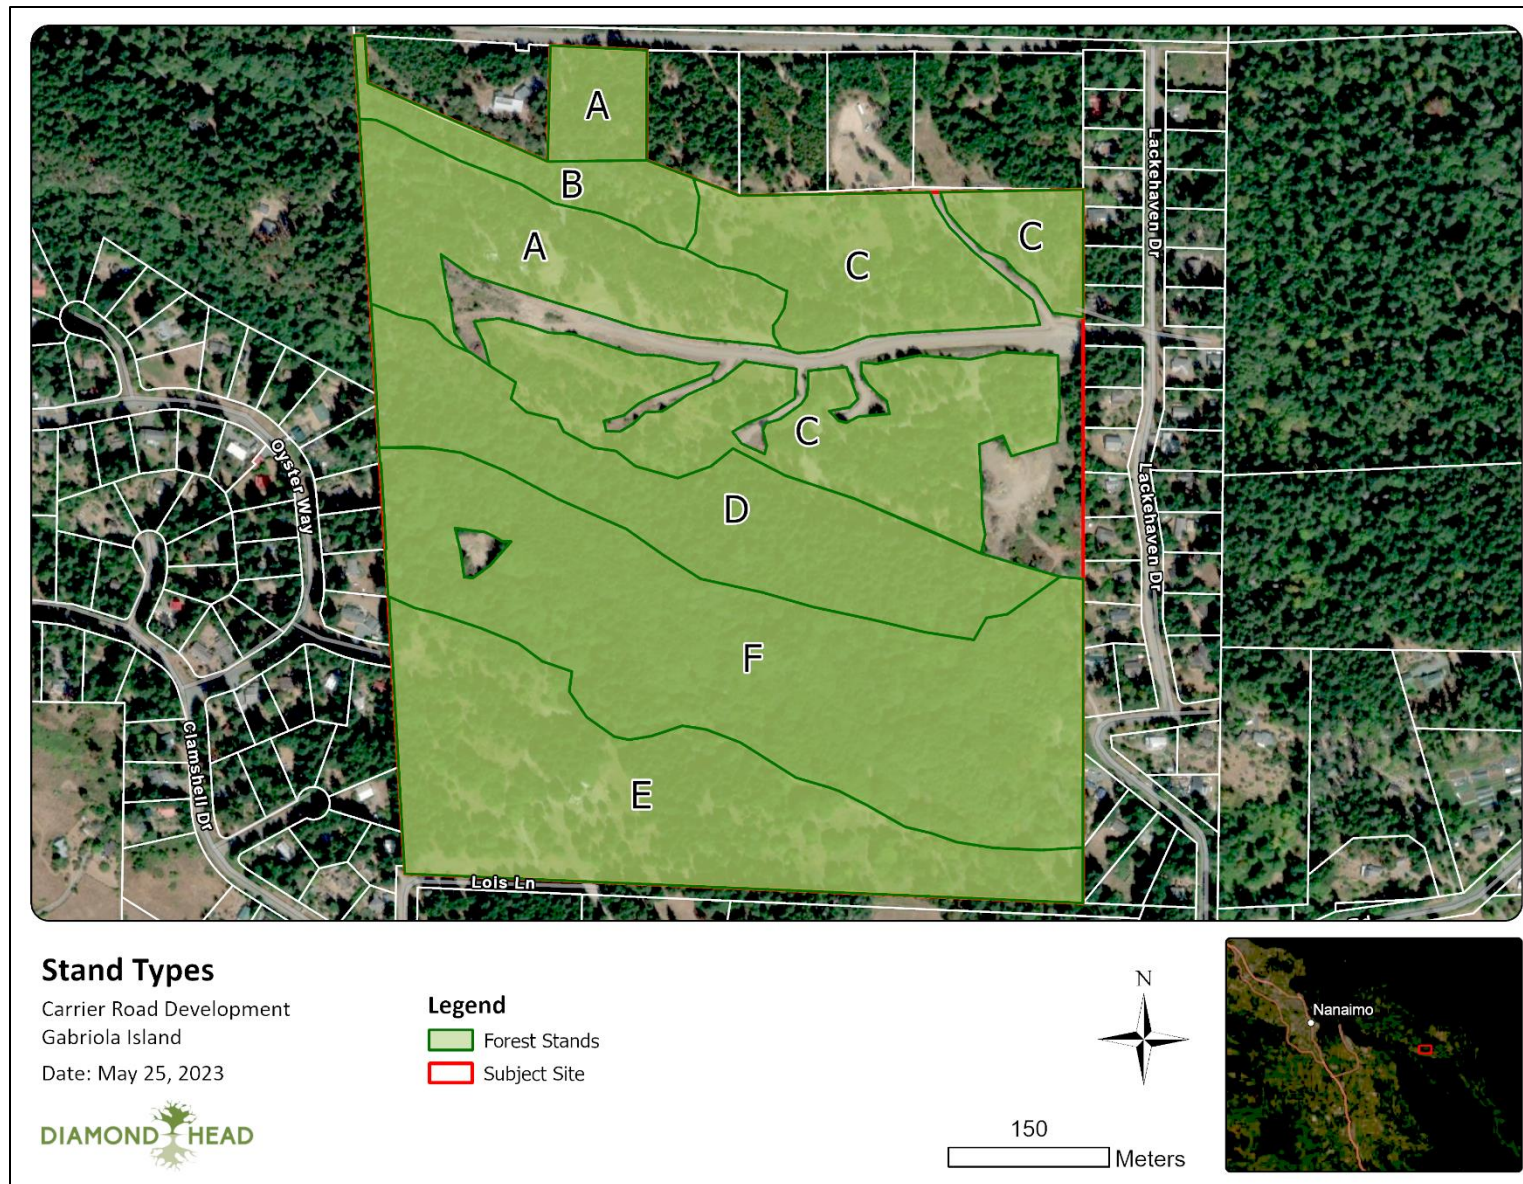
Figure 2. Stand types within forested areas.

Stands in the forest were stratified into distinct stand types. These stand types are forests with similar characteristics. Six stand types were identified on the site and are discussed in the following sections individually. Stand types are mapped in Figure 2.

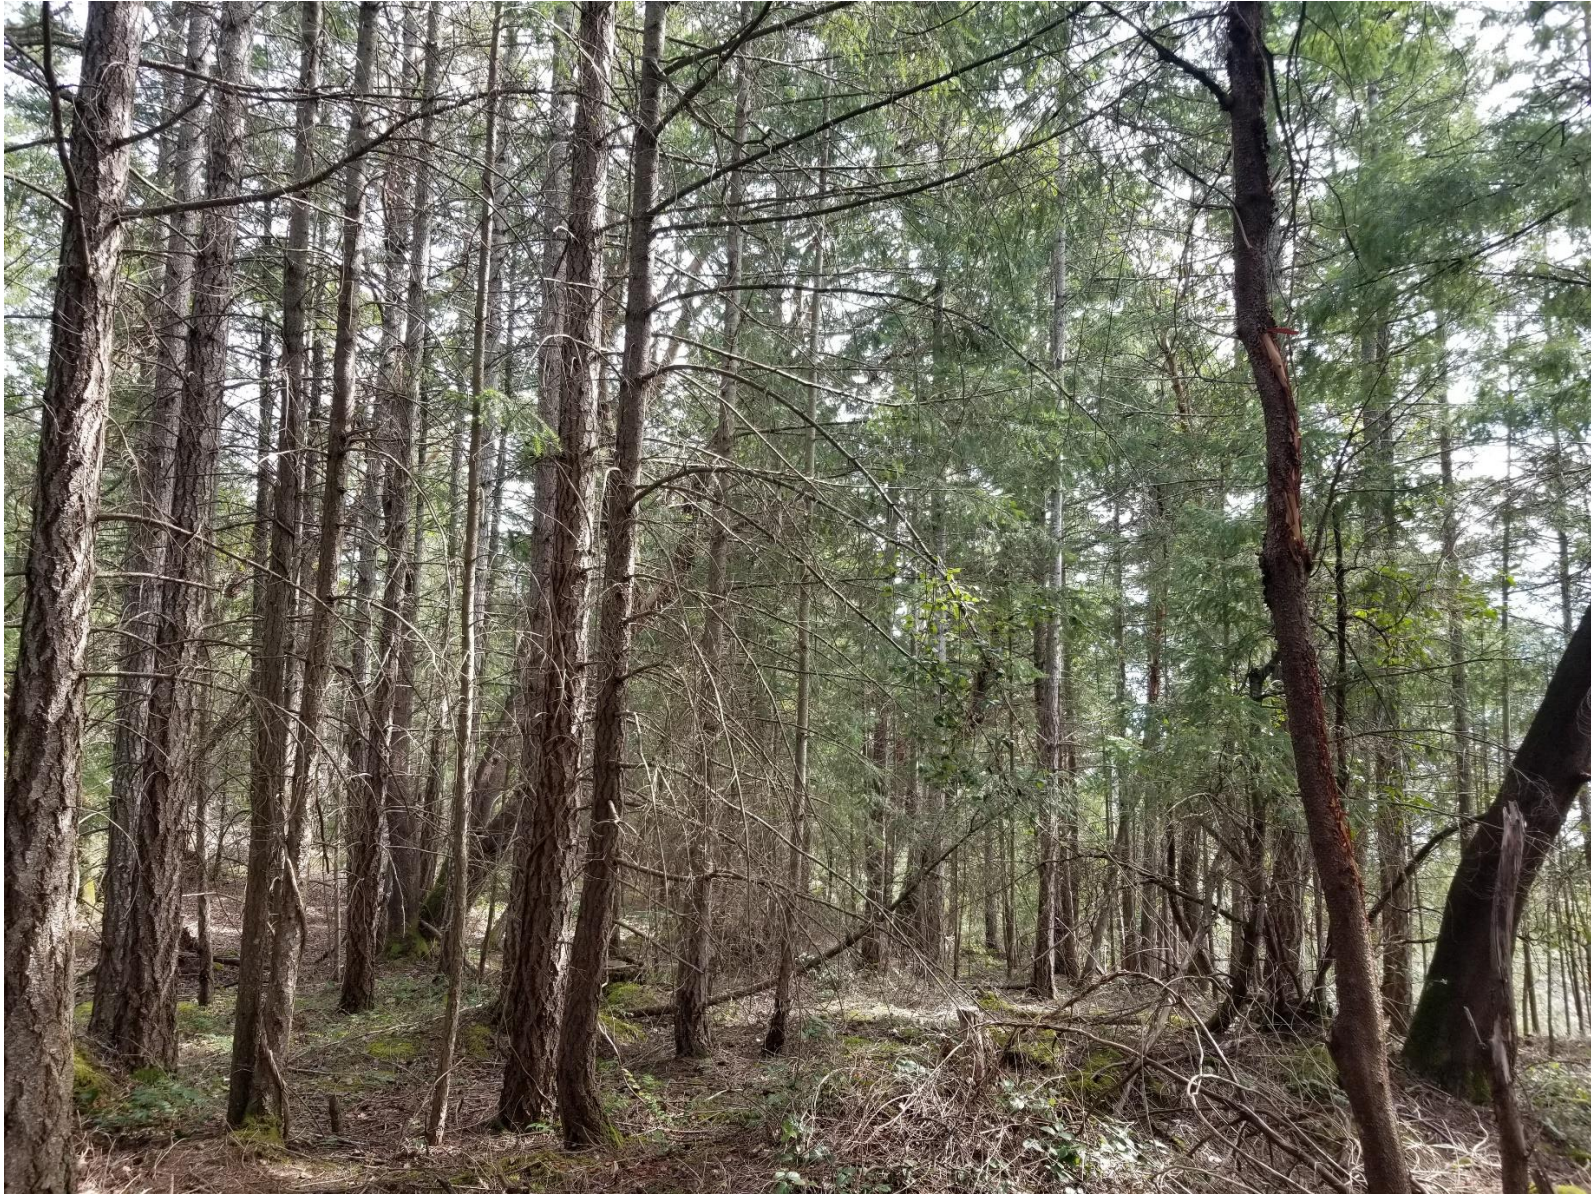
Photo 1. Typical stand conditions and structure for Stand Type A.

| Stand Type A | Semi-mature, thinned mixedwood stand |
|---|---|
| Crown Closure (%) | 20-40% |
| Health and structure rating | Moderate |

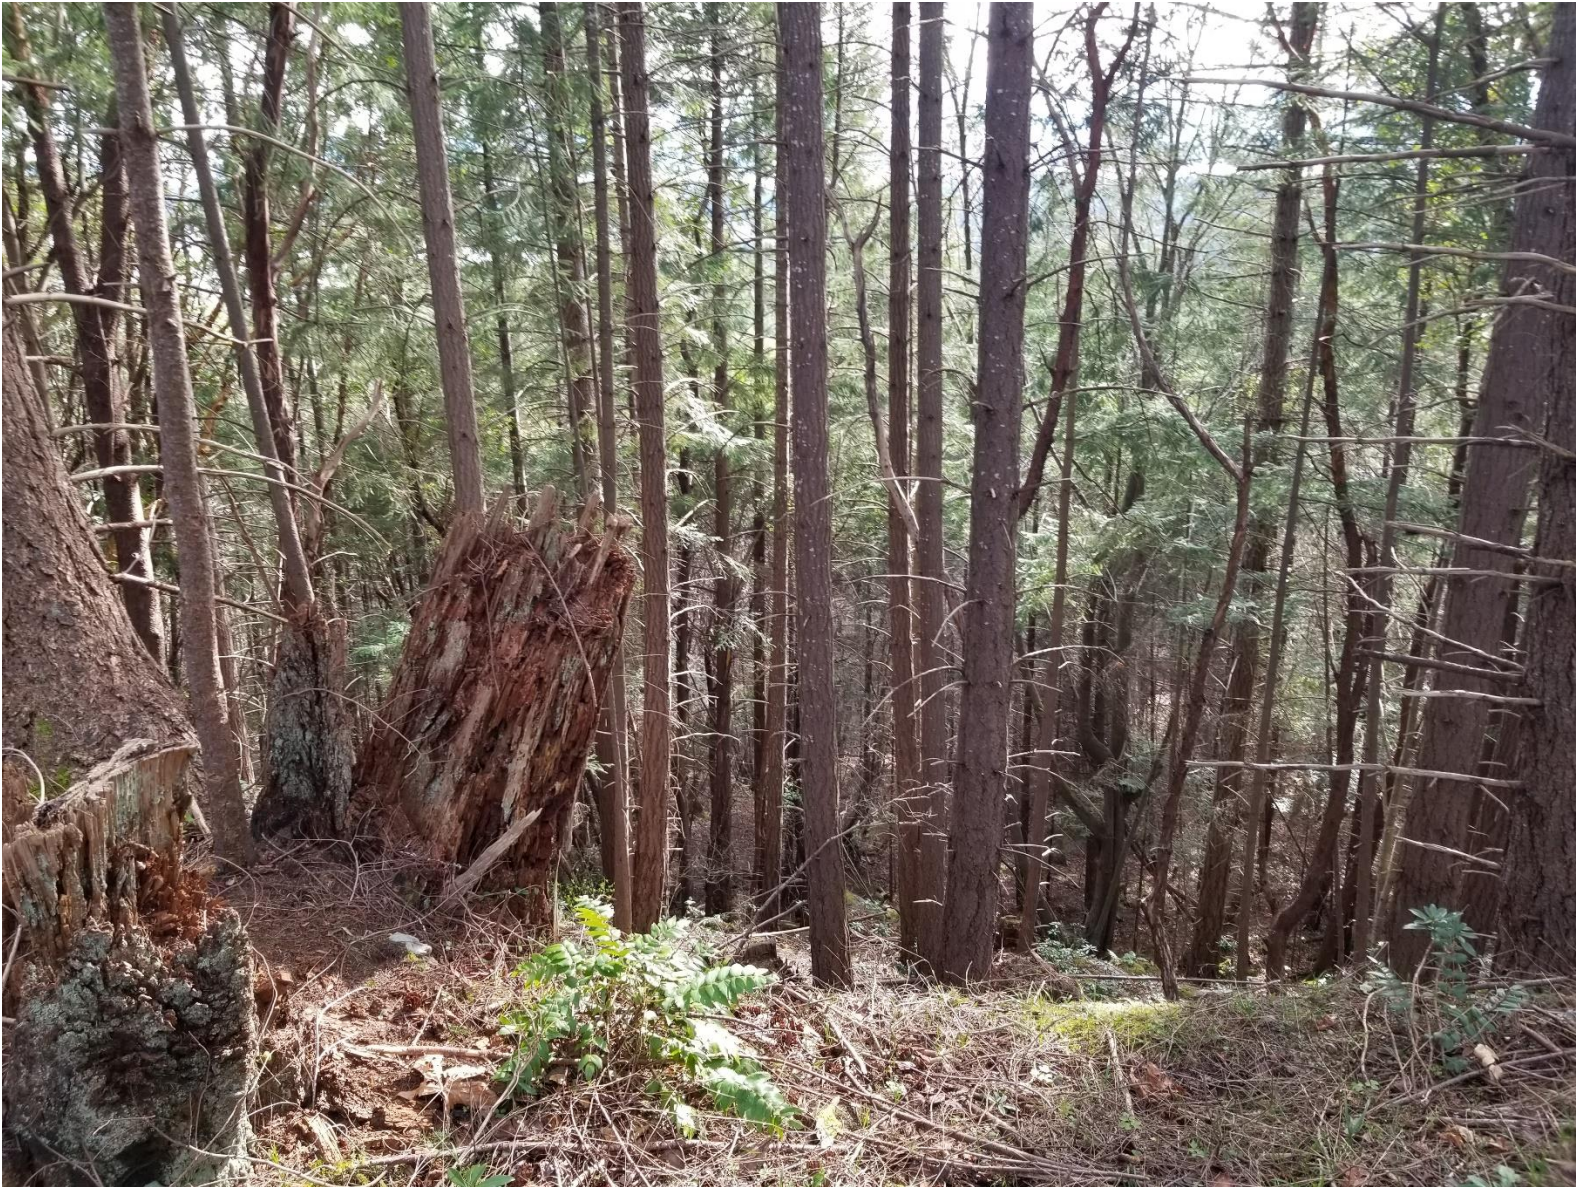
Photo 4. Typical stand conditions and structure for Stand Type D.

| Stand Type D | Mature, second growth coniferous stand |
|---|---|
| Crown Closure (%) | 40-60% |
| Health and structure rating | Moderate |

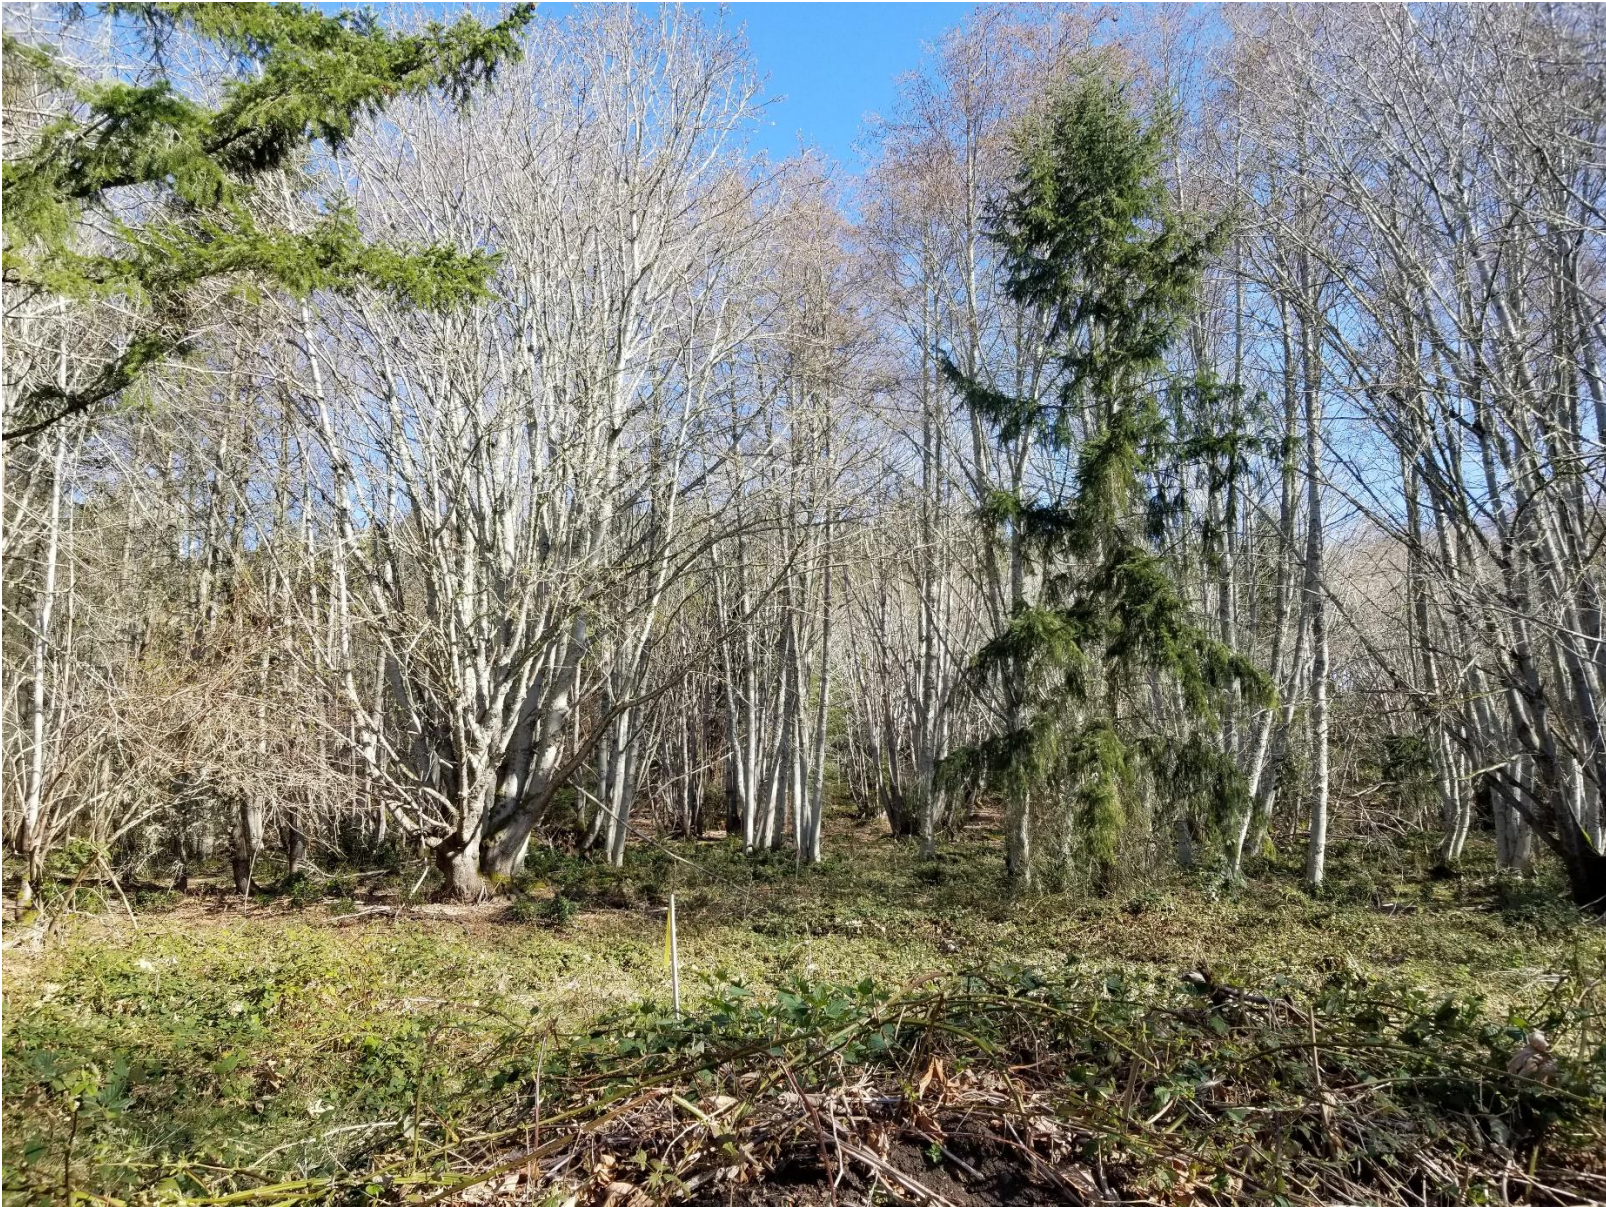
Photo 6. Typical stand conditions and structure for Stand Type F

| Stand Type F | Single storied, thinned, mature deciduous stand |
|---|---|
| Crown Closure | <20% |
| Health and structure rating | Moderate |
