## **LASQUETI ISLAND WATERSHED ASSESSMENT FOR PRESENCE OF FISH HABITAT**

**Ms. Linda Prowse  
Islands Trust Northern Office  
700 North Road, Gabriola Island, BC, V0R 1X3**

**Jennifer Morgen, M.Sc., A.Sc.T., B.I.T.  
MADRONE ENVIRONMENTAL SERVICES LTD.  
1081 Canada Avenue, Duncan, BC, V9L 1V2**

**March 31, 2013**

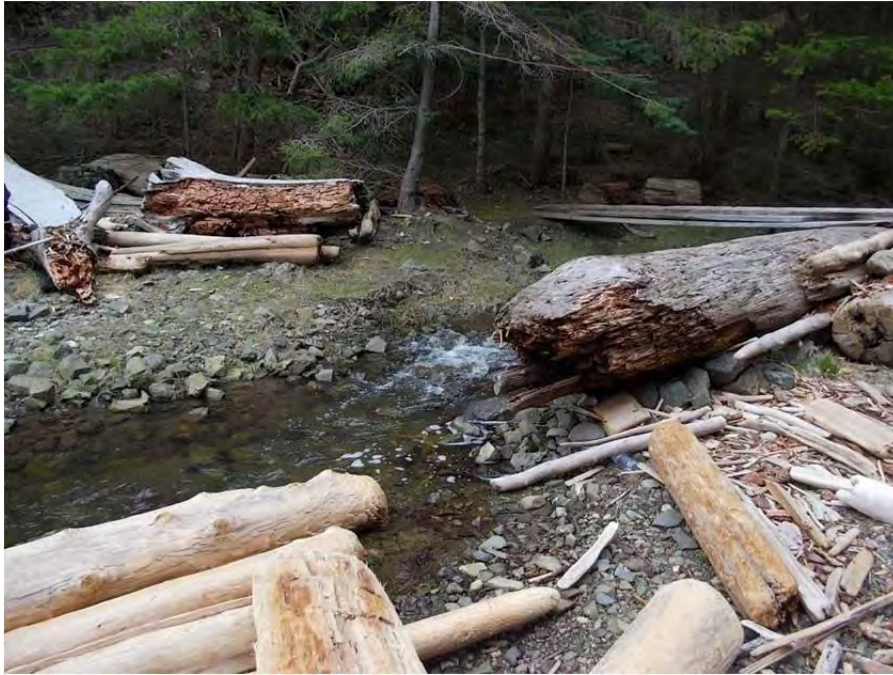
**Figure 1.** The outlet of Jenkins Creek at the tidewater boundary.

During the assessment, some log debris was observed at the mouth of the stream in the cove, but it did not appear to be blocking the outlet. However, the local landowner adjacent to the outlet mentioned that in previous years, salmon were observed in the cove, but unable to navigate beyond the log barrier. Logs have since been removed, though this appears to be a recurring problem in this location.

No permanent barrier to fish passage was observed on this creek and excellent, low-gradient fish habitat was observed throughout.

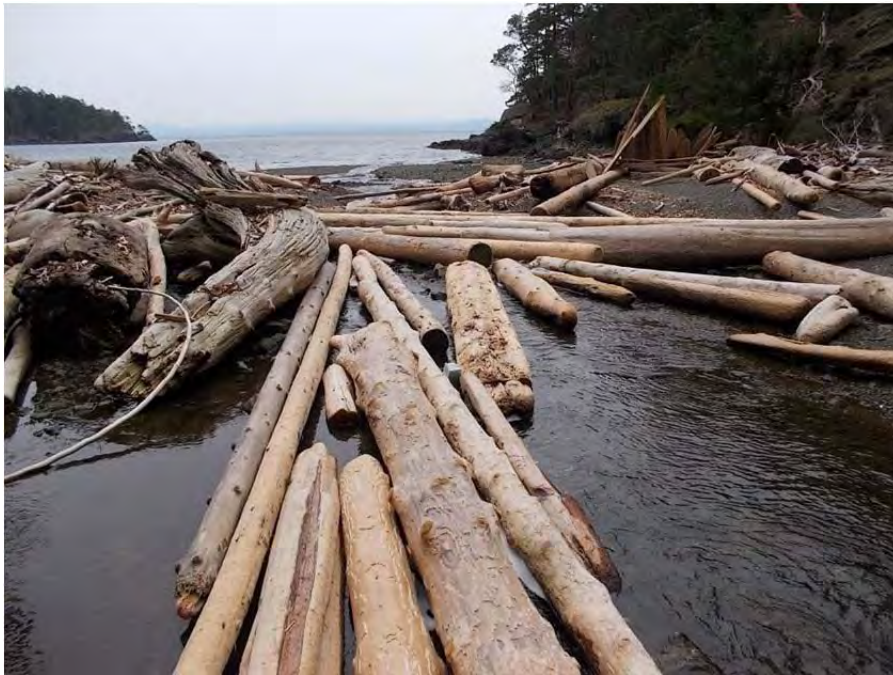
**Figure 2.** Facing south from the outlet toward Jenkins Bay.

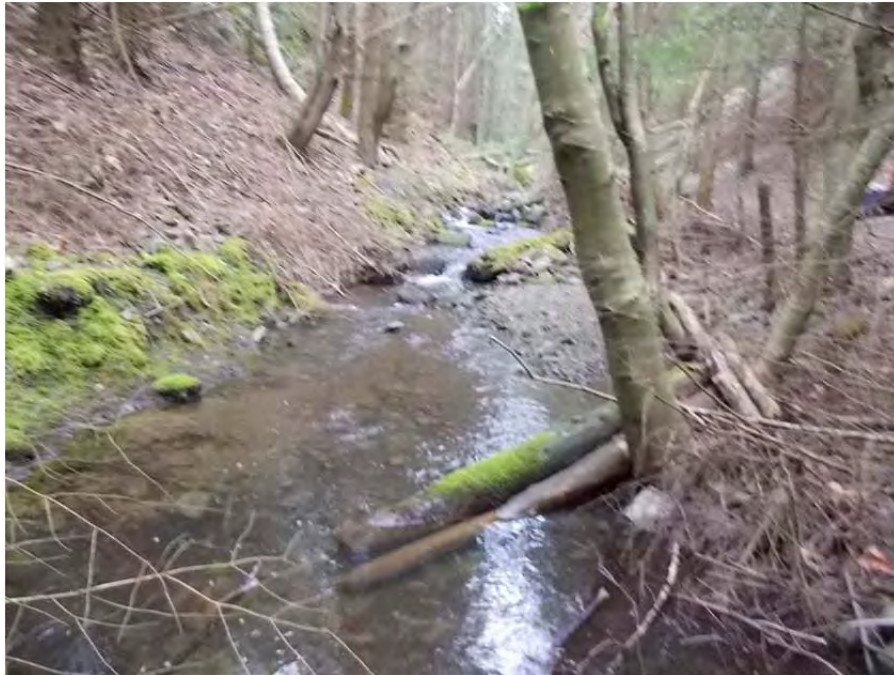
**Figure 3.** The morphology of the drainage, upstream of the ocean. Note the lack of understory vegetation due to overgrazing.

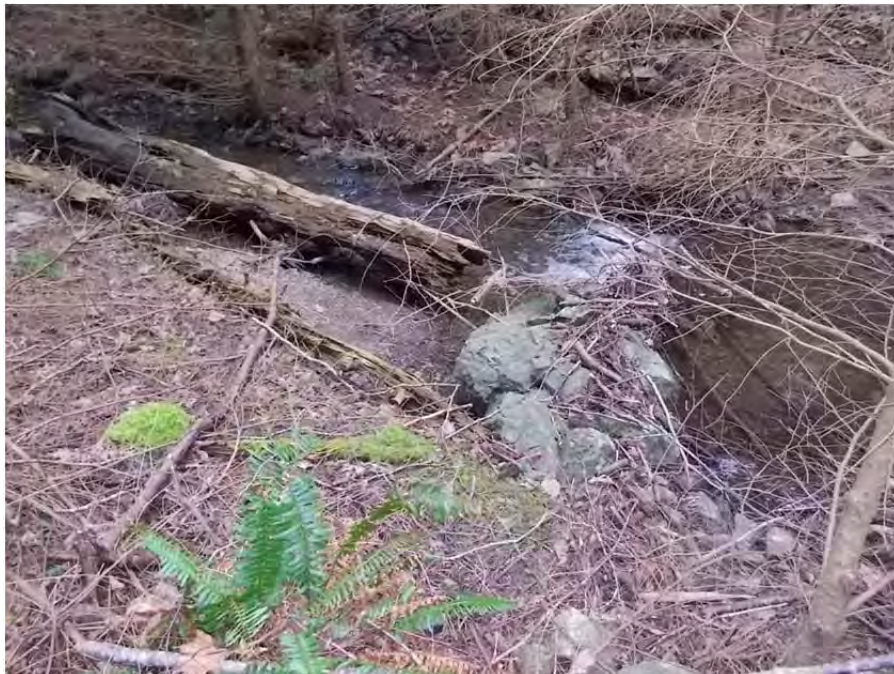
**Figure 4.** Placement of rock clusters and woody debris were part of past stewardship and stream restoration activities to improve habitat for fish.

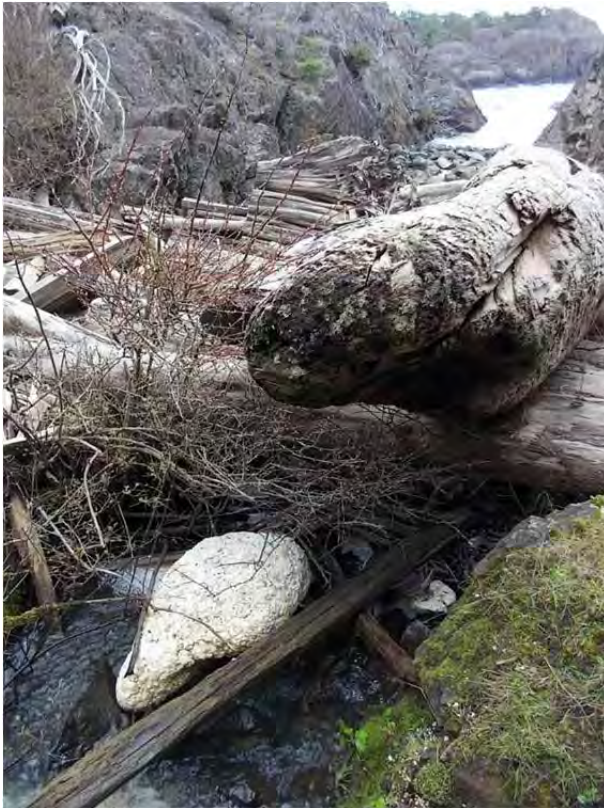
**Figure 5.** Looking east from Wamer Creek to the tidal boundary. Note the amount of debris on the beach.

The creek follows a low-gradient (<5% slope) course from the wetlands to the ocean with no observed barrier to fish migration. At the ocean, the mouth of the stream is currently blocked by debris, but it doesn't appear to be preventing water flow. The riparian vegetation is intact, though over-grazing was apparent. Some sections of the stream had been fenced along the banks to keep the sheep out and allow vegetation to recover. There is also evidence of tree planting in some spots as well.

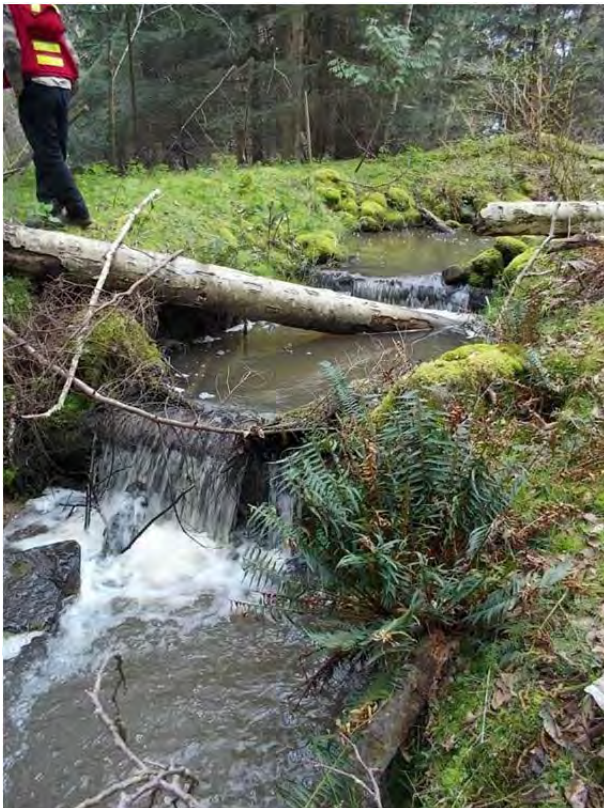
**Figure 6.** Photograph showing some of the in-stream features created to enhance fish habitat. Here, logs have been placed perpendicular to the stream and buried into each bank to create a cascade-pool channel habitat.

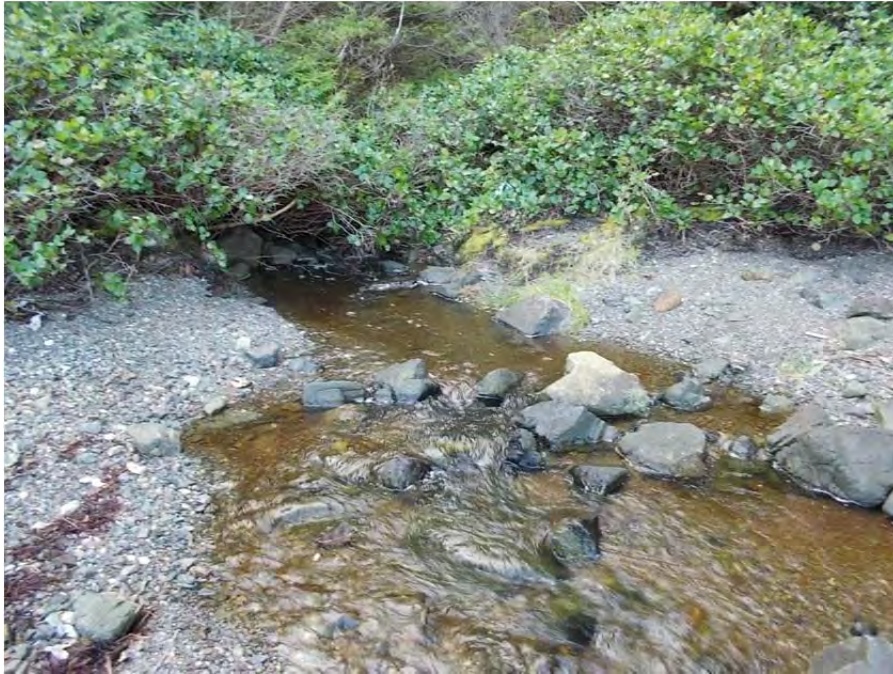
**Figure 8.** Outlet of the stream at the tidal boundary. Note the dense riparian vegetation and low gradient habitat.

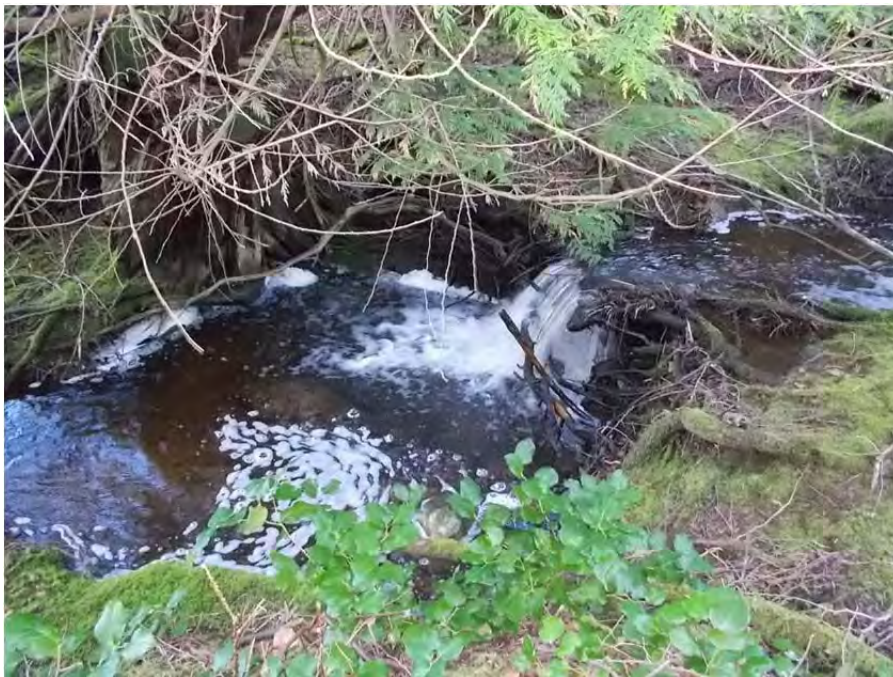
**Figure 9.** Instream features such as pools, undercut banks and woody debris provide excellent opportunities for juvenile salmonids.

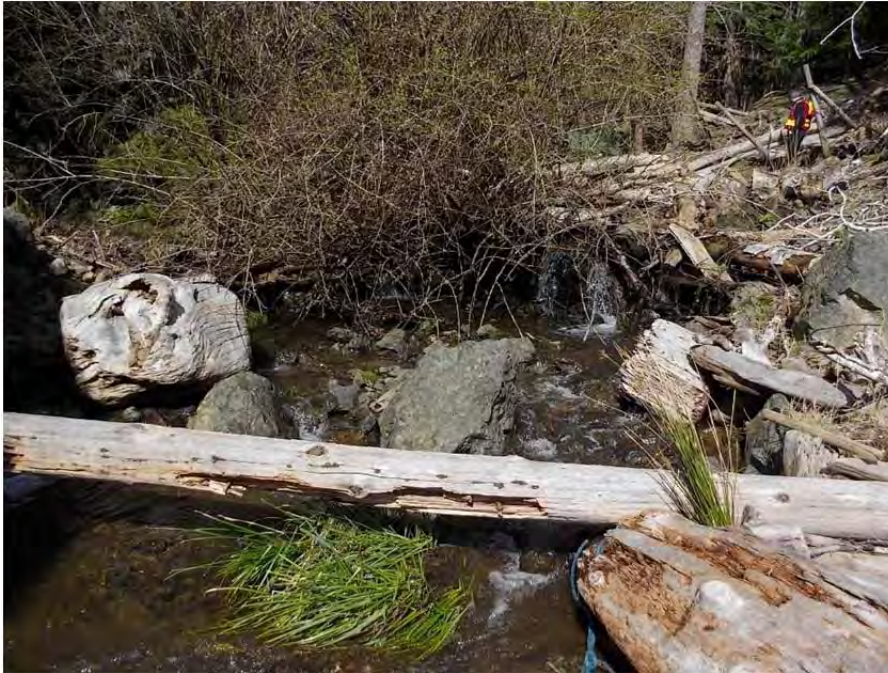
**Figure 10.** The outlet of Trematon Creek at the tidal boundary.

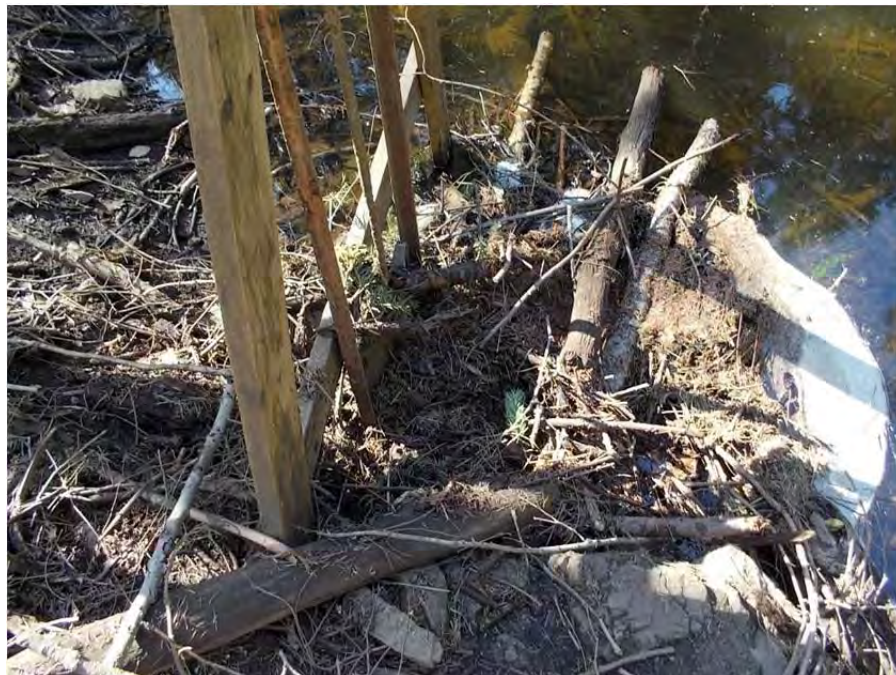
**Figure 13.** The manmade dam on Trematon Creek. Water flows through a pipe, not visible through the debris. This is a barrier to upstream fish migration.

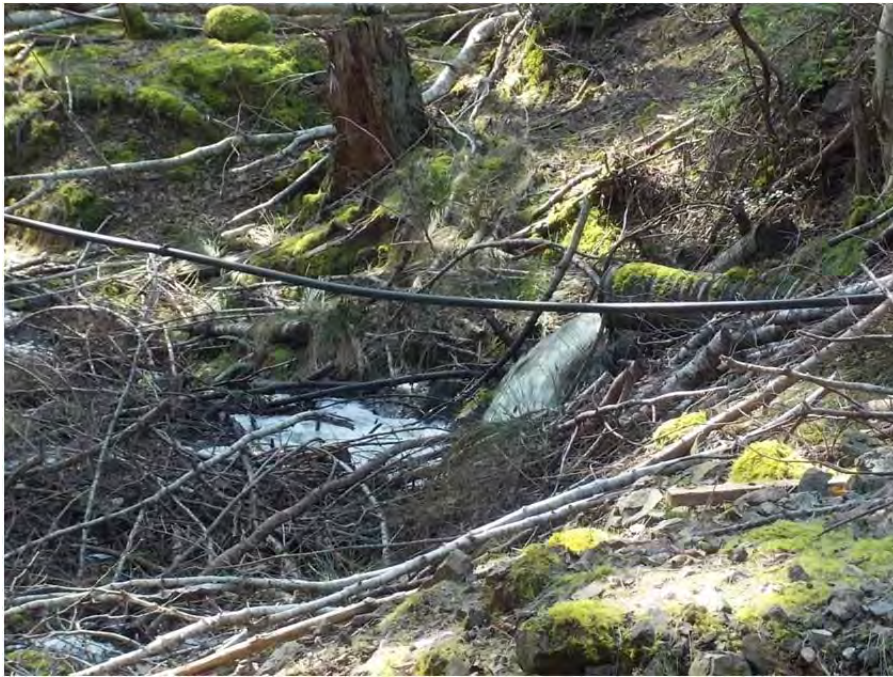
**Figure 14.** The outlet pipe from the dam, which drains the pond into the mainstem of the creek. This point is also the confluence of an Unnamed Tributary with Trematon Creek.

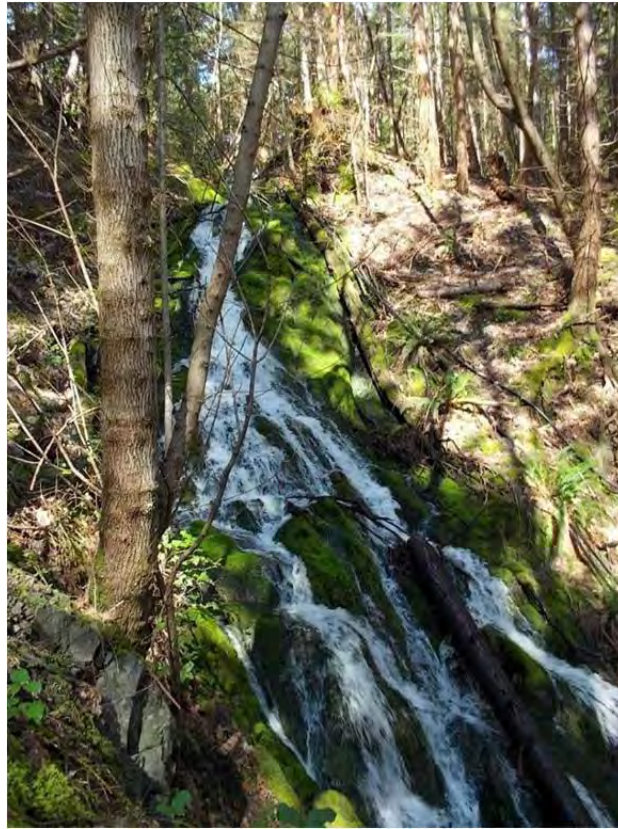
**Figure 16.** The bedrock cascade, which is a barrier to fish migration. The cascade is located on Trematon Creek, upstream of the pond.

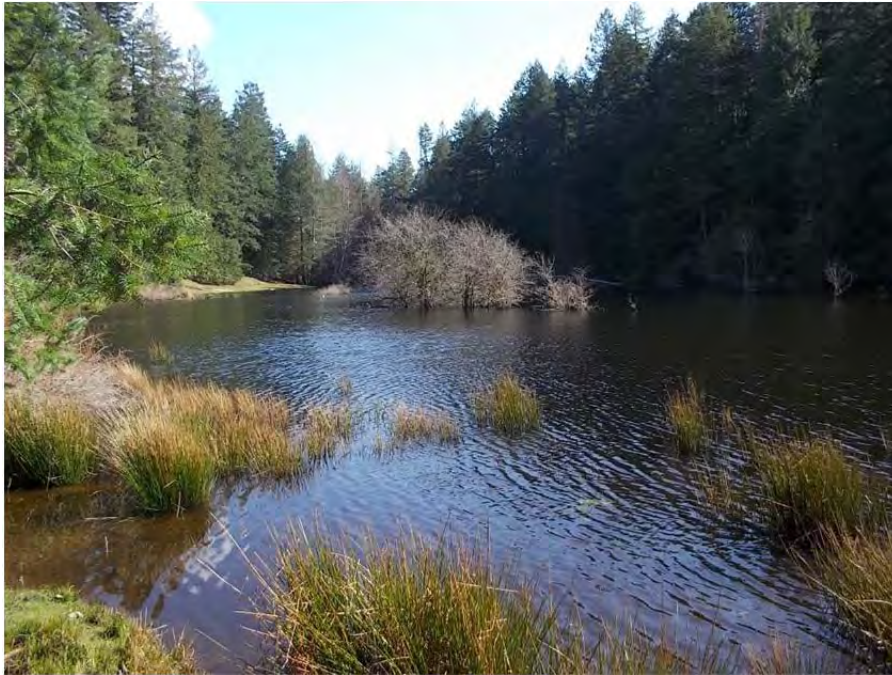
**Figure 17.** The headwaters for the stream located within the Osland Nature Reserve. This wetland was recently re-created by filling in the agricultural ditches and allowing the fields to flood.

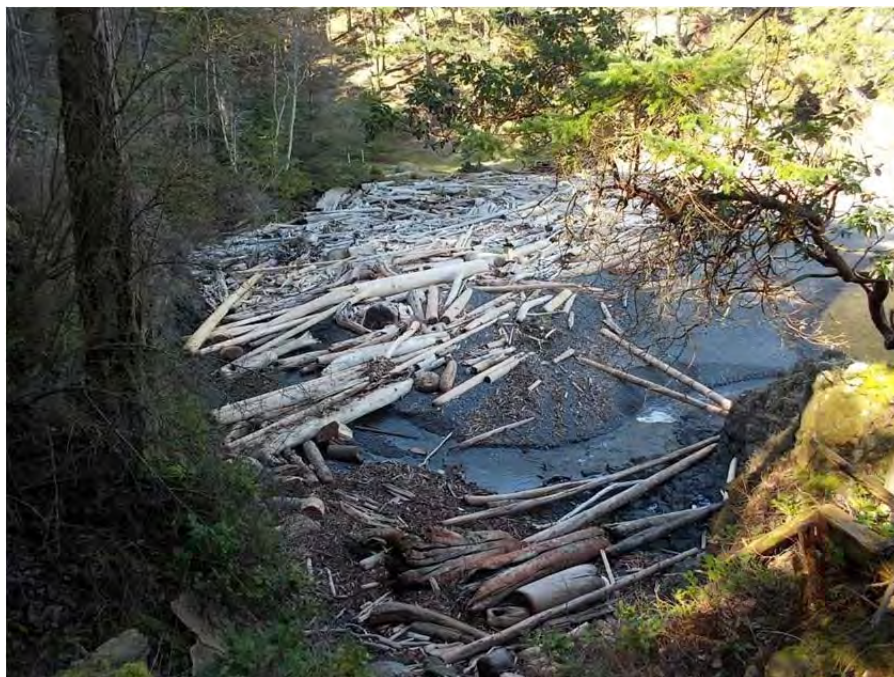
**Figure 18.** Looking north at the outlet of the stream. Note the accumulation of woody debris and that the stream flows under the logs.

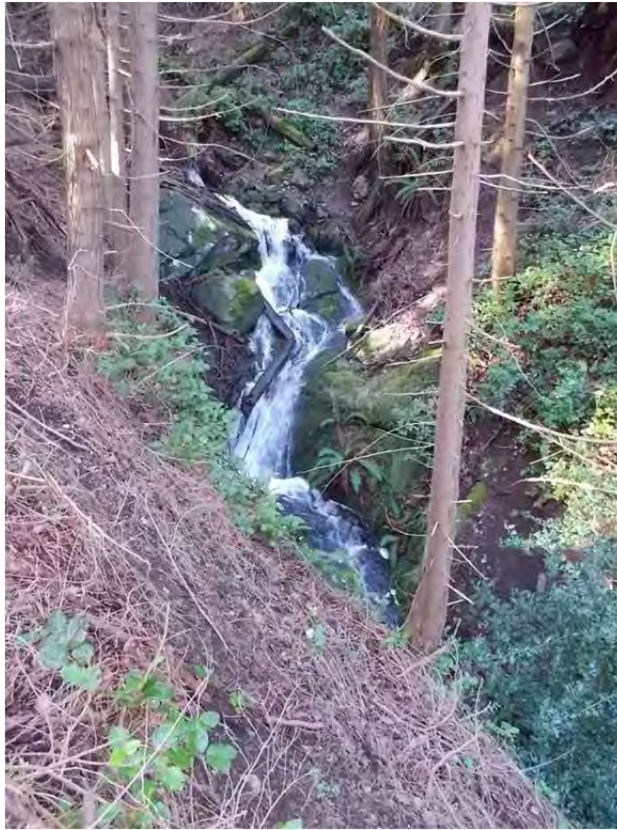
**Figure 19.** The cascade located upstream of the ocean, which is likely a barrier to fish passage. It should be noted that suitable habitat exists downstream of this barrier.

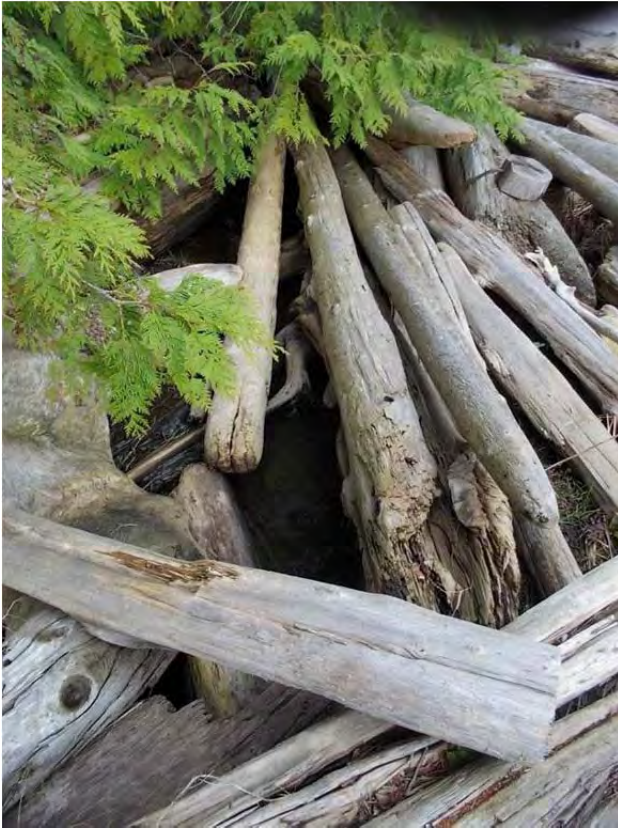
**Figure 20.** The outlet of the stream, which is barely visible through the log debris on the beach.

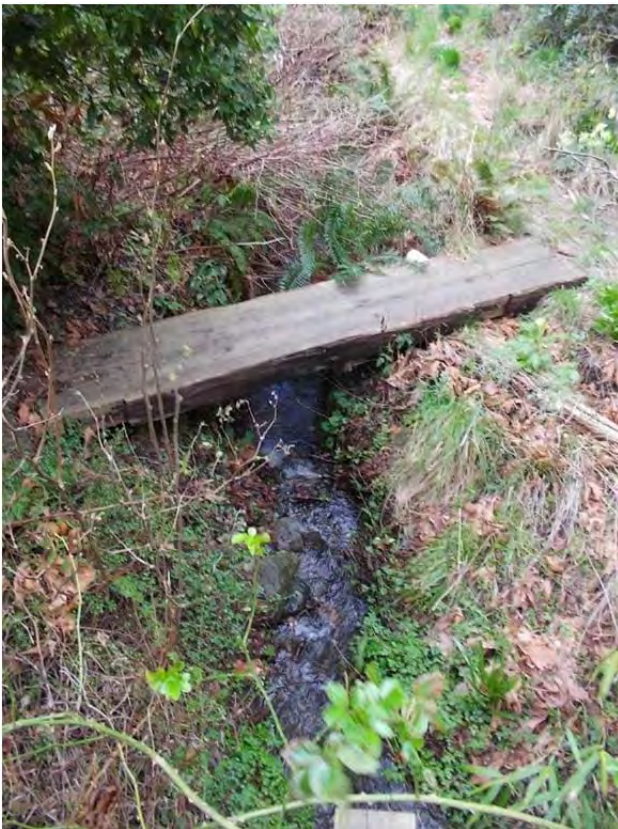
**Figure 21.** Looking upstream from the ocean. The stream flows within a residential property and shows signs of human influence.

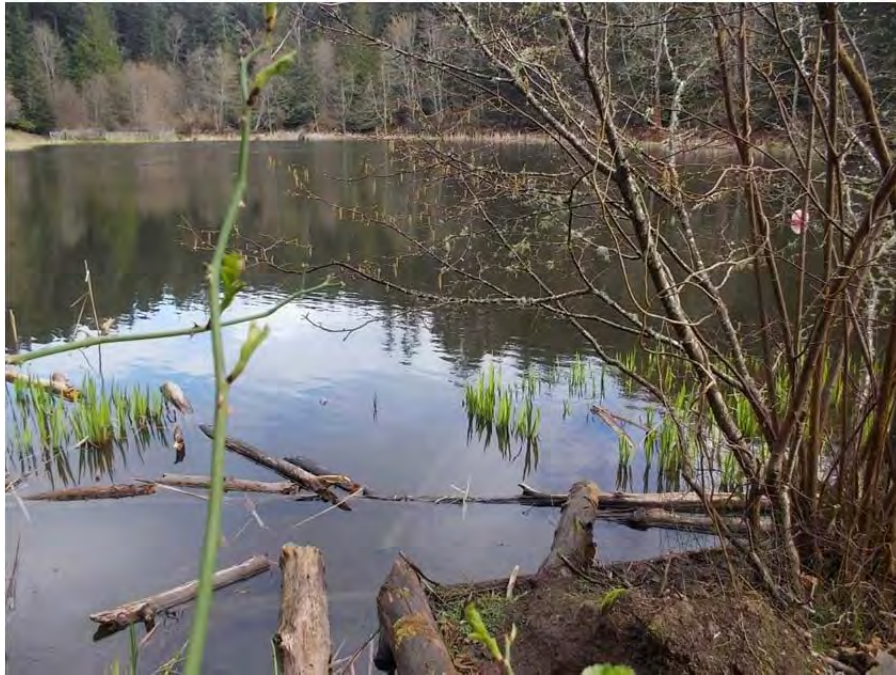
**Figure 22.** The manmade pond located approximately 100 m upstream from the ocean. There is a dam on the pond; however, water flow is not blocked.

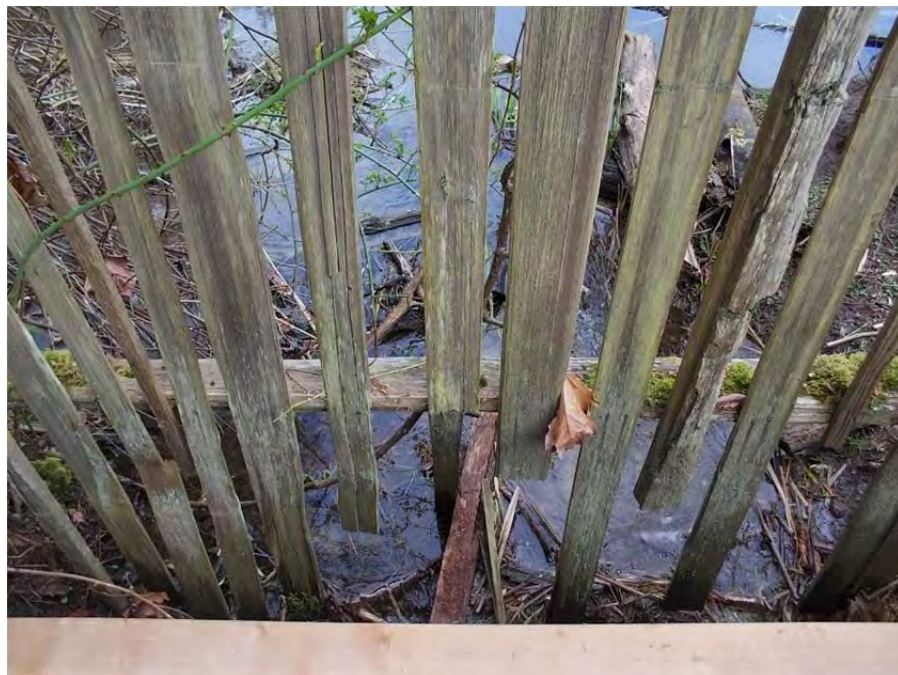
**Figure 23.** Looking down at the outlet from a bridge that crosses over the stream. Note that water flow from the pond is not impeded.

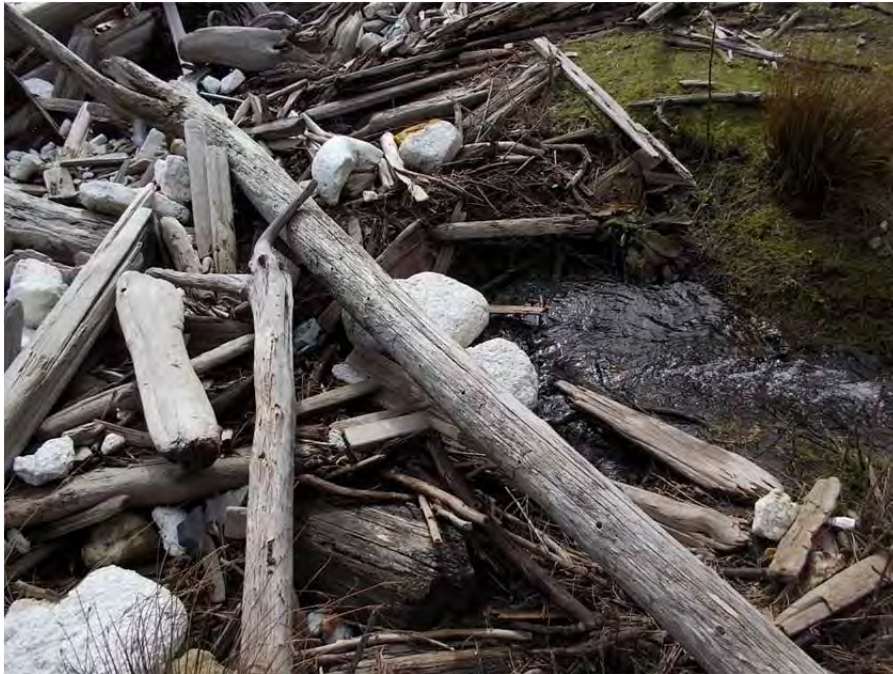
**Figure 24.** The outlet of the stream at tidewater, which is not visible due to the volume of debris located on the beach in Windy Bay.

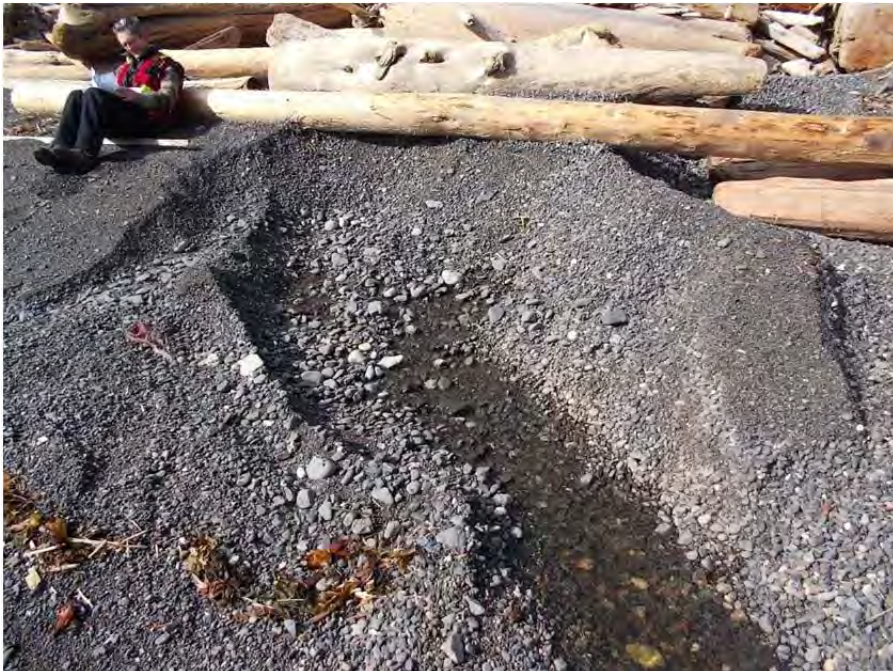
**Figure 25.** Wave action has deposited a large amount of gravel onto the beach. Note how the stream appears to resurface from the gravel. It is uncertain whether this will be a barrier to fish migration during periods of high tide when the water levels are increased.

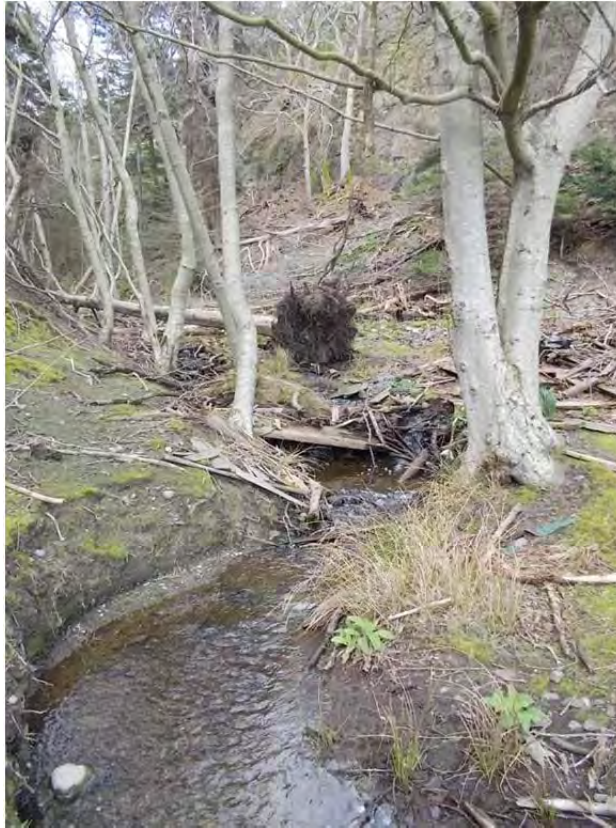
**Figure 26.** Photograph showing the low gradient habitat upstream from the tidewater boundary. Note the lack of established understorey vegetation due to overgrazing by feral sheep.

At the tidal boundary, the stream flows over cobbles and boulders. The landscape within the stream's eastern riparian corridor has been greatly altered by human use, with a residence, driveway and overgrazing by feral sheep observed. A thin strip of salmonberry (*Rubus spectabilis*) and sword fern (*Polystichum munitum*) comprises the

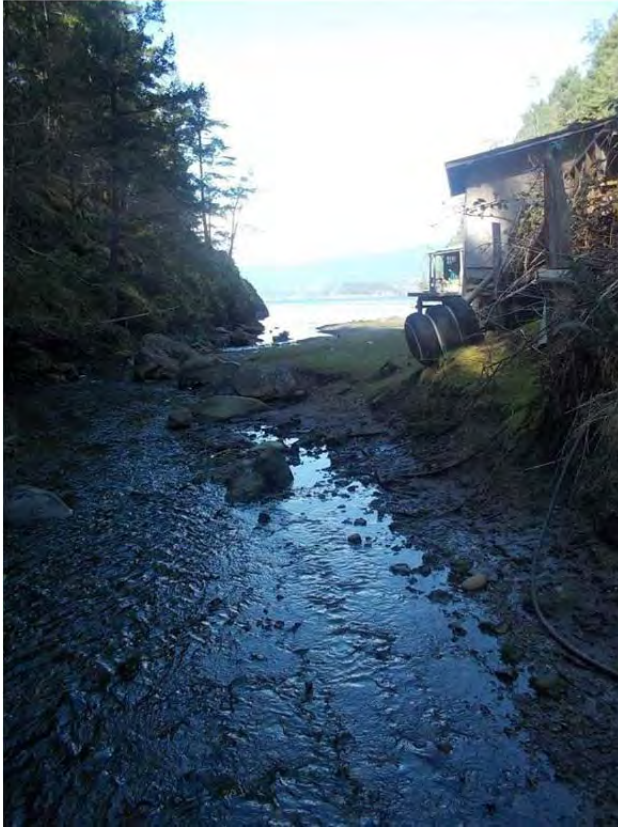
**Figure 27.** The tidewater boundary of Monahan Creek at Anderson Bay. Note the residence located on the eastern bank of the stream.

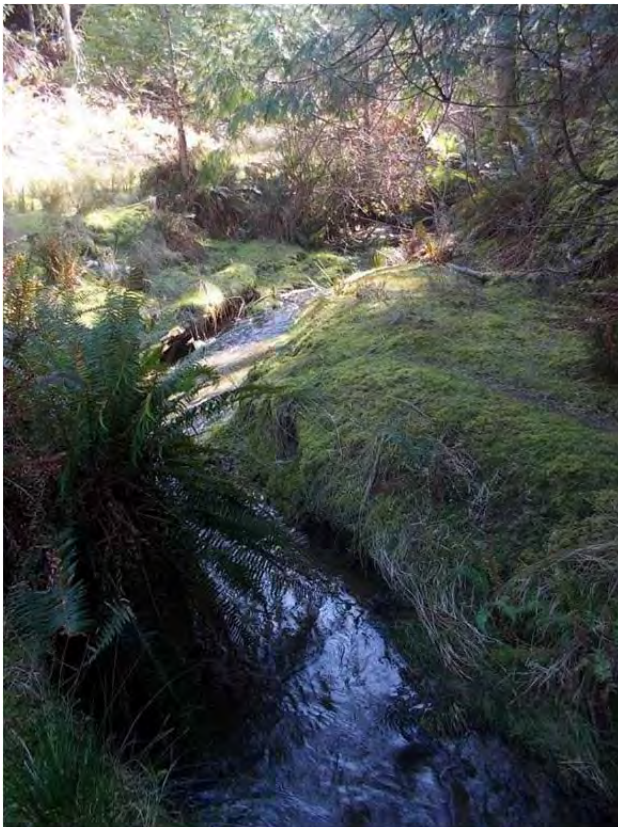
**Figure 28.** Looking south at the stream. Low gradient habitat exists from the tidal boundary and approximately 30 m upstream. Note the lack of vegetation along the eastern bank.

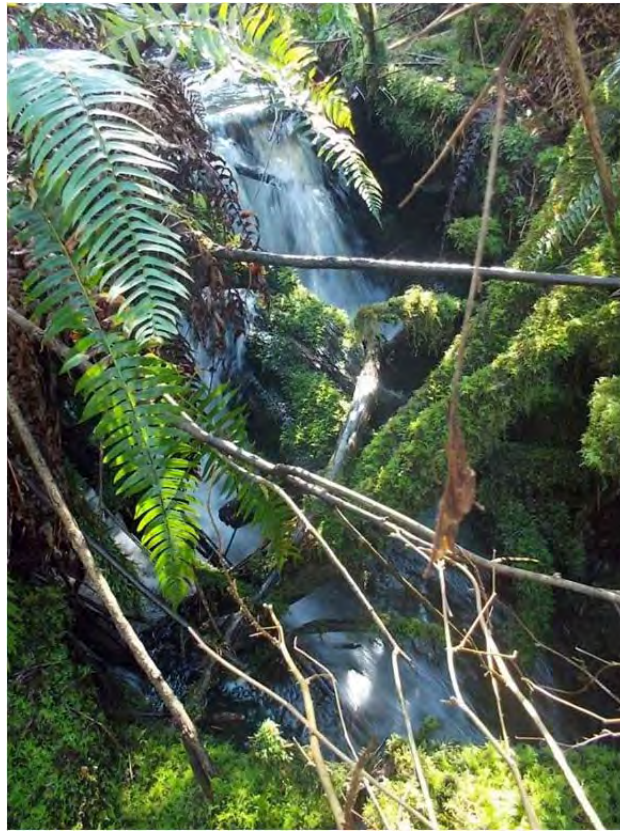
**Figure 29.** The lower cascade, located approximately 50 m upstream from the ocean. It should be noted that of the gradient is greater than 30% and likely a barrier to upstream fish migration.

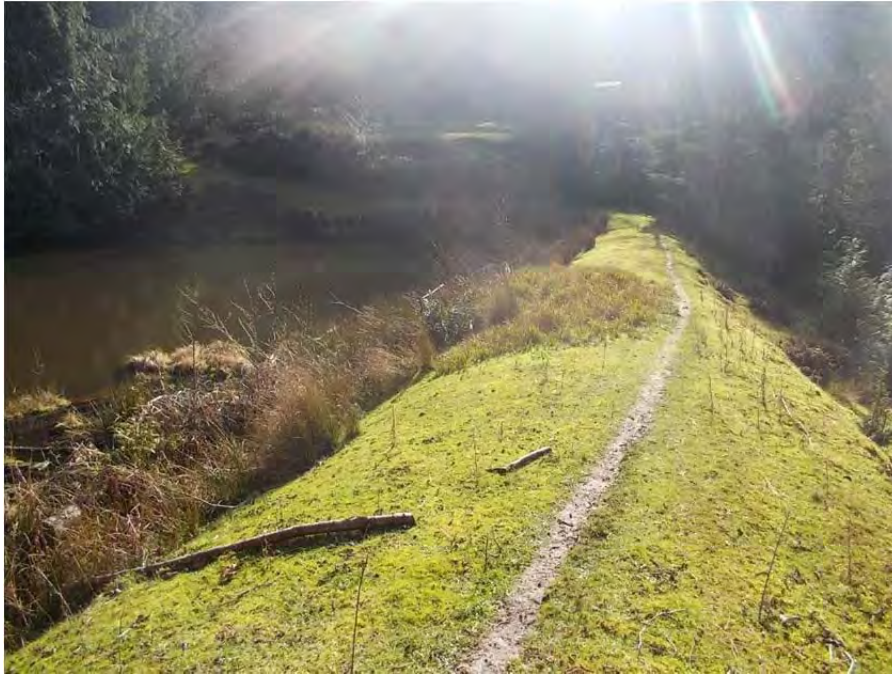
**Figure 30.** The manmade causeway dam and pond, created to hold water. If favourable water quality conditions exist within the pond, this could provide suitable habitat for fish. It is also considered a perennial water source under RAR.

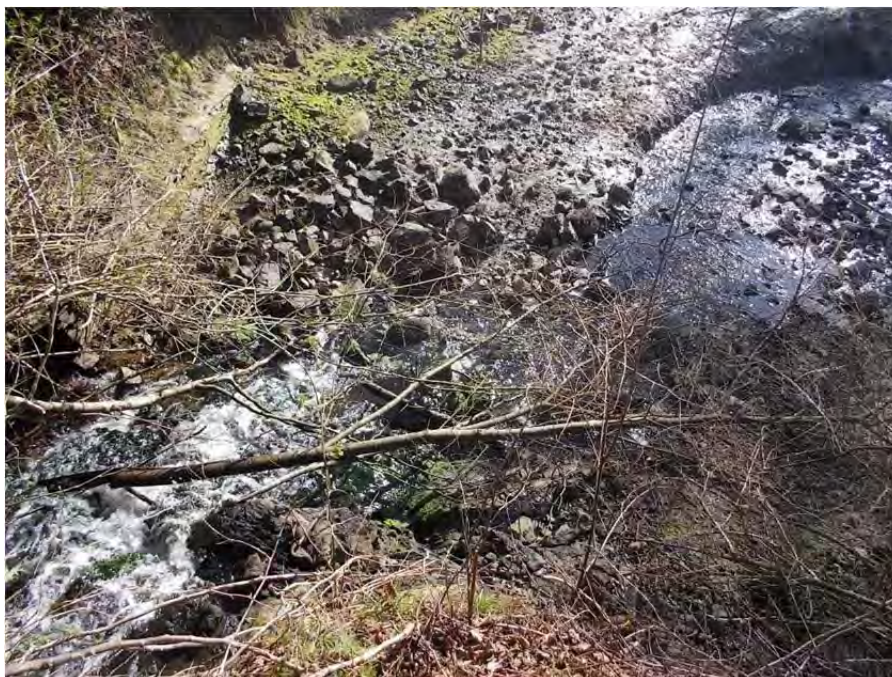
**Figure 31.** Looking down at the confluence of the stream with the tidewater. Note how the water cascades down to the beach.

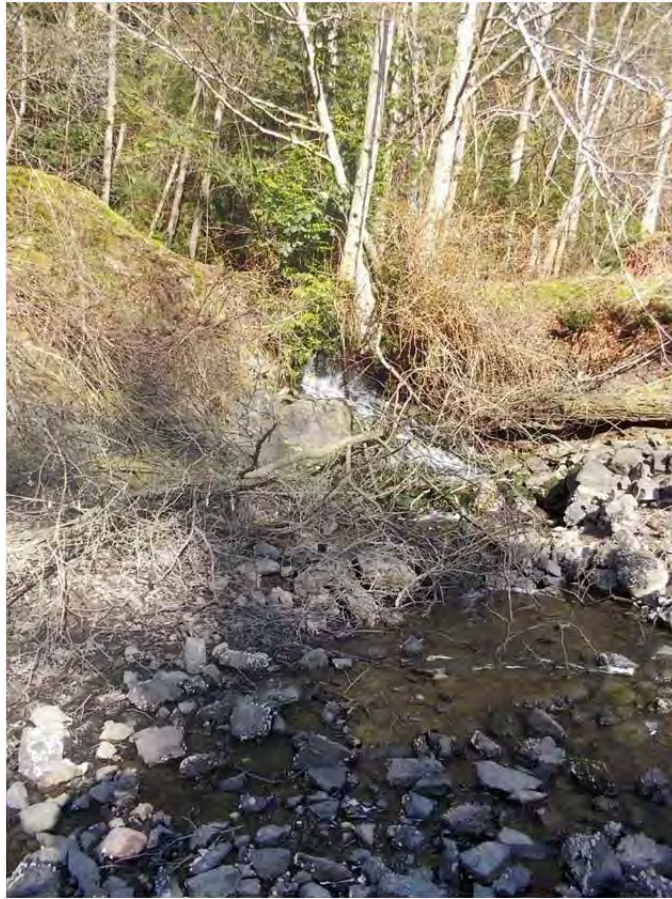
**Figure 32.** Looking south at the cascade from the beach. Although steep (25%), the cascade is short and may not act as a barrier to fish passage.

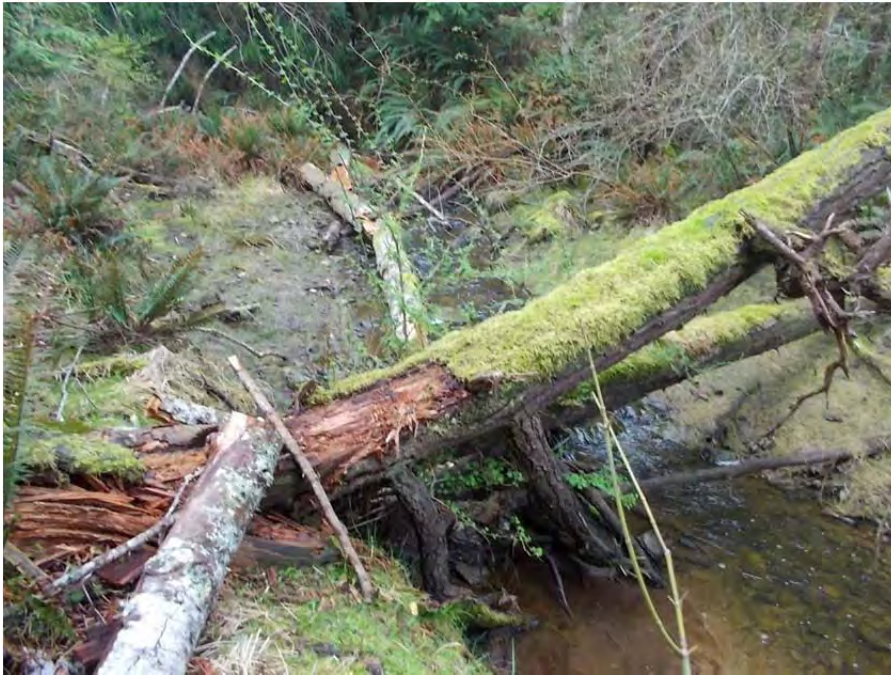
**Figure 33.** Looking upstream from the tidewater boundary. Note the well-established vegetation within the riparian corridor.

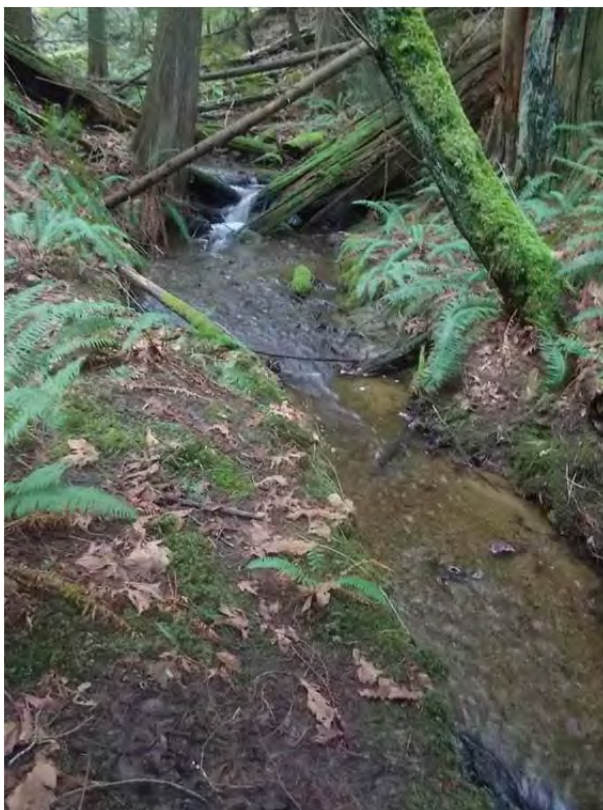
**Figure 34.** Low gradient habitat with a dense canopy of riparian vegetation is found throughout the lower reach of this stream.

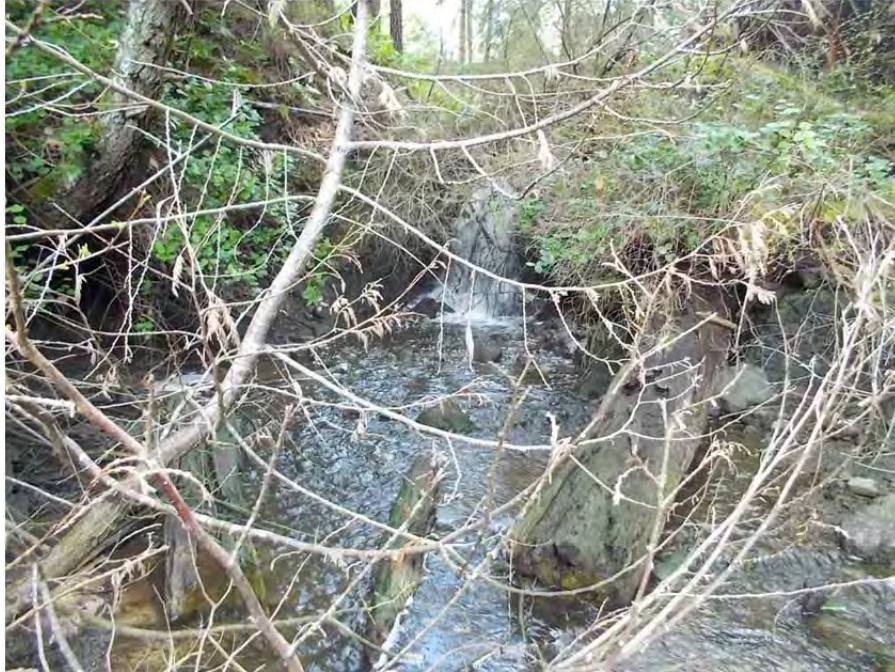
**Figure 35.** The outlet of the stream at the tidewater boundary. The cascade will likely act as a barrier to upstream migration at low tide.

Although there is a barrier at the tidal boundary on Stonehouse Creek and at Cocktail Cove, perennial habitat may exist. We recommend these systems be reassessed during the late summer when the flows are at their minimum to determine if they provide fish habitat.

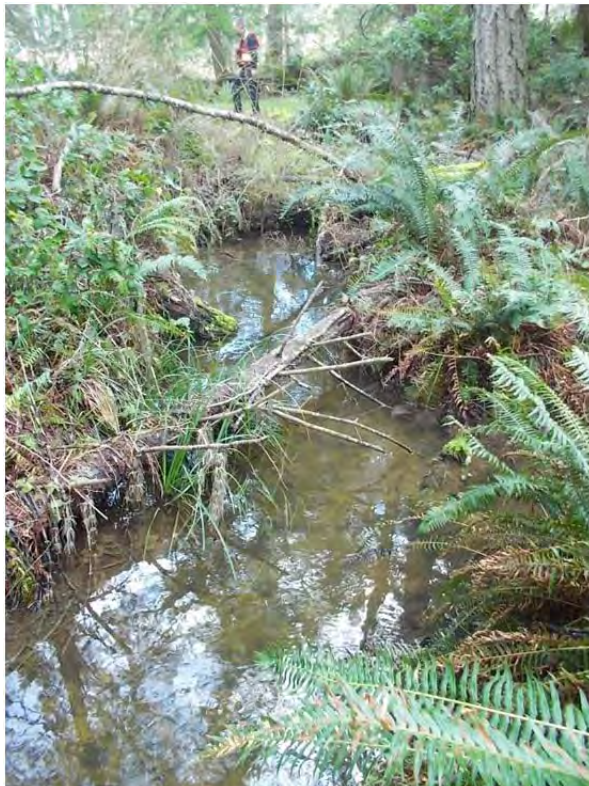
**Figure 36.** Habitat upstream from the cascade is low gradient and is fed by a perennial water source, though water quality is likely an issue.

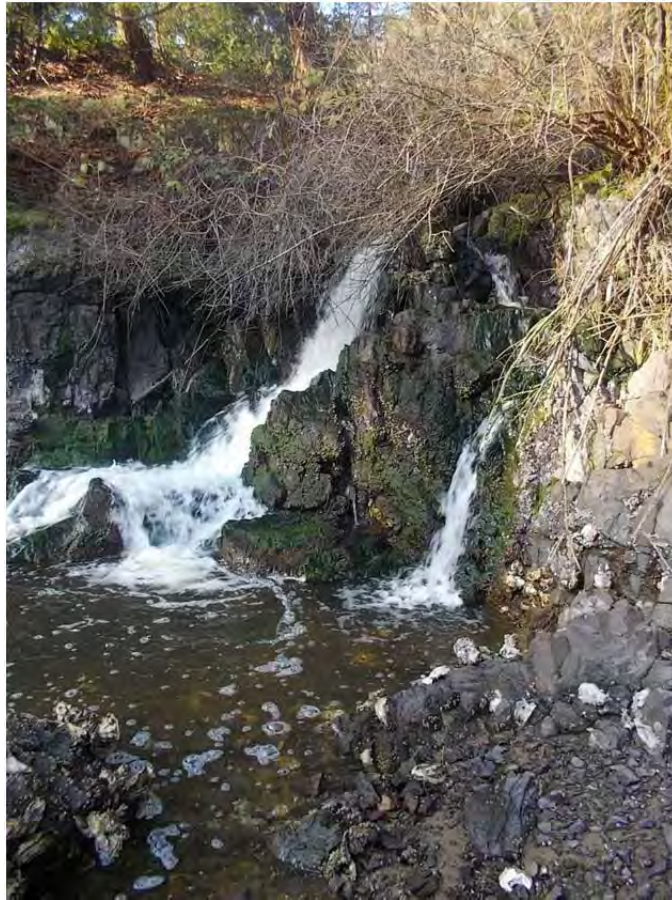
**Figure 37.** The tidewater boundary of Stonehouse Creek. Note how the water enters the ocean over a steep bedrock cascade (45% gradient). A perennial source of water may exist above this barrier and will need to be revisited during the period of low flows.

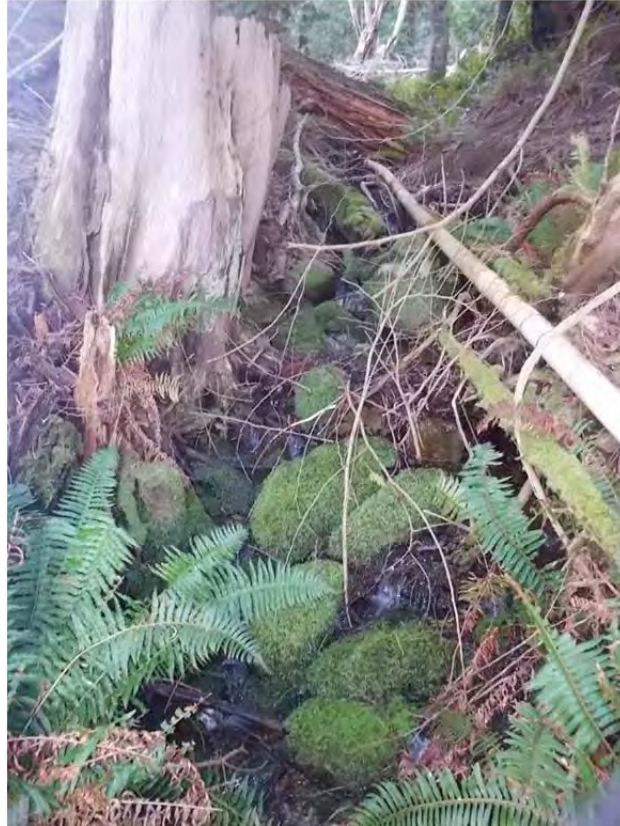
**Figure 38.** A cascade of greater than 30% at the tidewater boundary acts as a barrier to upstream fish migration. In addition, a lack of perennial flow classifies this as not a stream under RAR.

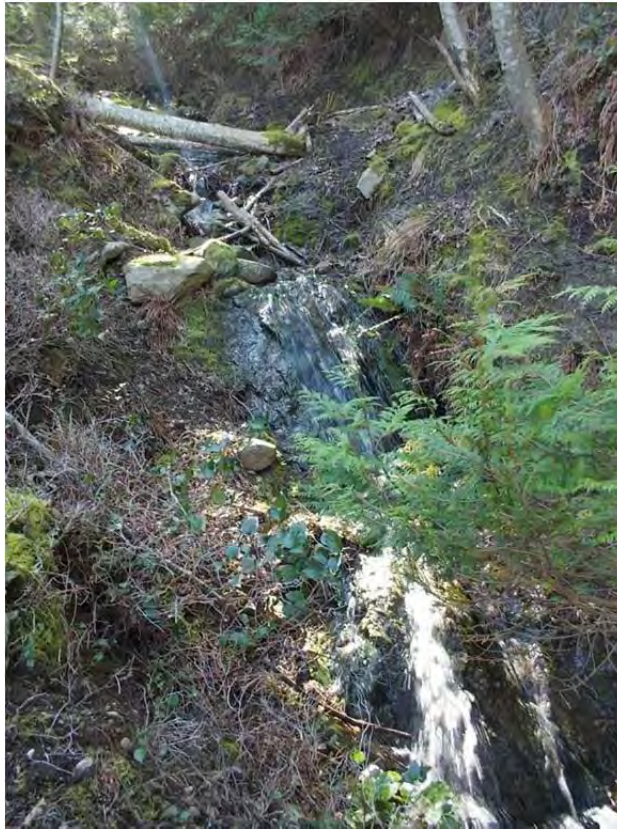
**Figure 39.** The stream possesses a relatively high gradient throughout (20%), and empties into the ocean over a steep cascade. There is no perennial habitat above the barrier.

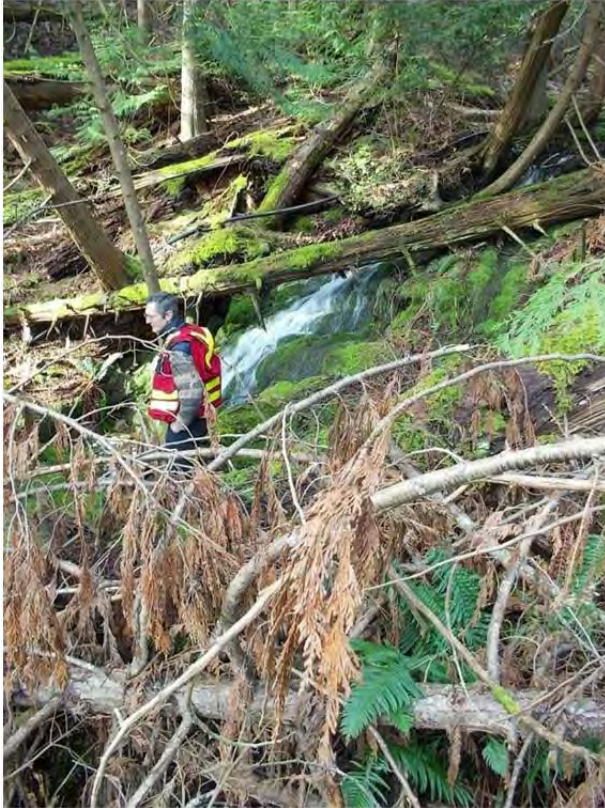
**Figure 40.** Looking at the stream prior to its entry into the ocean. It should be noted the gradient is steep, at 35%.

A barrier to fish migration was observed at the tidewater boundary in Rouse Bay, which is located on the east tip of the island. The gradient of the barrier (step-cascade habitat) is approximately 35% with no plunge pool at the base to assist upward migration by fish. A recent storm had caused several of the trees along the stream banks to blow down, making the outlet of the stream difficult to see. Although some low gradient habitat was observed upstream, evidence from the orthophotos do not suggest that significant headwaters exist to provide perennial habitat. Therefore, this watershed is does not have fish habitat.

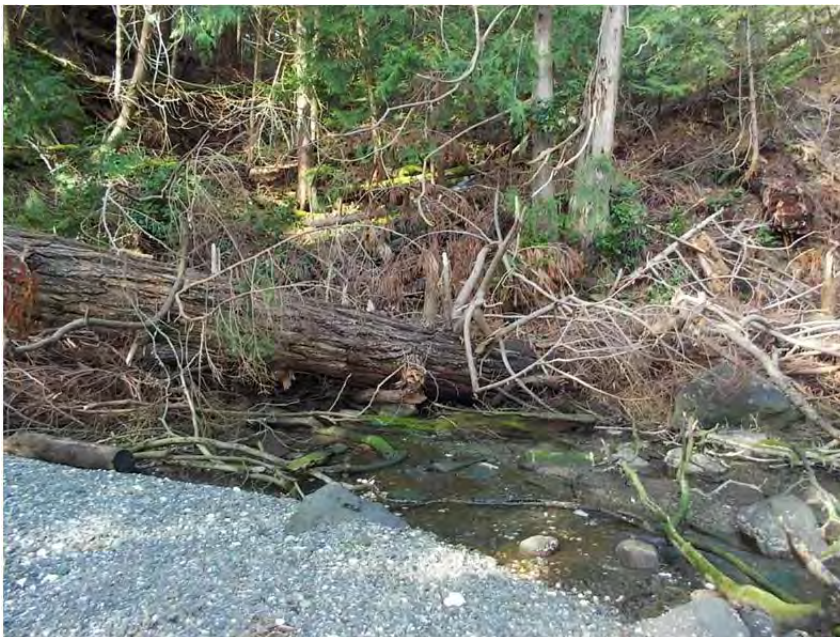
**Figure 41.** Looking upstream from the beach. The cascade is barely visible (in the centre of the photo) through the recent blowdown at the tidewater boundary.
