## **LASQUETI ISLAND WATERSHED ASSESSMENT FOR PRESENCE OF FISH HABITAT**

**Ms. Linda Prowse  
Islands Trust Northern Office  
700 North Road, Gabriola Island, BC, V0R 1X3**

**Jennifer Morgen, M.Sc., A.Sc.T., B.I.T.  
MADRONE ENVIRONMENTAL SERVICES LTD.  
1081 Canada Avenue, Duncan, BC, V9L 1V2**

**March 31, 2013**

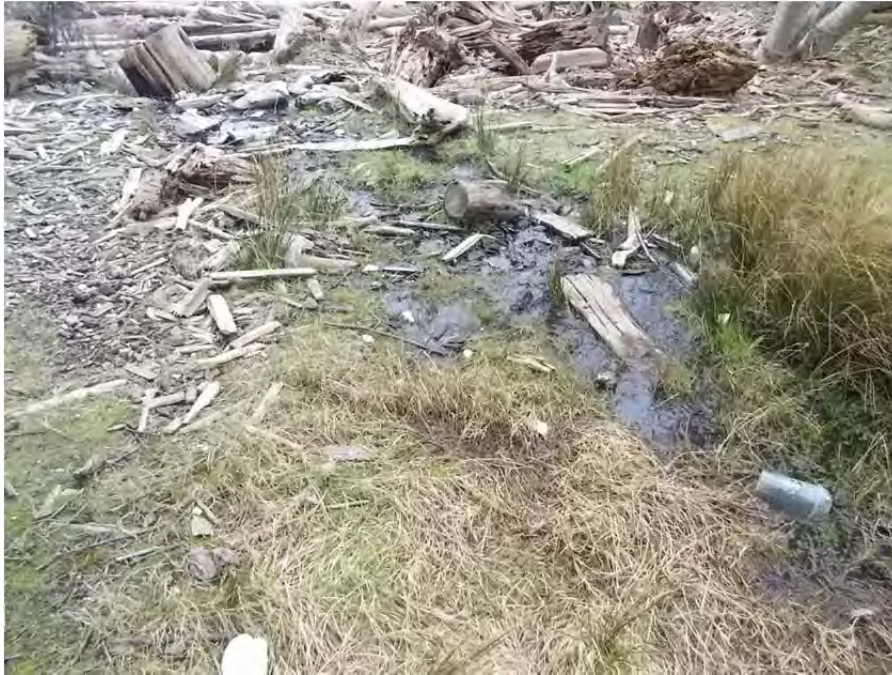
**Figure 42.** The tidal boundary of the non-classified drainage (NCD). Note the small amount of water and lack of a defined channel.

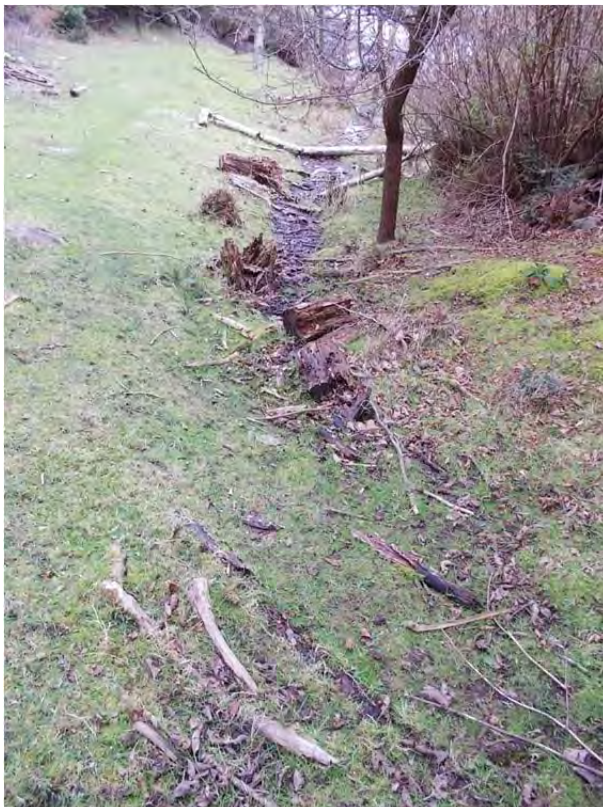
**Figure 43.** Approximately 30 m upstream from the ocean. Note the flow stops and goes subsurface. Also, note the lack of scour and alluvium.
