# **LASQUETI ISLAND WATERSHED ASSESSMENT – DETERMINATION OF THE APPLICABILITY OF THE RIPARIAN AREA REGULATION**

## **STONEHOUSE CREEK, COCKTAIL COVE AND HADLEY LAKE WATERSHEDS ADDENDUM**

**September 12, 2014**

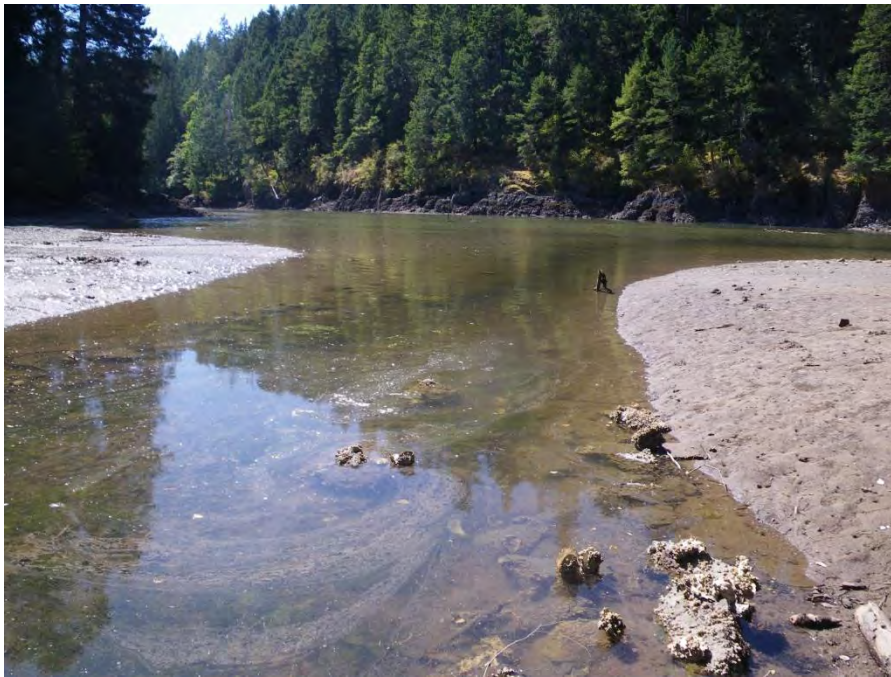
**Photo 1.** Looking west at the area where Stonehouse Creek flows into the marine environment.

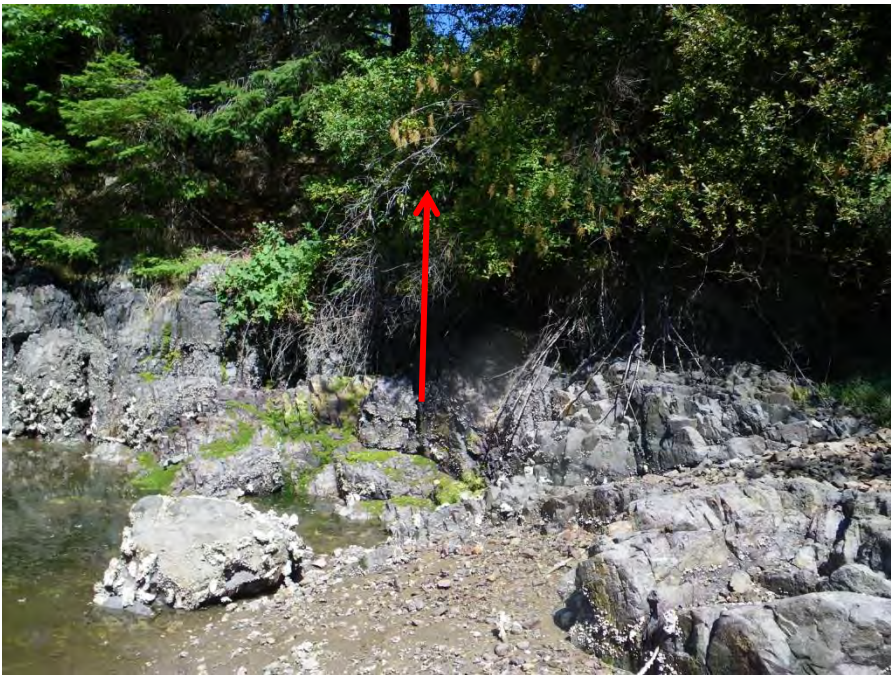
a gradient of approximately 45-55%. At the base of the ledge, there is no plunge pool and water flows over bedrock outcrops. It should be noted that during the highest tides of the year, the sea level extends up to the base of the ledge. At the time of the assessment, the bedrock ledge was concealed by dense Himalayan blackberry (*Rubus discolor*) growth.

**Photo 2.** The outlet of Stonehouse Creek. Note the vertical bedrock ledge and lack of a plunge pool. Also, vegetation growth conceals the area where water flows over the ledge (marked with red arrow).

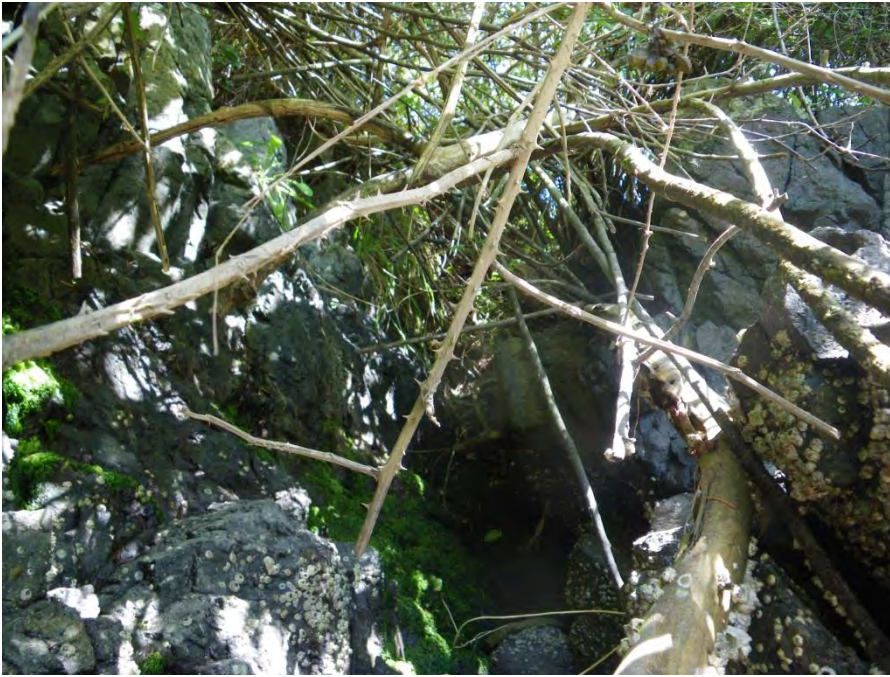
**Photo 3.** A photo representing the area where Stonehouse Creek flows over the bedrock ledge.

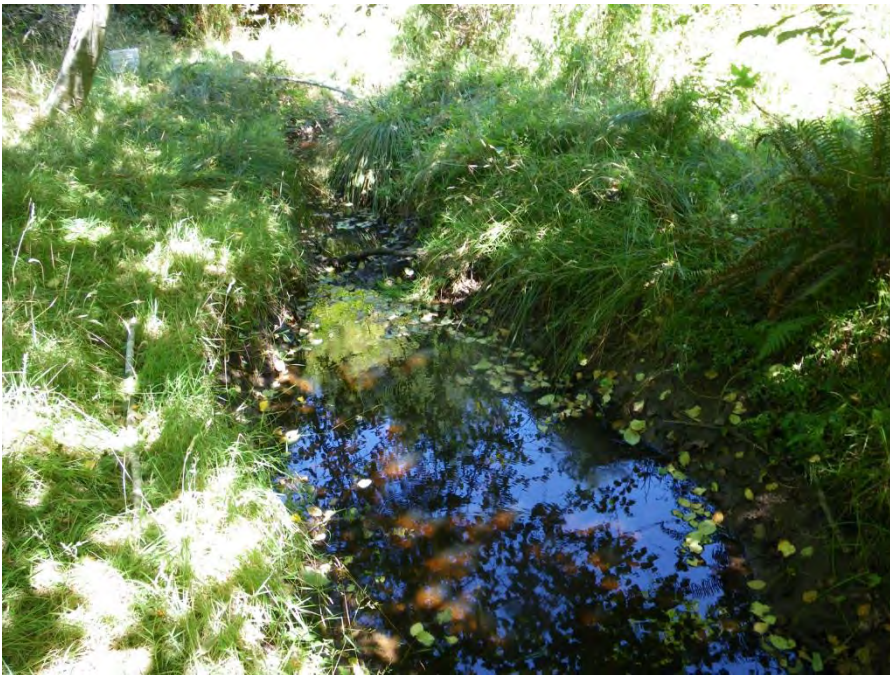
At the time of the assessment, the stream bed was dry, and only one small pool of standing water was observed. Based on the field observations, Stonehouse Creek possesses a seasonal flow regime and contains water through the winter and early spring. According to the Water Allocation Plan (Bryden & Barnett, 1992), Oasis Swamp represents the headwaters of Stonehouse Creek. During the summer months anecdotal evidence suggests that water levels recede and the swamp does not contribute water to the stream. This was verified during the field assessment, as the stream was not flowing.

**Photo 4.** A portion of Stonehouse Creek, approximately 35 m upstream of the bedrock ledge. It should be noted this pool of water was isolated at the time of the assessment, and there was no water flowing in or out of the pool. This pool does not represent adequate habitat for resident fish.

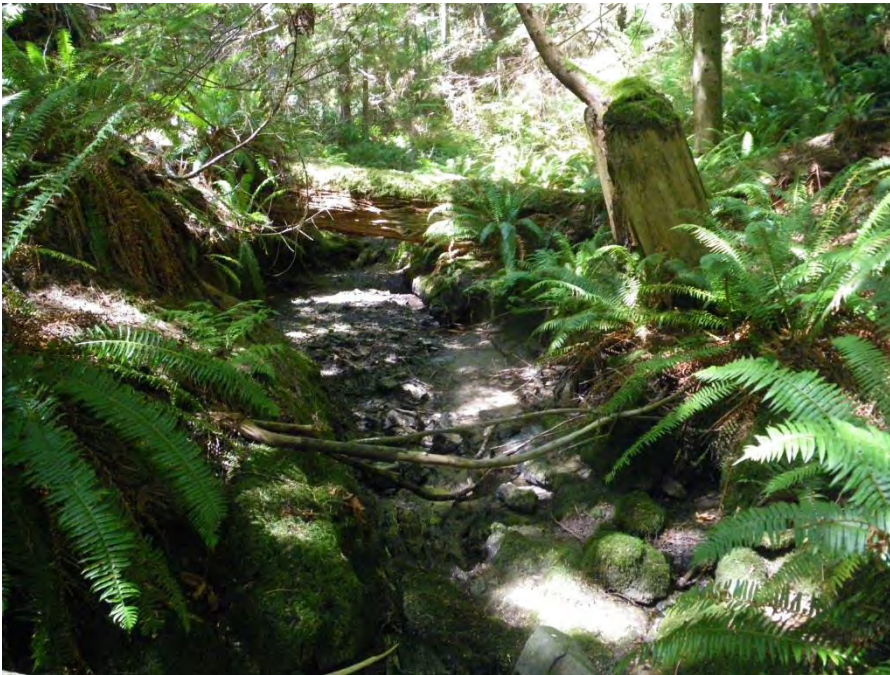
whether perennially-available habitat was sufficient to support resident fish. During the assessment, the stream bed was dry, and no continuous segments of flowing water were noted. The stream is also not of a sufficient magnitude to allow the retention of wetted pools that would provide suitable summer refugia for fish.

**Photo 5.** A photo representing the lack of perennial water flow within Stonehouse Creek. Based on the channel characteristics (*i.e.* bedrock substrate and bank erosion), it appears as though Stonehouse Creek is a flashy drainage.

Based on a lack of perennial habitat for resident fish, and lack of access to any parts of the watershed to anadromous fish that could potentially use seasonal streams (e.g. chum – *O.keta* and pink - *O.gorbuscha* – salmon), this watershed has been designated a “Watershed with No Fish Habitat”. In addition, this watershed is not subject to the RAR process.

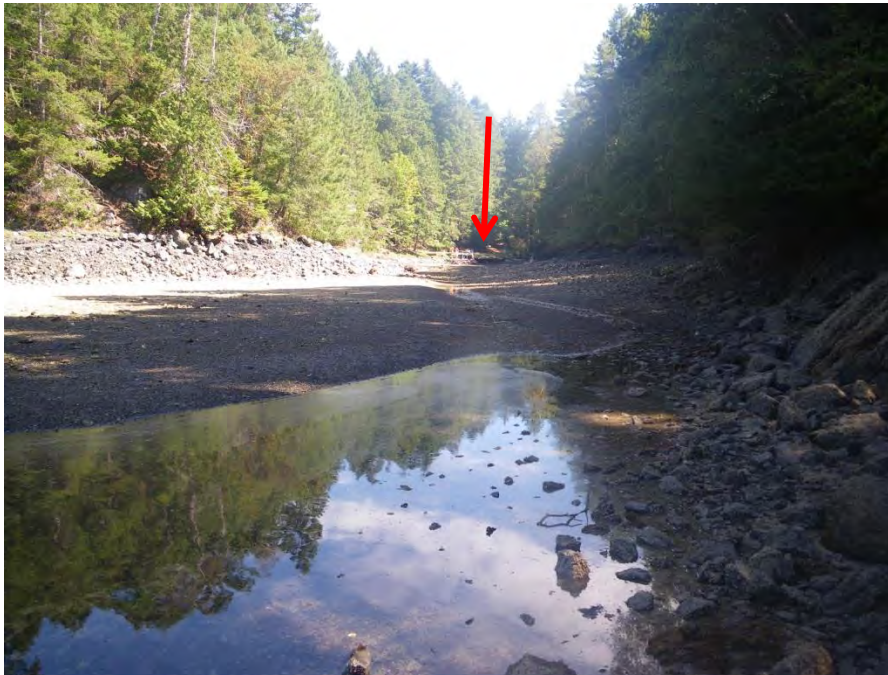
**Photo 6.** Looking east towards the head of Cocktail Cove. The red arrow marks the approximate location where the main outlet drainage for the watershed flows into the marine environment.

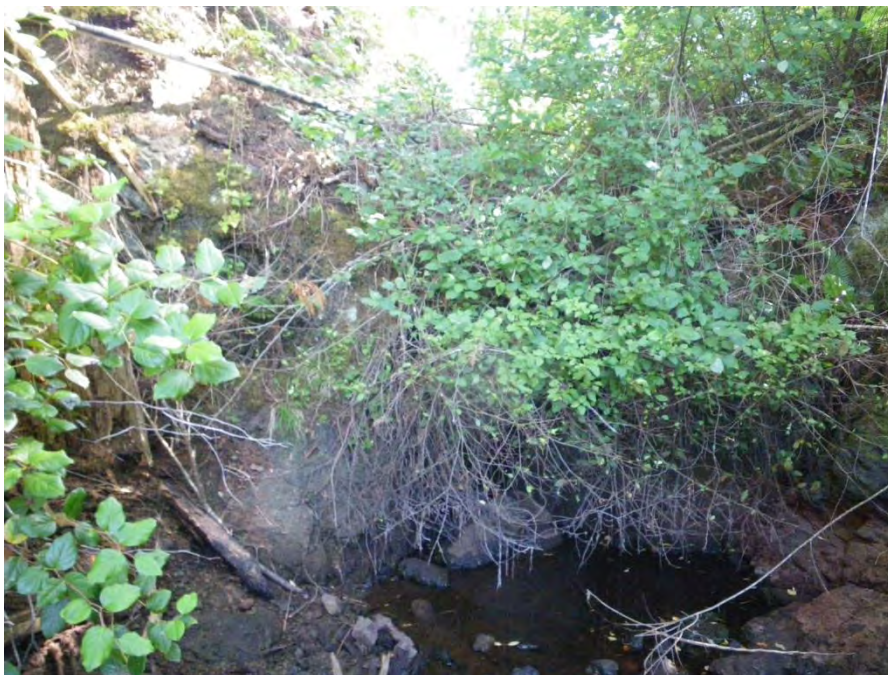
The outlet of the Cocktail Cove Watershed enters the ocean at the northwest end of Lasqueti Island, at the head of Cocktail Cove. At tidewater, the stream flows over a vertical bedrock ledge, approximately 2-3 m high and onto a gravel/sand beach. Immediately upstream of the bedrock cascade, the stream is well defined and the bankfull width of the stream is between 2.0 m and 2.5 m. The gradient of the stream bed is 1-2% and the composition of the substrate is dominated by organics (*i.e.* decomposing leaf litter and woody debris); however, pockets of small gravel alluvium were observed. Isolated pockets of standing water, approximately 0.2 m deep, were noted within the channel at the time of the assessment.

**Photo 7.** A photo of the ledge that the Cocktail Cove outflow creek flows over at tidewater. Note the dense shrub growth that conceals the ledge.

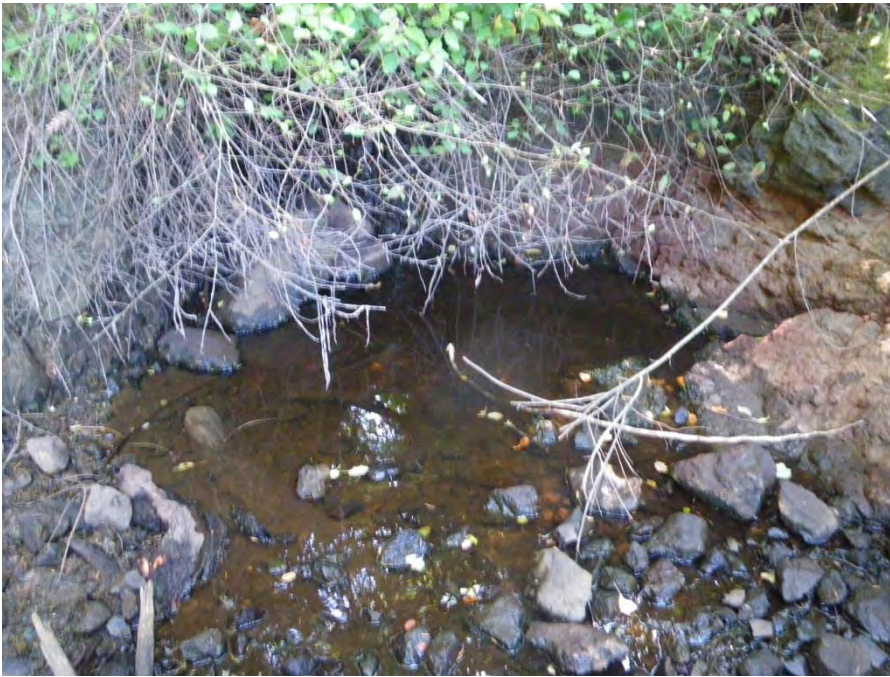
**Photo 8.** The shallow plunge pool located at the base of the bedrock ledge. It should be noted that this pool does not provide sufficient depth for anadromous salmonids to jump the ledge, even during a high tide.

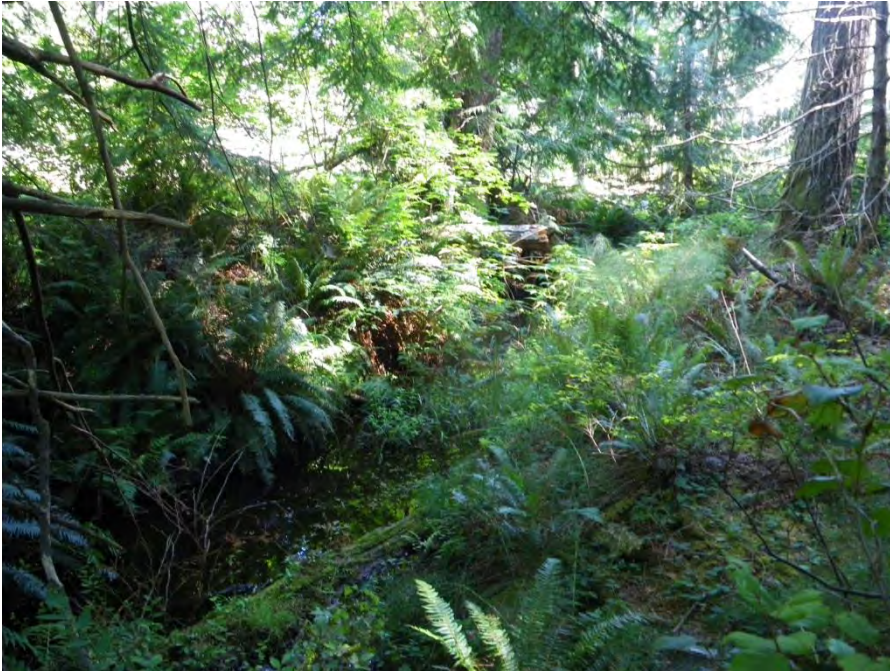
**Photo 9.** The morphology of the Cocktail Cove outlet drainage approximately 30-40 m upstream of tidewater. It should be noted that sections of the channel contain water due to the recent construction of beaver dams immediately upstream.

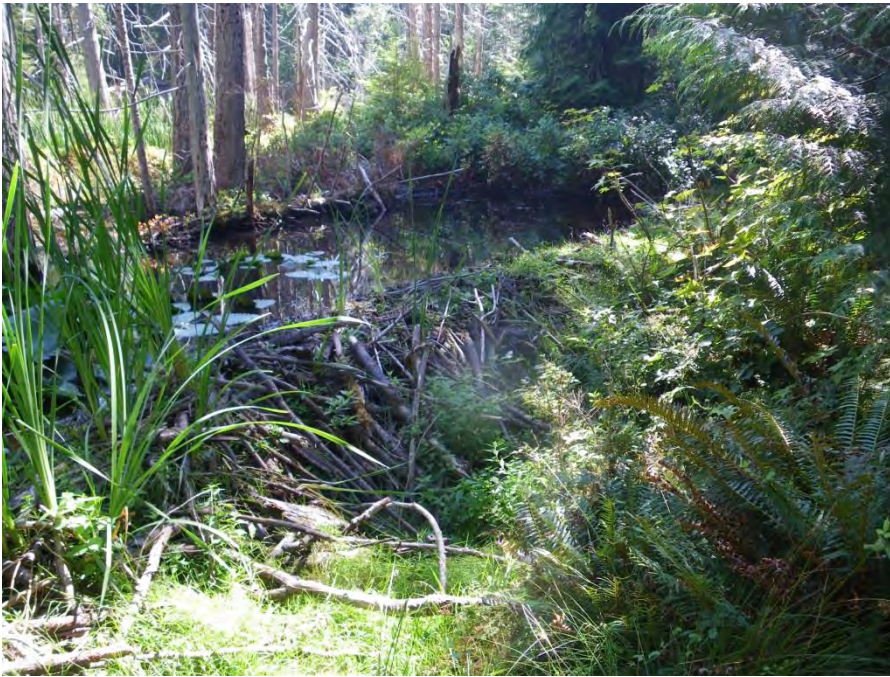
Approximately 75 m upstream of tidewater, the stream is fed by a wetland that has been created as a result of beaver activity (*i.e.* dam construction). The wetland is at least 50 m wide and 200 m long. Substrate within the wetland is composed entirely of organic material.

**Photo 10.** The beaver dam, which was constructed approximately 70 m upstream of tidewater. Construction of the dam has altered hydrology throughout the area and created a wetland that currently contains water on a perennial basis.

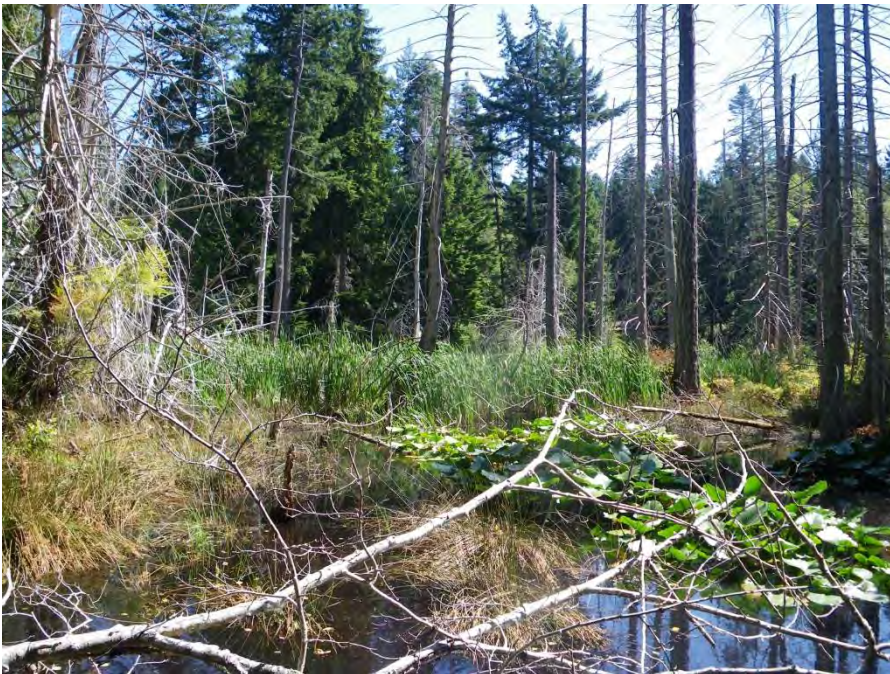
Aquatic plant growth was noted as being abundant within the wetland. Cattails (*Typha latifolia*) and yellow pond lily (*Nuphar polysepalum*) were noted as being the dominant species.

**Photo 11.** The wetland as seen from the beaver dam. Note the abundance of aquatic vegetation throughout the wetland.

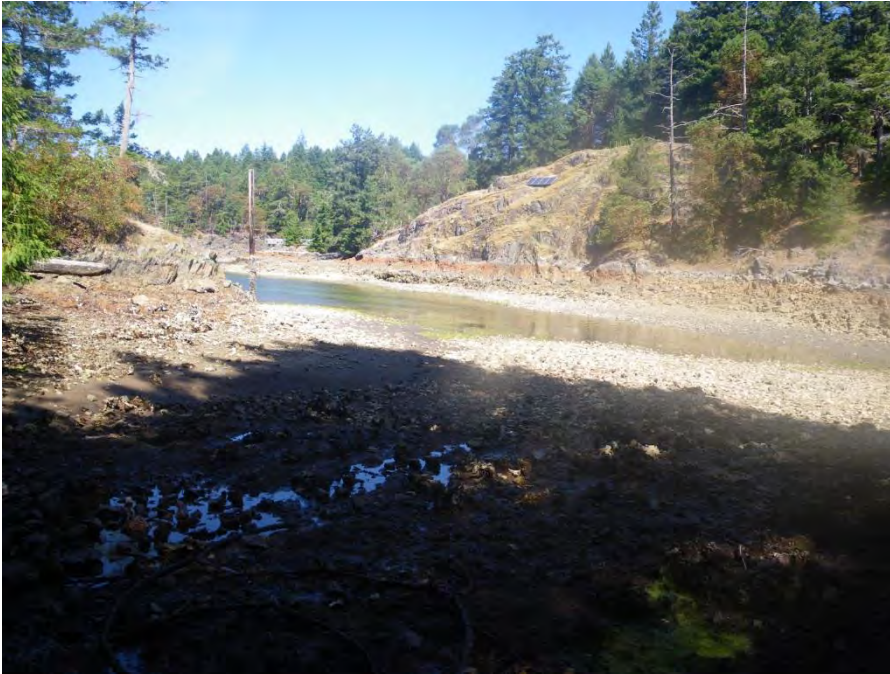
**Photo 12.** Looking northwest at the estuary of Hadley Creek.

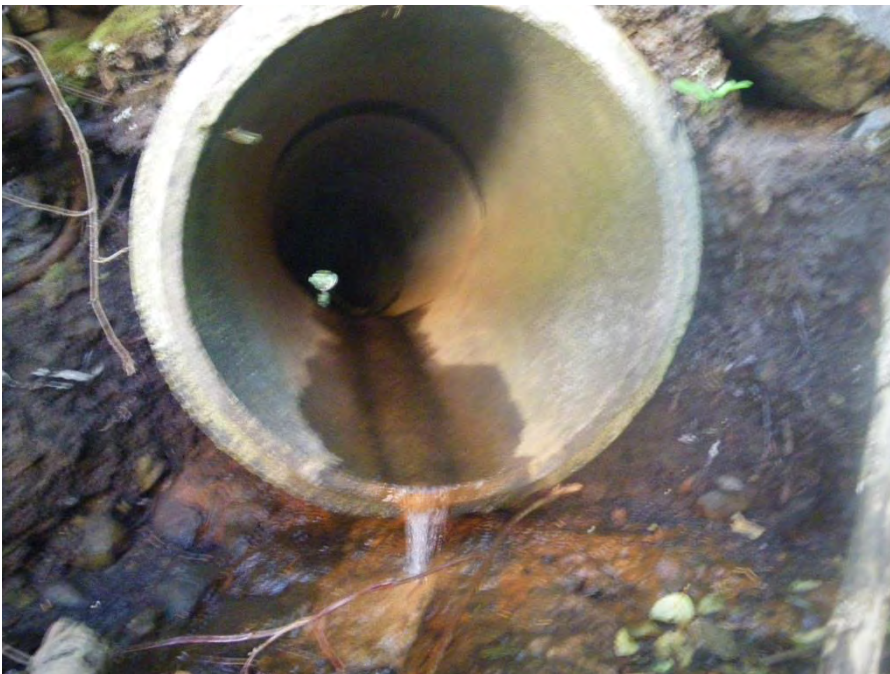
Hadley Creek, which represents the outlet drainage of Hadley Lake, flows in a westerly direction and enters the ocean on the northwest shore of Lasqueti Island. At tidewater, the stream flows through a 30 m long cement culvert that is approximately 400 m in diameter. Water flows from the outlet of the culvert and spreads out over a bedrock outcrop, which contains numerous steps that range between 0.5 m and 1.0 m high. When the culvert was installed, it was positioned at a slope of 15-20% and gravel fill was imported and landscaped around the culvert to provide stability.

**Photo 13.** The cement culvert at the outlet of Hadley Creek, near tidewater. It should be noted that this culvert currently represents a barrier (albeit not permanent) to upstream migration by anadromous salmonids.

As the tidewater culvert does not represent a permanent barrier to fish, and no other natural barriers to the upstream movement of anadromous fish were observed and due the potential for resident fish to occur in Hadley Lake, Hadley Creek represents a “stream” under the RAR. As a result, the Hadley Lake watershed is subject to the RAR process.

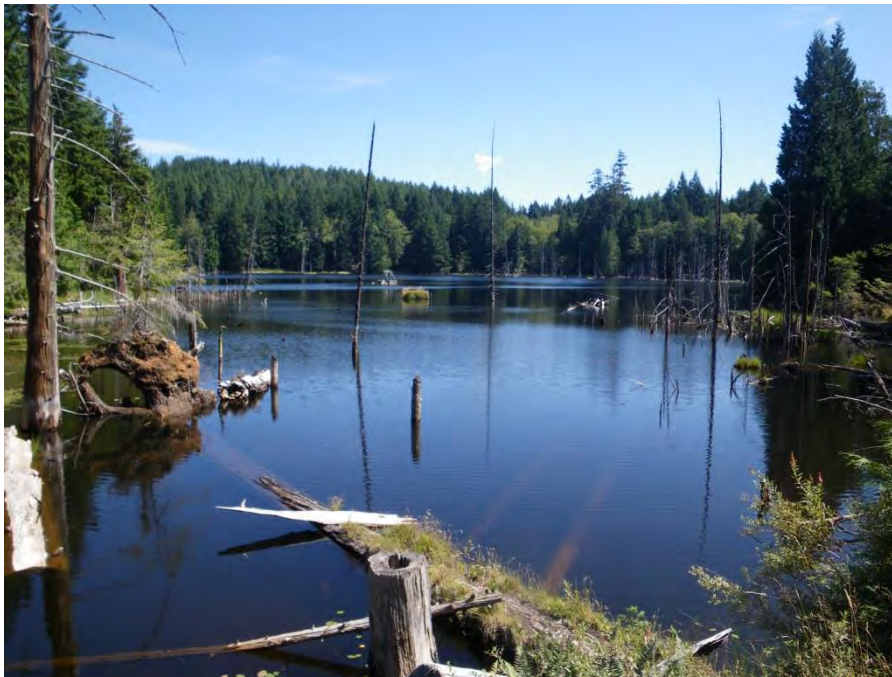
**Photo 14.** Looking east from the outlet of Hadley Lake. This lake provides potable water to residents of Lasqueti Island. The lake provides at least potential habitat for resident salmonid fish to occur.

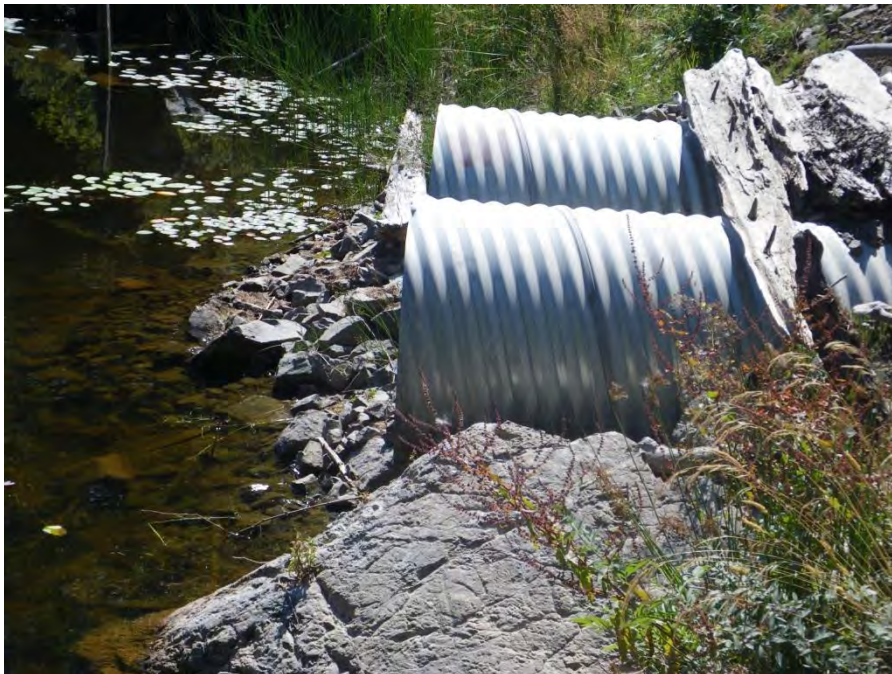
not defined and water flows over a steep bank that has a slope of greater than 30%. The bank is composed of rip-rap boulders. It should also be noted that once the lake level drops below its two outlet culverts the only source of water input to the creek is through rain fall. The stream channel becomes defined approximately 30 m downstream of the lake outlet.

**Photo 15.** The inlets of the two outlet culverts that drain Hadley Lake. Note the summer-time water level of the lake is approximately 1.0 m below the bottom of the culverts.

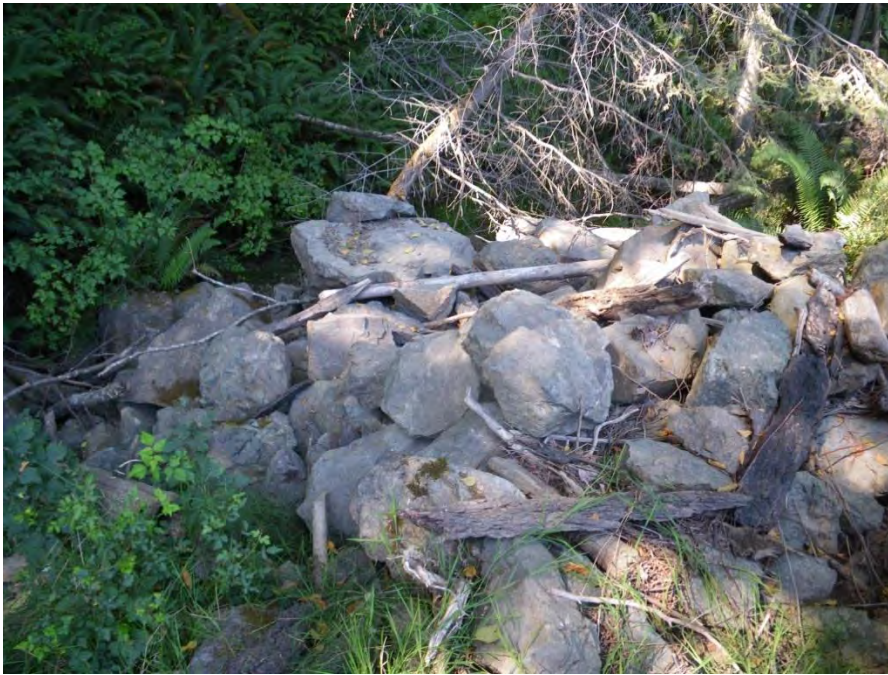
**Photo 16.** Looking downstream (west) from the outlets of the two culverts that drain Hadley Lake. During periods of high flow, water flows over the rip-rap boulders and into the defined channel at the base of the slope (marked with red arrow).
