# **Review of Mayne Island Riparian Area Regulation Requirements - Recommendations Resulting from Application of the Detailed RAR Assessment Methodology**

**Trystan Willmott, B.Sc. A.Sc.T.  
MADRONE ENVIRONMENTAL SERVICES LTD.**

**March 7, 2017**

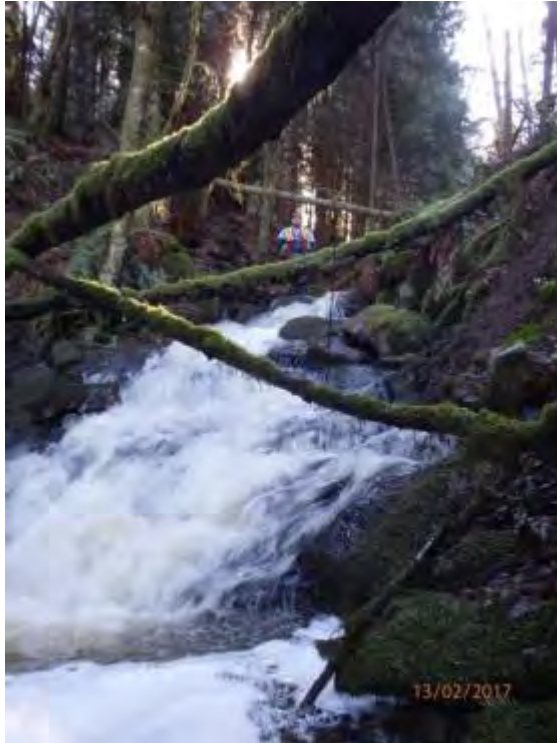
Above and below (following 2 photos): looking upstream along the cascade barrier to upstream fish movement located at tidewater on Campbell Creek. Note shallow, high-velocity cascading flow over bedrock.

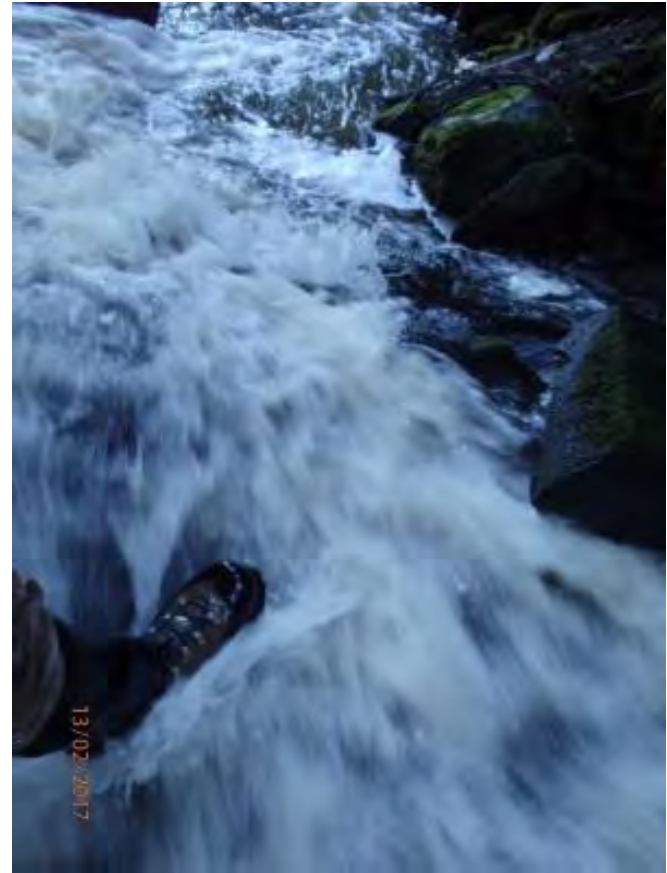
Examples of shallow, high-velocity flow over smooth bedrock through the cascade at tidewater on Campbell Creek.

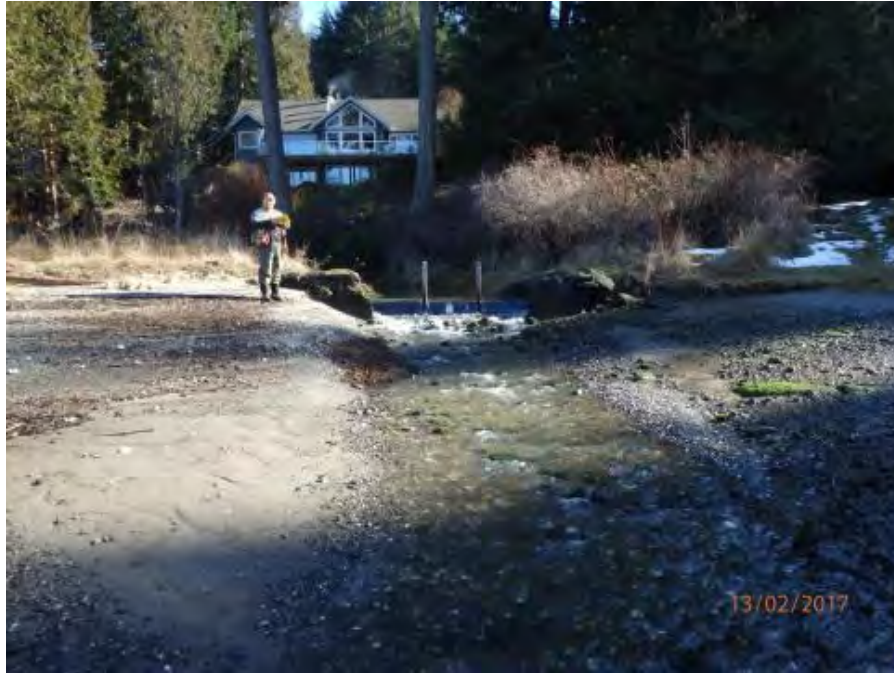
Looking upstream towards the weir located at the mouth of Deacon Creek.

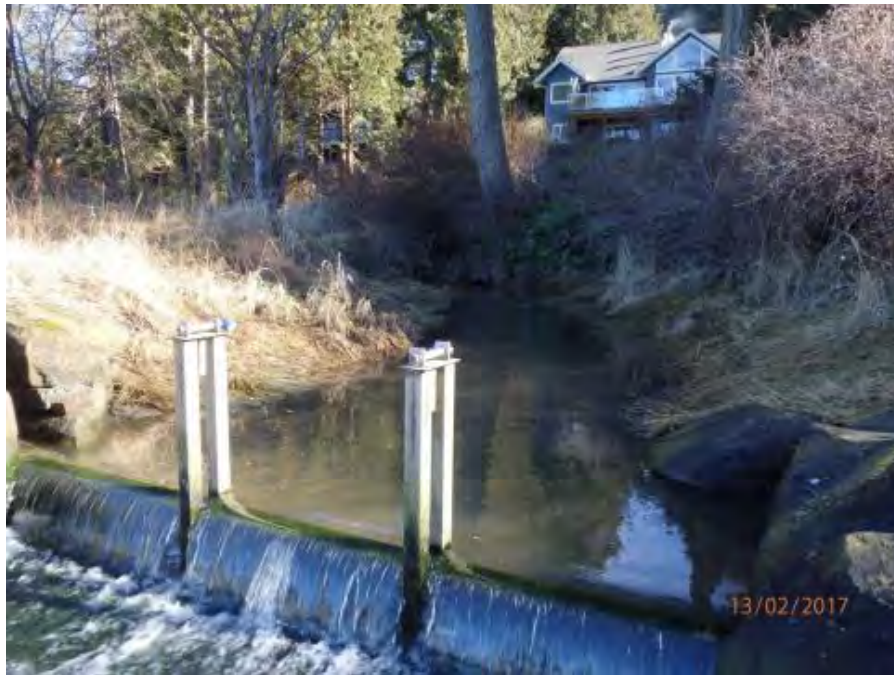
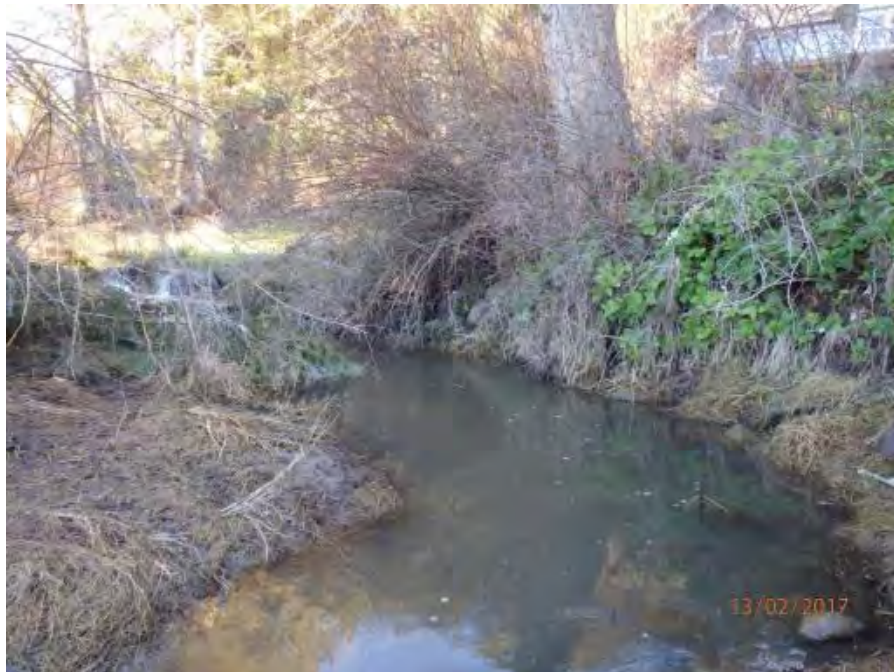
Above and below: looking upstream through the lower segment of Reach 1.

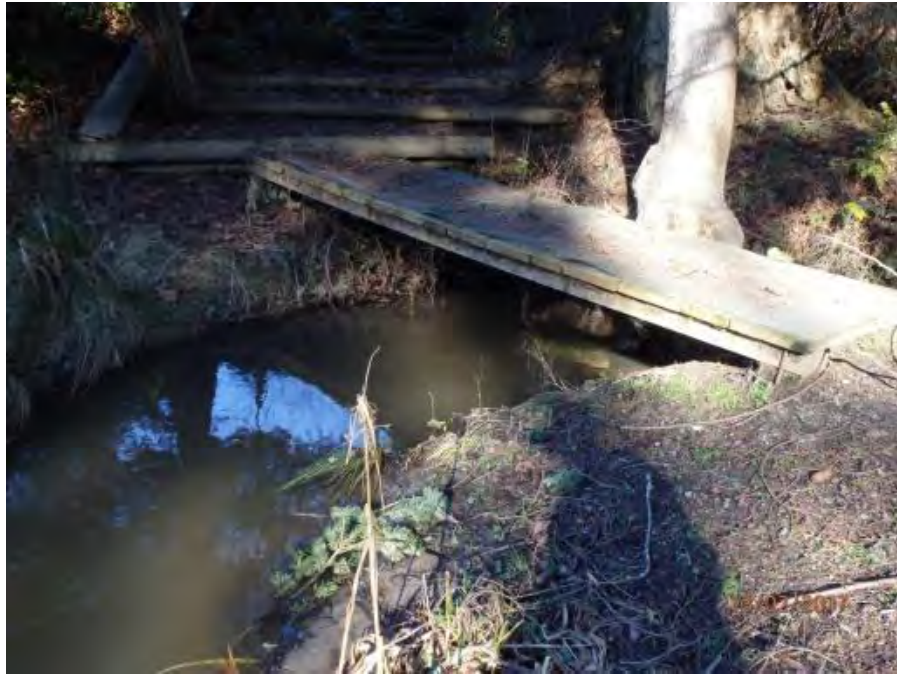
Channel characteristics in the lower segment of Reach 1 where it flows through the 535 Dalton Road property.

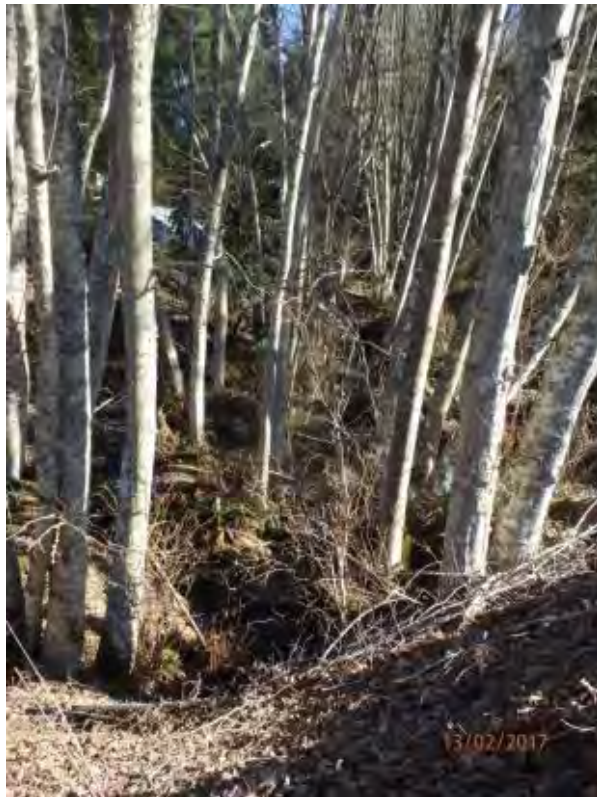
Looking upstream through the lower segment of Reach 2 from Dalton Road. Note the presence of a functioning riparian zone.

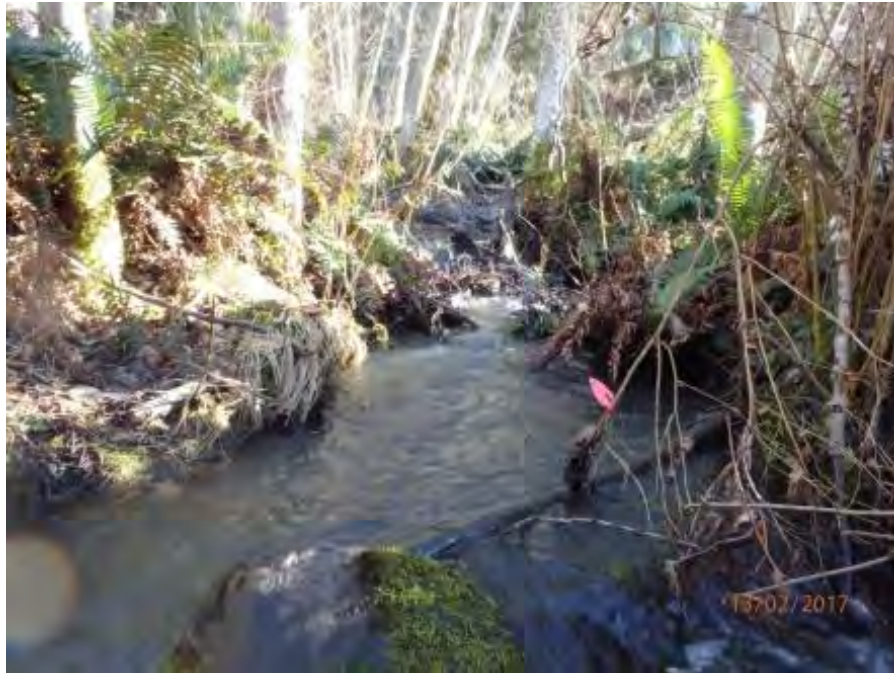
Looking upstream through the lower segment of Reach 2 from the Dalton Road culvert inlet. Note stable channel characteristics.

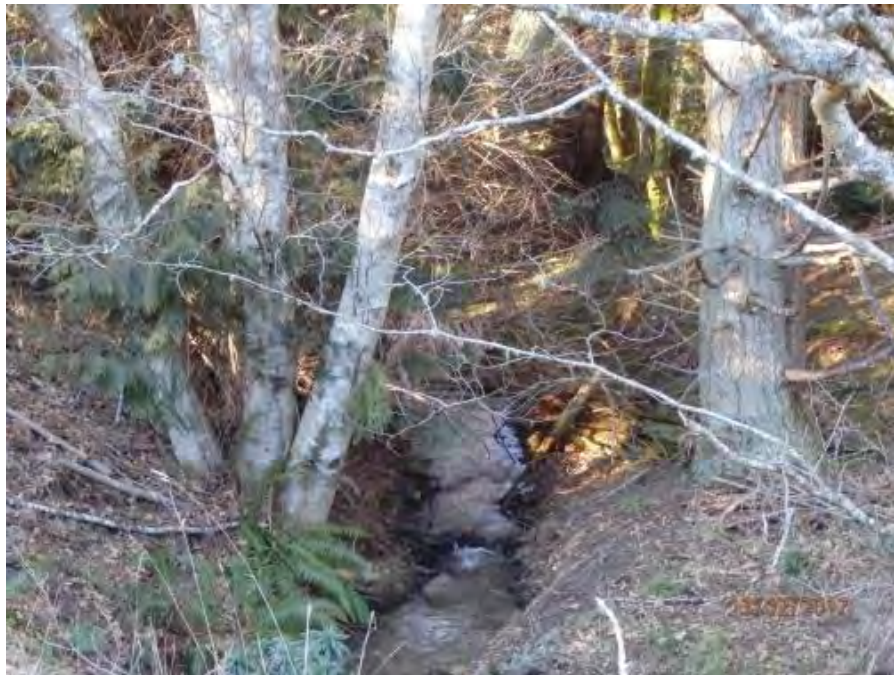
Looking downstream through the upper segment of Reach 2 from Merryman Road. Note presence of a continuous, functioning riparian zone.

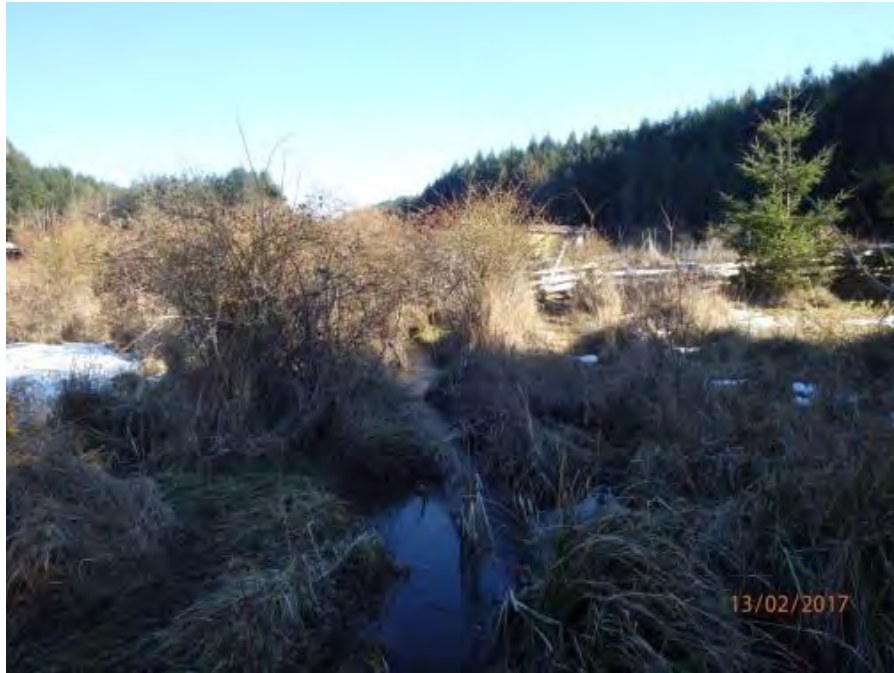
Looking upstream through the lower segment of Reach 3 where it flows through agricultural land on the 316 Wood Dale Drive property.

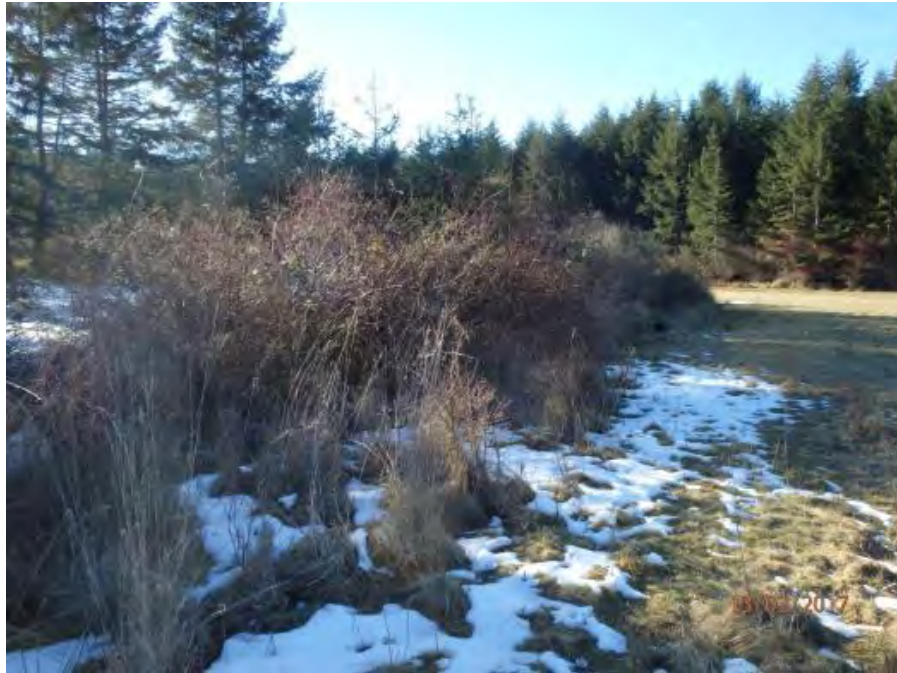
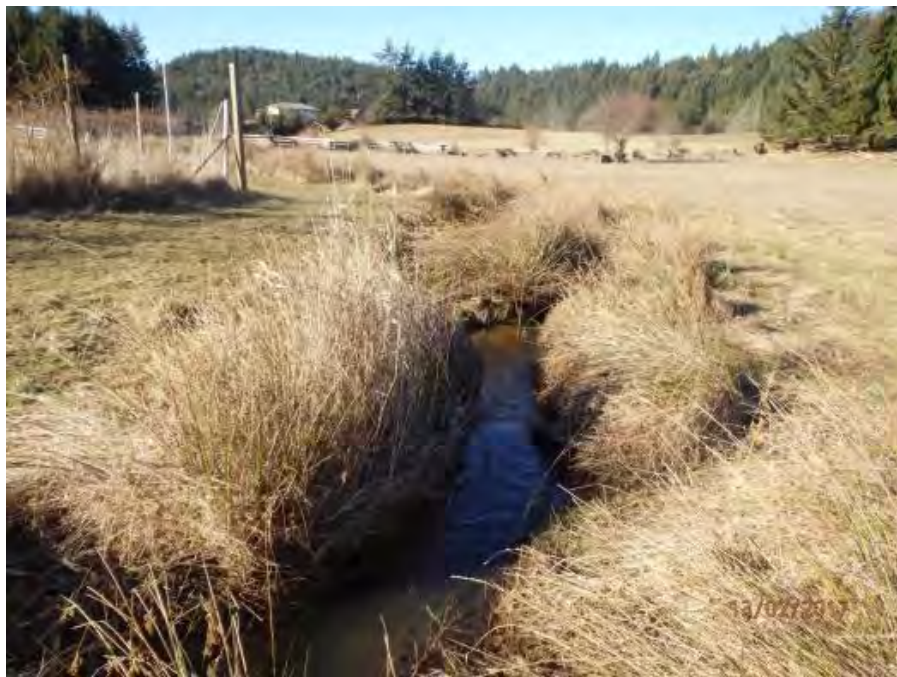
Above and below: looking downstream through the channelized segment of Deacon Creek (Reach 3) where it flows through agricultural land located on the 316 Wood Dale Drive property.

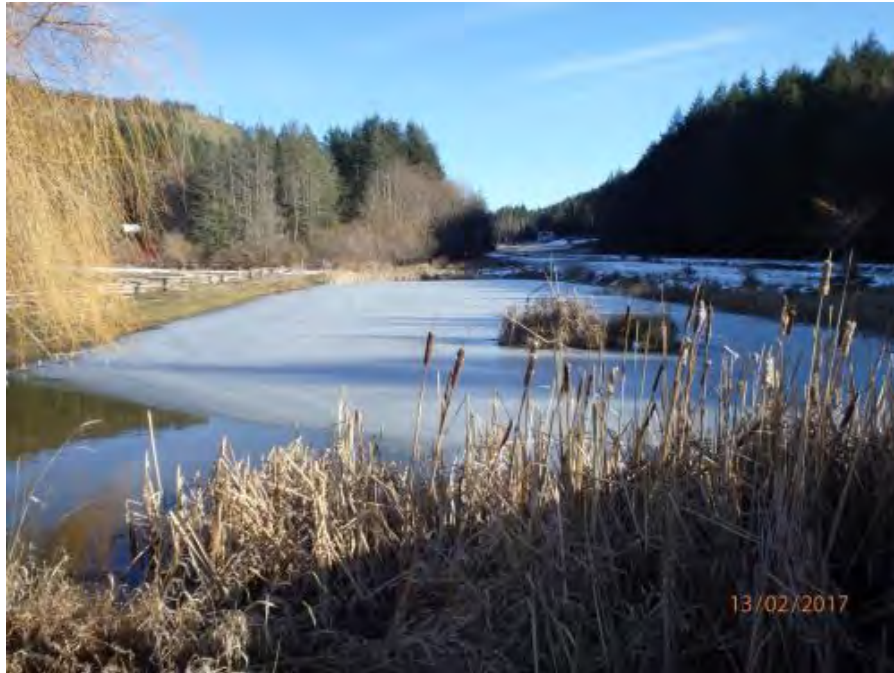
Looking upstream over the irrigation pond representing Reach 4 of Deacon Creek (305 Merryman Road).

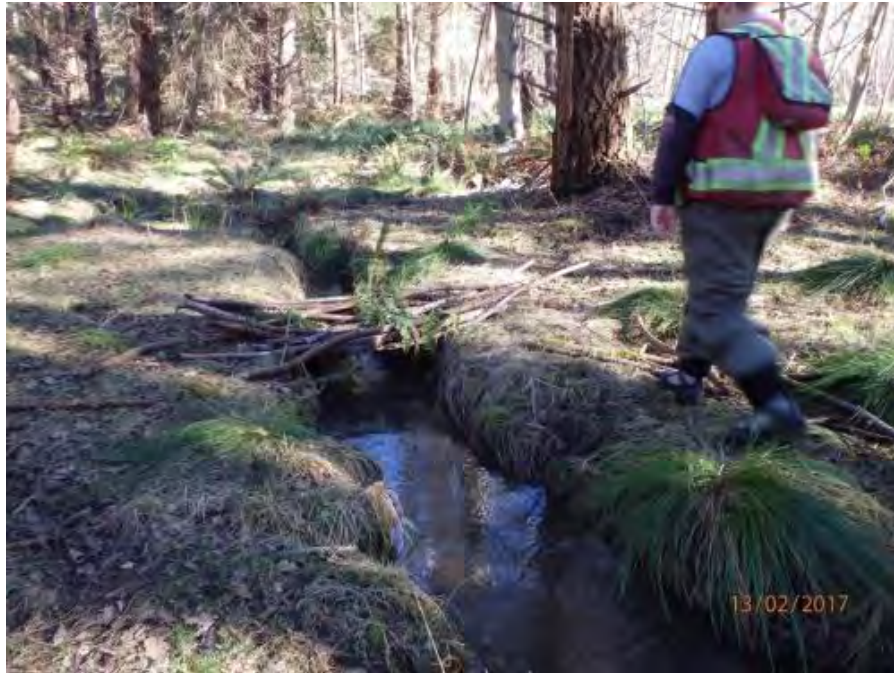
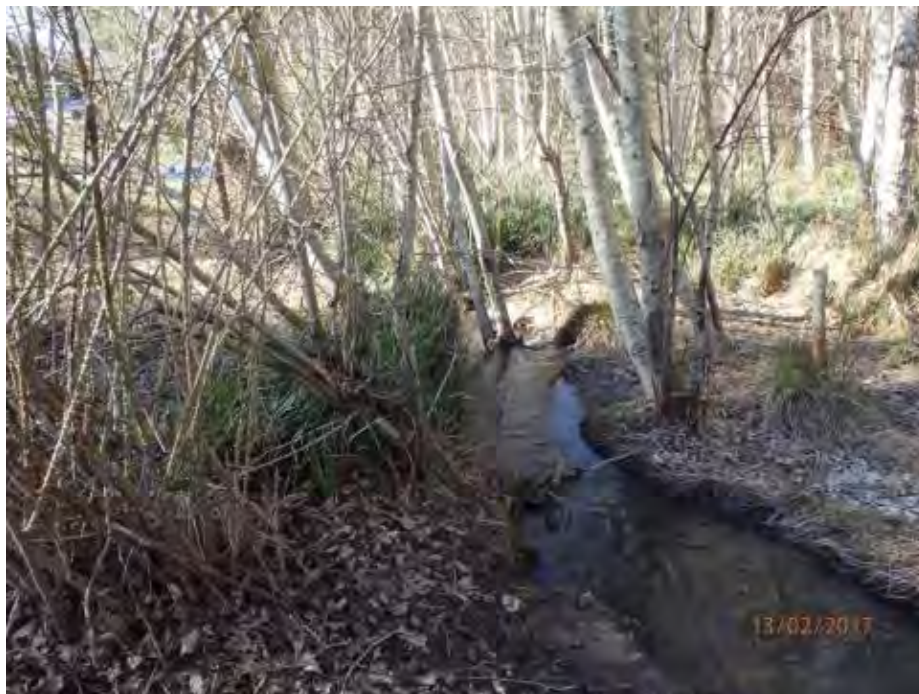
Above and below: typical channelized characteristics of Reach 5 where it flows through the 325 Merryman Road property.

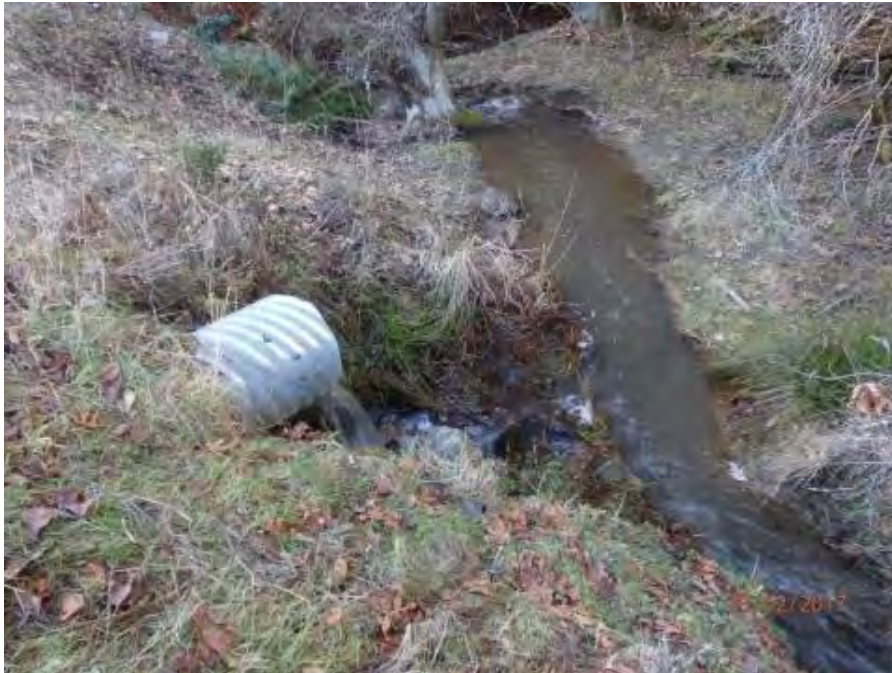
Perched culvert and inflow of ditch flowing along the south side of Merryman Road into Deacon Creek.

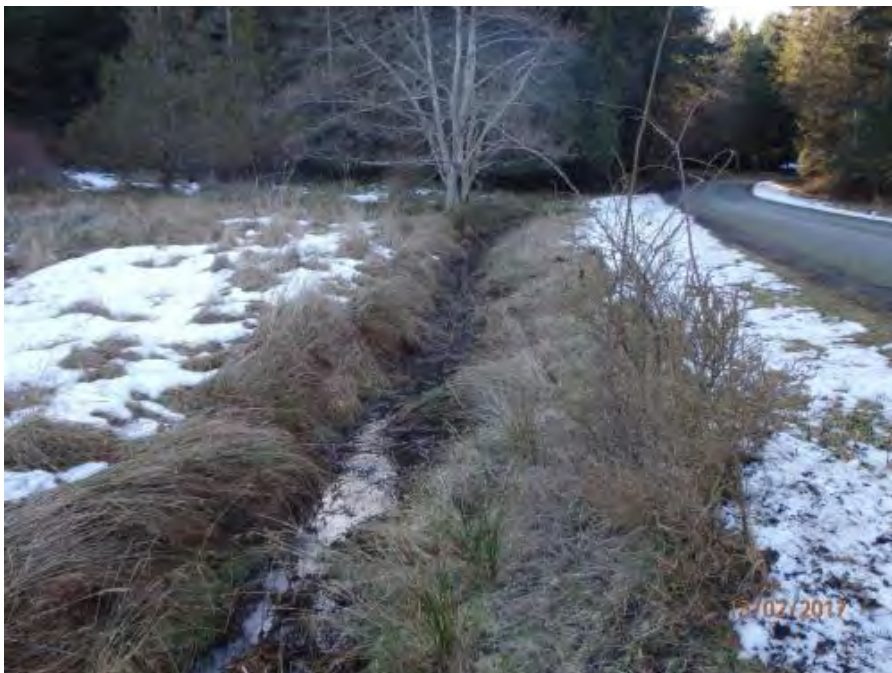
Looking upstream (west) along the ditch flowing along the south side of Merryman Road.

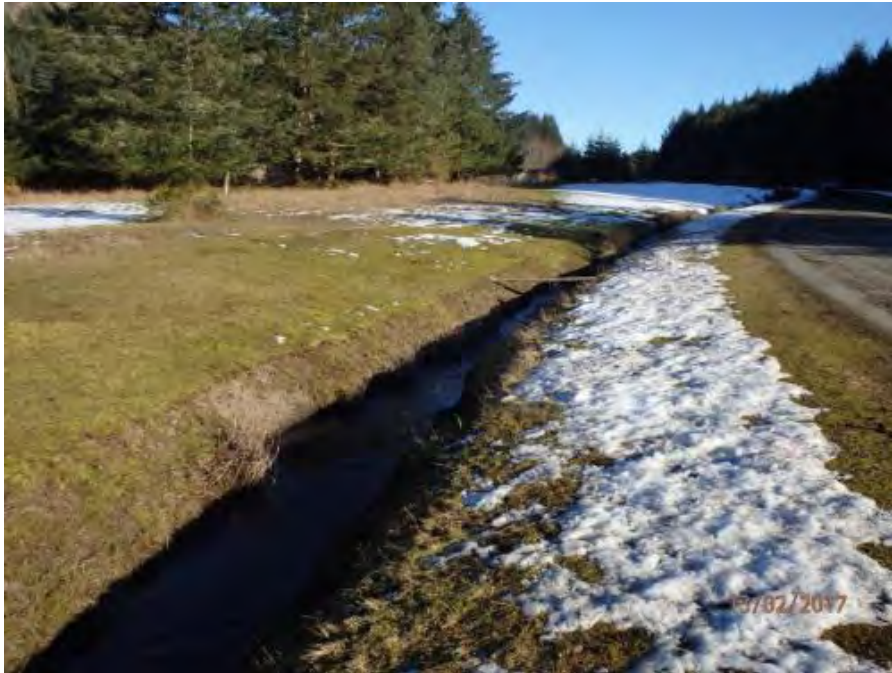
Looking upstream (east) along the ditch flowing along the north side of Merryman Road immediately upstream of its confluence with Deacon Creek.

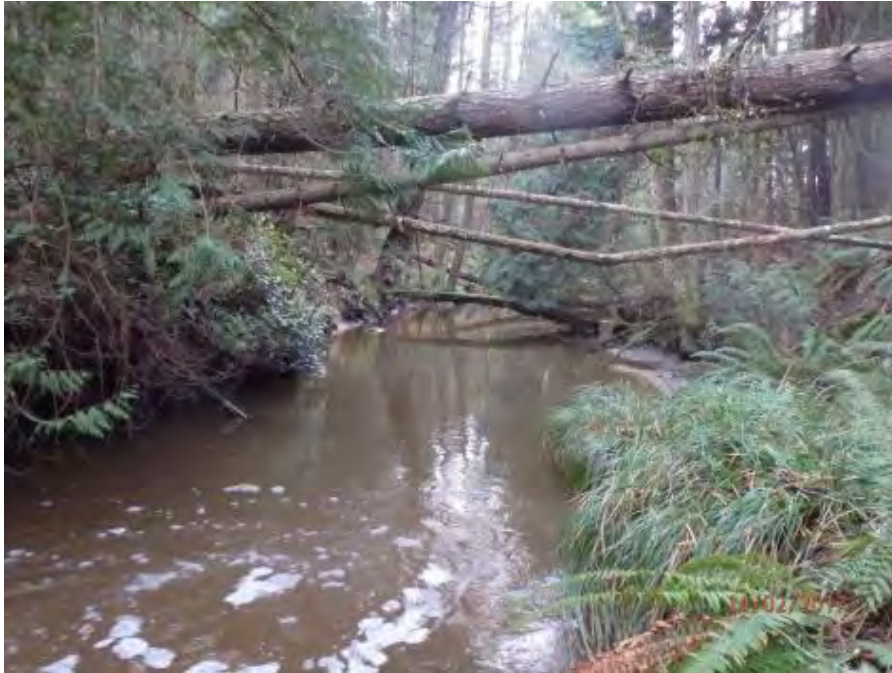
Looking downstream along tidal Reach 1 from the Horton Bay Road crossing.

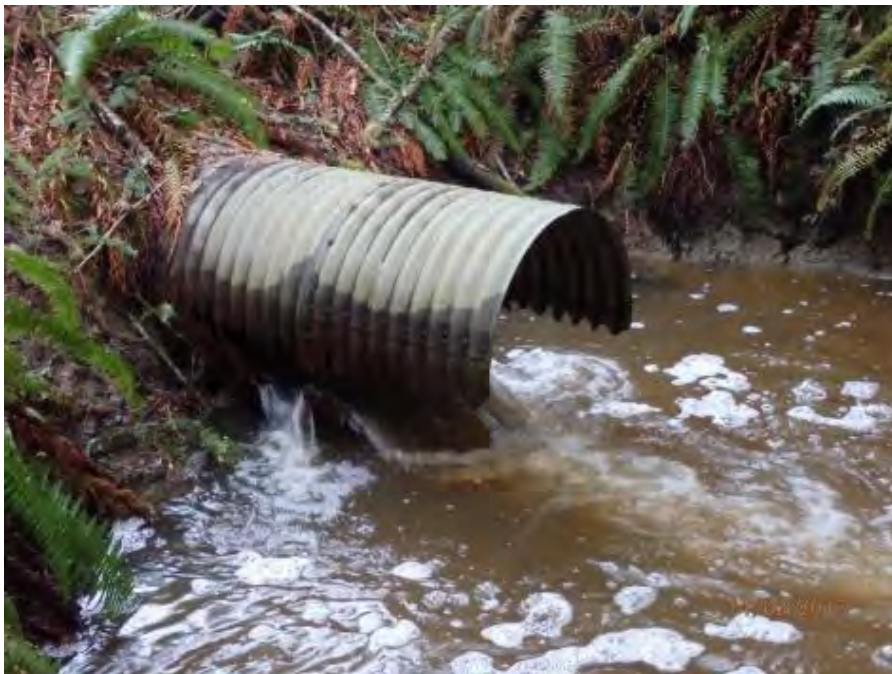
Partially collapsed culvert carrying Horton Creek underneath Horton Bay Road. This culvert will be submerged during high tides.

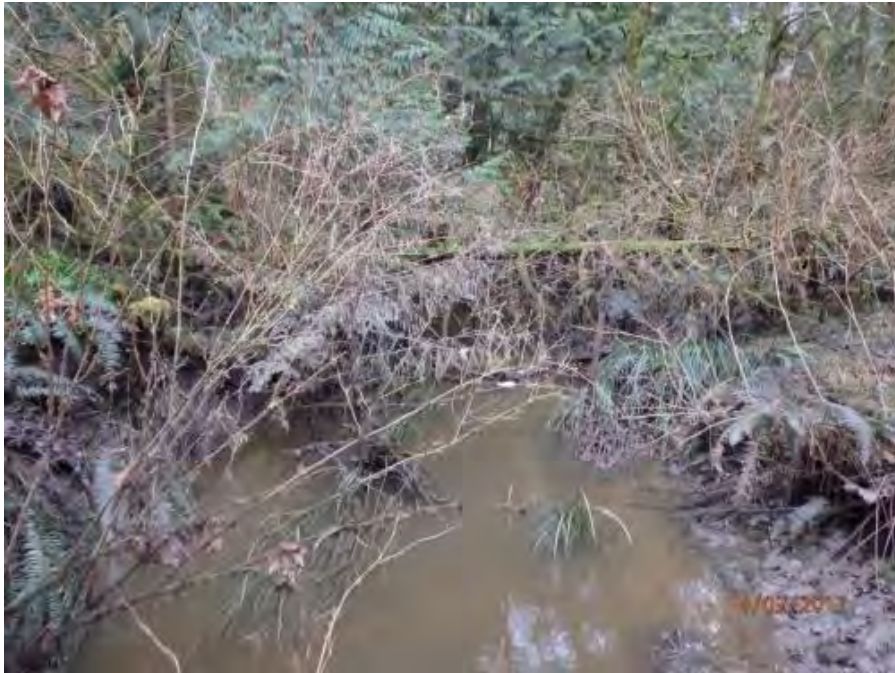
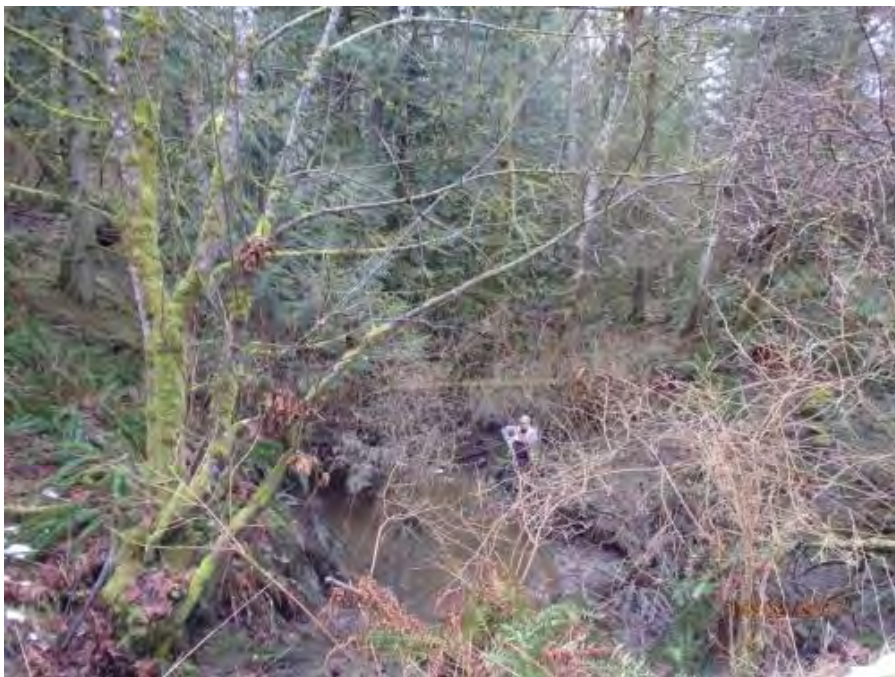
Above and below: looking upstream through the lower segment of Reach 2 from the Horton Bay Road crossing. Note evidence of tidal inundation in the upper photo.

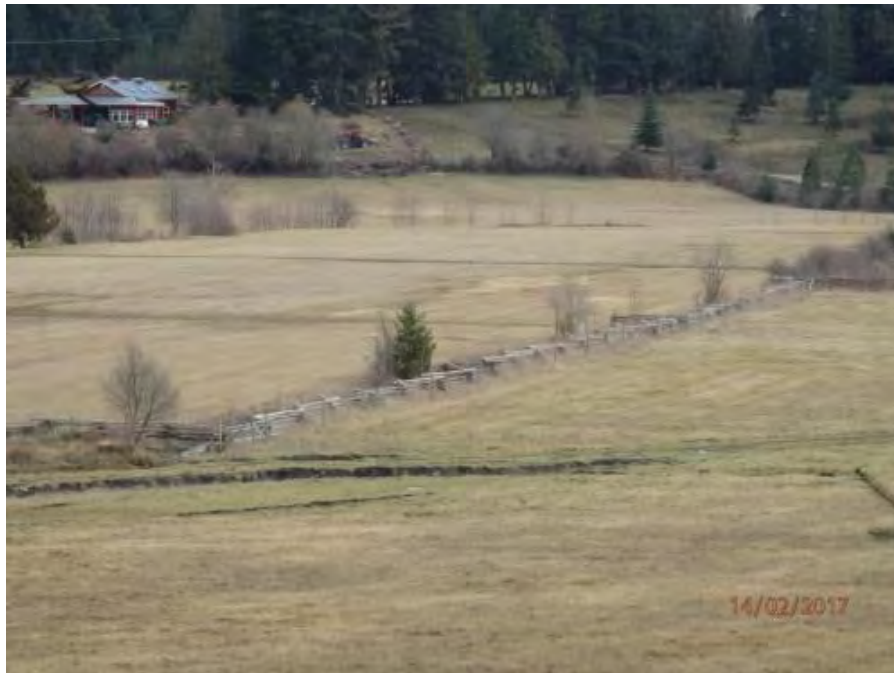
Looking downstream along the channelized segment of Reach 4 from Simpson Road where it flows through the Glenwood Farm property.

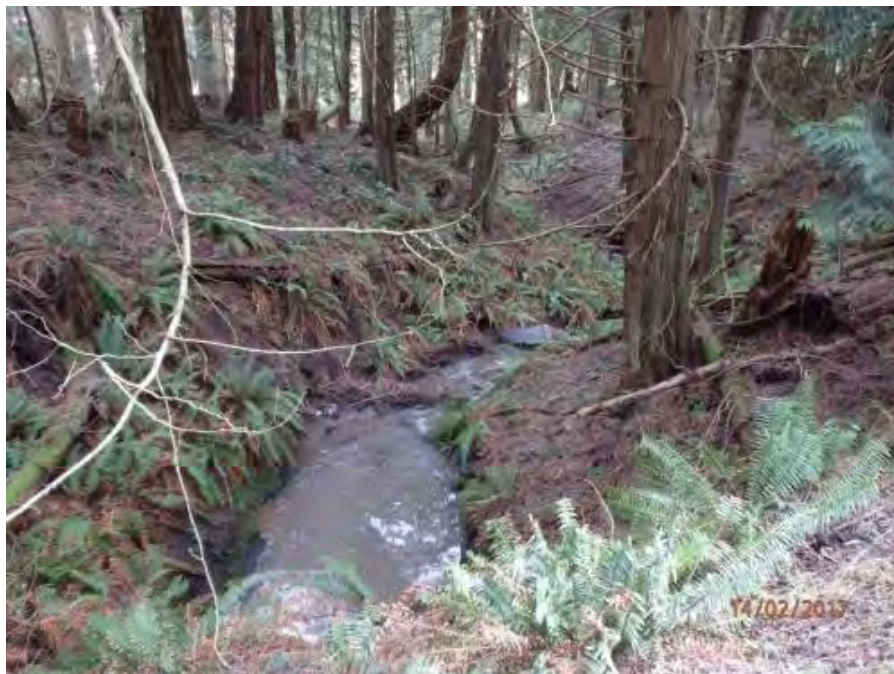
Looking downstream along the upper segment of Reach 4 from Simpson Road. Note more natural channel conditions, natural drainage draw and functioning riparian vegetation.

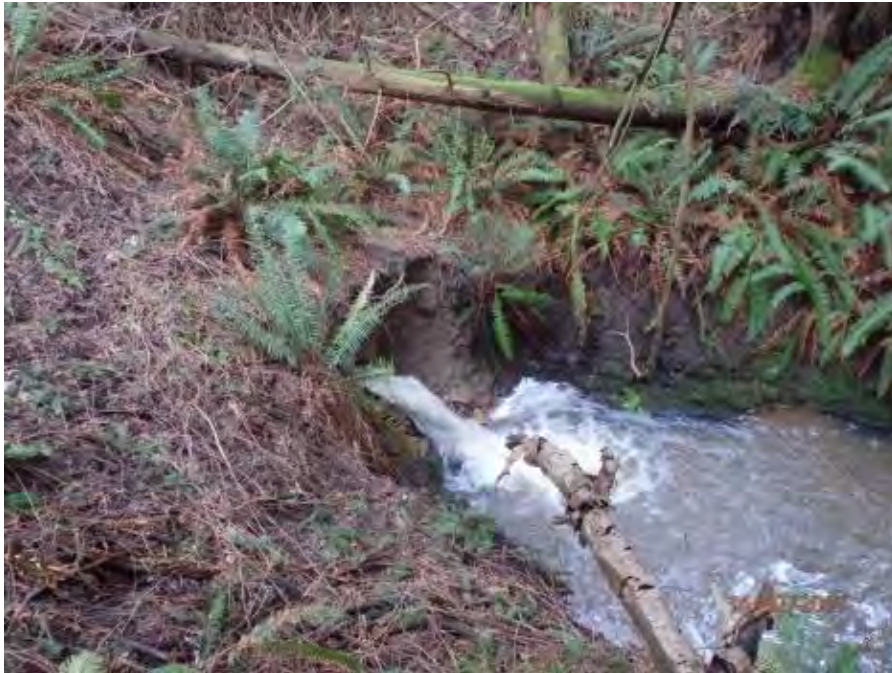
Outflow of perched culvert carrying Horton Creek underneath Simpson Road. This feature represents a barrier to the upstream movement of fish, but is located well above the pond outlet barrier located in Reach 3.

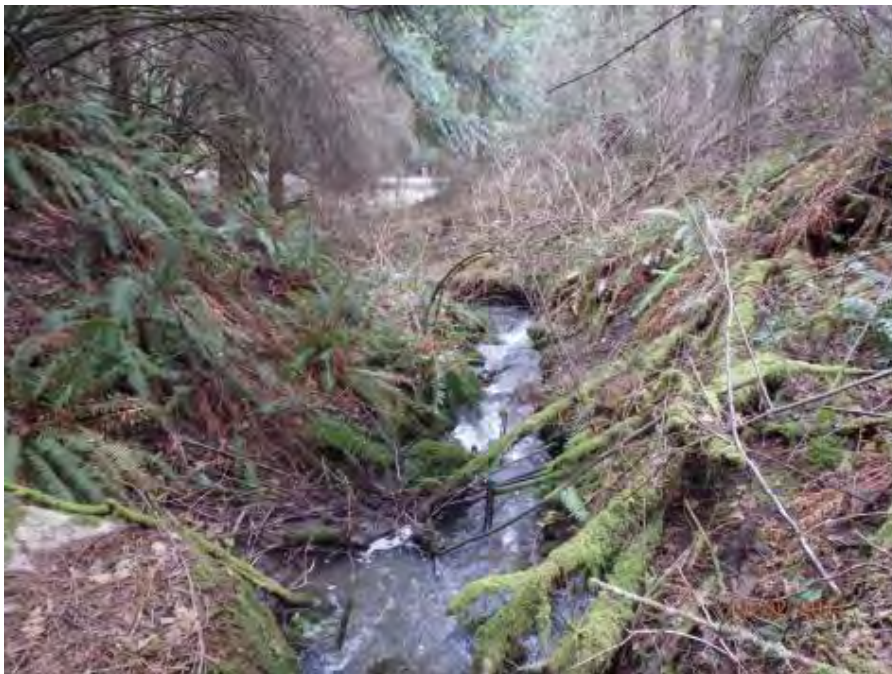
Looking downstream through natural stream draw typical of the lower segment of Reach 5 where it flows through the 622 Gallagher Bay Road property.

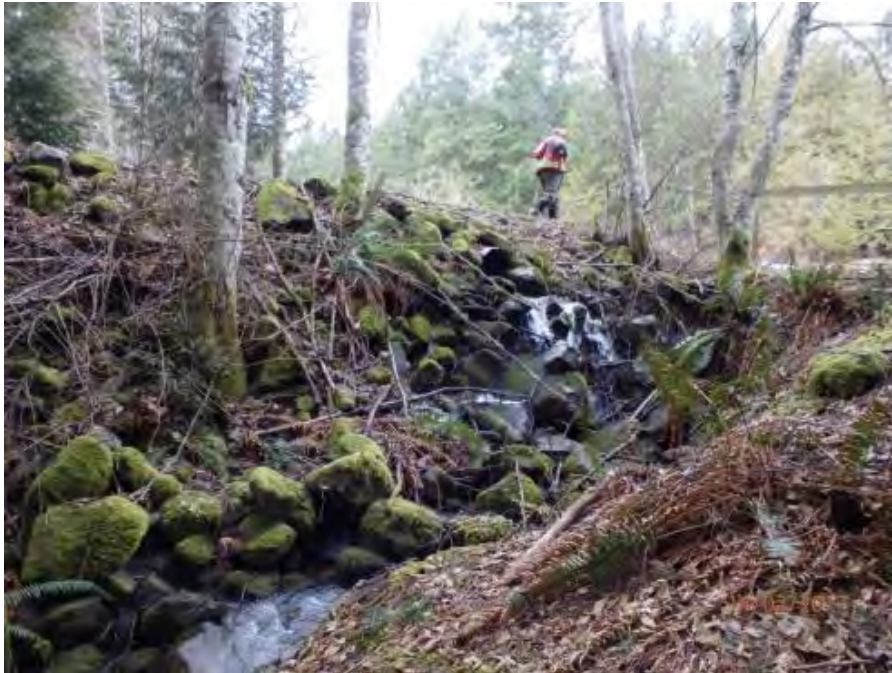
Dam and culvert outlet representing a barrier to upstream fish movement located mid-way through Reach 5 (622 Gallagher Bay Road). This feature is located well above the pond outlet barrier located in Reach 3 and also the perched culvert barrier located at Simpson Road.

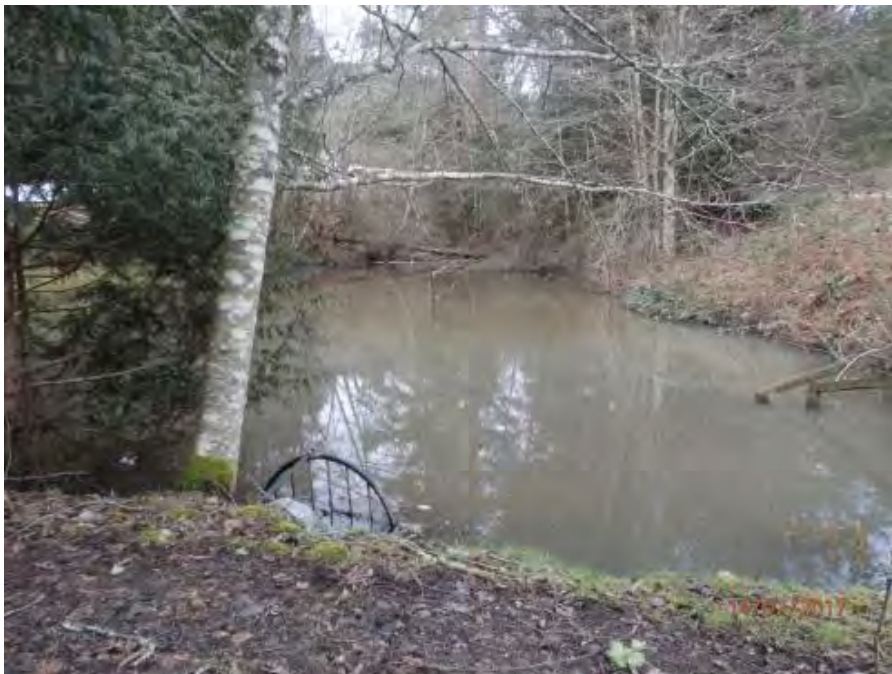
The dam shown above impounds water to form a small irrigation pond located mid-way through Reach 5.

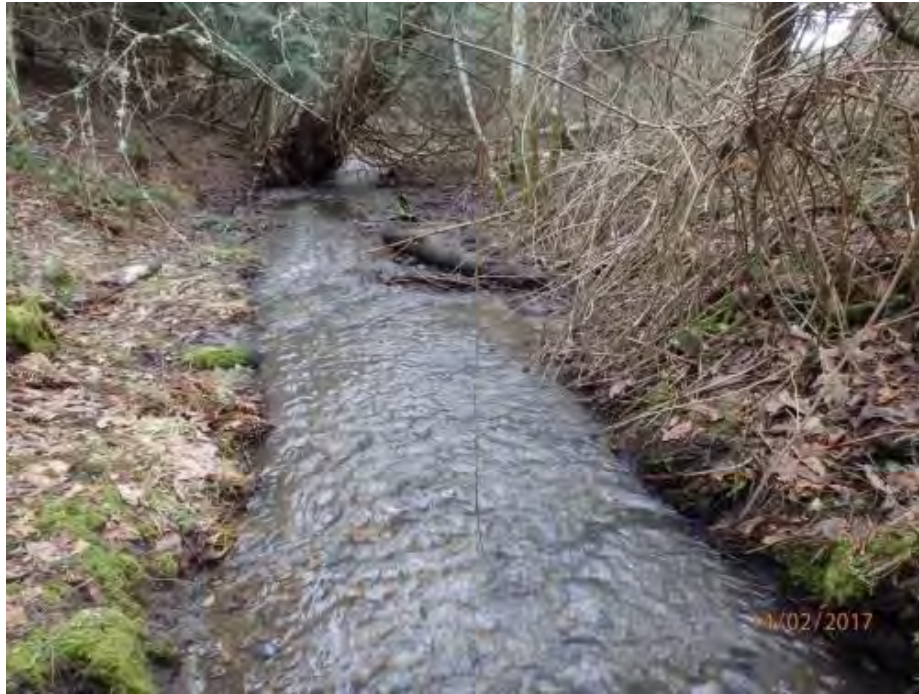
Typical channel and substrate characteristics (gravel/cobble) throughout the lower segment of Reach 5 (622 Gallagher Bay Road).

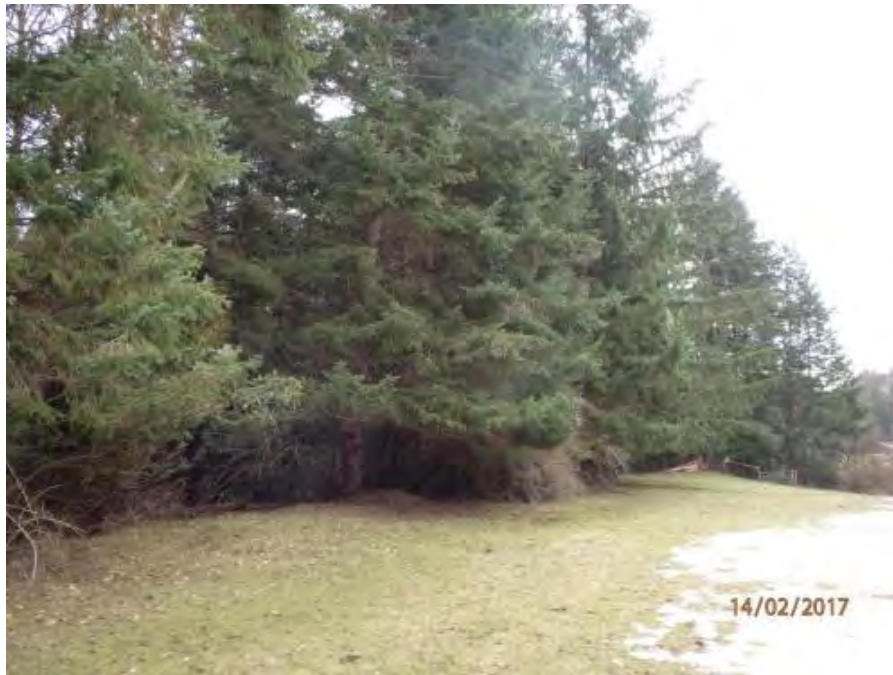
Functioning riparian vegetation growing along the natural draw associated with the lower segment of Reach 5 (622 Gallagher Bay Road).

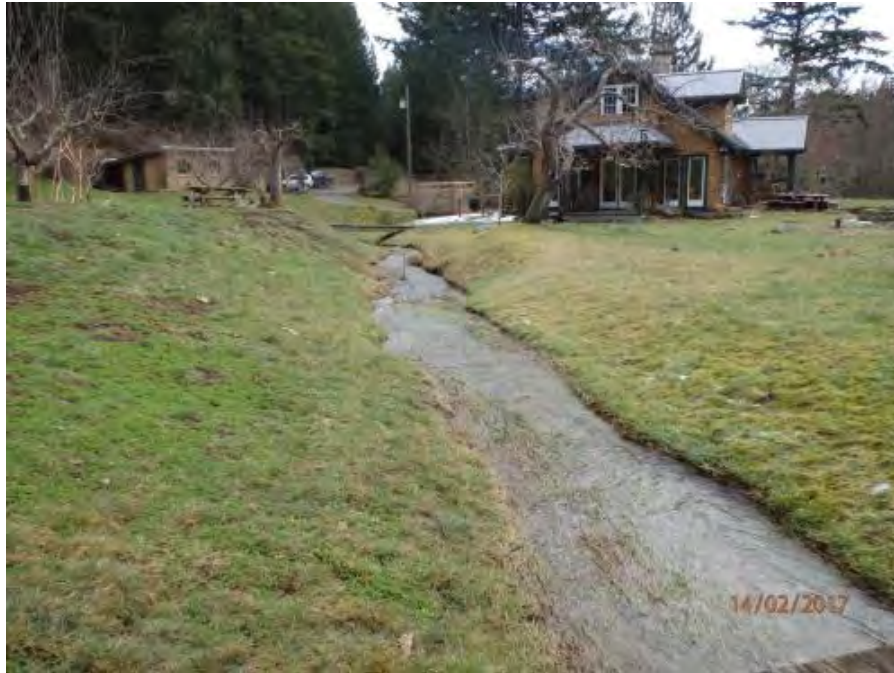
Typical channel characteristics and lack of riparian vegetation evident through the upper segment of Reach 5 (622 Gallagher Bay Road).

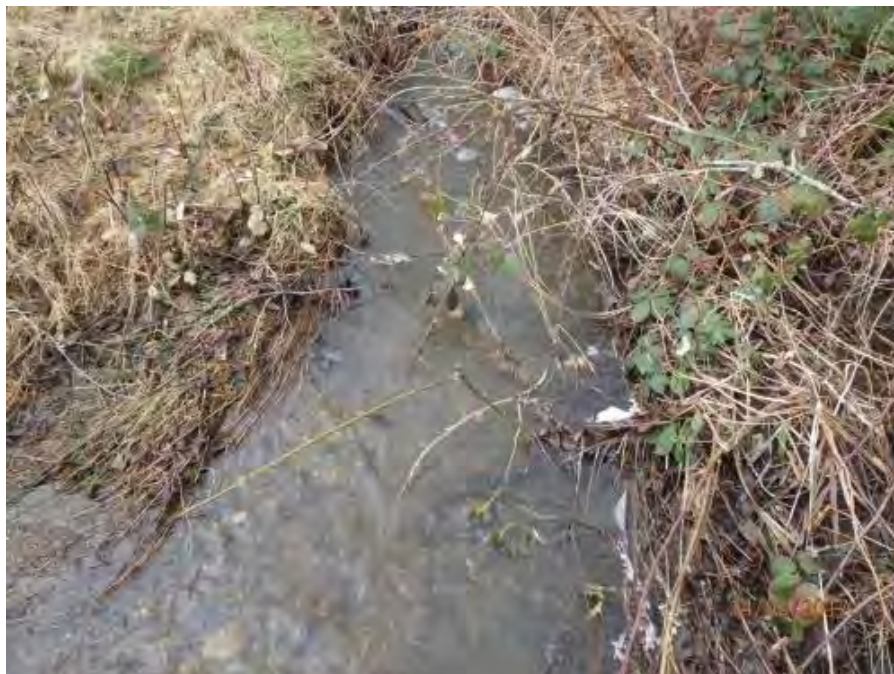
Typical gravel/cobble substrate exhibited throughout the majority of Reach 5.

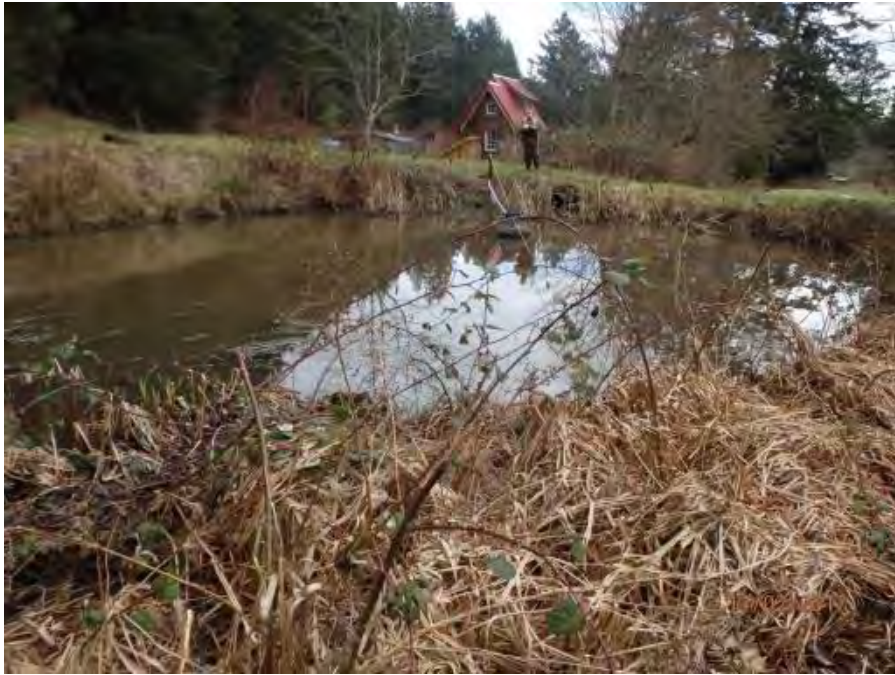
Small constructed irrigation pond located close to the upper limit of Reach 5 on the 622 Gallagher Bay Road property.

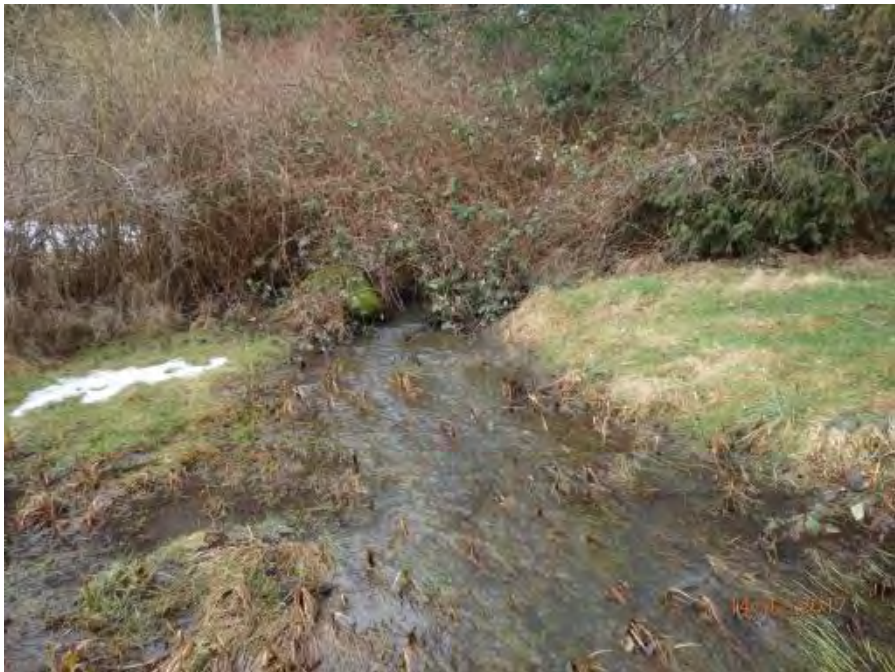
Characteristics of Reach 5 where the stream flows into the pond pictured above.

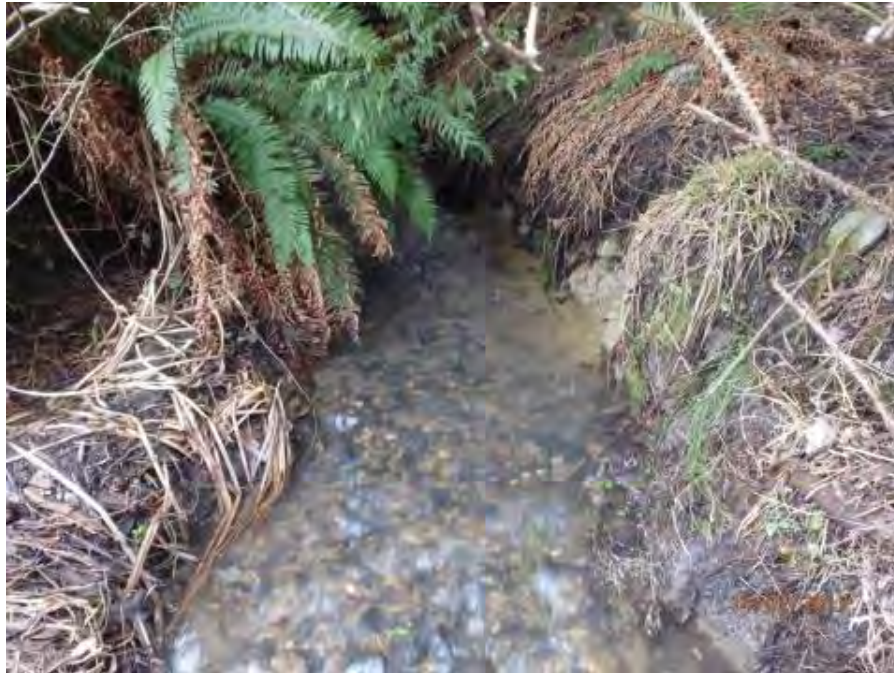
Well-defined channel (historically channelized) and gravel substrate noted at the Gallagher Bay Road crossing (beginning of Reach 6).

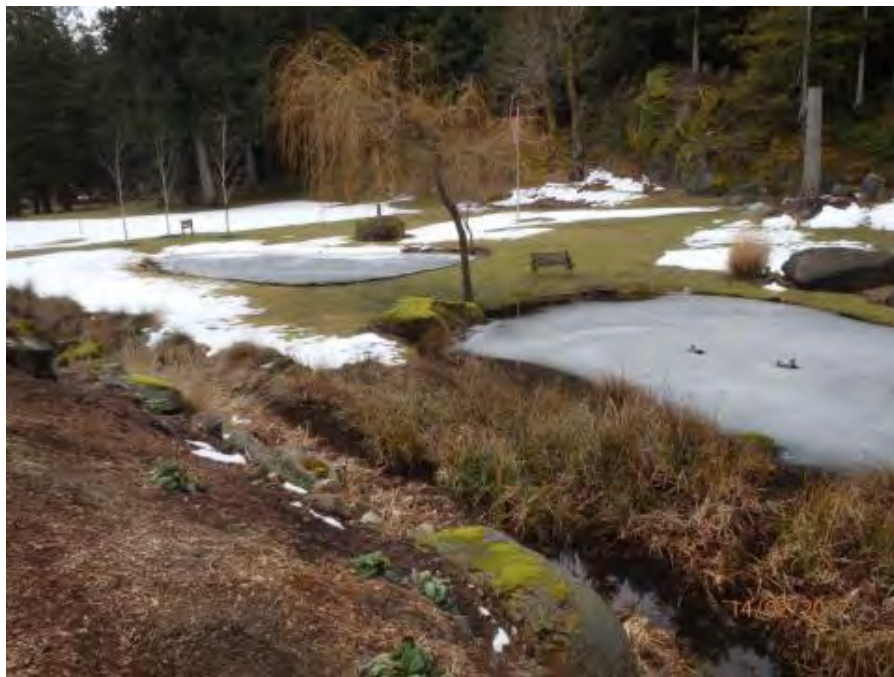
Small ponds located in a moist area close to the terminus of Tinker Road representing part of the headwaters of Horton Creek. The pond in the background does not connect by surface flow to the drainage network.

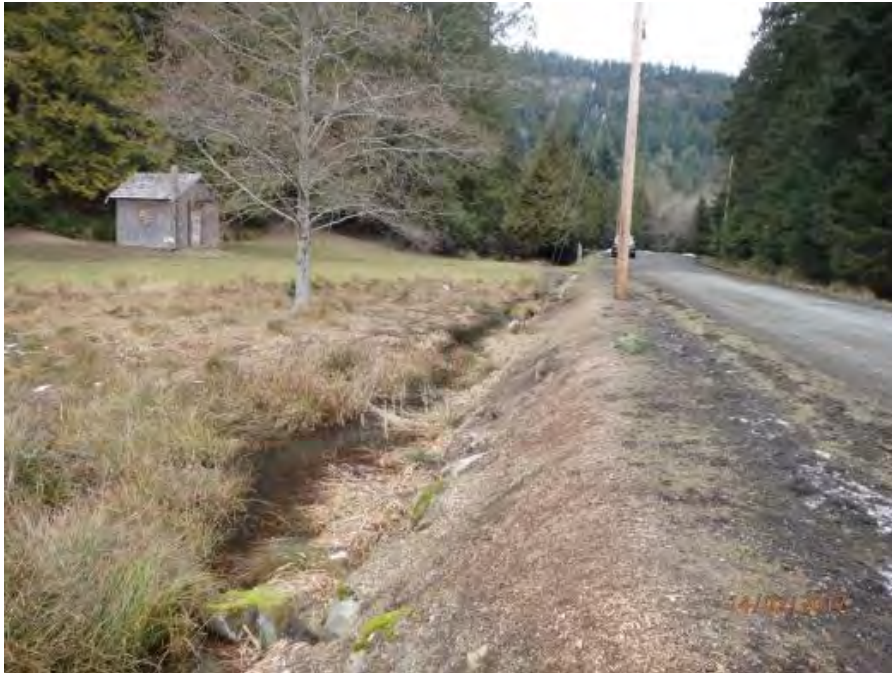
Looking downstream (north) along the headwaters of Horton Creek from Tinker Road.
