# **Review of Mayne Island Riparian Area Regulation Requirements - Recommendations Resulting from Application of the Detailed RAR Assessment Methodology**

**Trystan Willmott, B.Sc. A.Sc.T.  
MADRONE ENVIRONMENTAL SERVICES LTD.**

**March 7, 2017**

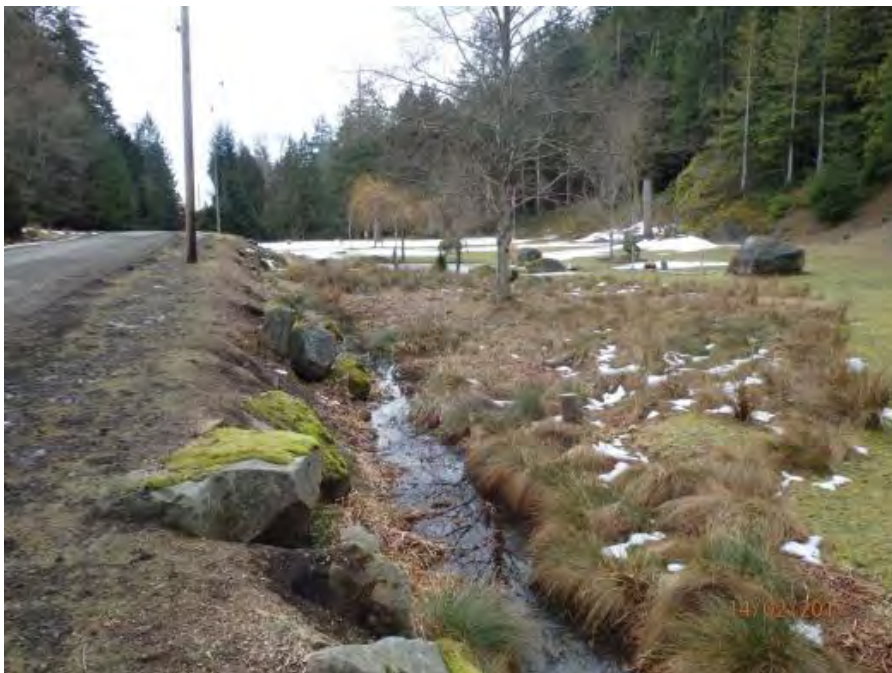
Looking upstream towards the moist area representing part of the headwaters of Horton Creek.

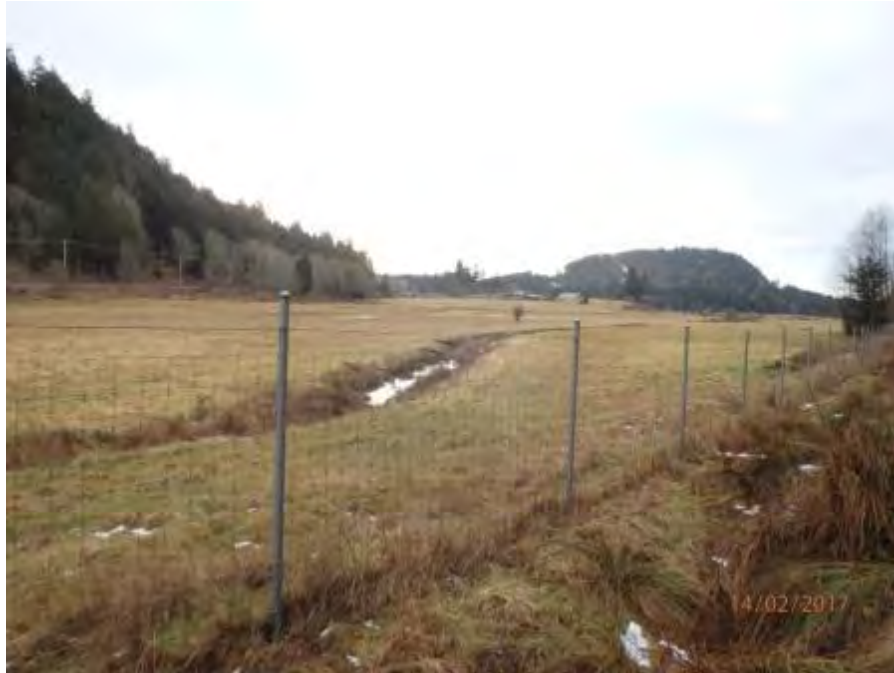
Looking south east along the upper segment of Reach 1 where it has been channelized through agricultural land on the Glenwood Farm property.

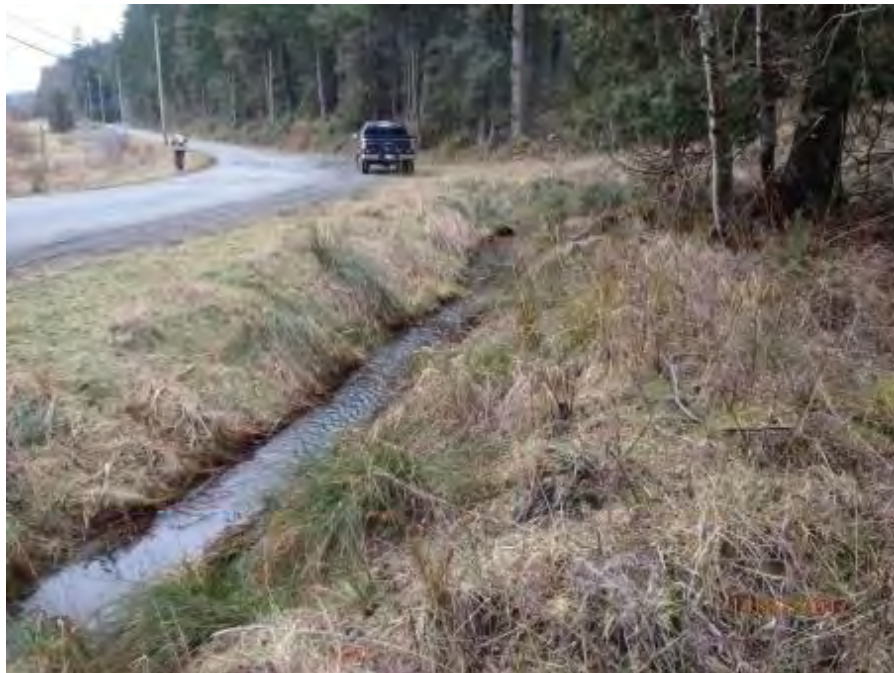
Looking downstream (south east) along Gallagher Bay Road close to the intersection with Horton Bay Road. The channelized stream flows underneath Gallagher Bay Road via two culverts at this location and represents the lower segment of Reach 2.

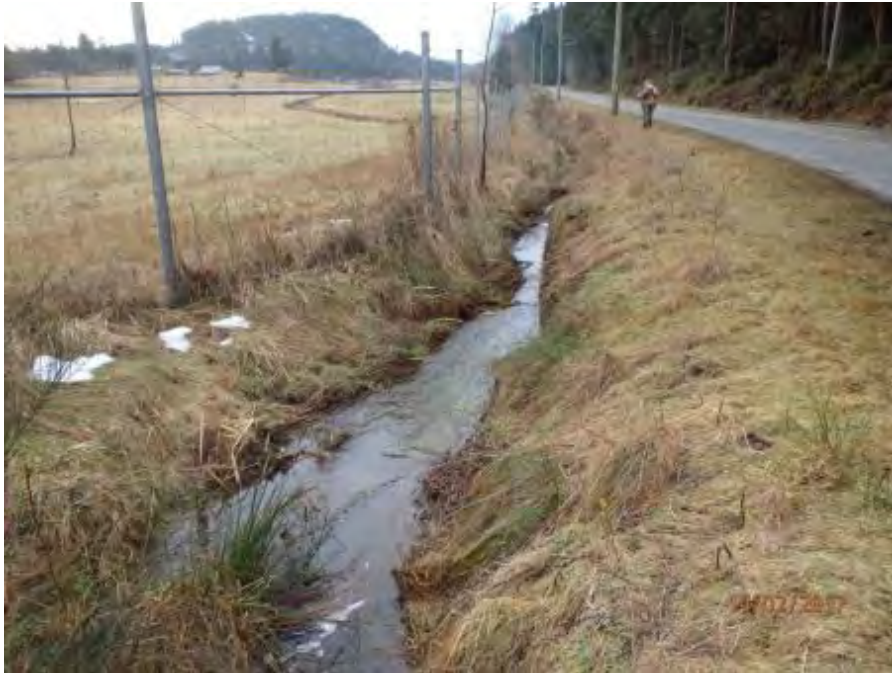
Looking downstream (south east) where the lower segment of Reach 2 flows alongside Gallagher Bay Road prior to flowing onto agricultural land.

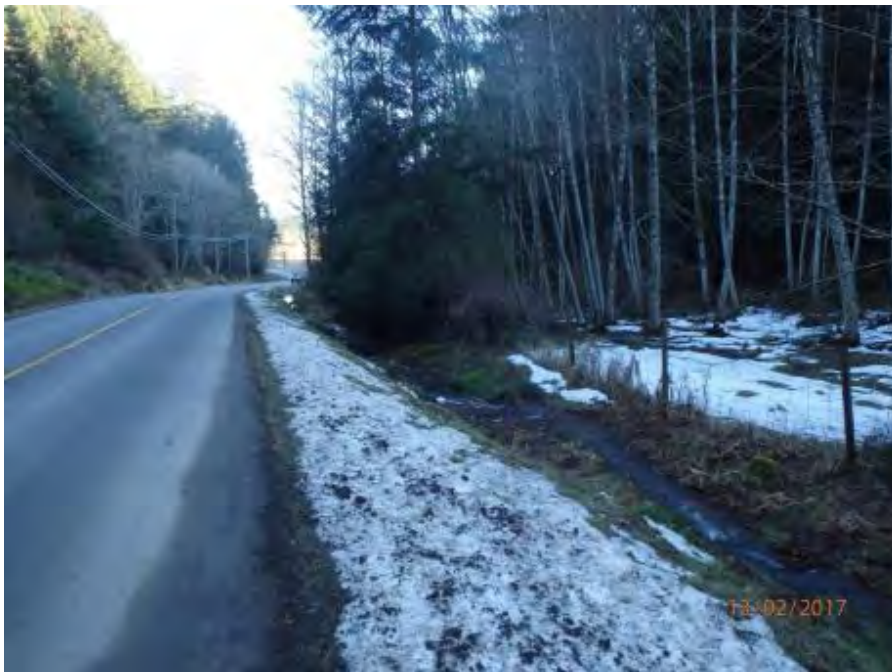
Looking downstream (south east) along the upper segment of Reach 2 where it has been channelized along Horton Bay Road.

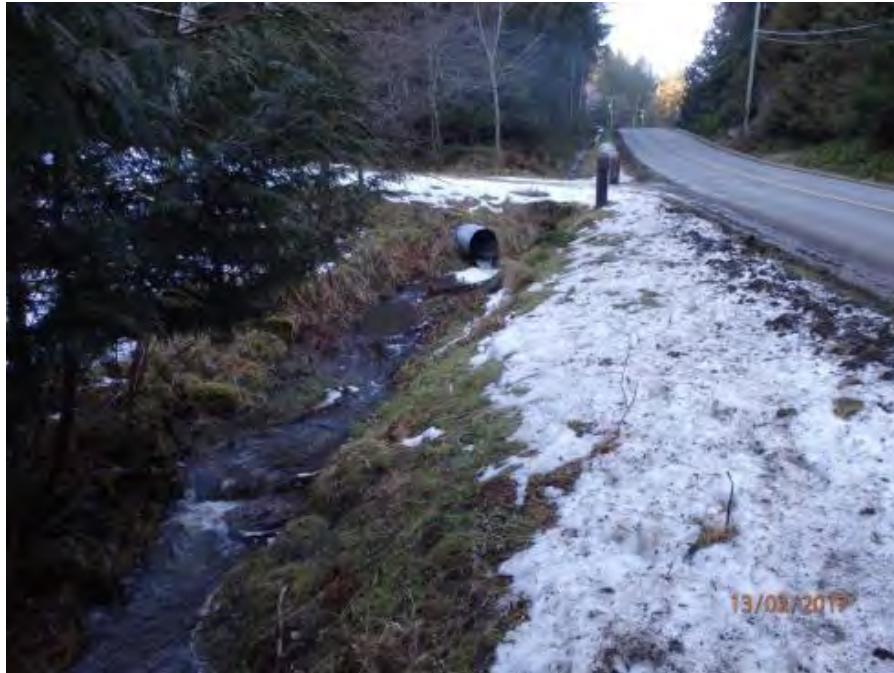
Looking upstream (north west) along the upper segment of Reach 2 where a culvert carries the flow underneath a property access driveway (523 Horton Bay Road).

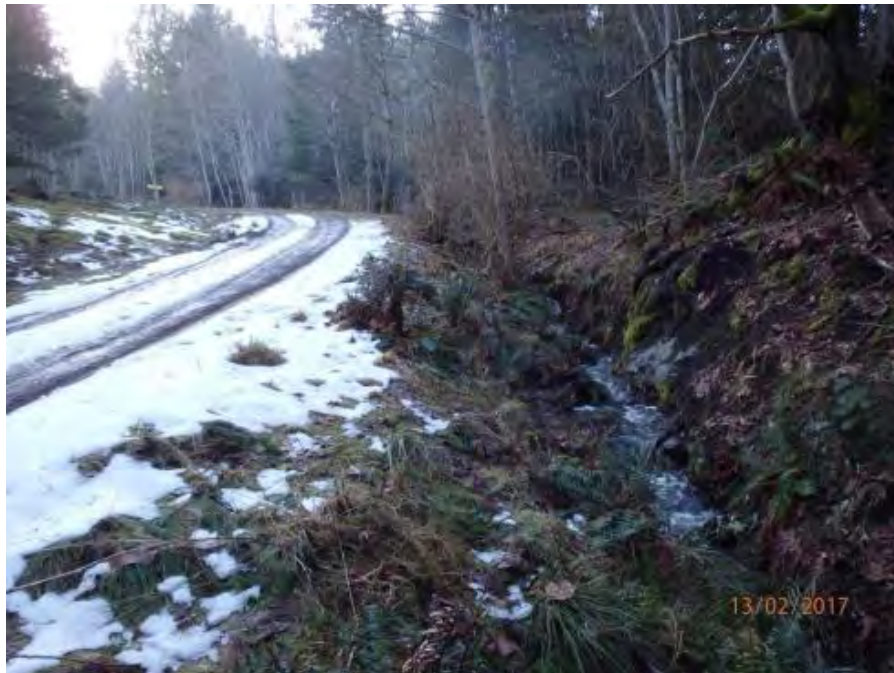
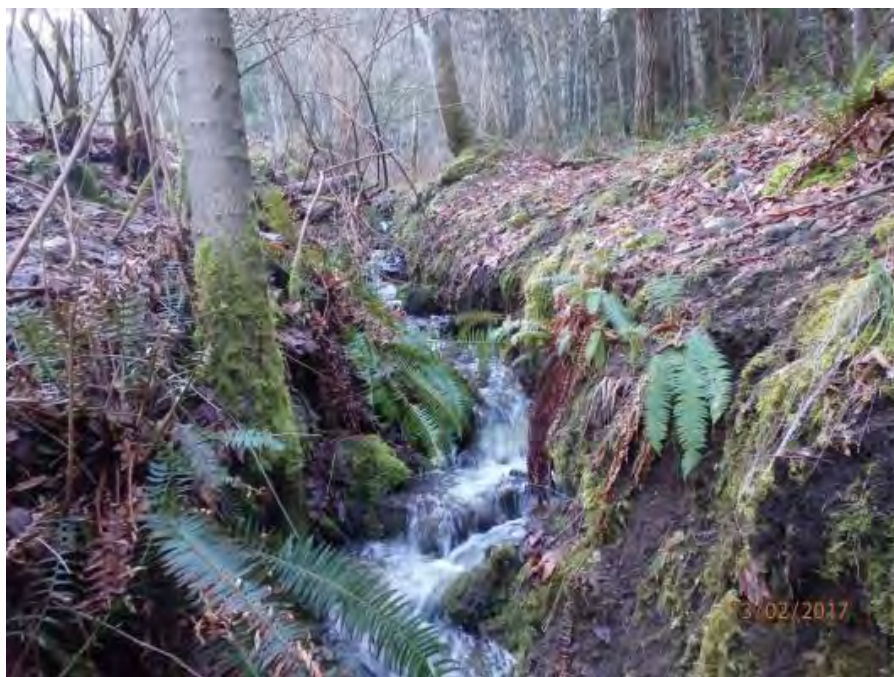
Above and below: looking upstream (west) along the upper segment of Reach 2 where it becomes incised along the edge of the 523 Horton Bay Road property driveway.

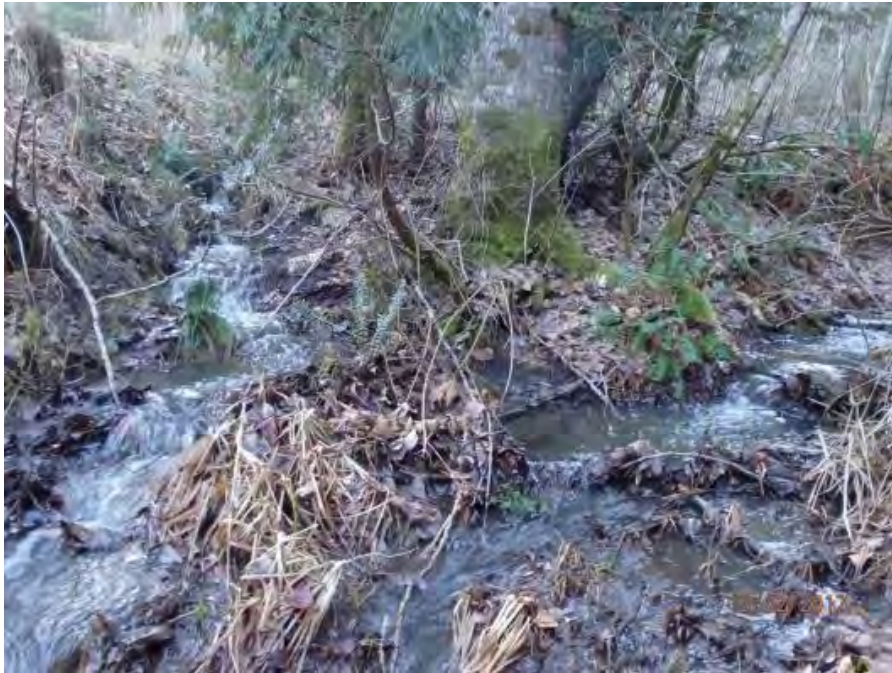
Confluence of the ditch (to the left) flowing into the main-stem drainage on the 523 Horton Bay Road property (beginning of Reach 3).

An additional ditch was discovered on the 523 Horton Bay Road property, which joins the main-stem along the property driveway close to the break between Reach 2 and 3. This ditch is very short (approximately 50 m) and drains a moist area close to the top of the driveway. This ditch is associated with a 2 m SPEA, as it is located above the steep segment of the main-stem, which precludes any potential for fish access.

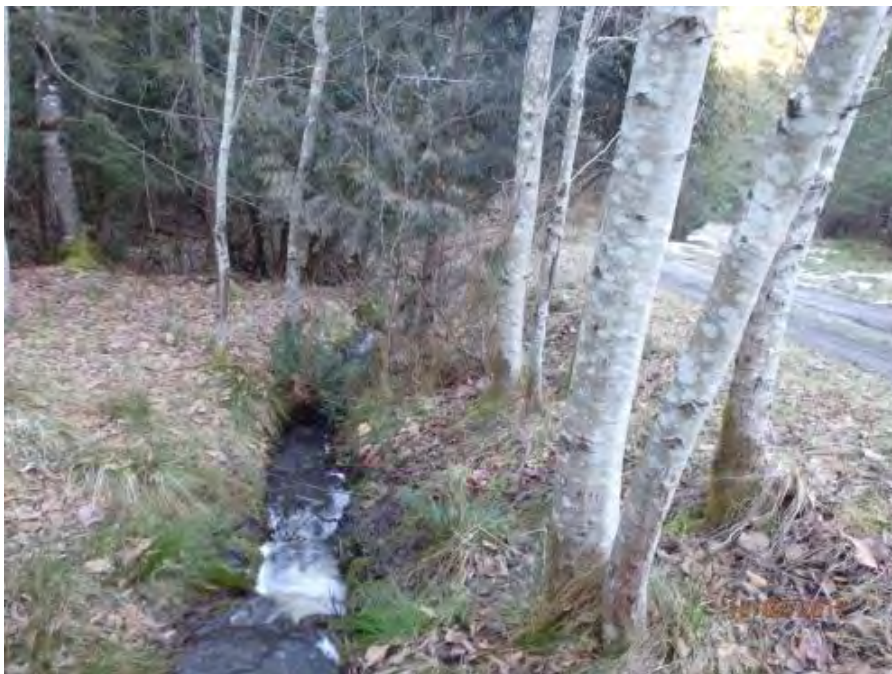
Upper segment of the ditch located on the 523 Horton Bay Road property.

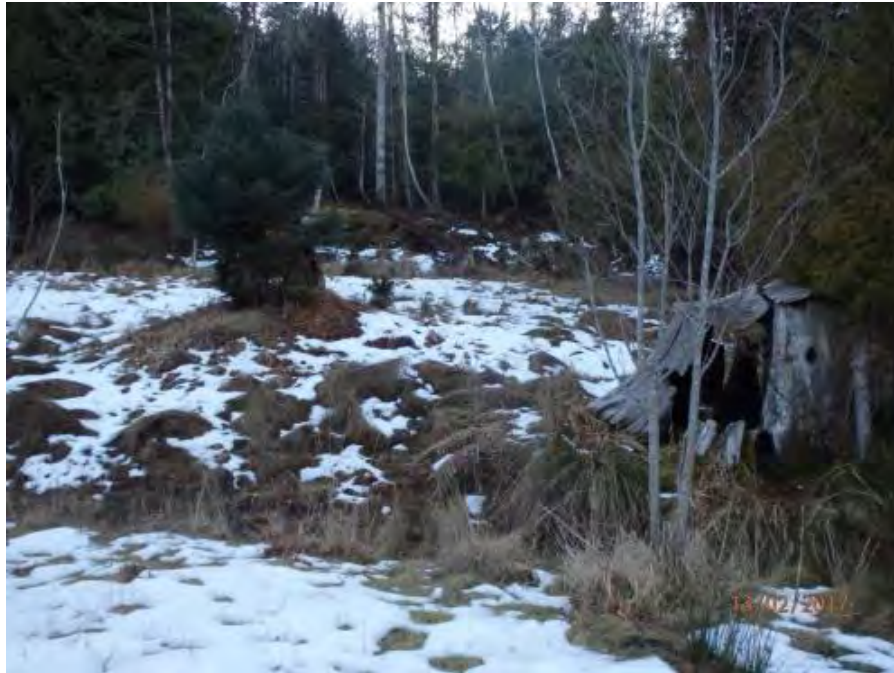
Moist area drained by the ditch located on the 523 Horton Bay Road property.

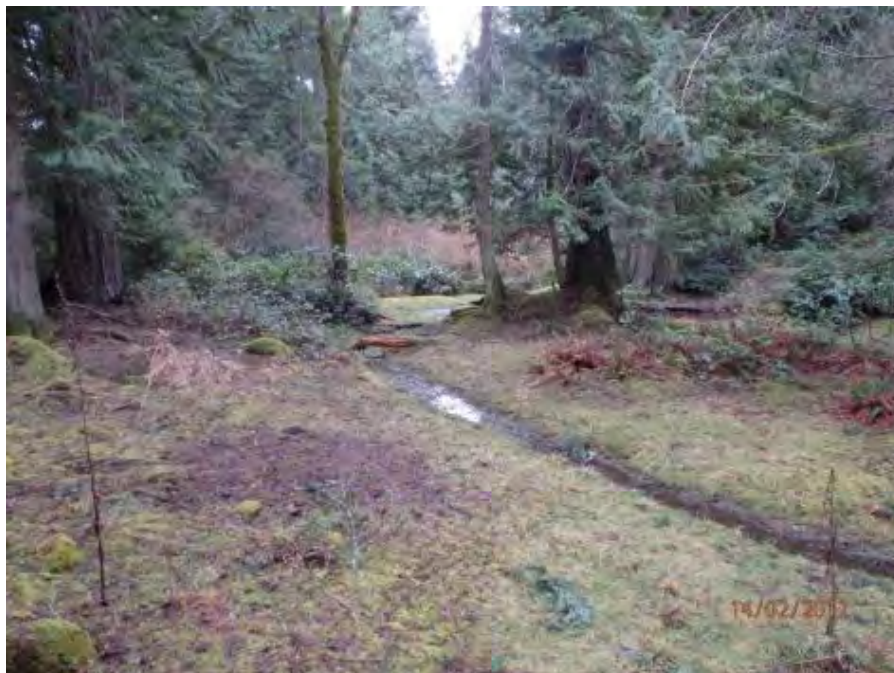
Characteristics of the upper segment of Reach 3 from the Montrose Road right of way.

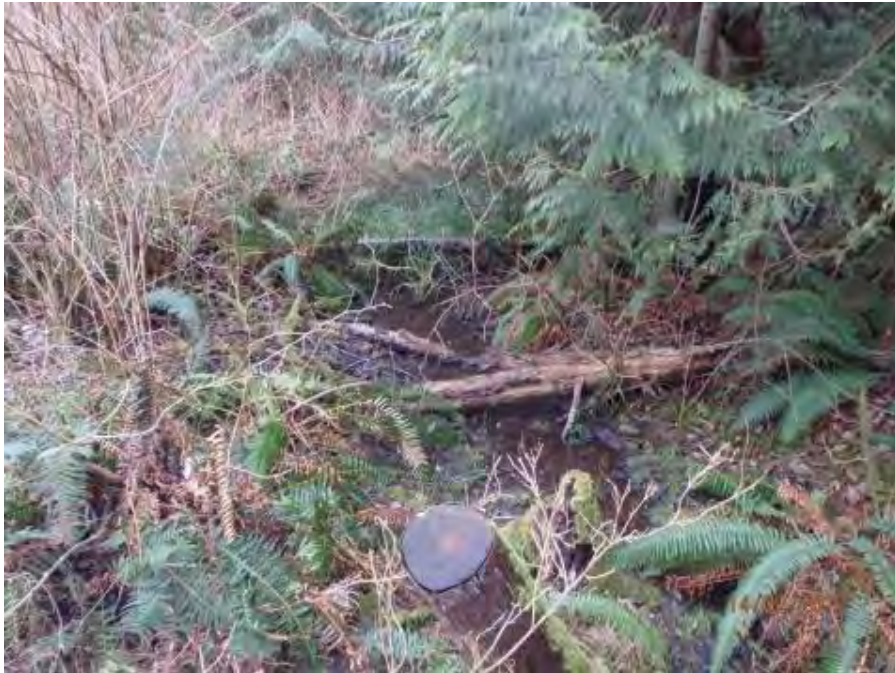
Reach 3 immediately downstream (east) of a foot trail through Mount Parke Regional Park.

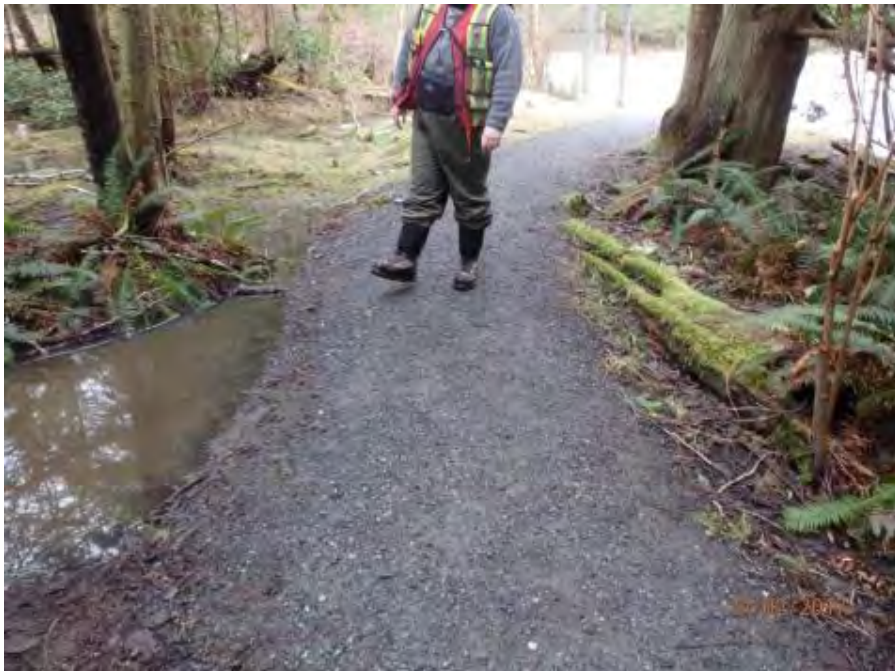
Foot trail to the immediate west of the photo shown above. Water is now directed via a constructed ditch along the north side of Montrose Road.

A constructed ditch now captures surface flow coming from the top of Reach 3 (originating from the pond) to the north of the blockage associated with the trail. While it should be noted that this ditch is directly located on the Reach 3 stream channel, a ditch classification has been applied at the point where the ditch has been constructed along the north side of Montrose Road. The more “natural” stream channel continues to the south of Montrose Road below the trail blockage, connecting with Reach 2 on 523 Horton Bay Road.

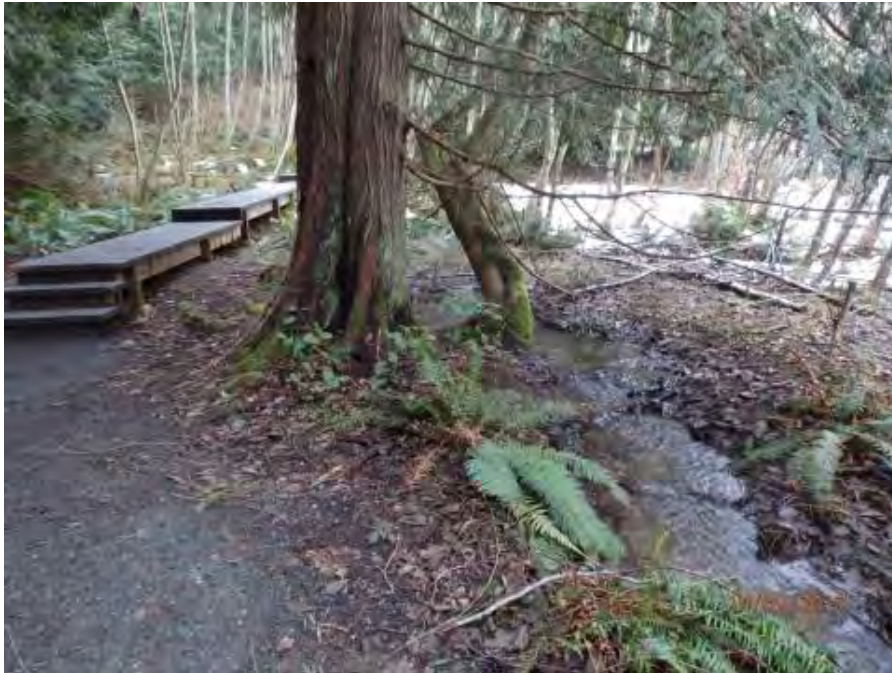
Upper segment of Reach 3 along the Mount Parke foot trail.

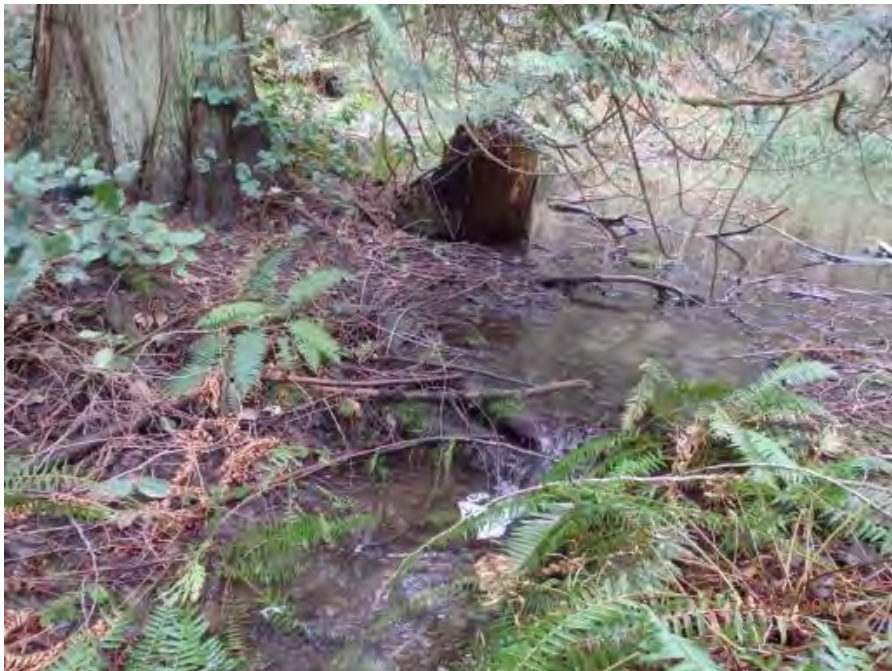
Headwaters of Hunt Brook draining a pond located close to the Mount Parke boundary.

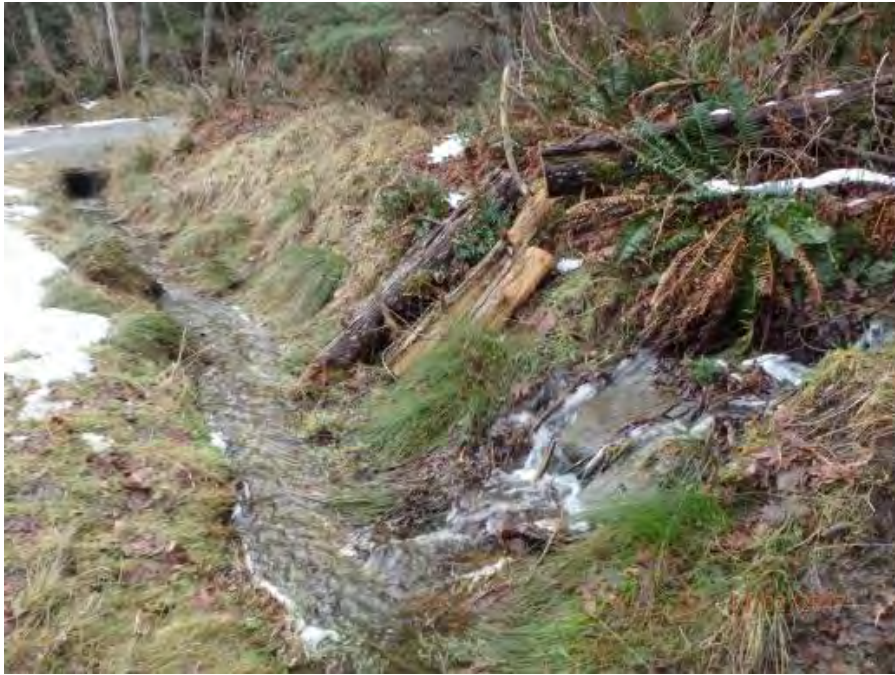
Outlet of the ditch draining the Mount Parke area where it flows off the 515 Horton Bay Road property into a ditch located along Horton Bay Road.

The ditch continues along the north side of Montrose Road prior to flowing under the road via a culvert discharging onto the property to the immediate west of 515 Horton Bay Road. The ditch was observed flowing off the 515 Horton Bay Road property, where it is directed along the west side of Horton Bay Road. This ditch joins with the channelized segment of Reach 2 at the bottom of the 523 Horton Bay Road property driveway. This ditch was previously unmapped, which may indicate that the work was done after the 2010 assessments completed by Clough and Swell.

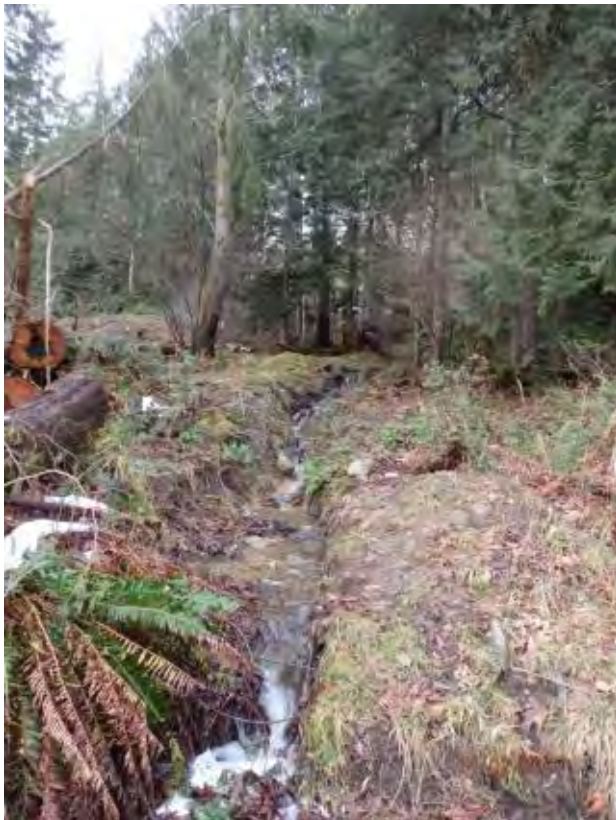
Looking upstream (west) through the 515 Horton Bay Road property from Horton Bay Road along the ditch draining the Mount Parke area.

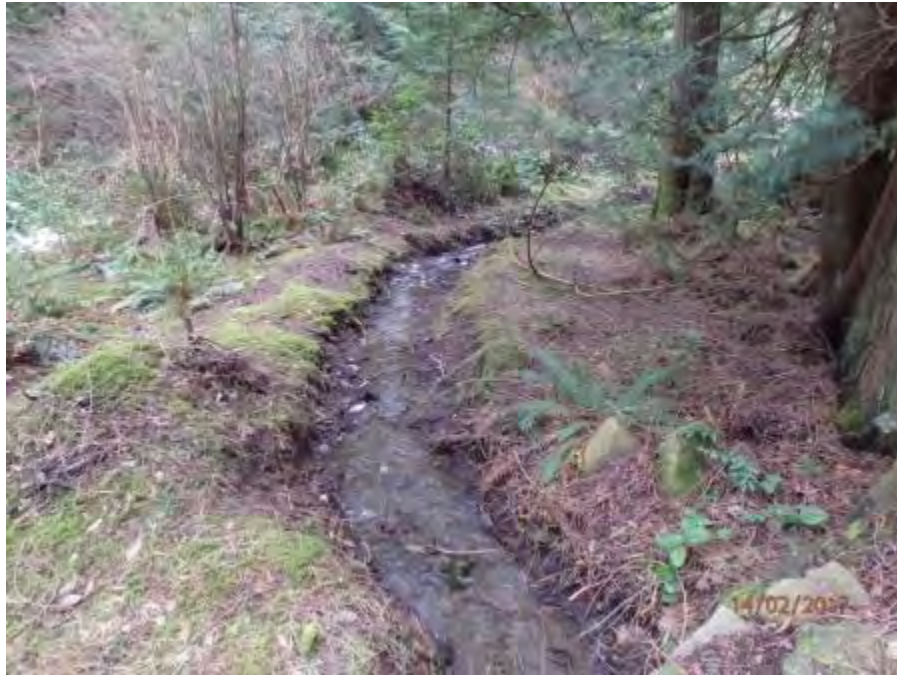
Looking downstream (east) along the ditch at the point where it flows out of the culvert under Montrose Road and onto private property.

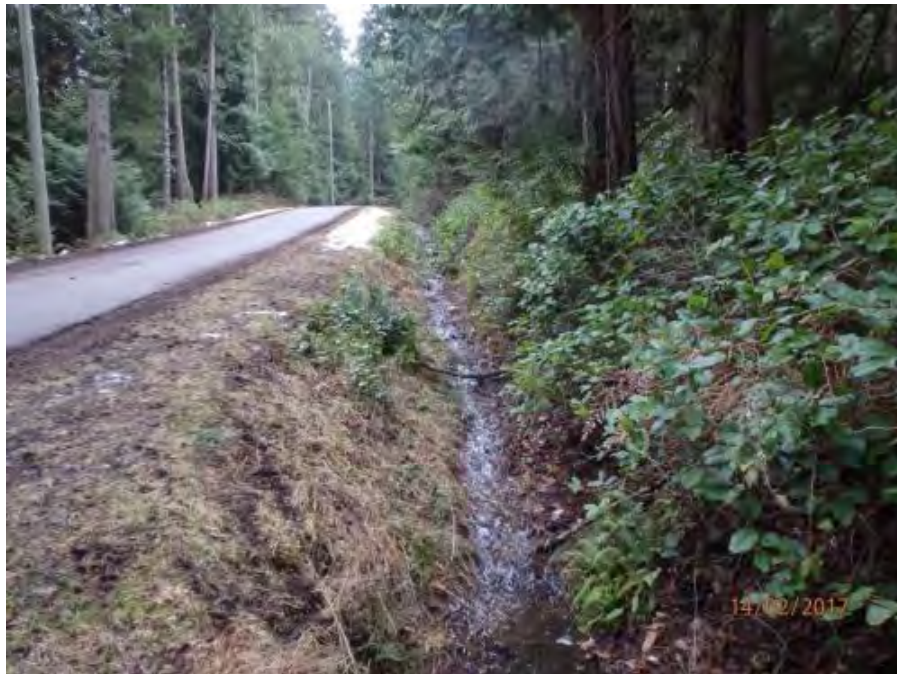
Looking upstream (south west) along the ditch that drains the Mount Parke area along the edge of Montrose Road.

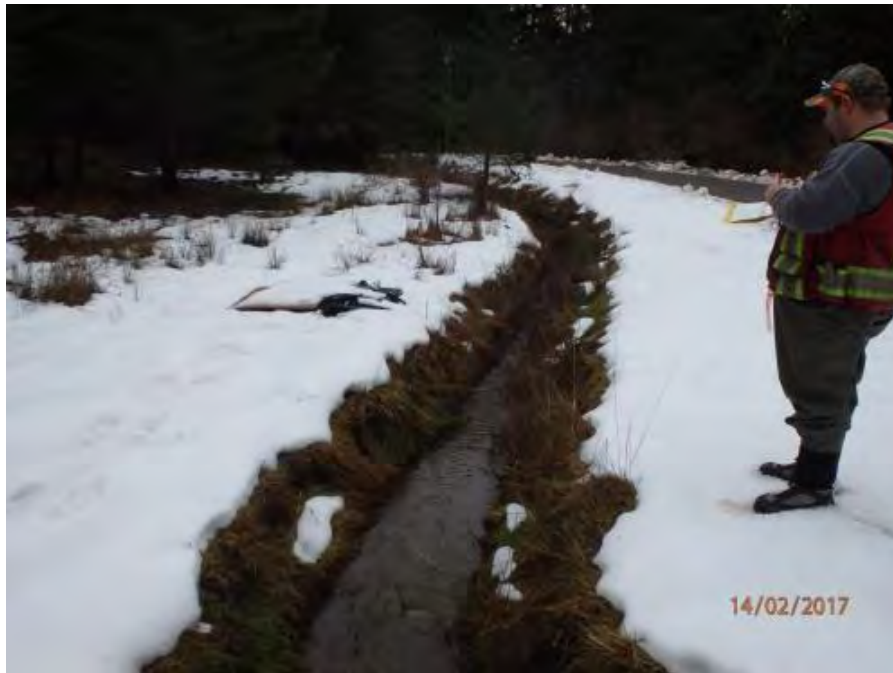
Looking downstream (north east) along the constructed ditch along the edge of Montrose Road close to the Mount Parke Regional Park parking area.

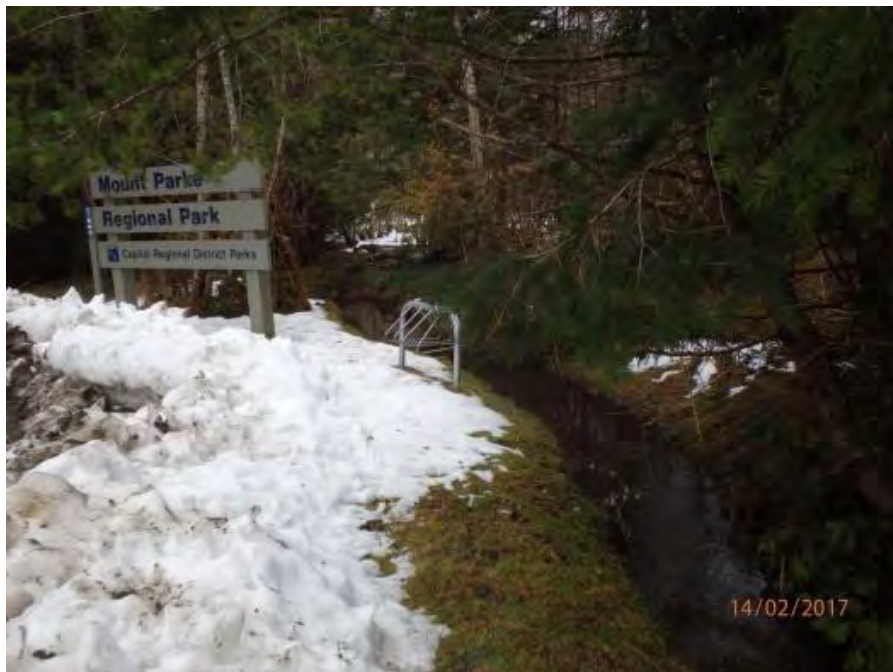
Looking upstream (west) along the beginning of the ditch draining the Mount Parke area taking water along the northern side of Montrose Road.
