## **North Pender Island Board of Variance Meeting Agenda**

The purpose of the report is for an appeal to the Board of Variance to vary the North Pender Island Land Use Bylaw No. 103, 1996 (LUB) for the setback to the natural boundary of the sea for the replacement of an existing shoreline protection structure on the subject property.

Re: Existing Foreshore Slope/Seawall Assessment & Recommendations  
2603 Galleon Way – Pender Island, BC

### **RE: 2603 Galleon Way, Pender Island – Environmental Review - Board of Variance Application: Proposed Shoreline Stabilization and Restoration Planting Plan**

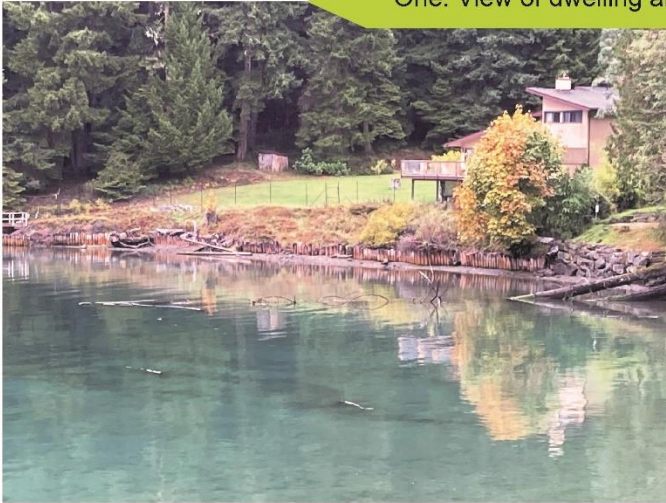
One: View of dwelling and existing shoreline protection from south

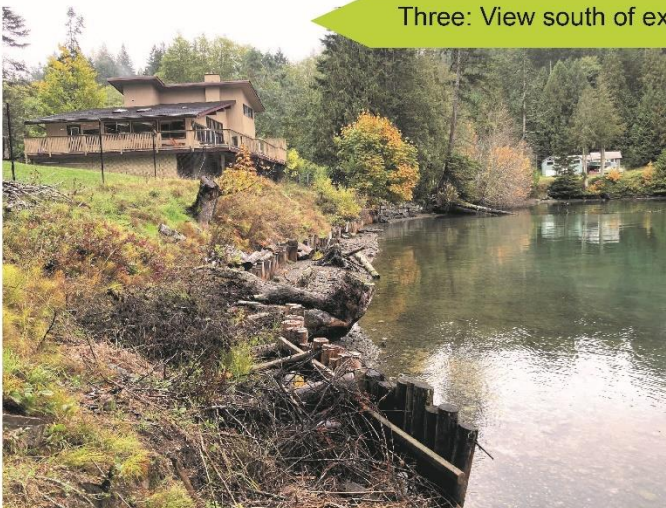
Three: View south of existing shoreline protection structure

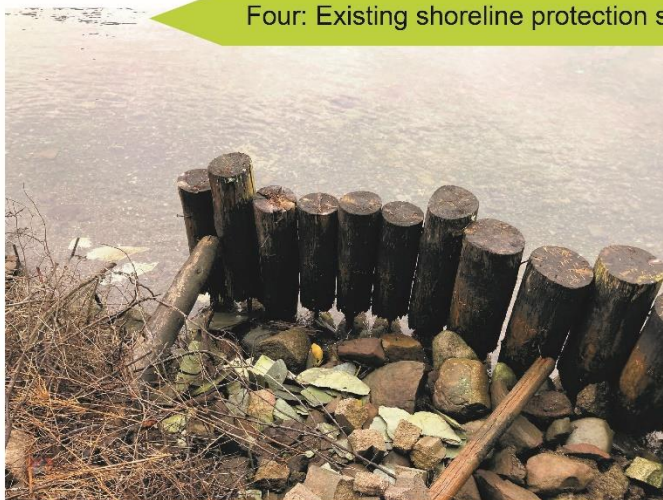
Four: Existing shoreline protection structure showing deterioration at base (typ.)

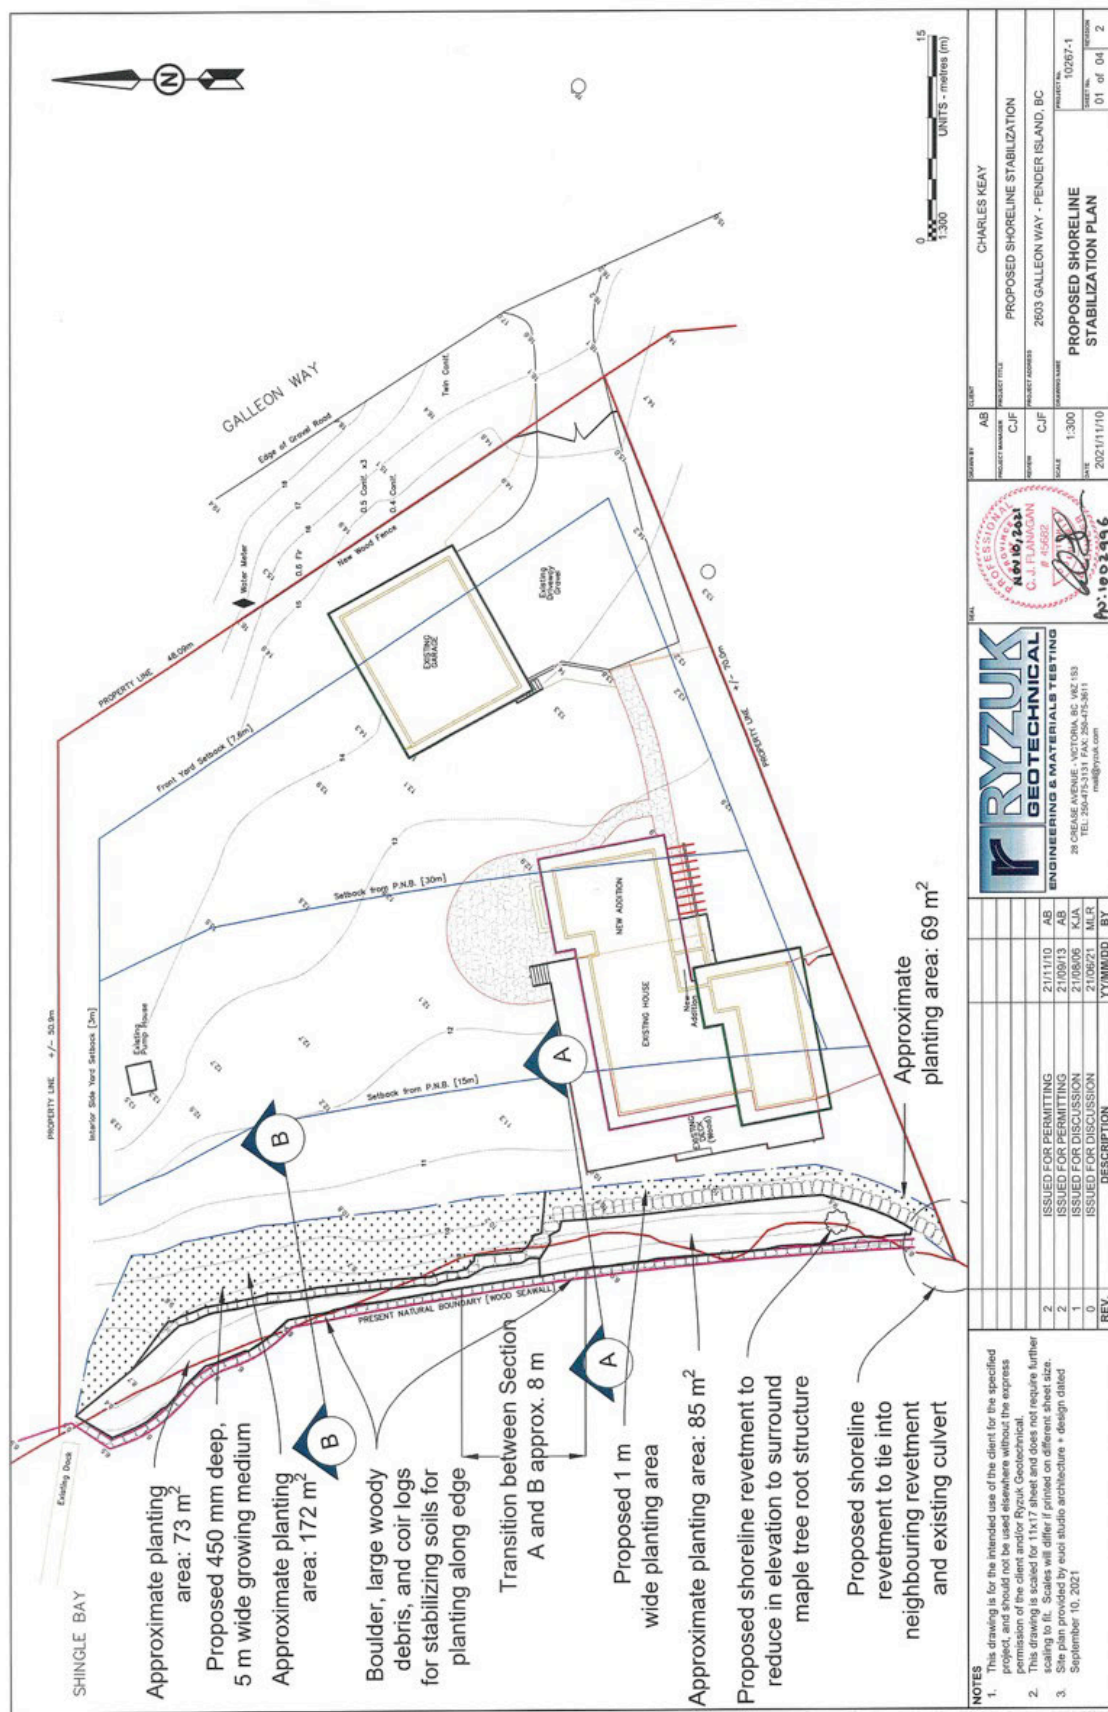
Figure 2. Site Plan for shoreline stabilization and restoration planting areas.

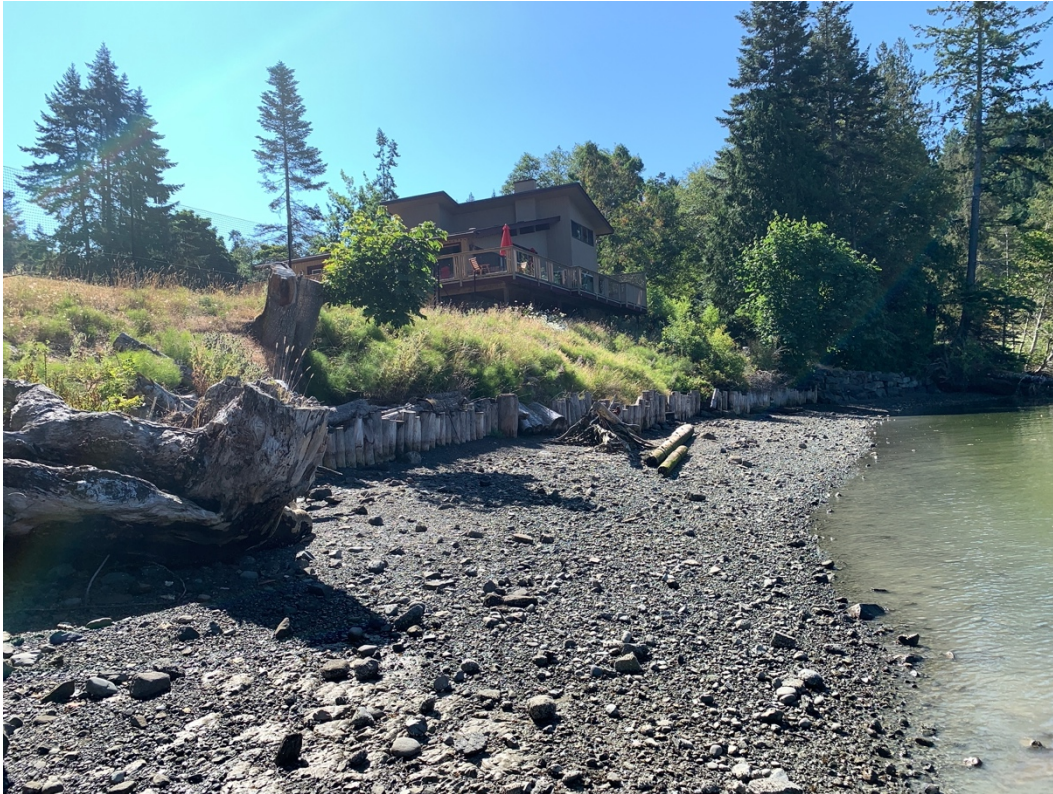
Photo 1. Looking south along the shoreline at failing log shoreline stabilization structure and eroding slope behind.

Ryzuk Geotechnical has observed that the existing log shoreline stabilization structure is failing, and the bank slope behind is actively eroding (Photos 1-10).

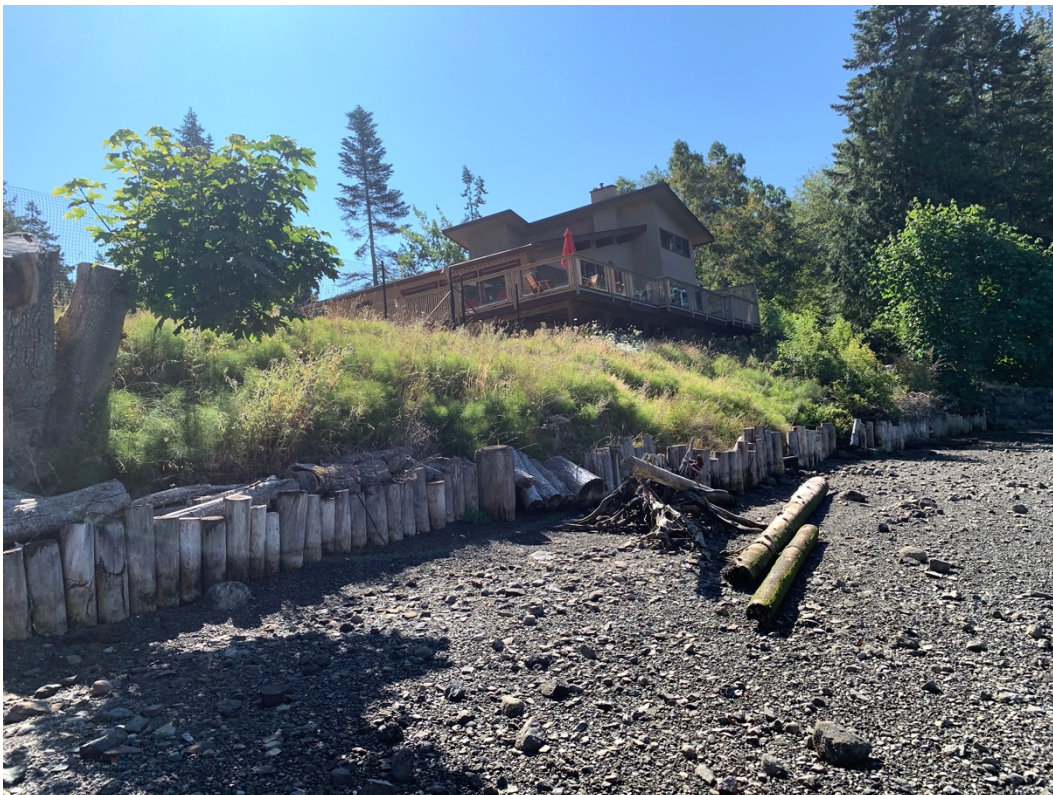
Photo 2. Looking south along the shoreline at failing log shoreline stabilization structure and eroding slope behind.

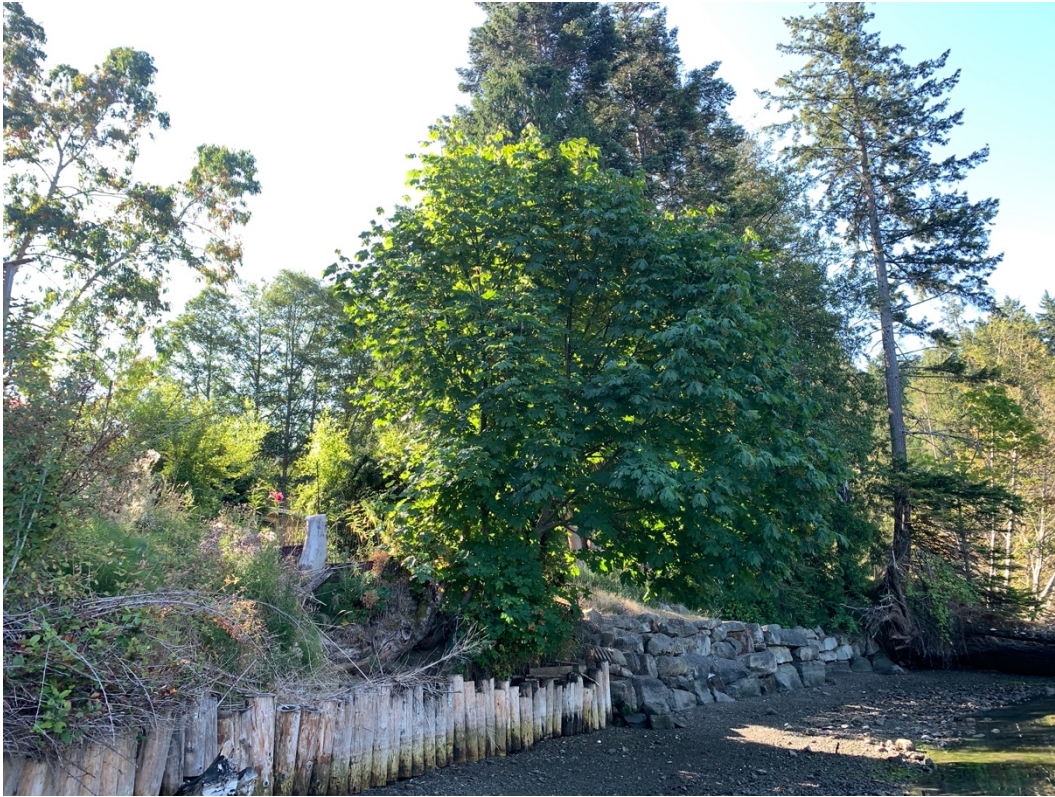
Photo 3. Looking south along the shoreline at the junction of the failing log structure and stacked boulder wall on the adjacent property. Temporary beach access by heavy equipment proposed for this section.

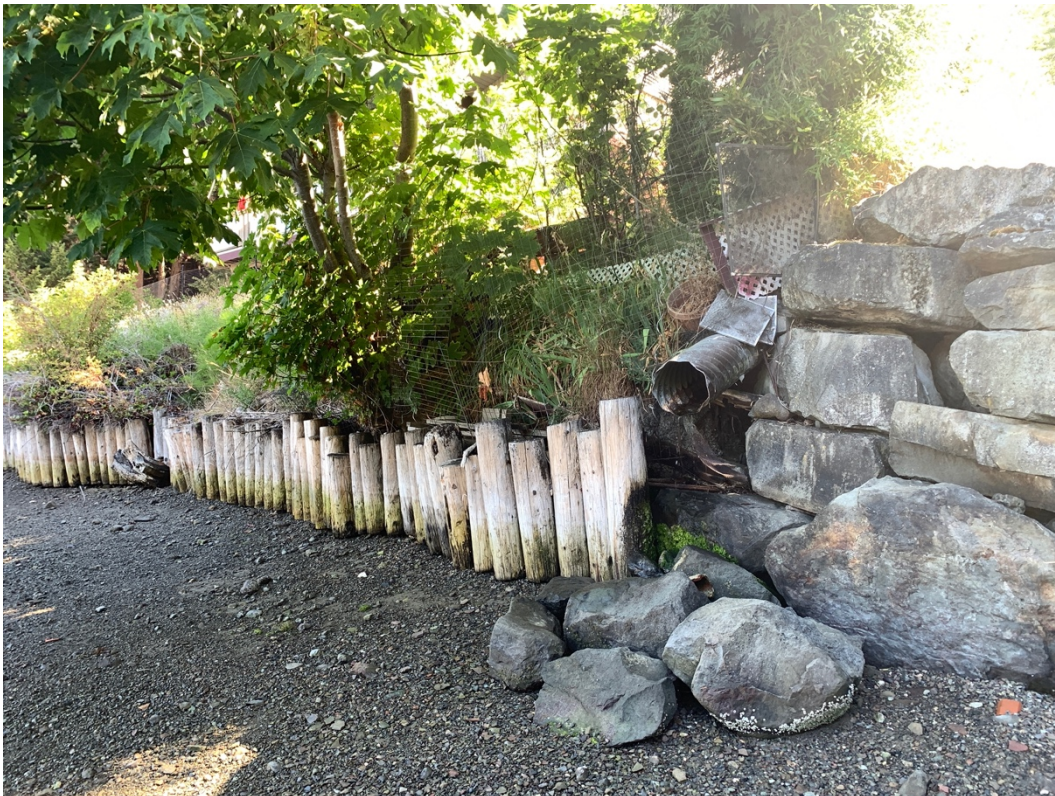
Photo 4. South end of the site: the proposed wall will be integrated with the existing stacked boulder wall to the south, incorporate the stormdrain outfall, and support the existing bigleaf maple. Retention of the maple will require temporary beach access for the heavy equipment.

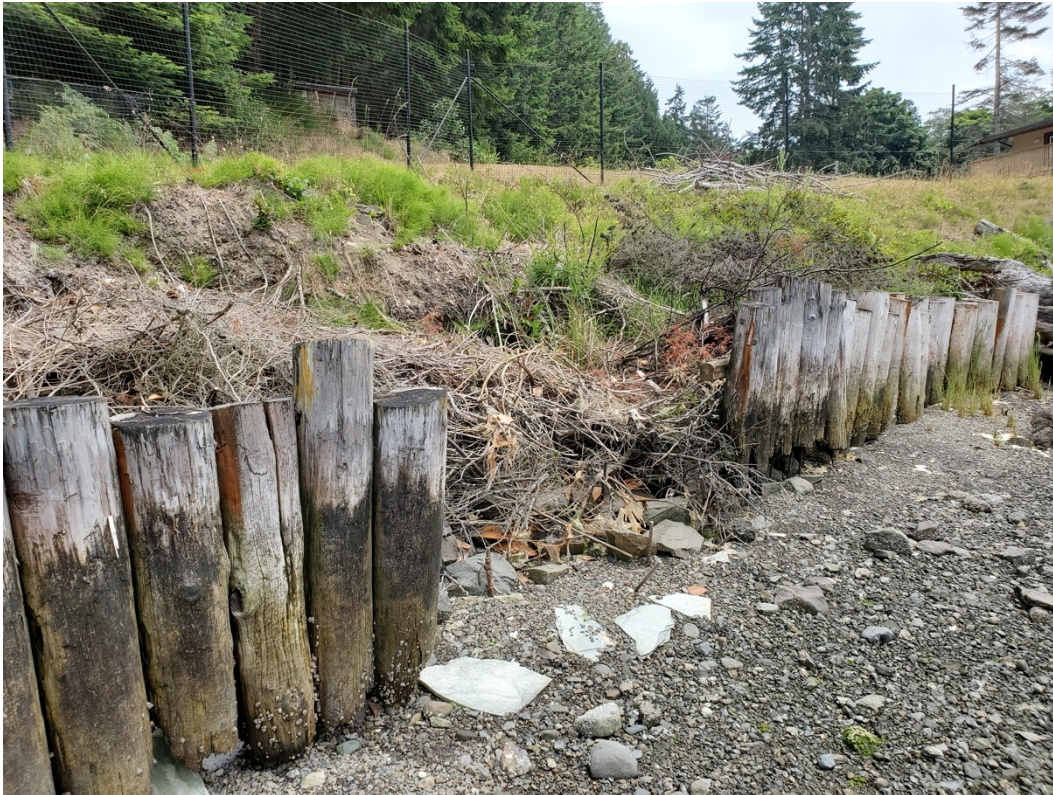
Photo 5. Towards the north end of the site, example of the failing log shoreline stabilization structure and eroding slope behind.

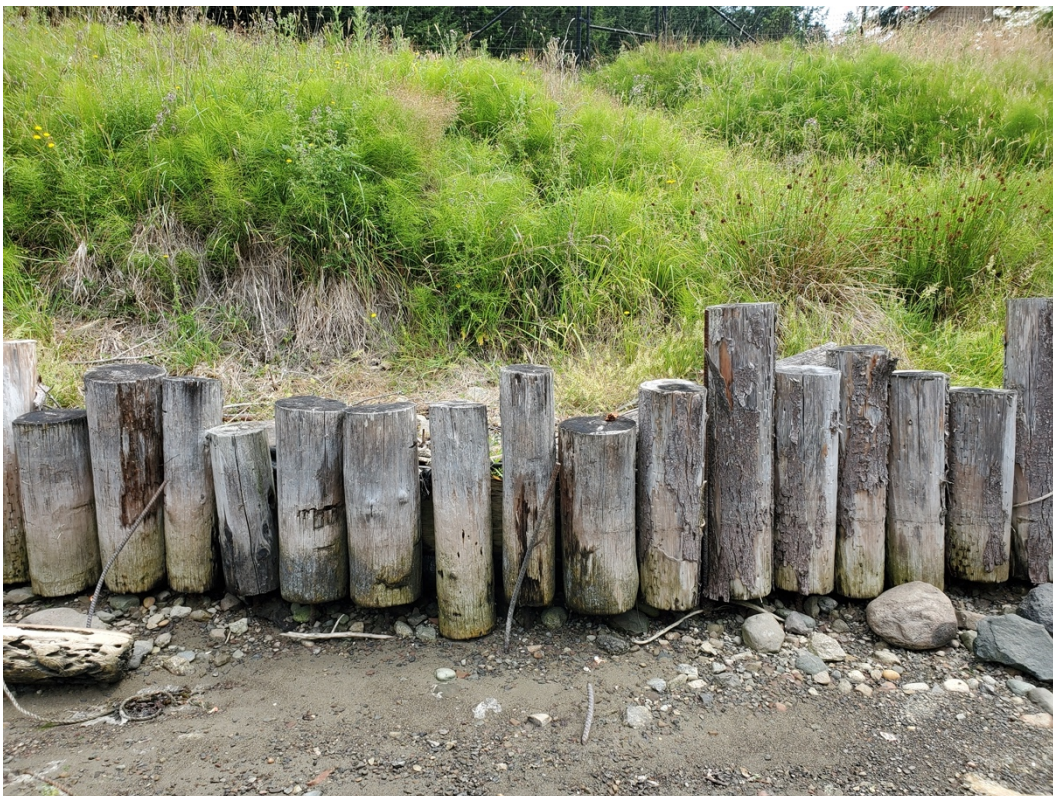
Photo 6. Towards the north end of the site, example of the failing log shoreline stabilization structure and eroding slope behind. Note that the log ends are not embedded into the shoreline substrate.

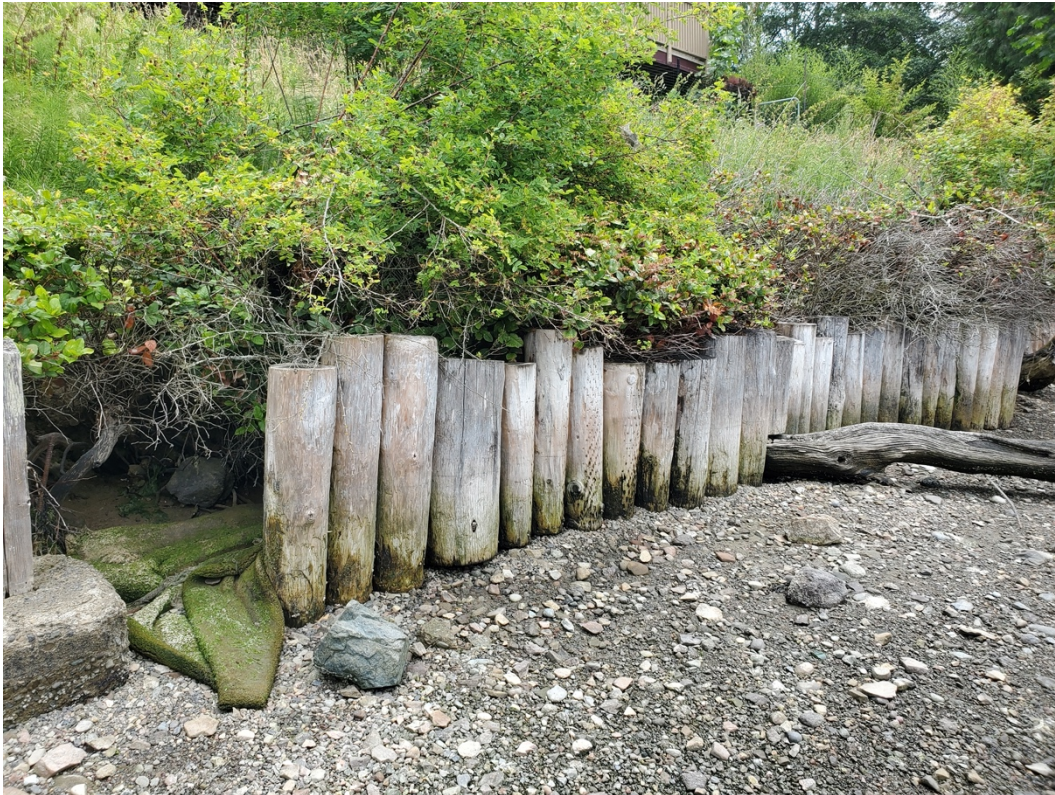
Photo 7. Towards the southern end of the site, near the house, remnant native vegetation on the overhanging slope, revealing erosion and old carpeting used in the original structure.

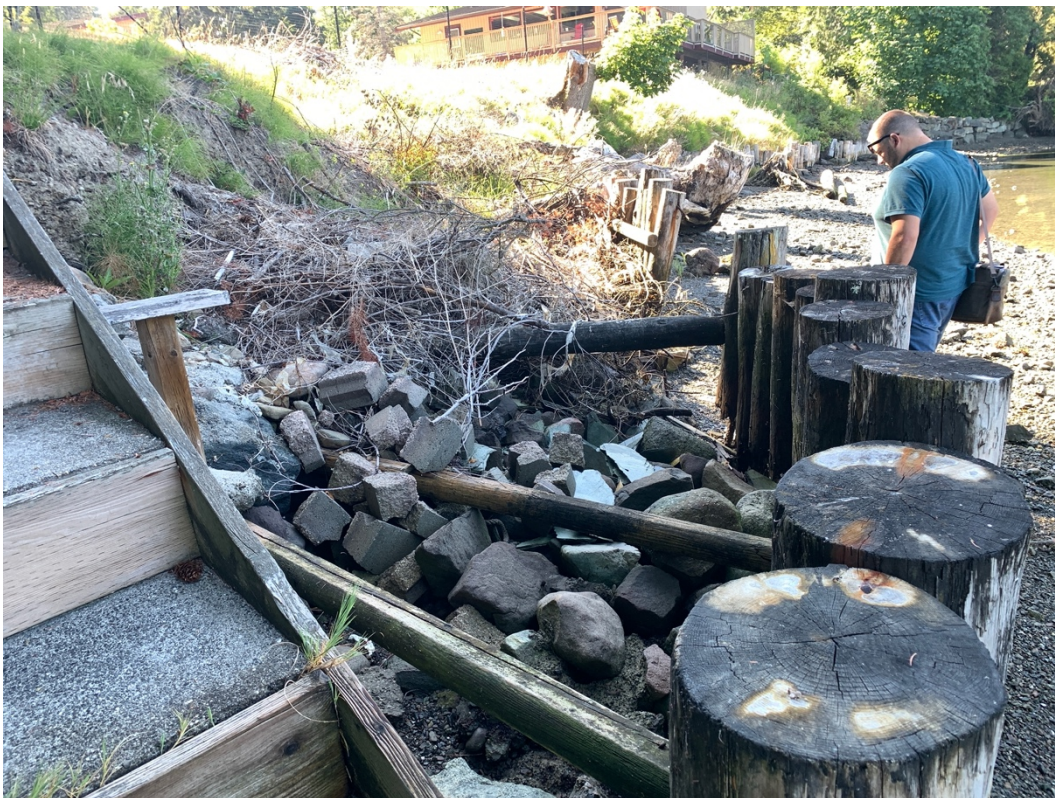
Photo 8. North end of the site adjacent to the dock, example of the failing log shoreline stabilization structure and eroding slope behind, with materials placed over the years to try to stop the erosion. Existing stairs to the shoreline.

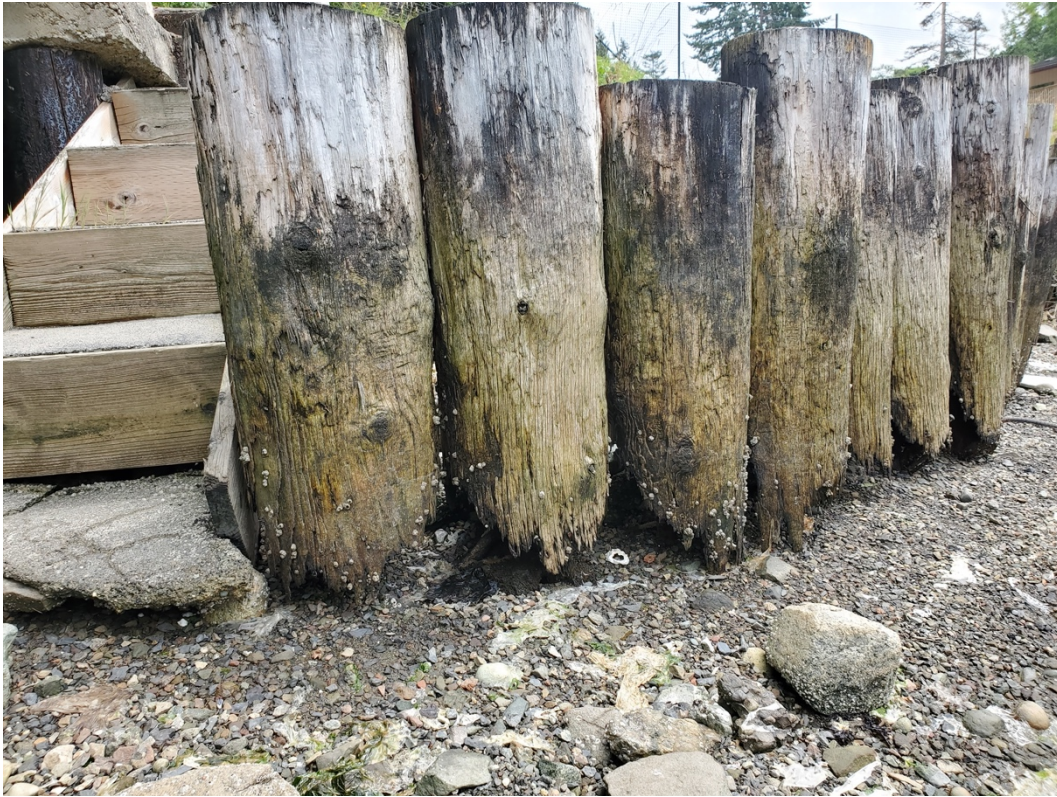
Photo 9. North end of the site adjacent to the dock, example of the failing log shoreline stabilization structure and eroding slope behind. Existing stairs to the shoreline.

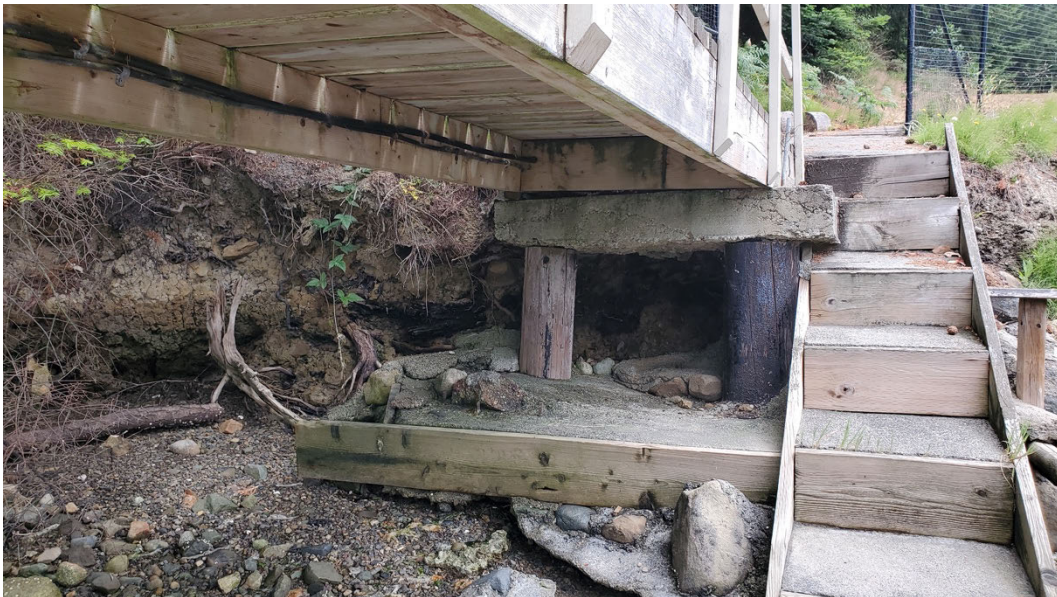
Photo 10. North end of the site at the dock and undercut eroding bank, with existing stairs to the shoreline.

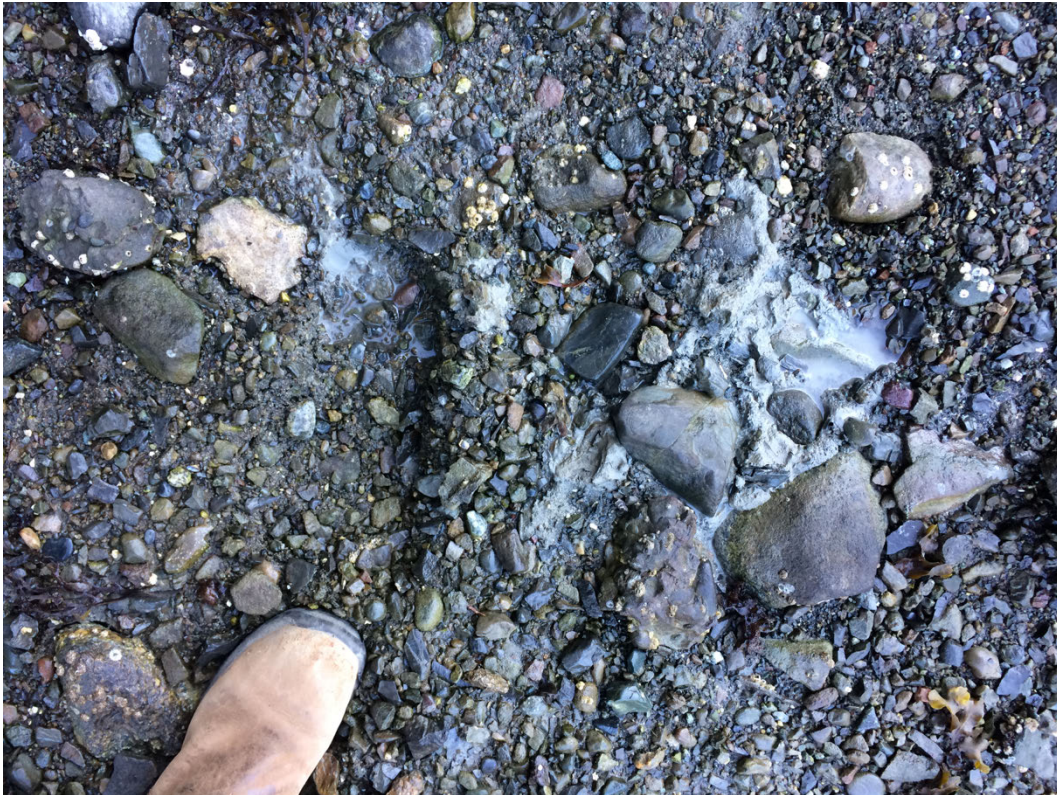
Photo 11. The beach is composed of gravel embedded in soft clay, unsuitable for forage fish spawning habitat.

The intertidal beach habitat is composed of gravel embedded in soft clay, which depresses easily with foot traffic (Photo 11). The clay substrate along this shoreline creates a sediment plume in the nearshore waters, even in mild sea conditions with no water disturbance (Photo 12). This beach substrate is entirely unsuitable spawning habitat for forage fish (such as Sand Lance and Surf Smelt), which require the interstitial spaces between sands and gravels for egg development.

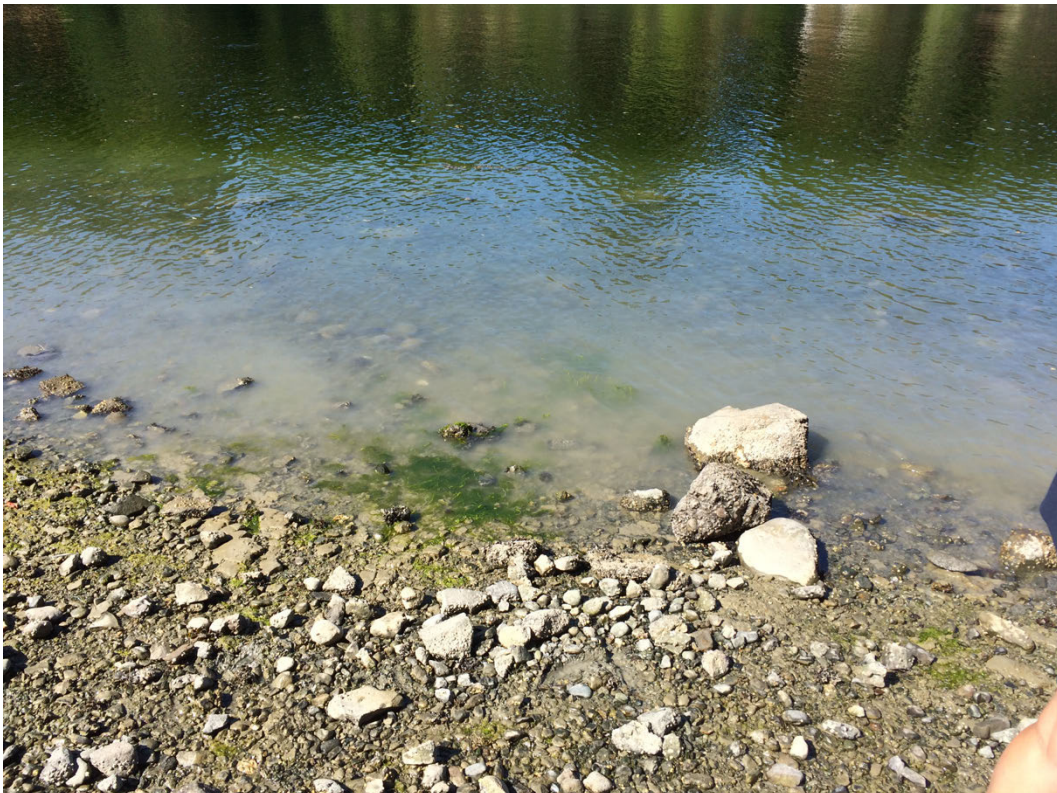
Photo 12. The clay in the beach substrate creates a sediment plume even in mild sea conditions with no foot disturbance.

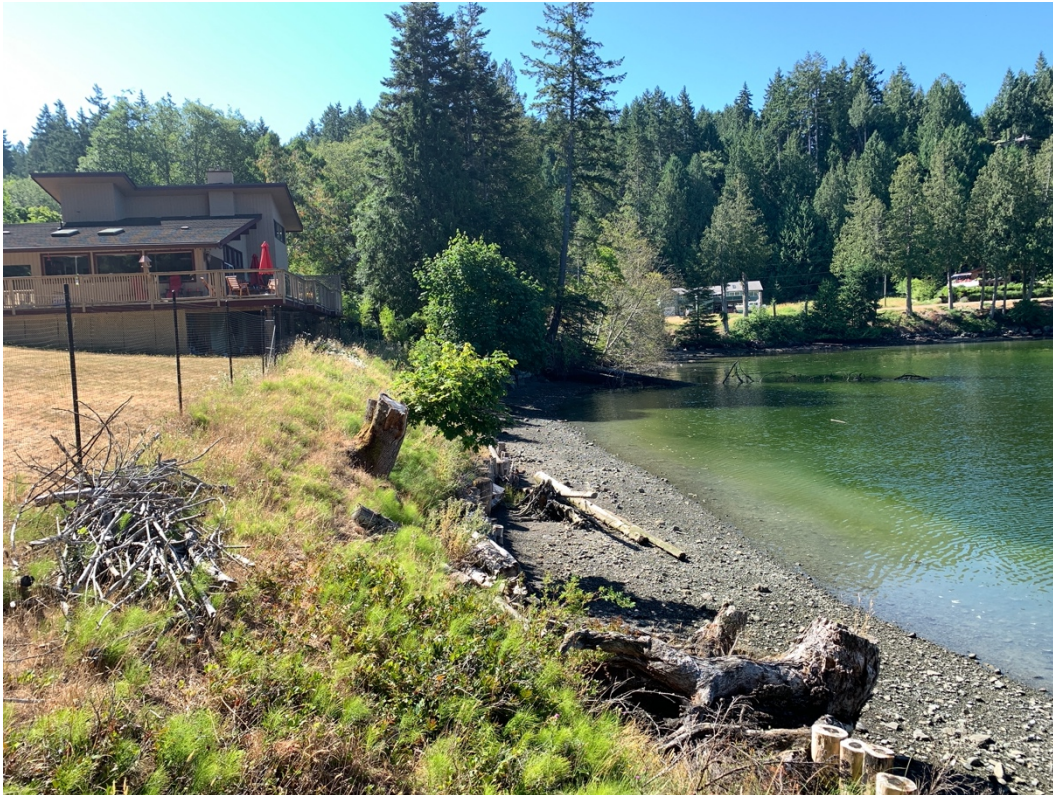
Photo 13. Looking south from the dock along the shoreline at the top of the eroding slope to the shoreline.

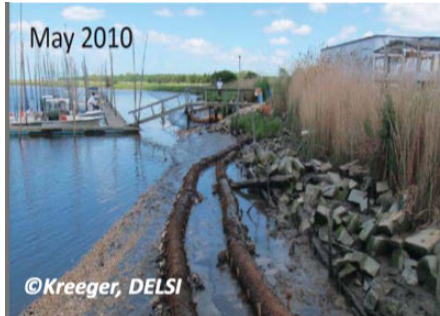
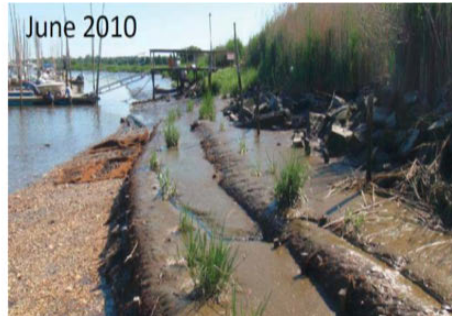
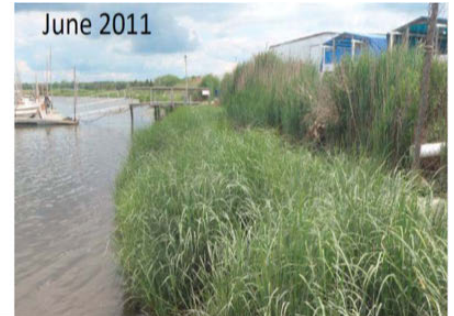
### Shoreline coir logs with plantings
