# **Salt Spring Island**

## ***Riparian Areas Regulation Mapping Project***

**February 2014**

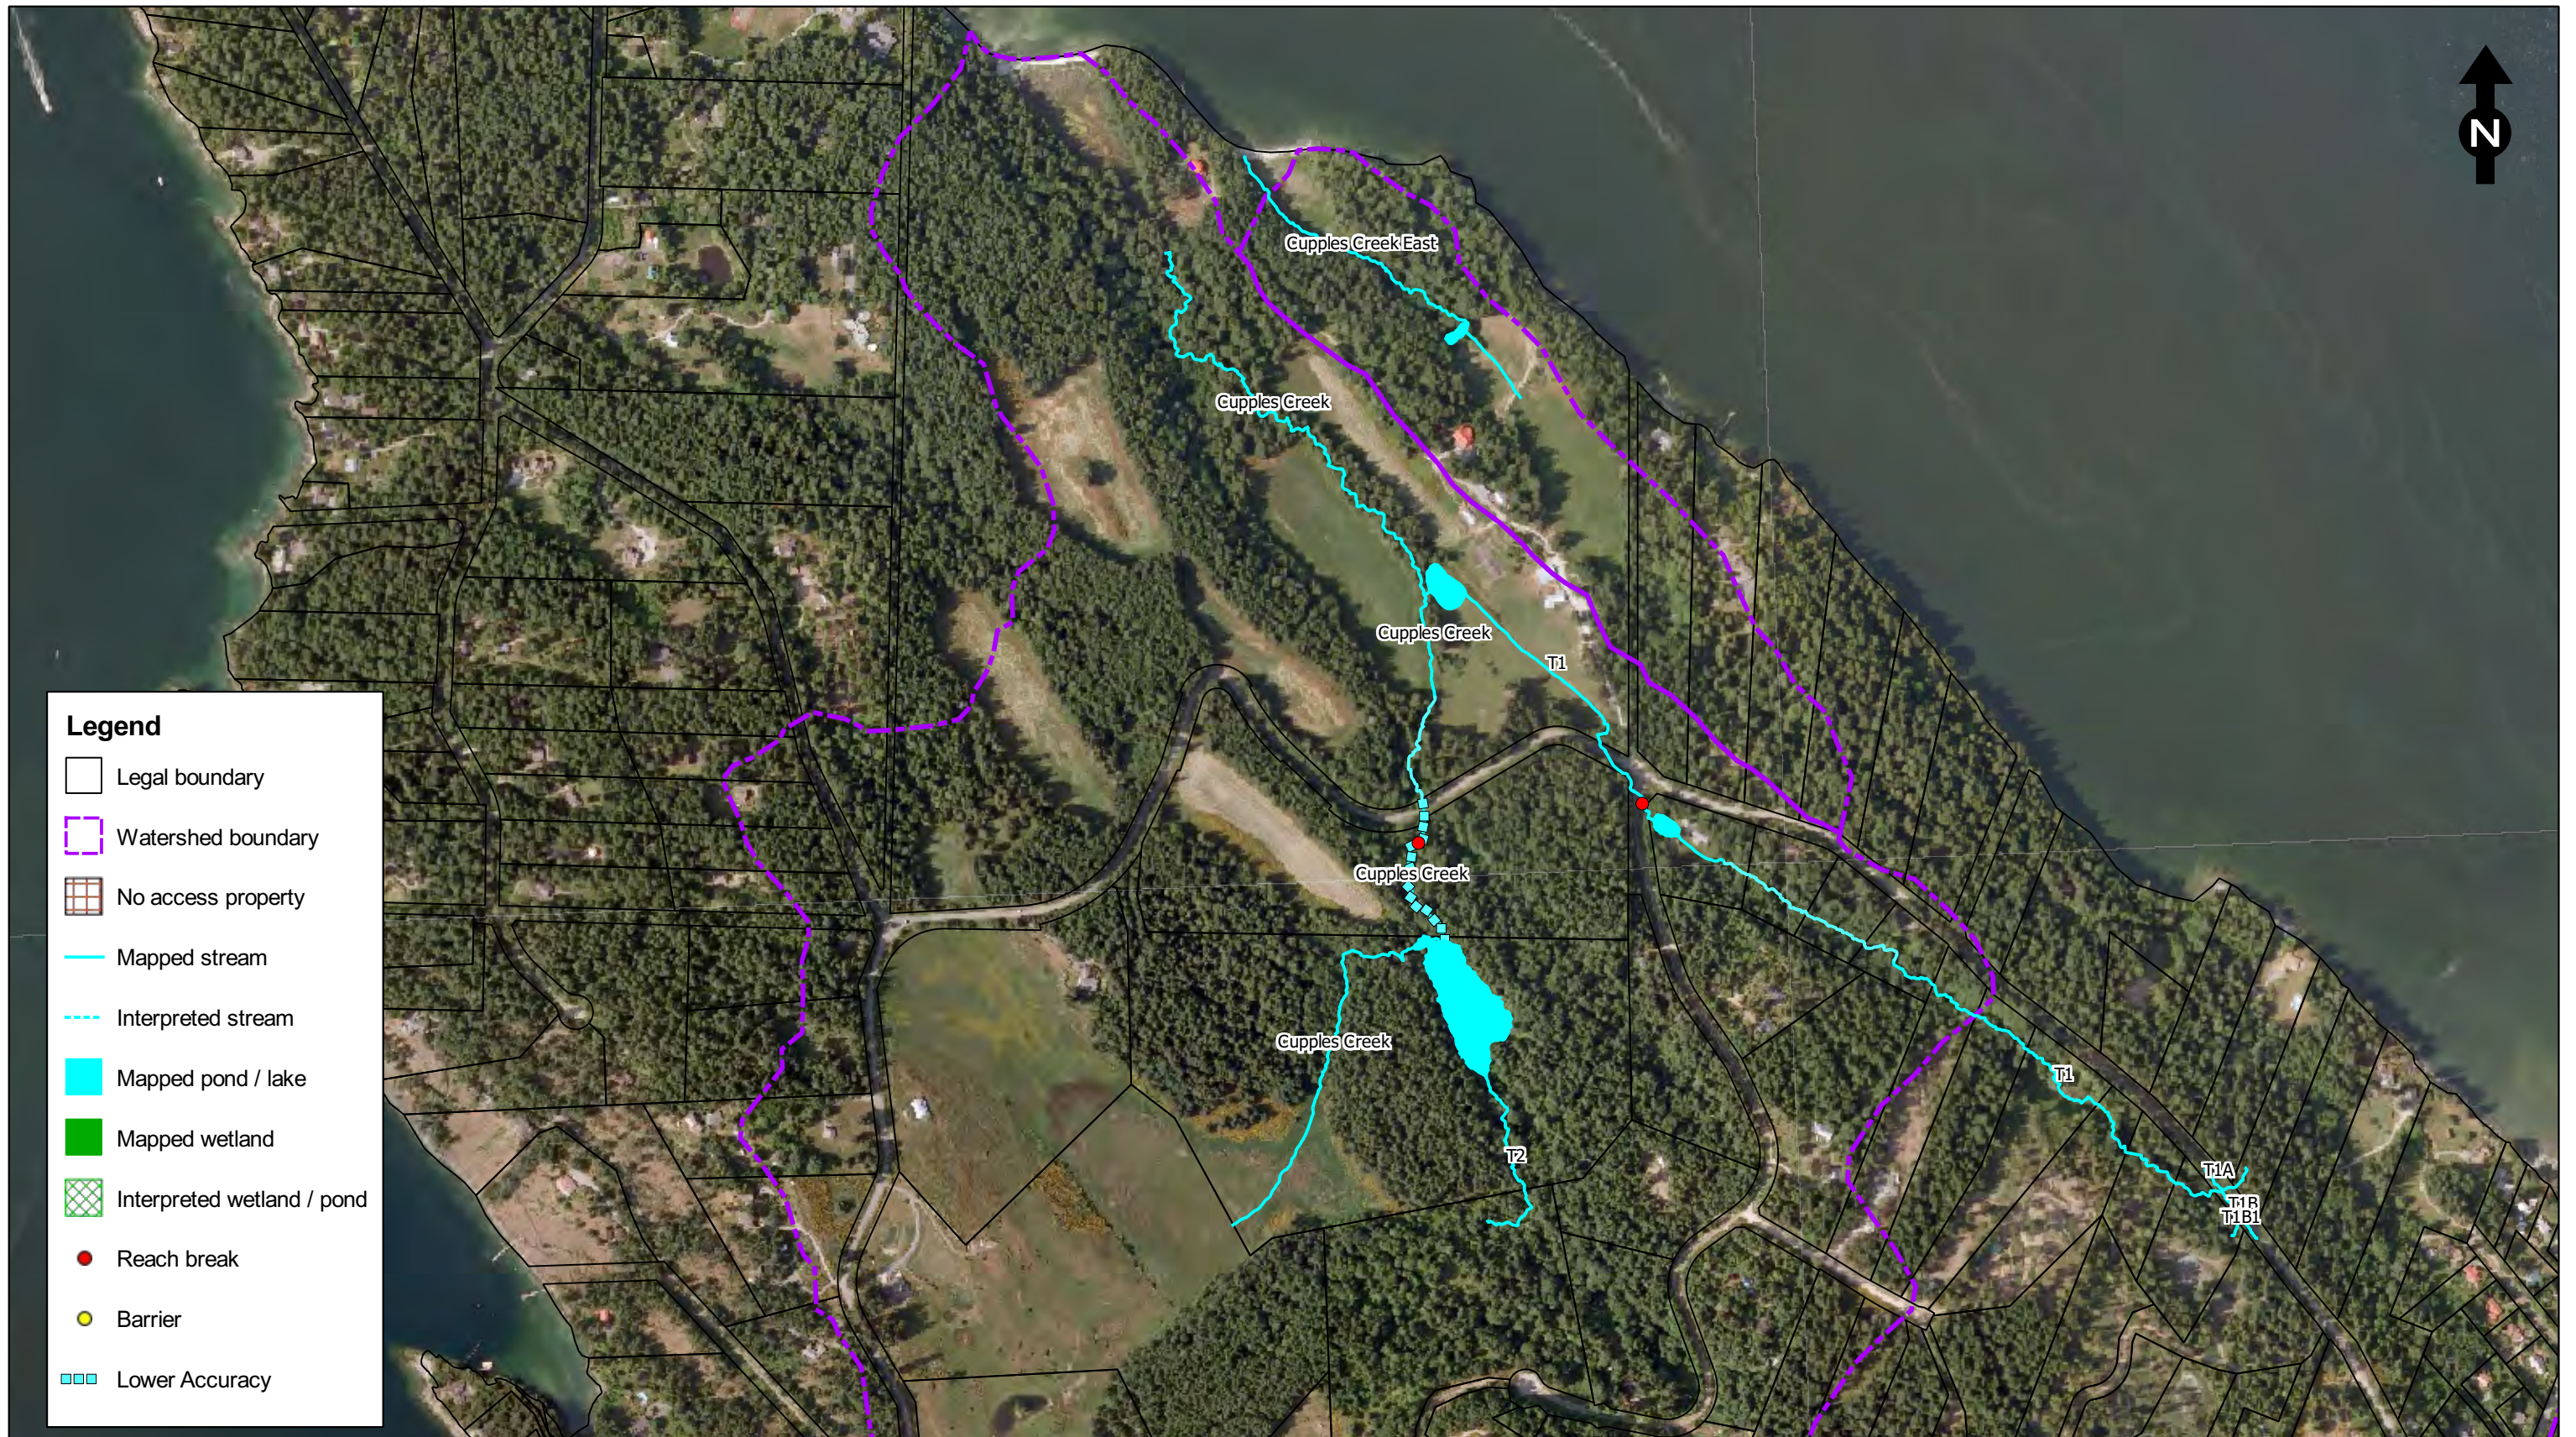
**Map 5 - Cupples and Cupples East Creek**

Survey Datum: NAD83, BC Albers  
 Projection: NAD83, BC Albers  
 Map Base: Developed from Island Trust Shape  
 Files and 2009 Orthophotos

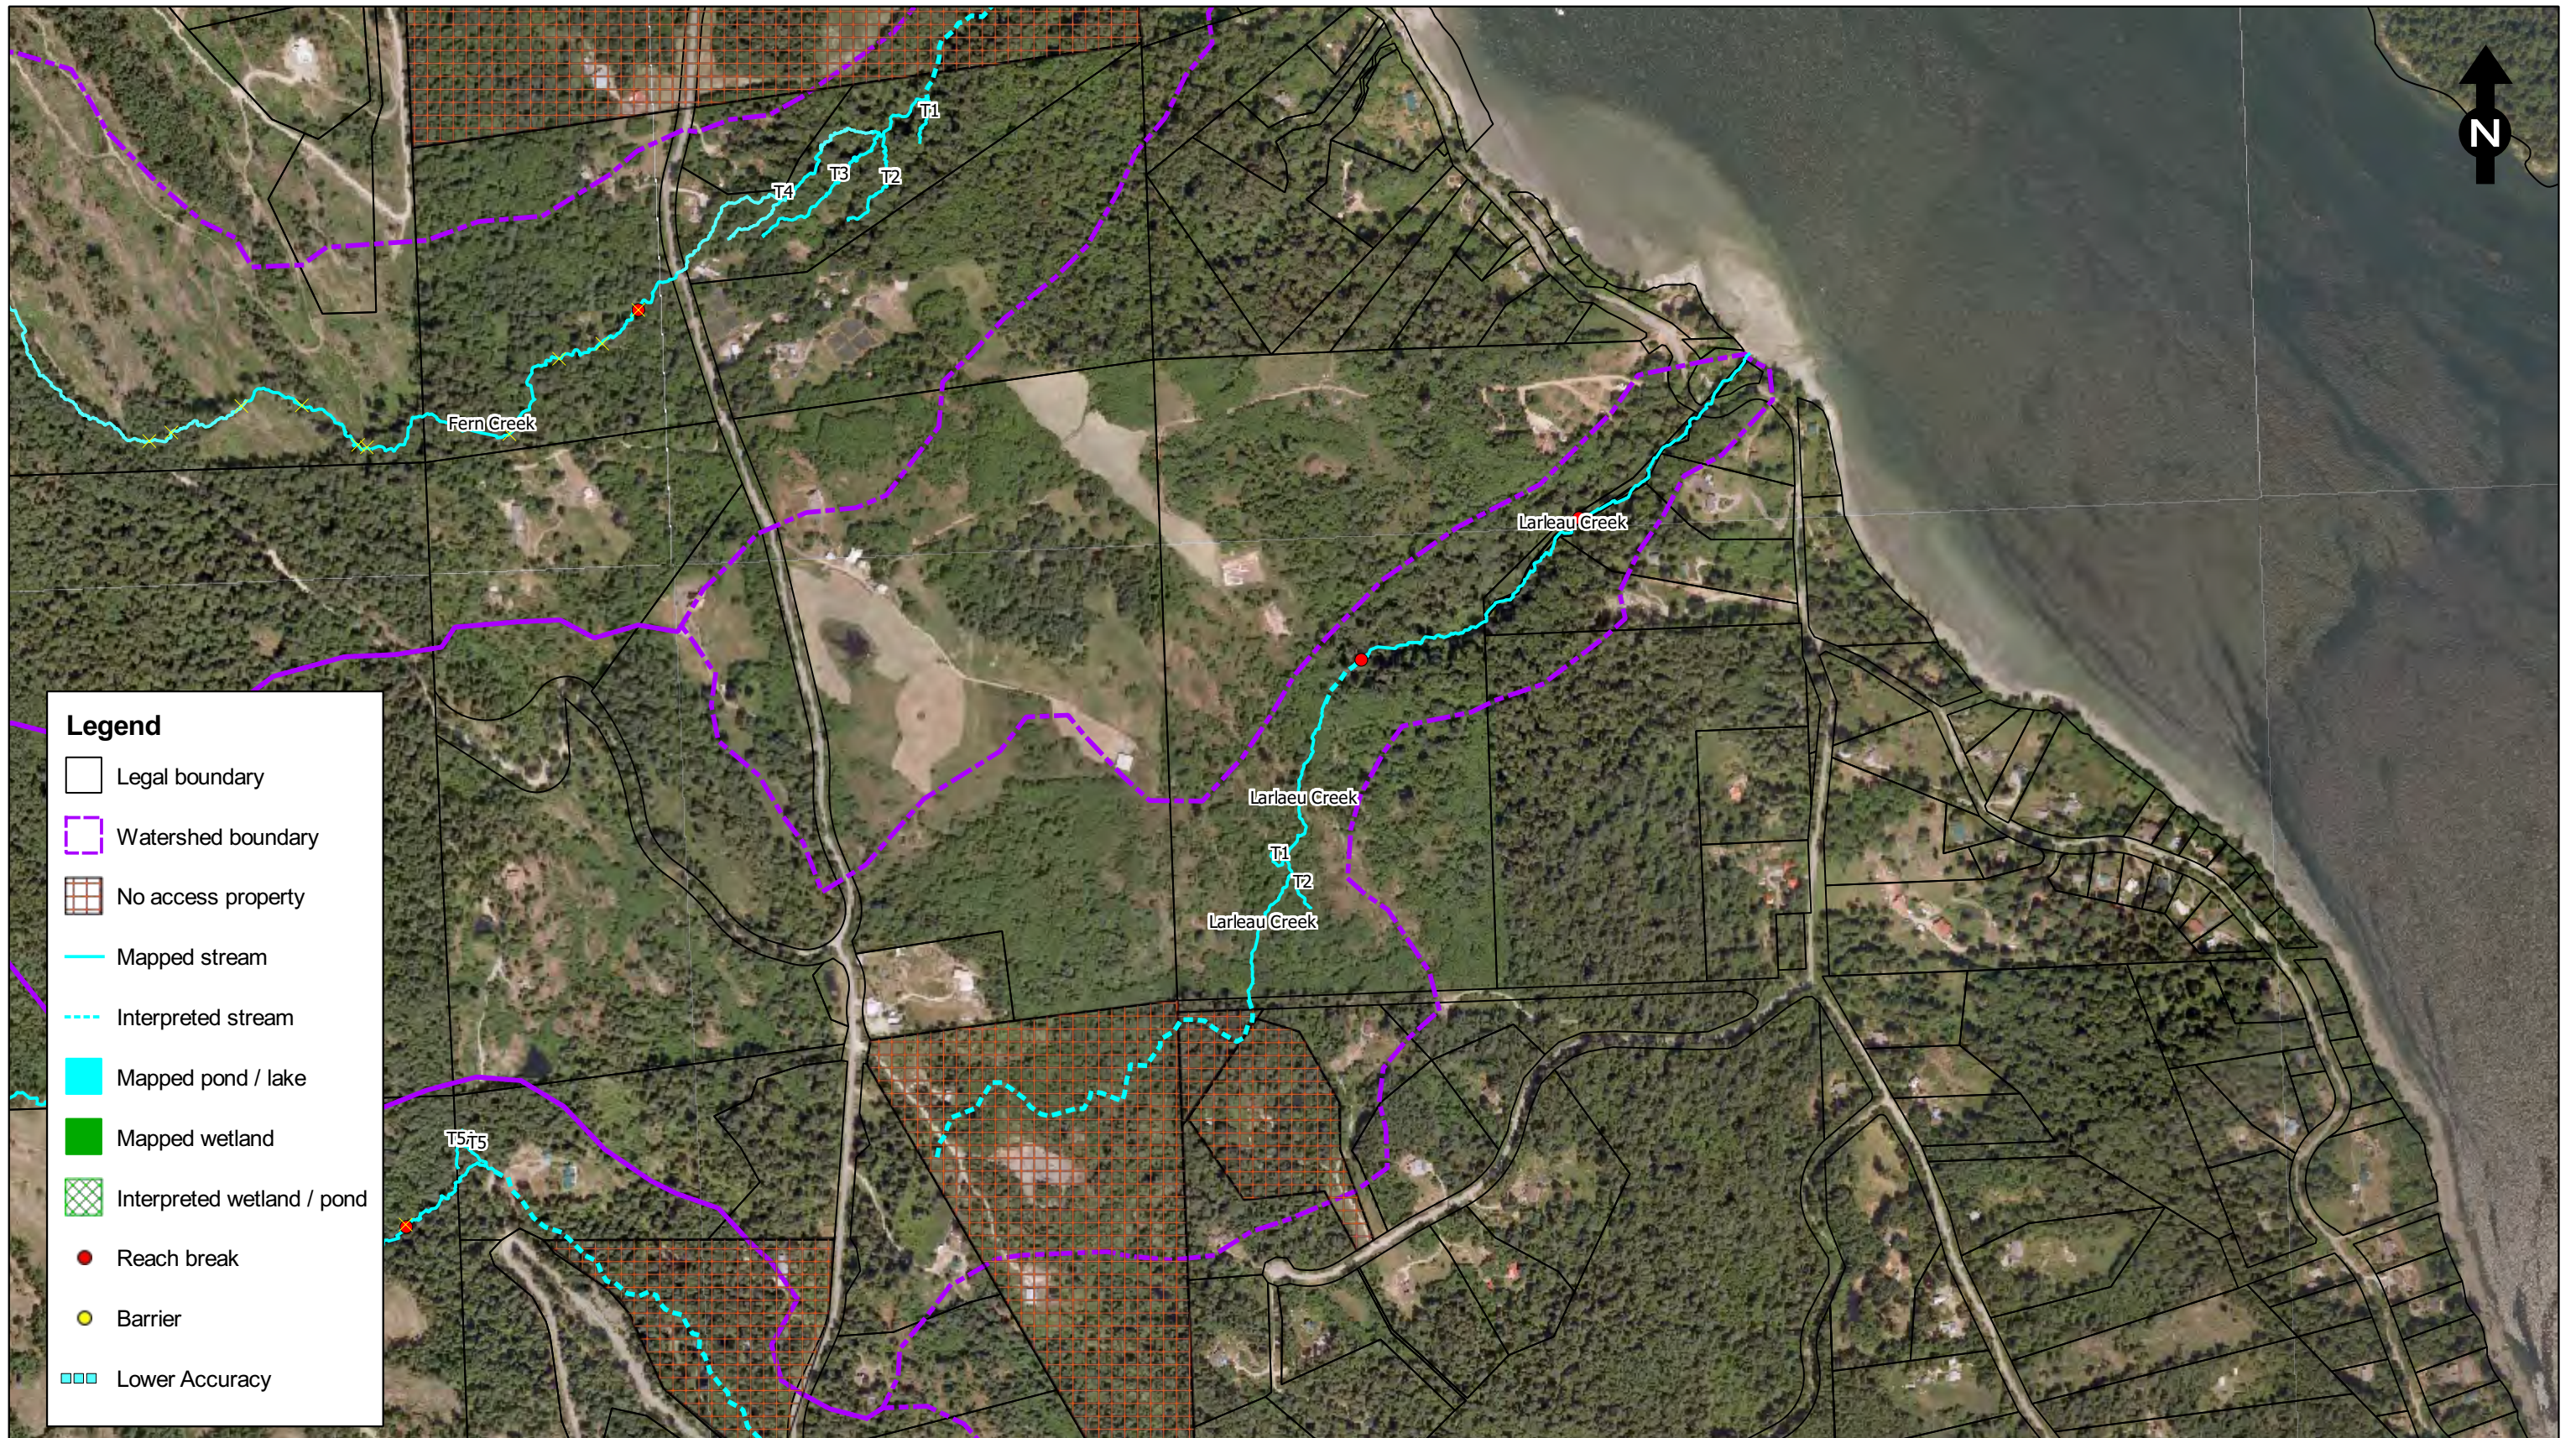
**Map 8 - Larleau Creek**

Survey Datum: NAD83, BC Albers  
 Projection: NAD83, BC Albers  
 Map Base: Developed from Island Trust Shape  
 Files and 2009 Orthophotos

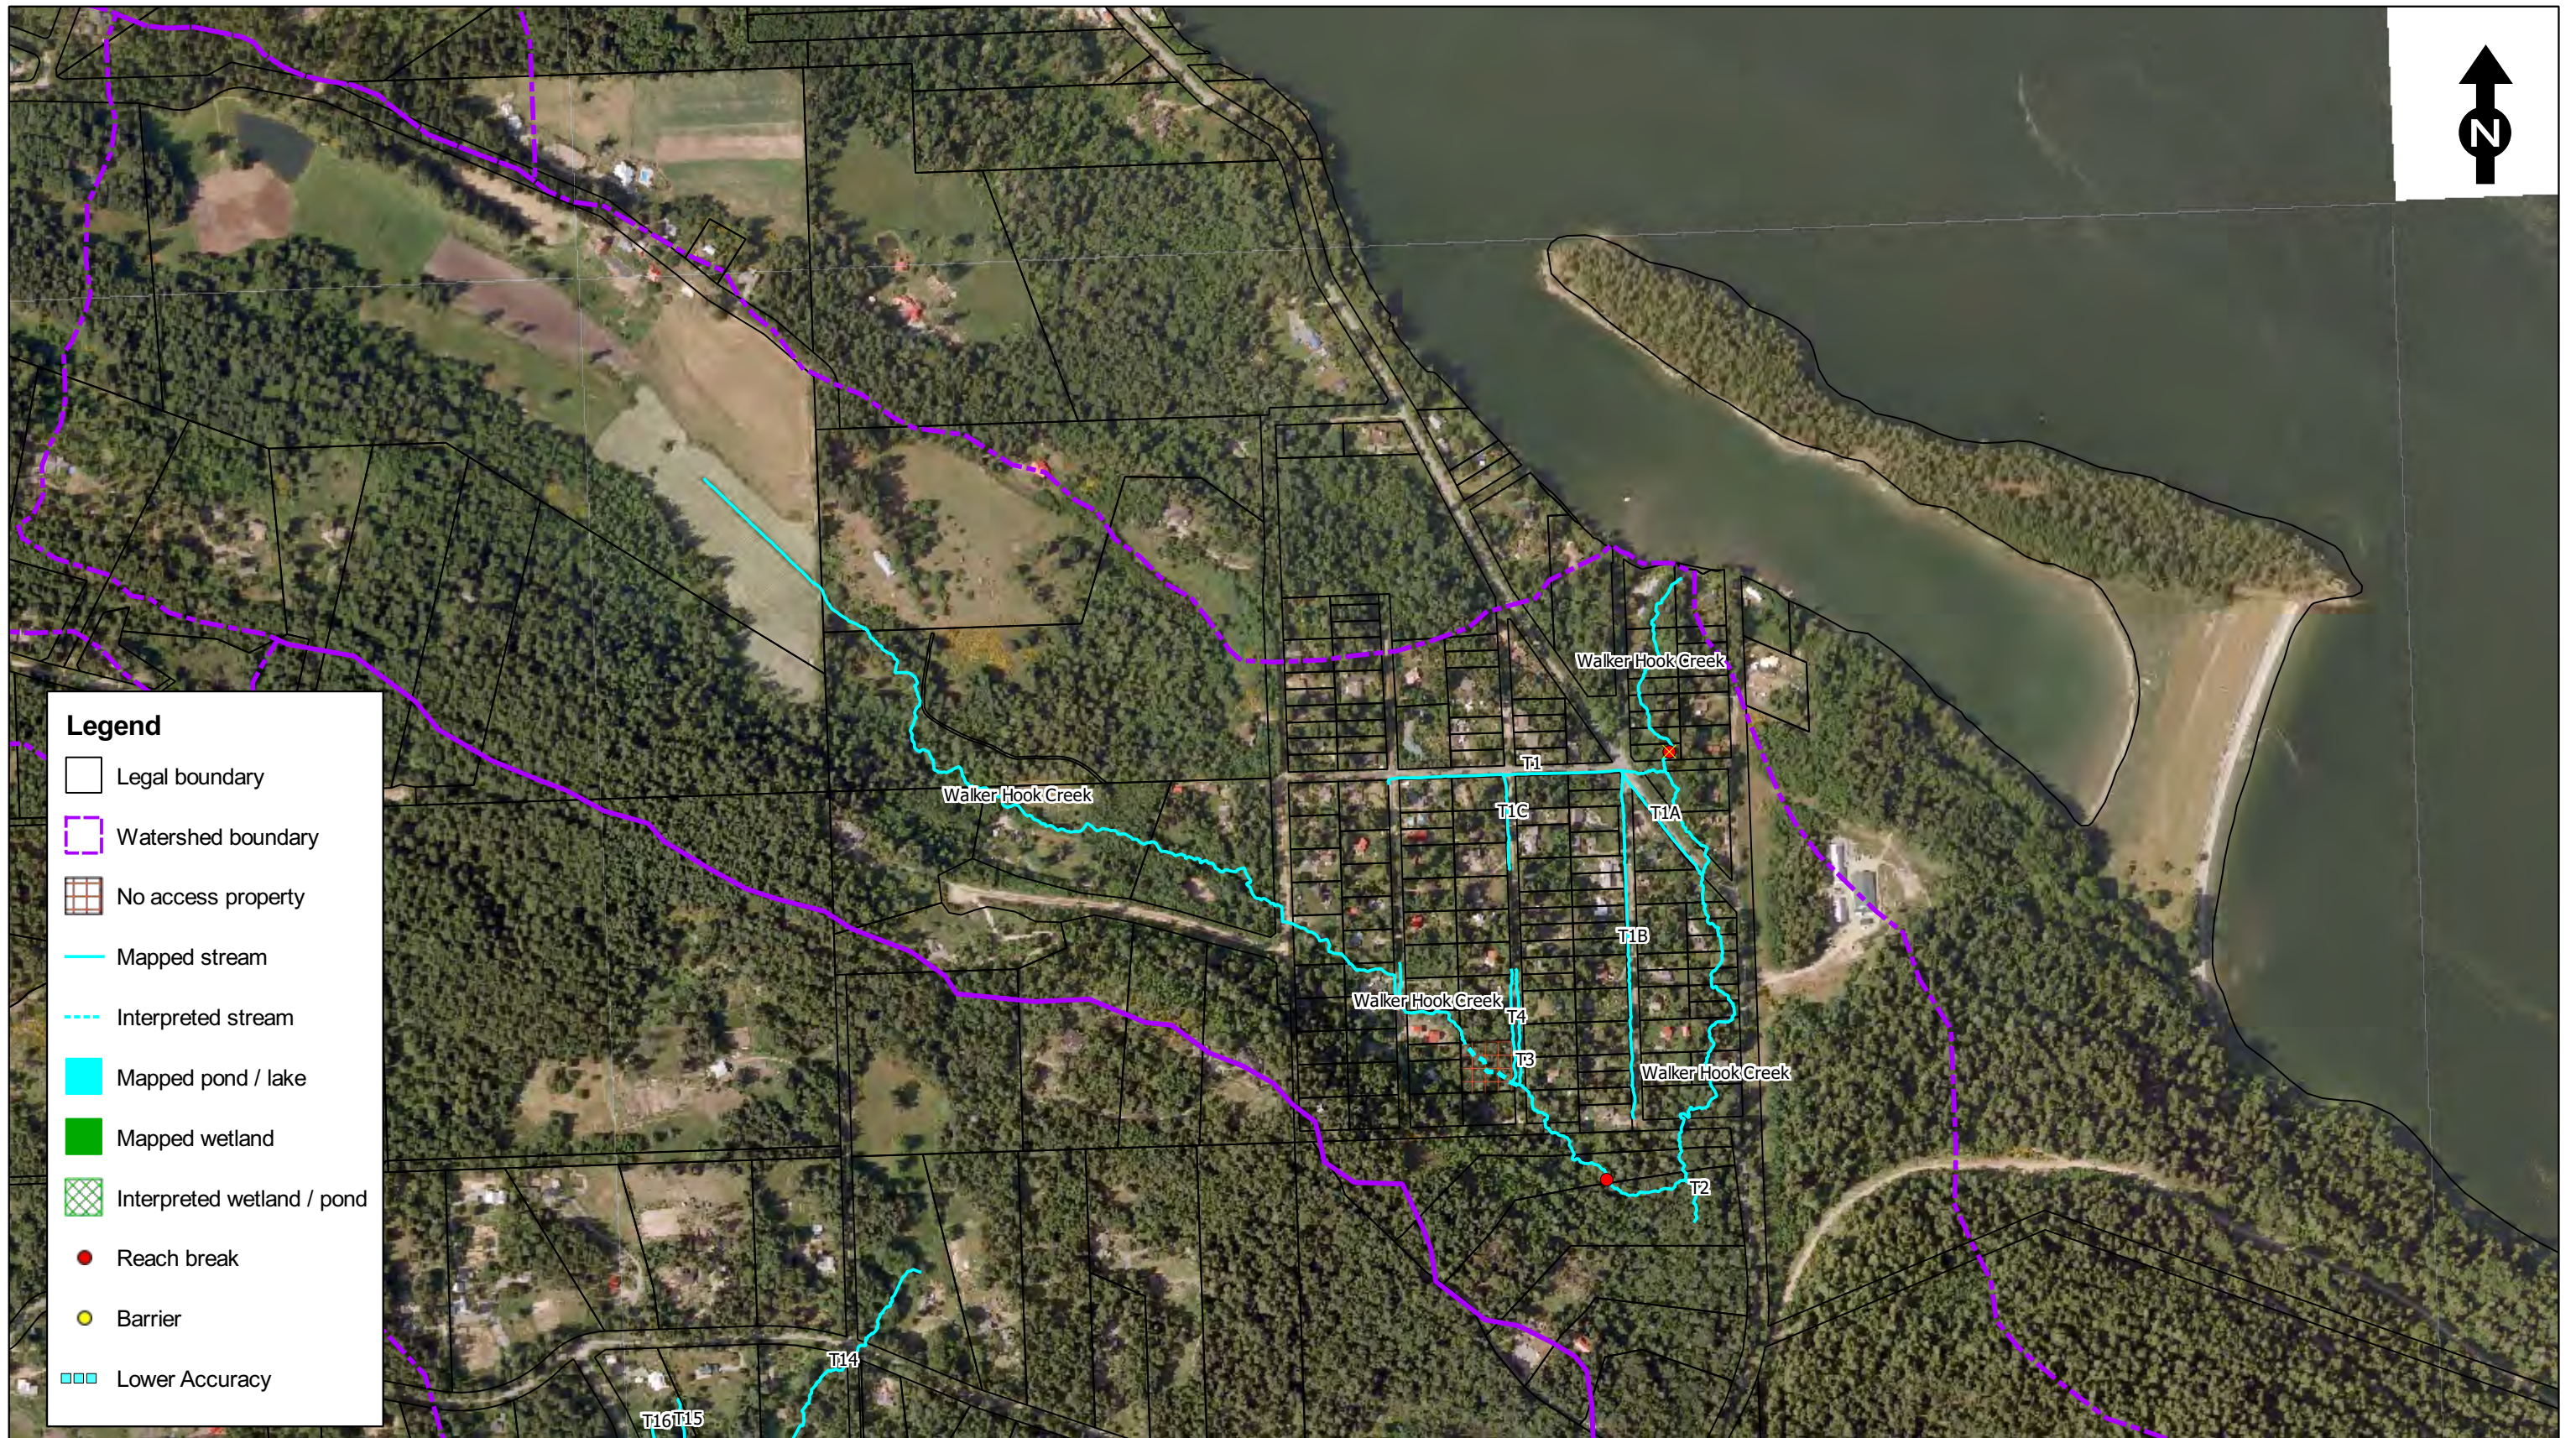
**Map 17 - Walker Hook Creek**

Survey Datum: NAD83, BC Albers  
 Projection: NAD83, BC Albers  
 Map Base: Developed from Island Trust Shape  
 Files and 2009 Orthophotos
