# Saturna Island Local Trust Committee

## Regular Meeting Agenda

**Date:** February 19, 2015  
**Time:** 12:30 pm  
**Location:** Saturna Recreation and Cultural Centre  
 104 Harris Road, Saturna Island, BC

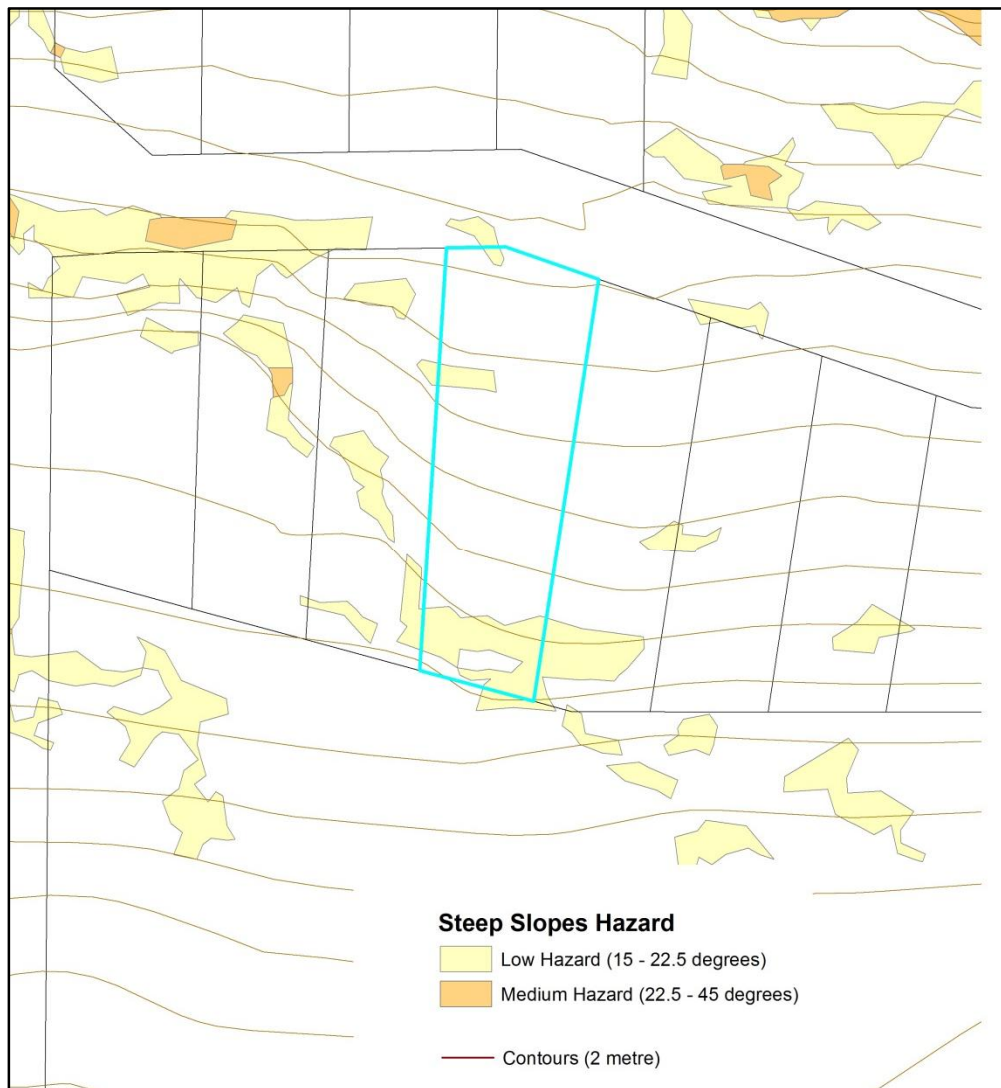
**Figure Six: Steep Slope Hazard Mapping with 2 m Contours**

The property has some occurrences of low hazard slopes of (15 to 22.5 degrees) as shown in Figure Six – above. The development does appear to have a small (upland) portion within the low hazard area. This is provided for information of the applicant.

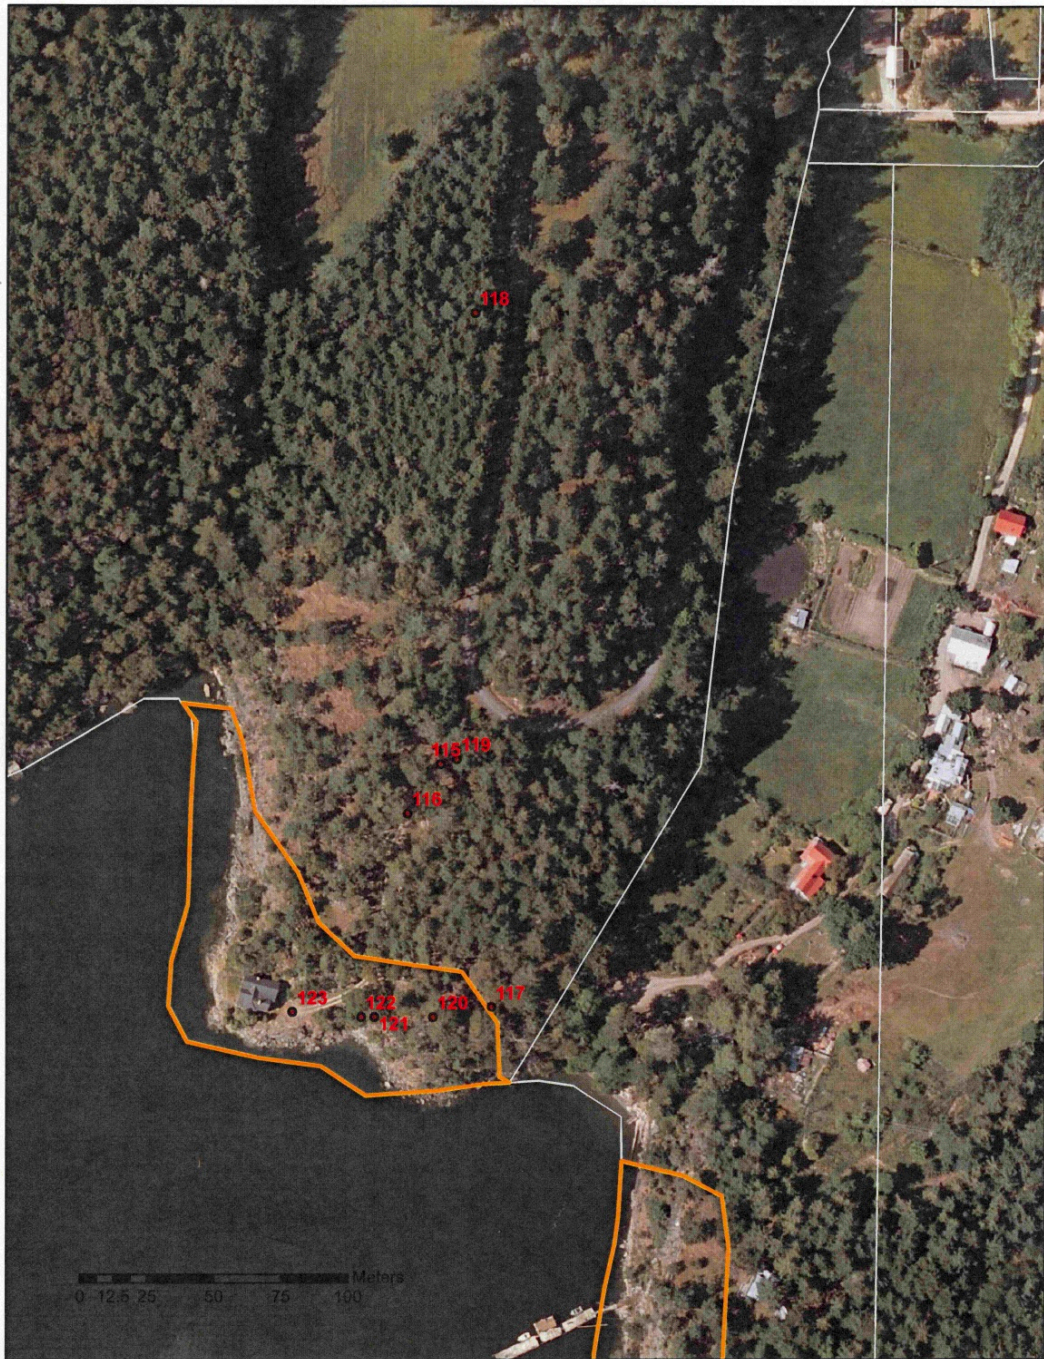
*Figure 2. Aerial photograph indicating the extent of the Coastal Bluff ecosystem (DPA 2) on Allotment 1, Old Point Farm.*

The property is pie-shaped and situated on a steep south/southwest-facing slope. The house is located on the southwest corner of the property (Figure 3). The existing driveway enters the property at the northern most point. The driveway follows the fall line almost directly south to the house (Figure 2). It is long, narrow and very steep, with a grade of greater than 20%. Poured concrete slabs provide traction and prevent erosion but litter-fall and duff must be continuously removed or the driveway becomes 'slippery' (Figure 4). "Drainage breaks" catch run-off and divert it off the road surface. The lower portion of the driveway as it turns toward the house has been built up with large boulders that form a wall (Figure 5). The narrowness and steepness of the driveway presents a serious challenge to visitors as well as emergency responders trying to access the home.

The lower one third of Allotment 1, Old Point Farm is designated as Coastal Bluff ecosystem as indicated on the 2013 Saturna Island DPA map (Figure 1) and air photo (Figure 2). Coastal bluffs are characterized by steep slopes (30% or more) and are often comprised of exposed rock and overhanging cliff faces. These areas provide important sheltering and nesting sites for birds, bats, snakes and lizards. Because of thin soils, vegetation is often limited. This property also can be characterized as having woodland ecosystem. Coastal bluffs are often found in combination with woodland habitat on the Southern Gulf Islands. Woodland ecosystems are dry, open forests characterized by a mix of deciduous and coniferous tree species. They are found on south facing slopes

The proposed plan reroutes the driveway so that it traverses the property in two legs to reduce the grade to 14%. The second leg or lower section of the driveway (~95 m) traverses east west through the DPA area along a narrow slope break (Figure 2: Points 117; and 120 – 122. Figure 3, Figure 6 and Figure 7). Removal of a 4 m x 4 m section of rock (near Point 117) at the upper end of the second leg (at the DPA boundary) is required (Figure 8). This rock will be used down slope in the construction of the road base. The driveway will require a large amount of rock and fill. The boulder/rock wall will have to be somewhat dismantled and rebuilt where the new driveway joins the old driveway near its terminus. The driveway will be 4 m wide.

*Figure 8. Section of rock to be removed. Located near Point 117 (Figure 2).*

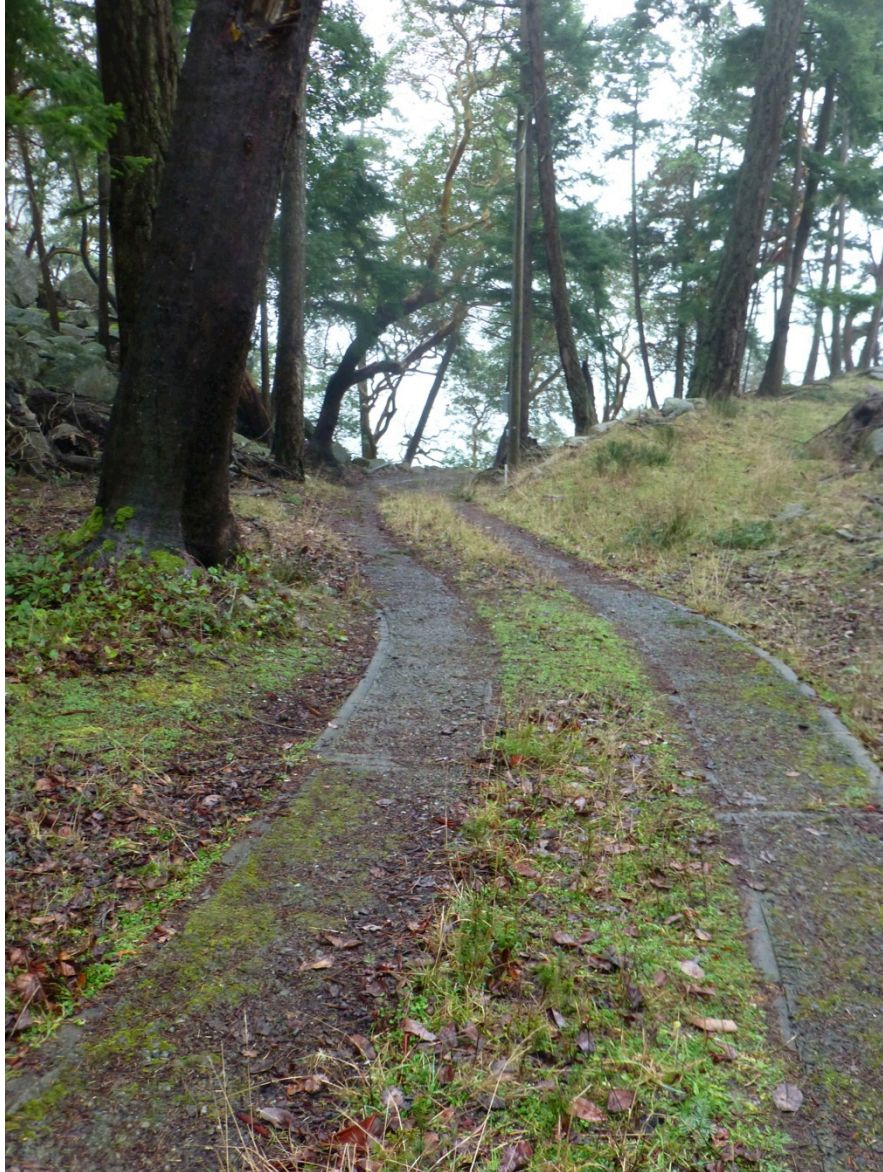
*Figure 4. Existing driveway. Photo taken, January 10, 2015.*

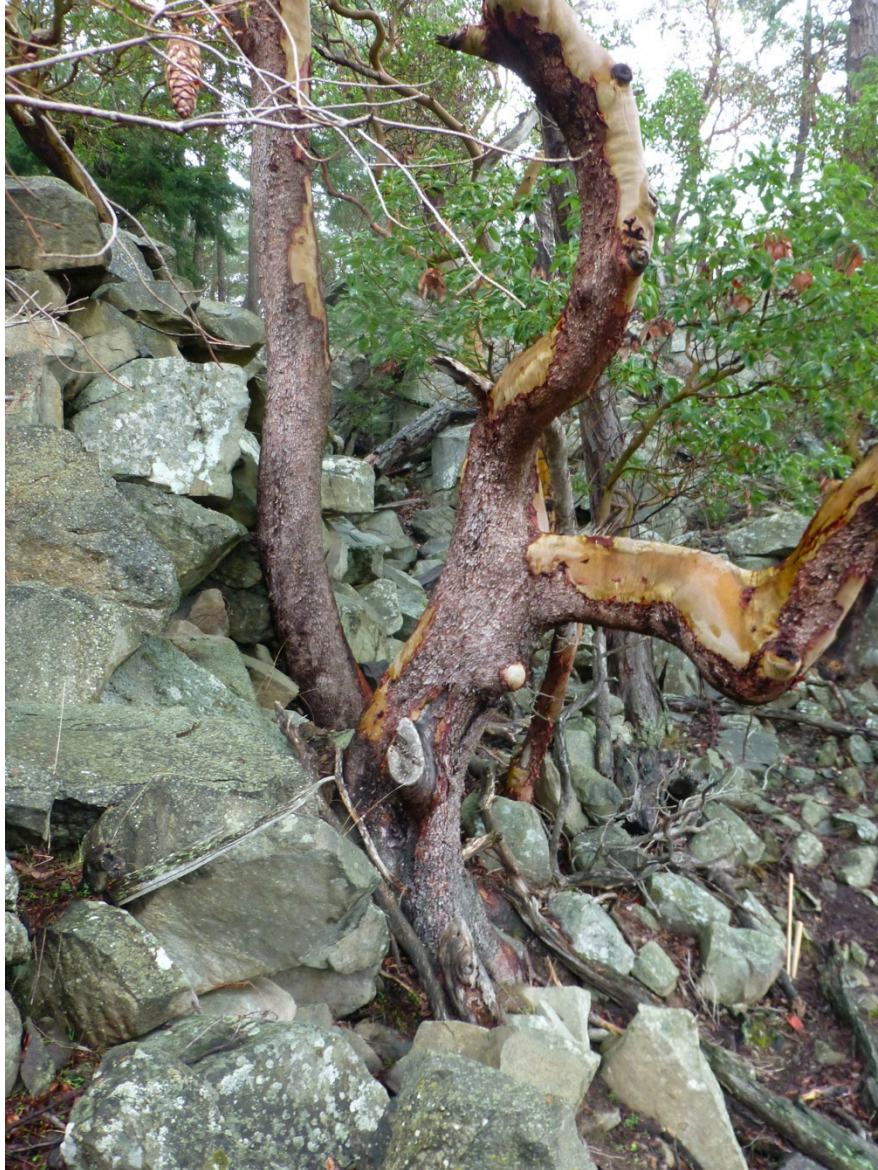
*Figure 5. Rock/boulder wall near terminus of existing driveway. Photo taken, January 10, 2015.*

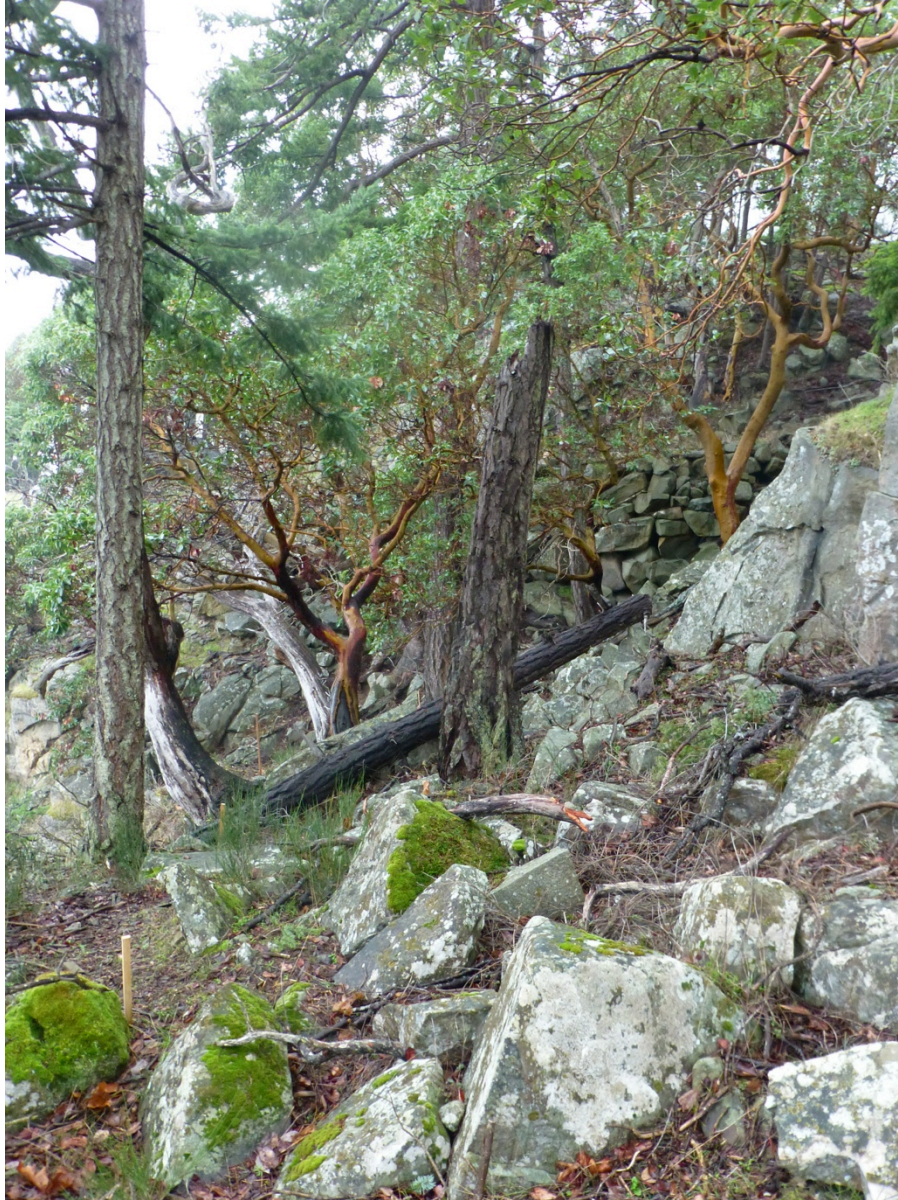
*Figure 6. Photograph taken on January 10, 2015, looking west northwest from approximate midpoint of proposed driveway, showing the nature of the Bluff DPA on landowner's property. Proposed driveway will follow a narrow slope break around cliff face (center right) to join existing drive at rock wall (upper right). Boulders in foreground will form road base. The arbutus in background will be removed.*

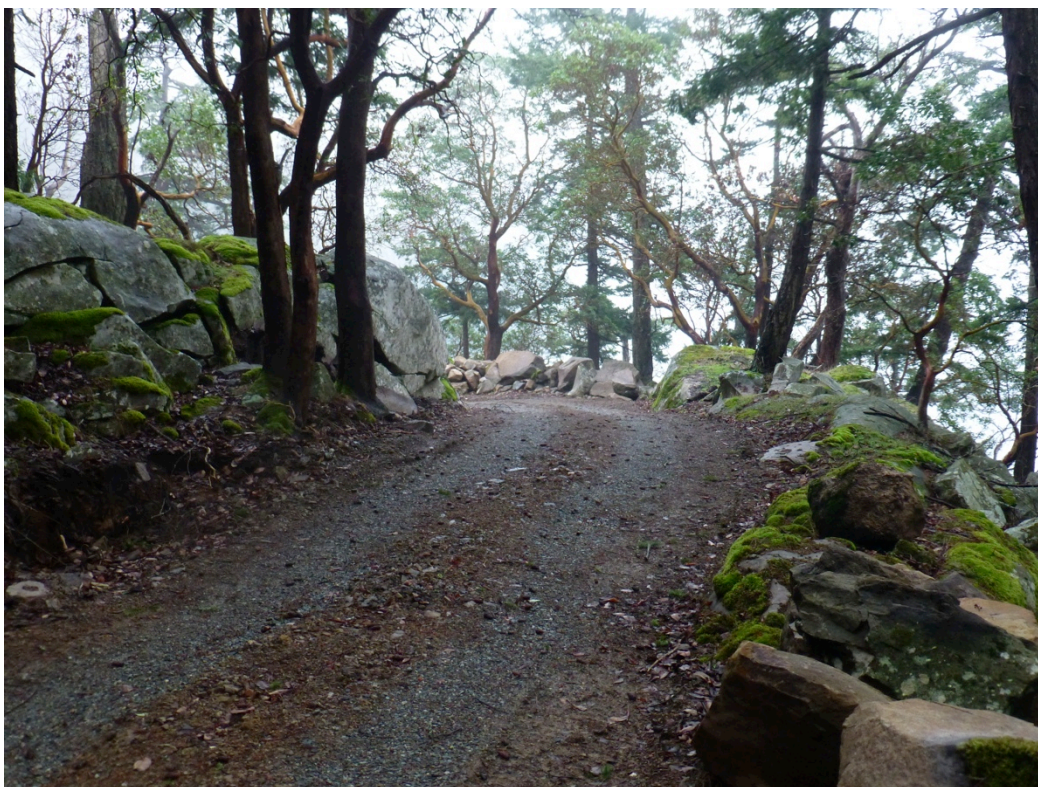
*Figure 7. The first leg of new driveway. Photograph taken, January 10, 2015.*

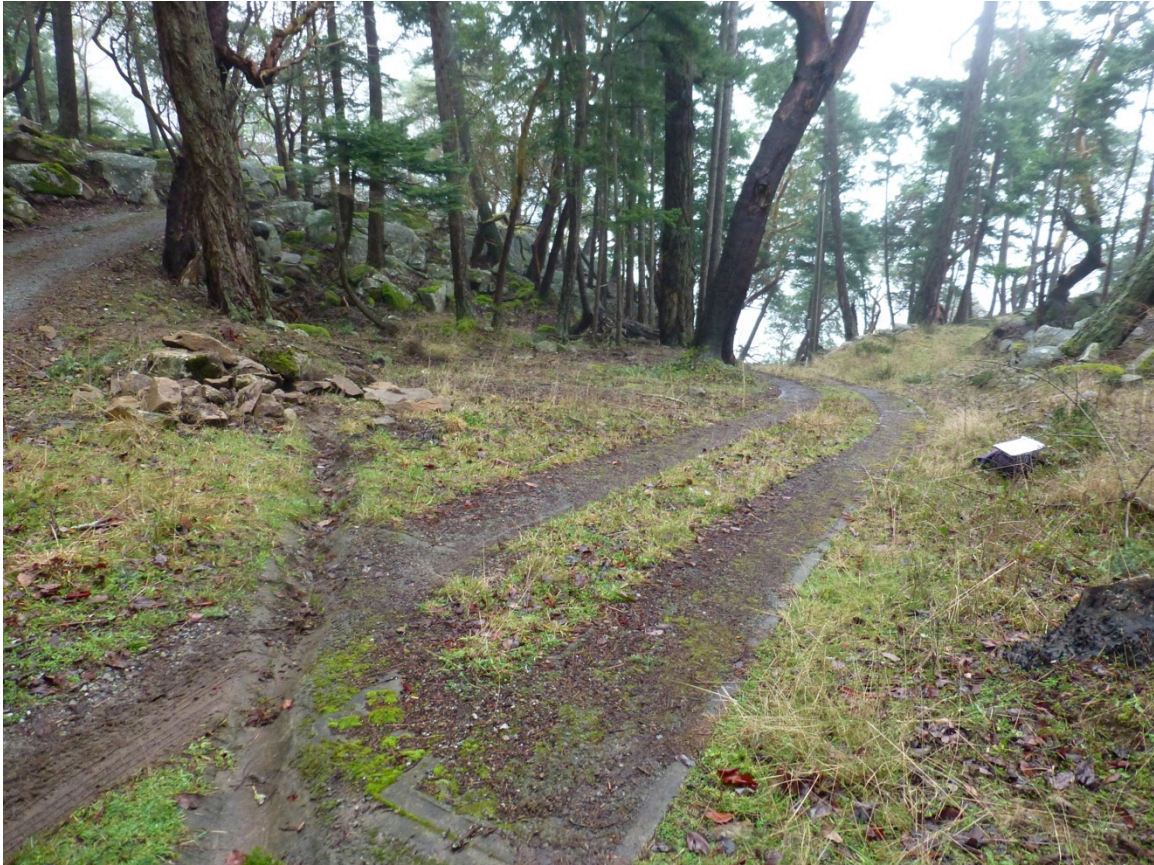
*Figure 9. View of the upper portion of existing driveway (upper section of new driveway is seen in upper left corner of photo. During reclamation cement slabs should be removed and native tree species re-established along its entire length. A deer/goat exclosure plot would work well here. Photo taken, January 10, 2015.*

- Reclamation of the old driveway; this would include removal of cement slabs and re-establishing native tree species such as Douglas-fir, Gary oak and arbutus (This may be accomplished through the planting of seedlings or by setting up deer/goat-exclosure plots that allow native flora to re-establish naturally);
- Continuation of the owner's program of invasive species removal, including the removal of Oxeye Daisy;
- Limit access to rocky knolls and cliff areas so as not to disturb fragile mosses and plants; and the
- Careful use of automotive or ice-removal agents or materials (oils, cleaners, salt, etc.) that could impact or compromise the health of the adjacent sensitive ecosystems.
