**Management Plan
for the Ruby Alton Nature Reserve
Isabella Point
Salt Spring Island, BC**

November 21, 2002

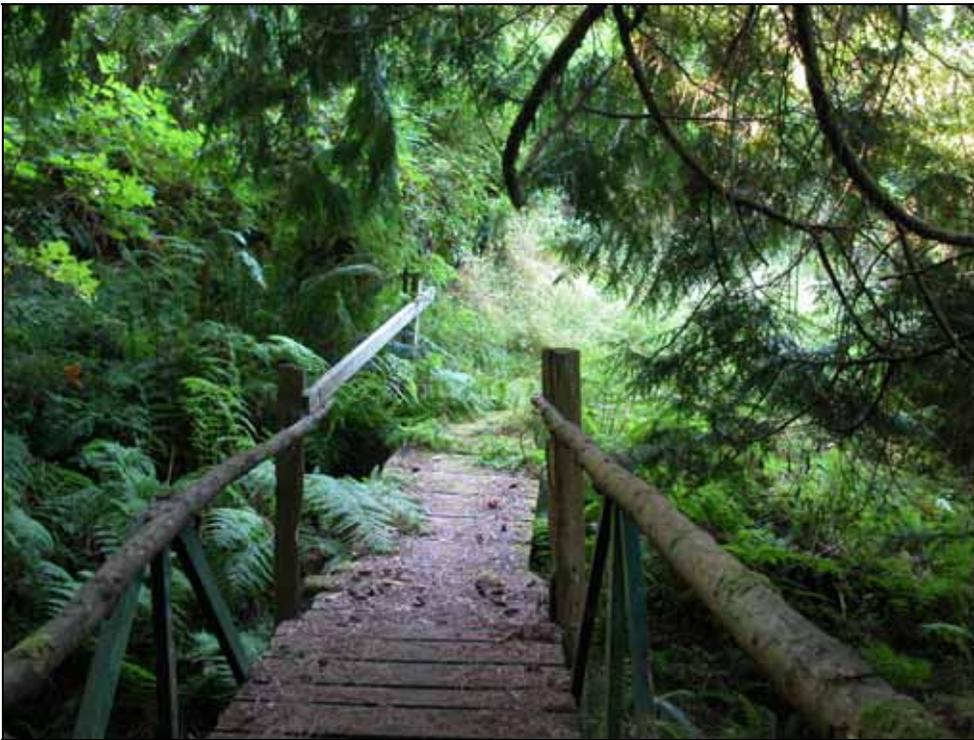
Figure 4. Bridge over Ruby's Creek (Forsen Brook)

A creek known locally as Ruby's Creek but formally described as Forsen Brook, crosses the southern portion of the property and flows east towards Fulford Harbour. Though its flow is significantly reduced during the dry season, it flows year round, and supplies water to both Ruby Alton's house and to the immediate neighbour to the north.

- The lid to the septic tank currently consists of four heavy 2"x10" loose boards.
- The railings on the bridge over Ruby's creek are loose.
- The steps in the south trail to the beach are slippery or in some cases have failed and the railing is loose.
- The mossy concrete walkways and steps and the sloping, uneven nature of the land make walking on-site somewhat hazardous.
- The lack of stability and rough construction of the outbuildings are potentially dangerous.
- The north trail to the beach by the boat house needs maintenance if it is to be made a public access trail.
- Electrical issues in the house need immediate attention.
- No smoke detectors exist in the house.

Suggested Actions: ITF and the Management Group should work together immediately to ensure the septic tank lid is secure and obvious, that the bridge is barricaded until its railings and footings can be stabilized, that steps and walkways are improved (leveled and moss removed); that outbuildings are stabilized, removed or clearly marked as hazardous/areas for caution, any trails for public use are identified and adequately cleared, and that electrical needs, including smoke detectors, are addressed before use of the house occurs.

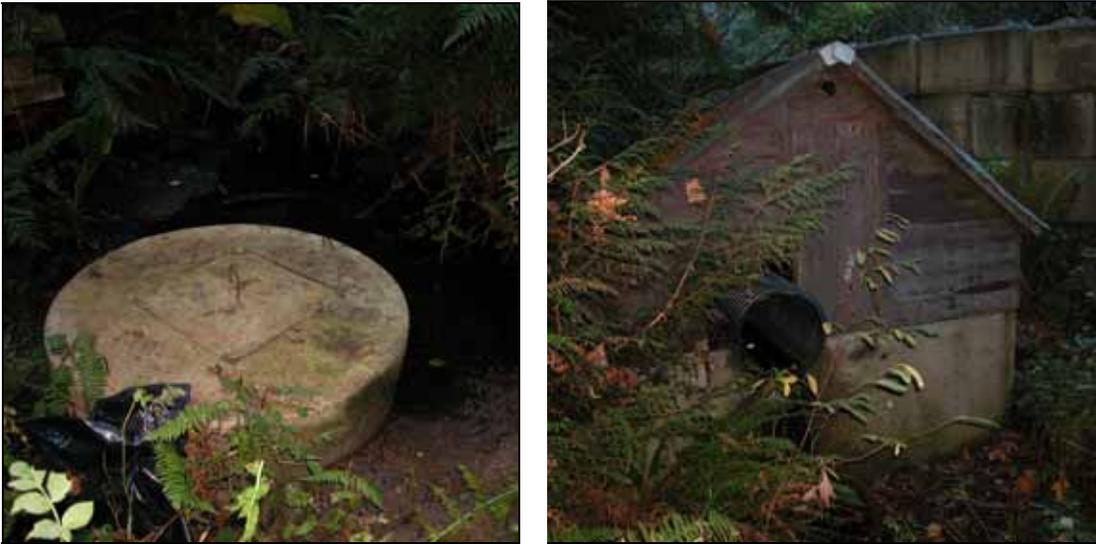
Figure 9. Concrete tile on adjacent NCC property, and the water reservoir visible from Isabella Point Road.

Both the Alton house and the neighbour to the north, use surface water from the stream that crosses the property. The two houses are fed from a reservoir constructed of concrete with a capacity of approximately 11,000 litres (Figure 9). It has a wooden roof and sides with an access door on the downstream side. Water is gravity fed through $\frac{3}{4}$ " tubing to the Alton and neighbour houses.

The Alton home has de facto precedence on the water supply because the neighbour to the north's inlet is located higher on the tank than is the Alton inlet. Distance from the reservoir to the Alton home is approximately 60m.

Agricultural uses of the watershed and test results from nearby surface wells, indicate a high likelihood of coliform bacteria contamination and elevated background bacterial counts in the water. If this is found to be the situation at the RANR a coarse filter and UV light point of entry system could be installed to address it. The potential for mineral contamination or heavy metal contamination from run-off from the road surface is also present and the situation is currently unknown. If, after cleaning this type of contamination is found an activated carbon filter would be necessary in order to bring the water to drinking-water standards. Depending on the outcome of the testing, another option would be to consider the water unfit for drinking and import bottled water to the property.

First, the water system should be shocked with chlorine and flushed to allow a more representative sample of water quality to be taken. Initially, it was suggested that this shocking take place in the fall of 2002, however the neighbour indicated that this cleaning should be conducted during the rainy season when the tank will fill up rapidly after being drained. Thus the test is recommended to be done in the winter 2002, or in a worst case, before major cleaning and improvement of the tank is undertaken.

As noted in section 5.2.8, the reservoir fills from a tile on the property west of the RANR now owned by Nature Conservancy of Canada. Consultation with Doug Macdonald, Ruby's nephew who has maintained the system for many years, yielded the following suggestions about water supply options:

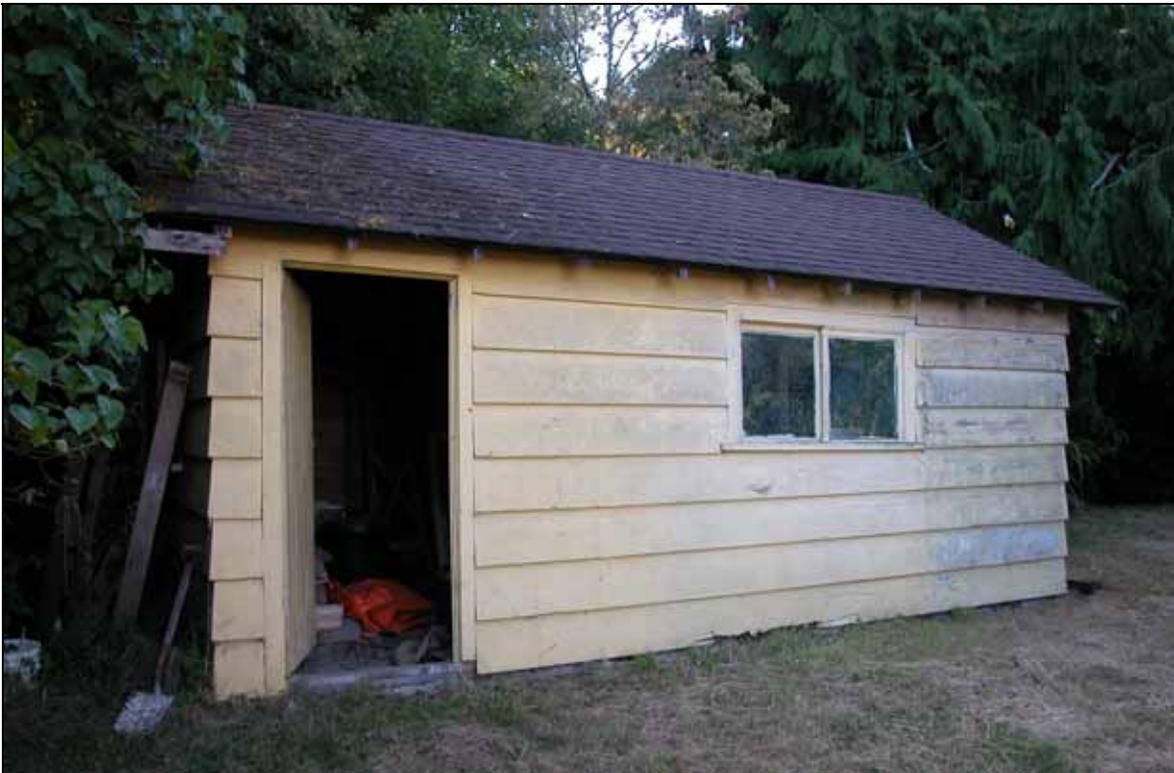
Figure 10. The garage

The garage is approximately 15 feet x 7 feet of simple stud construction resting either directly on the ground or on concrete blocks. It is clad with 1" x 12" horizontal boards and roofed with asphalt shingles. The windows are wood and appear to have been re-used from a previous building. The sill plate and bottom of the studs on the East side are rotten but the building is in relatively good condition overall.

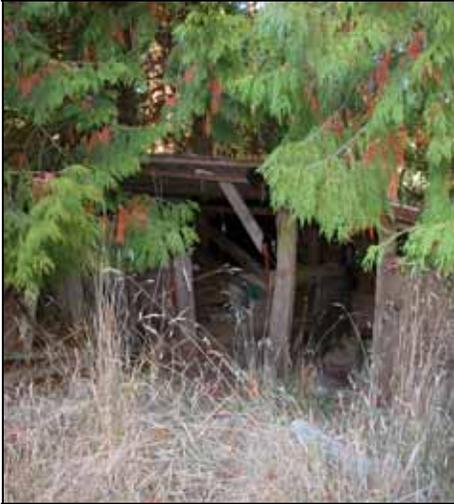
Figure 11. Sheep Shed (October, 2002)

The two part sheep shed uses a large fir tree as a major support.

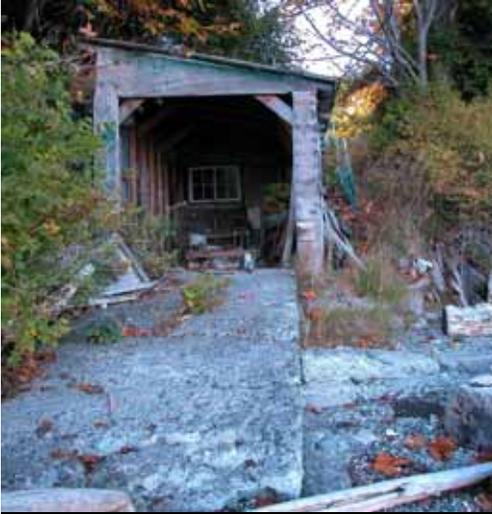
Figure 12. Boat House (October 2002)

The 16'x 24' boat house is a simple frame building clad with galvanized corrugated iron on the walls and aluminum on the roof (Figure 12). The windows are re-used vertical sash units. It faces onto a concrete and rock slipway down below the high water mark. Adjacent to the slipway is a concrete and rock terrace with steps up the side of the boat house. The sills of this building are rotten, as is the floor.
