Transportation
Safety Board
of Canada

Marine Transportation Safety Investigation Report M20P0092

DRAGGING ANCHOR AND SUBSEQUENT COLLISION

Bulk carriers *Golden Cecilie* and *Green K-Max 1*
Plumper Sound, Southern Gulf Islands, British Columbia
30 March 2020

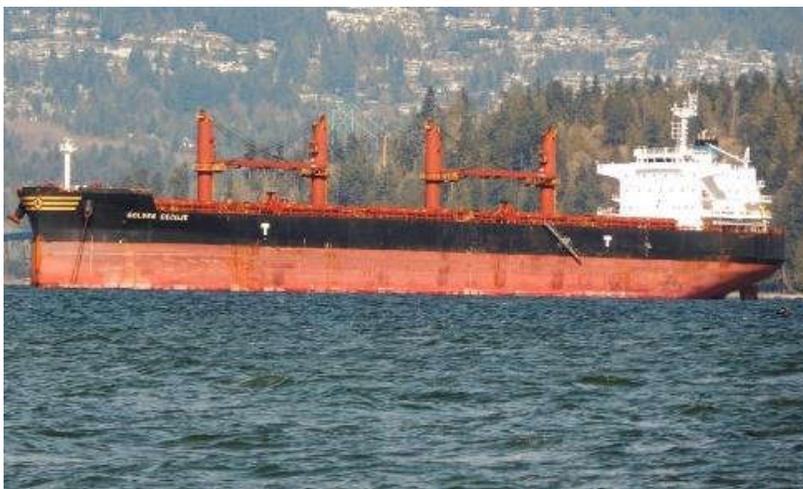
Figure 1. *Golden Cecilie* (Source: Csaba Magyar, Shipspotting.com)

The *Golden Cecilie* is a 198 m long bulk carrier of 34 311 gross registered tonnage. It was built in 2015 and is registered under the Hong Kong, China, flag (International Maritime Organization [IMO] No. 9692662) (Figure 1). At the time of the occurrence, there were 20 crew members on board.

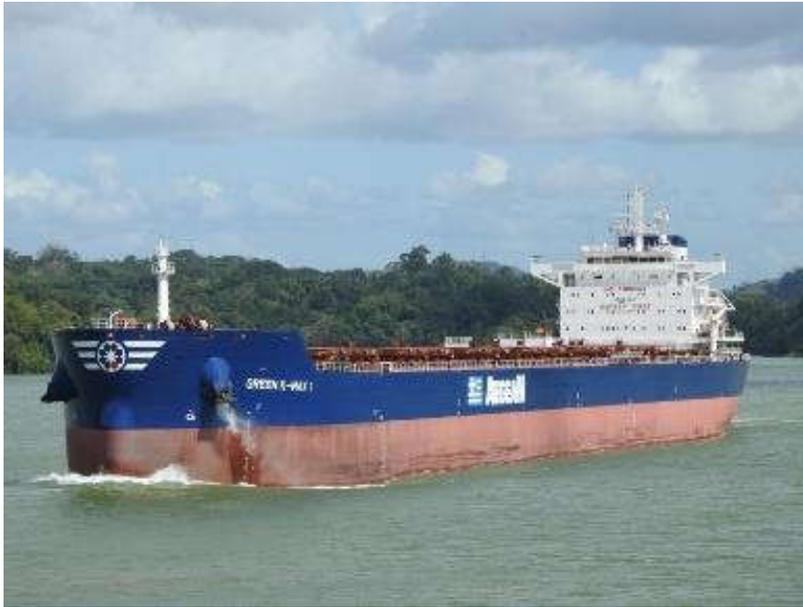
Figure 2. *Green K-Max 1* (Source: Captain Peter, Shipspotting.com)

The *Green K-Max 1* is a 229 m long bulk carrier of 44 076 gross registered tonnage, built in 2019 and registered under the Liberian flag (IMO No. 9838058) (Figure 2). At the time of occurrence, there were 19 crew members on board.
