MAP 11b: Eelgrass Presence Gabriola Island Local Trust Area - Northwest

The eelgrass inventory was completed by SeaChange Marine Conservation Society under contract by Islands Trust Fund and the Islands Trust. The inventory was conducted from July to November, 2013 using a towed underwater camera and Trimble Pathfinder Pro XR GPS.

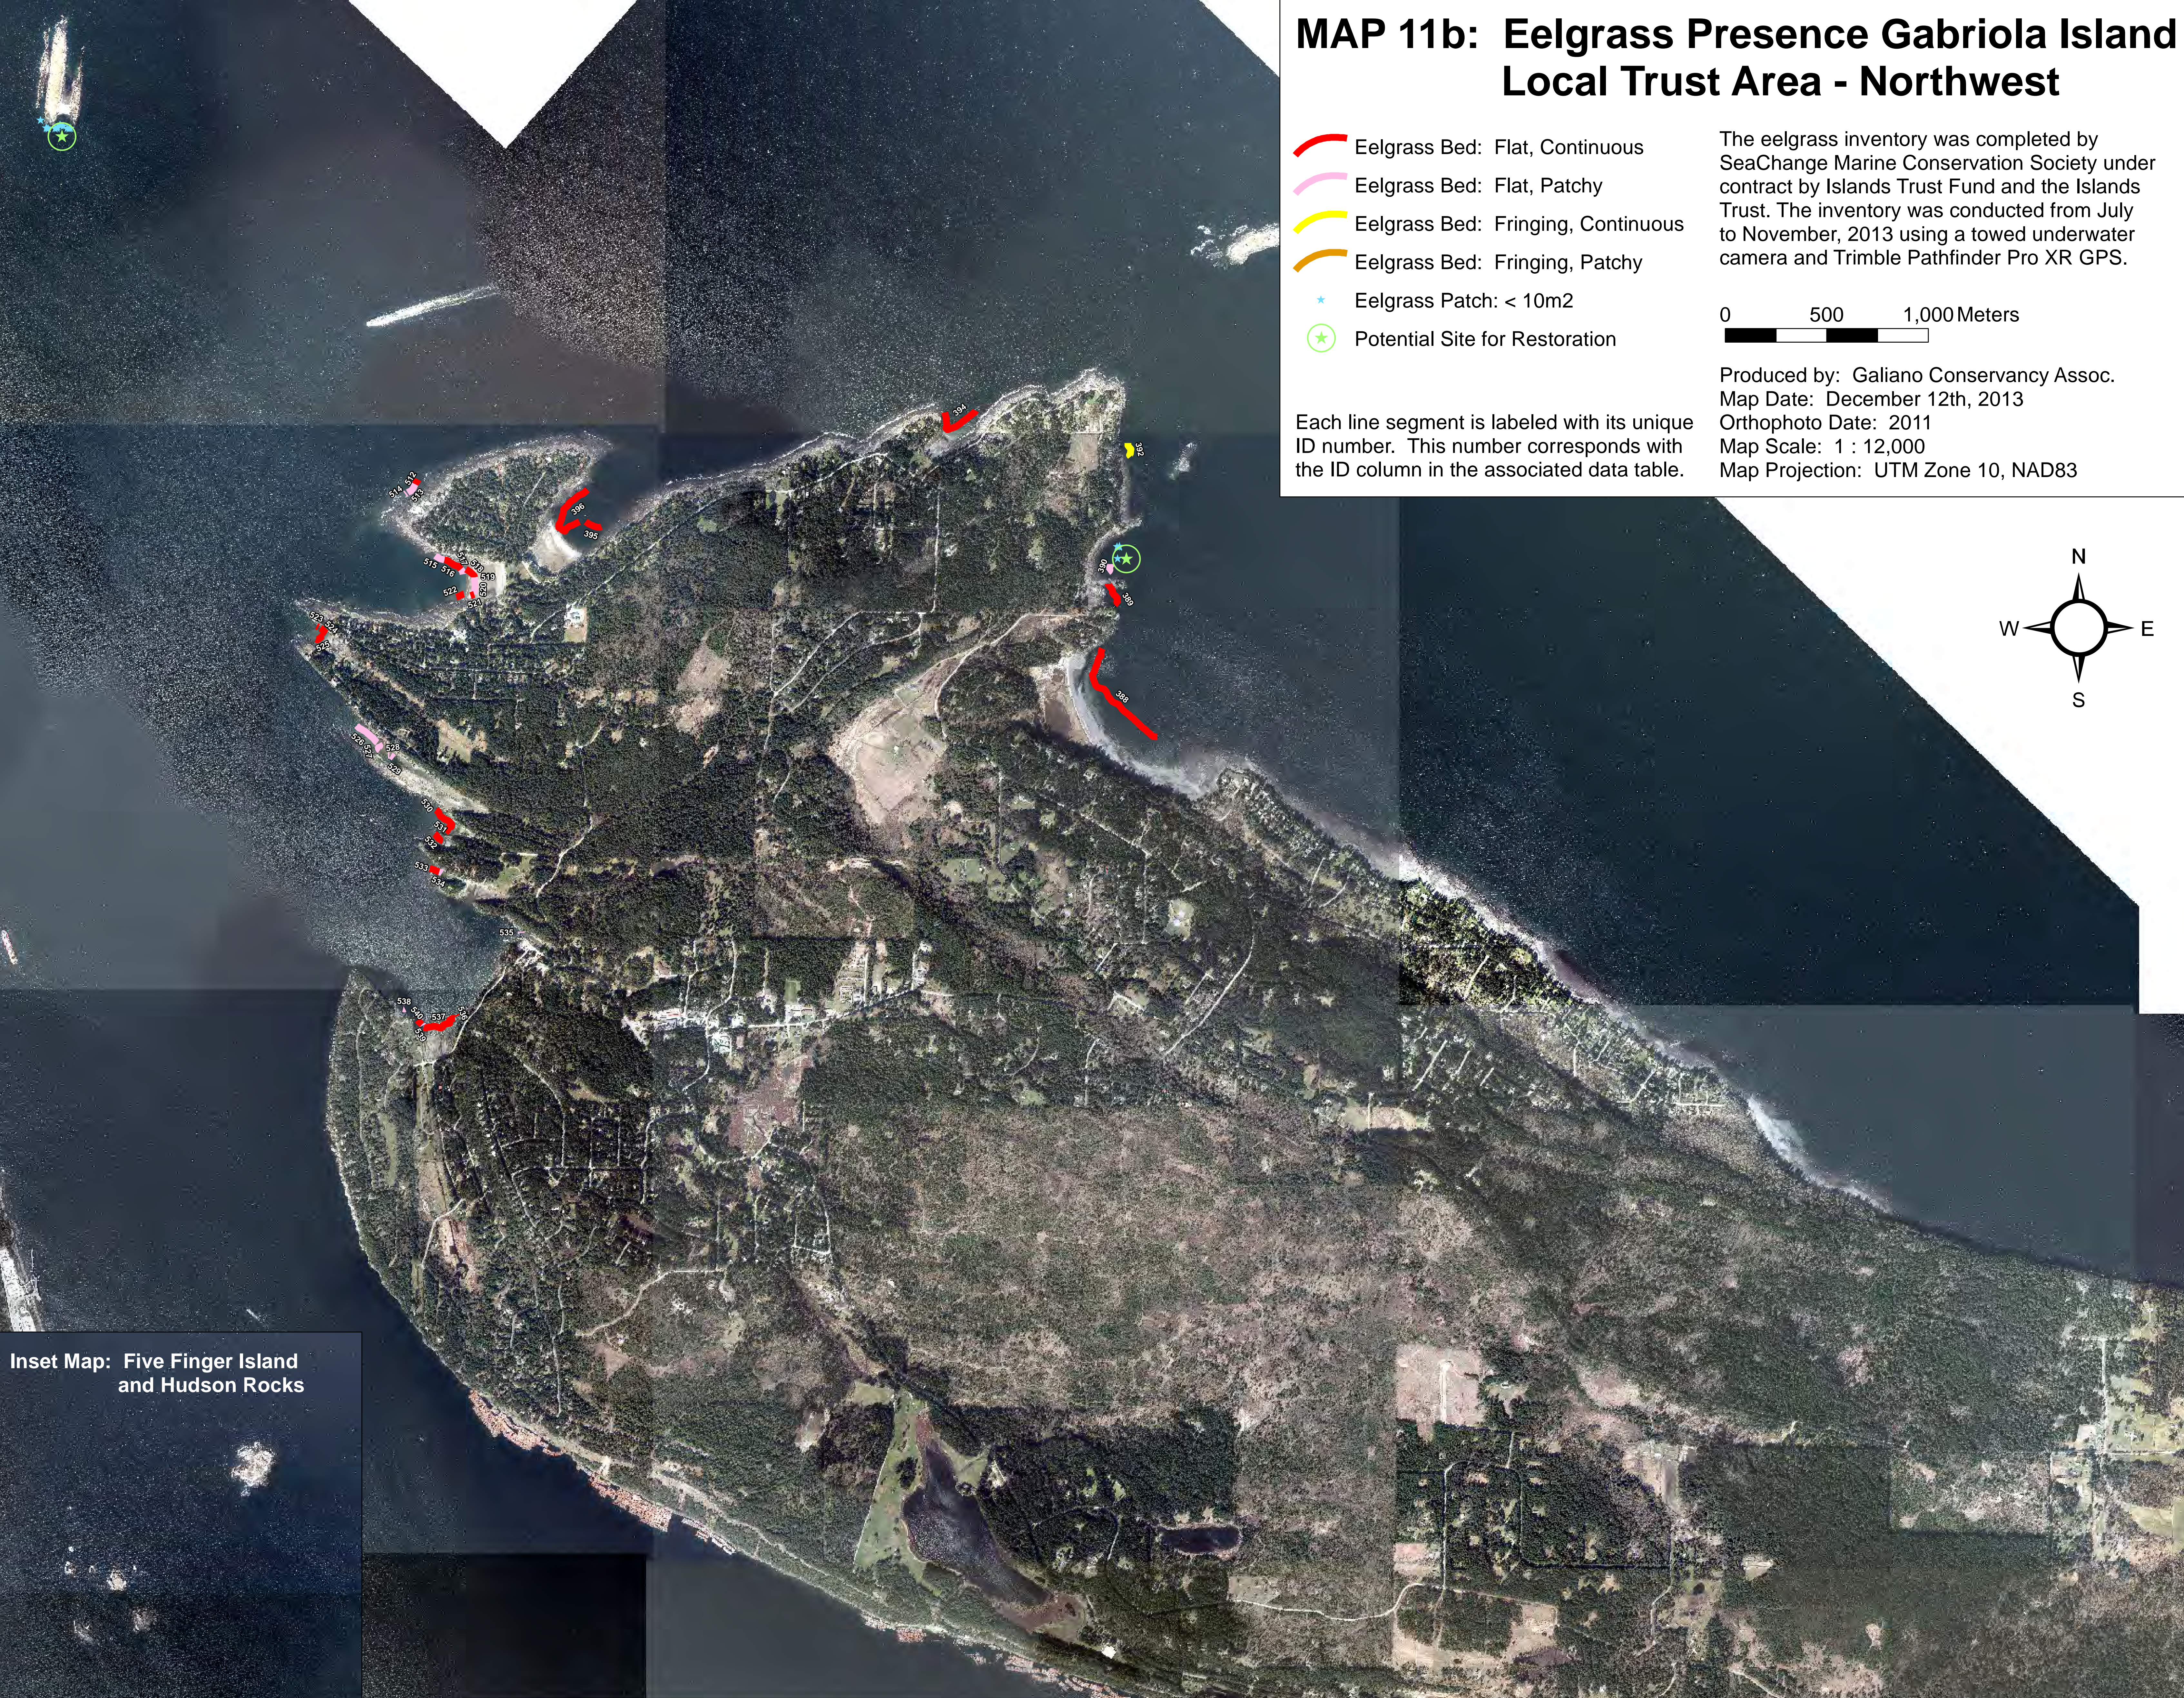
-   Eelgrass Bed: Flat, Continuous
-   Eelgrass Bed: Flat, Patchy
-   Eelgrass Bed: Fringing, Continuous
-   Eelgrass Bed: Fringing, Patchy
-   Eelgrass Patch: < 10m2
-   Potential Site for Restoration

Each line segment is labeled with its unique ID number. This number corresponds with the ID column in the associated data table.
